**TESTING OF A FULL-SCALE ROTARY MICROFILTER FOR THE
ENHANCED PROCESS FOR RADIONUCLIDES REMOVAL**

D.T. Herman
D.B. Stefanko
M.R. Poirier
S.D. Fink

JANUARY 2009

Savannah River National Laboratory
Savannah River Nuclear Solutions
Aiken, SC 29808

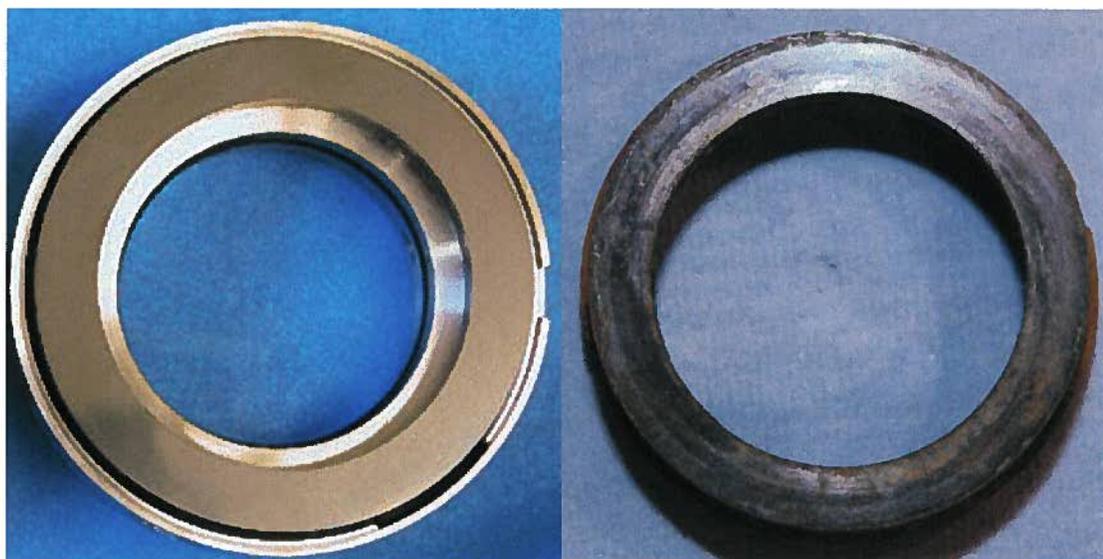
Figure 34. New Air Seal Carbon Face Compared to the Carbon Seal Face after 230 Hours of Operation

A photo of a new air seal carbon face compared to the carbon face after 230 hours of operation is shown in Figure 34.

The wear on the carbon face is judged to be “normal” for a nominally abrasive environment. The wear is not excessive. Measurements of the thickness of the seal face were the same as measured with a hand micrometer prior to start of testing (0.704”).

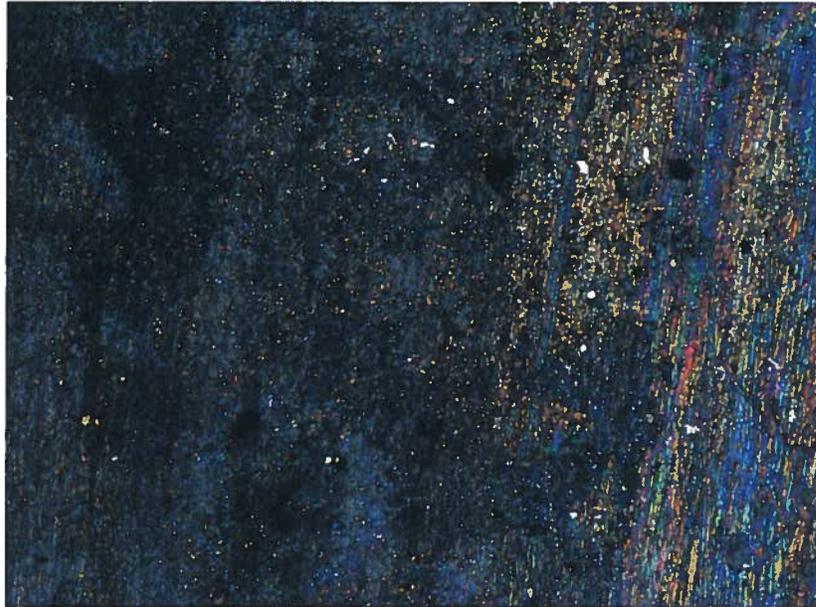
Figure 35. Air Seal Carbon Face at 4X Magnification

Figure 35 shows an area of the carbon seal face at the seal dam at 4X magnification. Some polishing of the seal face is observed in the photo. No evidence of significant scratching was observed when the seal face was examined under a microscope. Wear seen on the seal face occurs prior to liftoff, mostly occurring at startup and shutdown. The seal was subject to approximately 50 startup/shutdown cycles during testing.

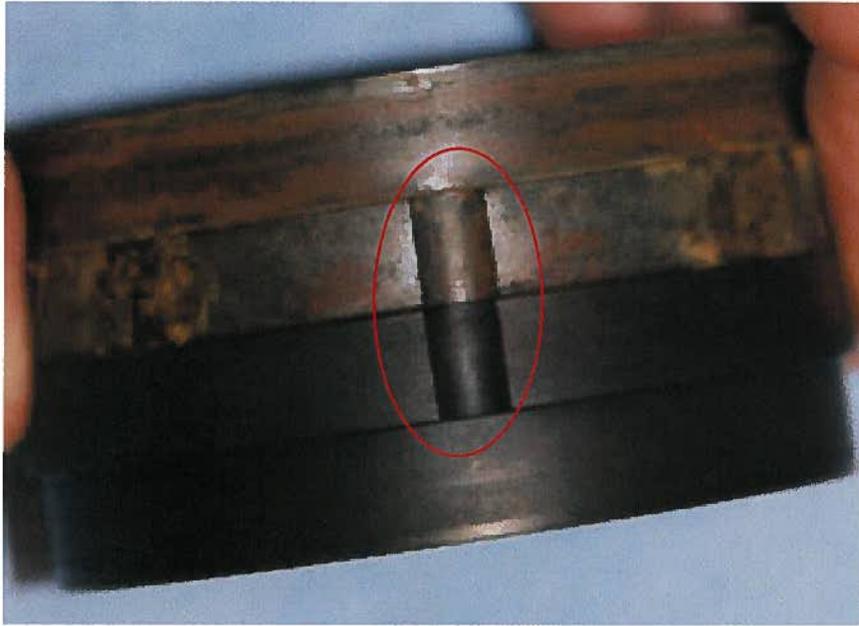
Figure 36. Photo of Seal Drive Tang after 230 Hours of Operation (top) Compared to a New Seal (bottom)

Figure 36 shows a photo of the drive tang from the seal after disassembly as compared to a new seal face. The two seal faces are photographed back-to-back with the drive tangs aligned. The new seal face is on the bottom and the seal used in testing is stacked on top. Note how there is significantly less wear on the drive tang than was observed on the initial air seal shown in Figure 6.

The decrease in the wear of the drive tangs indicates that improvements have been made to the amount of vibration seen by the seal, translating into less observable wear.

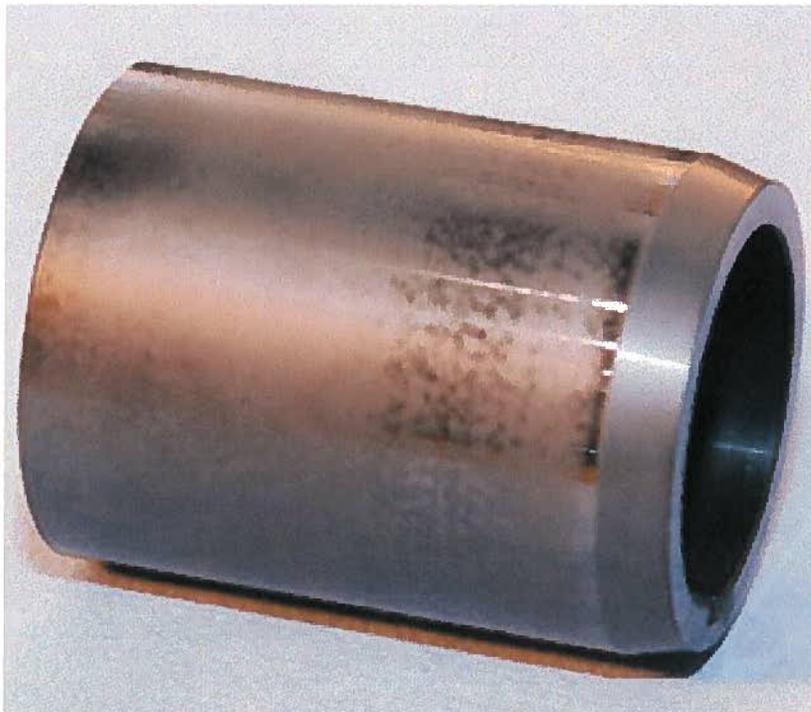
Figure 37. Photo of Lower Shaft Bushing Rotating Part

Inspection of the shaft bottom bushing shows that the assembly continues to wear well. This is the second test campaign using this bushing configuration. Total operational time is approximately 380 hours. The primary area of contact on the shaft bushing is at the bottom of the bushing and continues to show the most polishing. A photo of the bushing removed from the shaft is shown in Figure 37. The polishing observed just above the chamfer is continuous around the circumference.

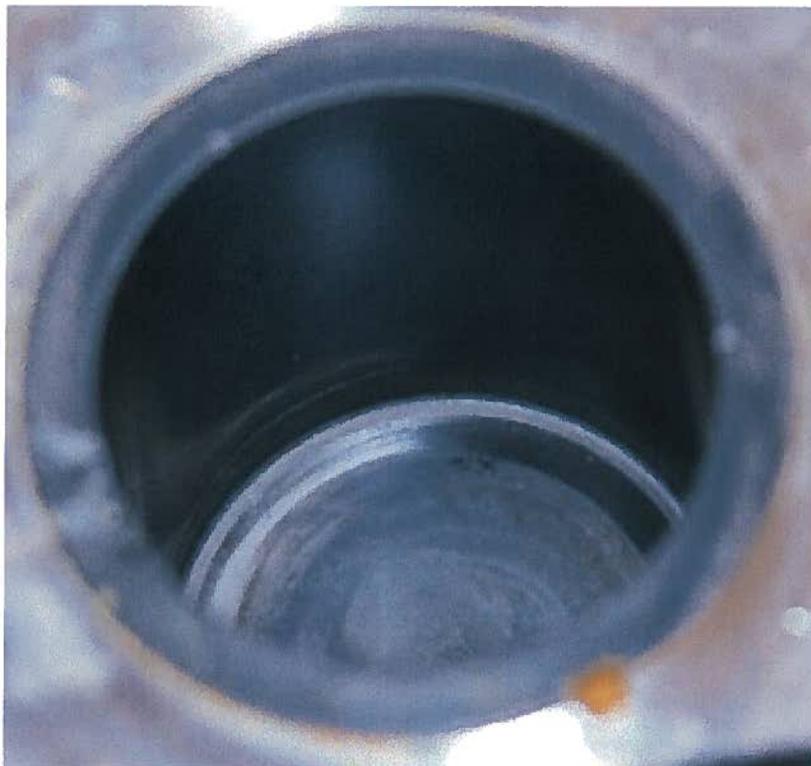
Figure 38. Photo of Lower Shaft Bushing Stationary Cup

The end of the bushing also continues to show polishing. The sealant that prevented the bushing from sliding down on the shaft was completely dissolved by the process or cleaning fluids. Therefore, the bushing was able to contact the bottom cup and a wear pattern can be observed. Figure 38 is a photo of the stationary silicon-carbide cup. The circular trace from the rotating bushing is seen in the bottom of the cup and some minor polishing can be observed in the lower side walls.

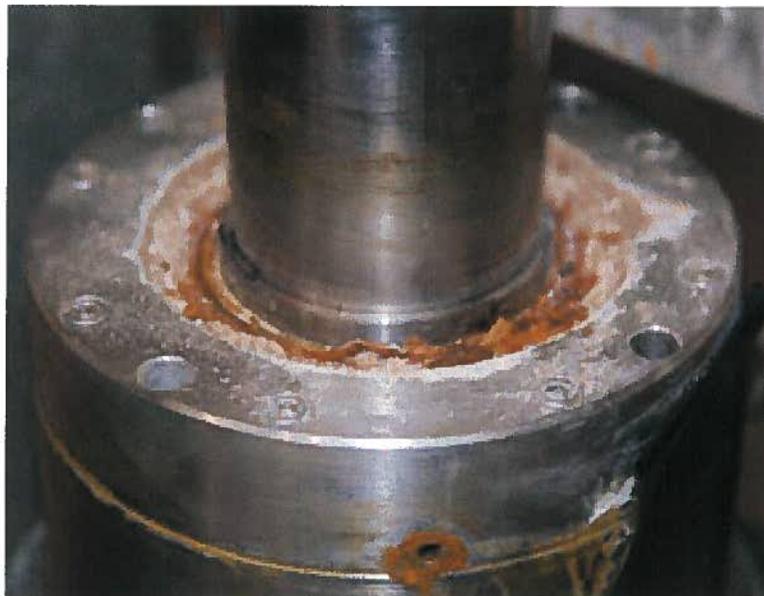
Figure 39. Rotary Joint at Test Completion

Inspection of the rotary joint prior to disassembly showed a fair amount of what appeared to be dried salt deposits. These deposits were found on both the top and bottom side of the rotary joint. A picture of the top of the rotary joint is shown as Figure 39. Some of the deposits had a brownish color similar to corroded carbon steel. The deposits did not have the brown color until nitric acid was used in cleaning of the filter disks.

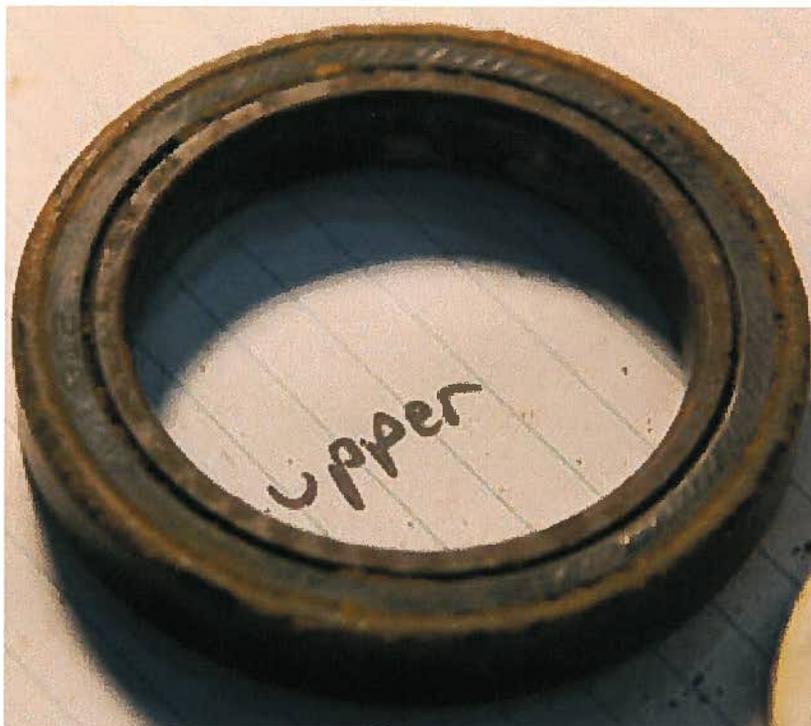
Figure 40. Photo of Upper Bearing from Rotary Joint

Disassembly revealed that salt solution had penetrated both the upper and lower bearings. Rust was evident on both bearings, and is the probable cause on the brown color on the material on the outside on the joint. The bearings were not manufactured from stainless steel. The upper bearing seal ring showed evidence of excessive torque as the seal ring had distended. A photo of the upper bearing is shown in Figure 40.

- Install a forsheda ring (or similar) in the rotary joint to shield the lower bearing from filtrate that crosses the mechanical seal faces. Additionally, assure all bearings are stainless steel to reduce potential corrosion.

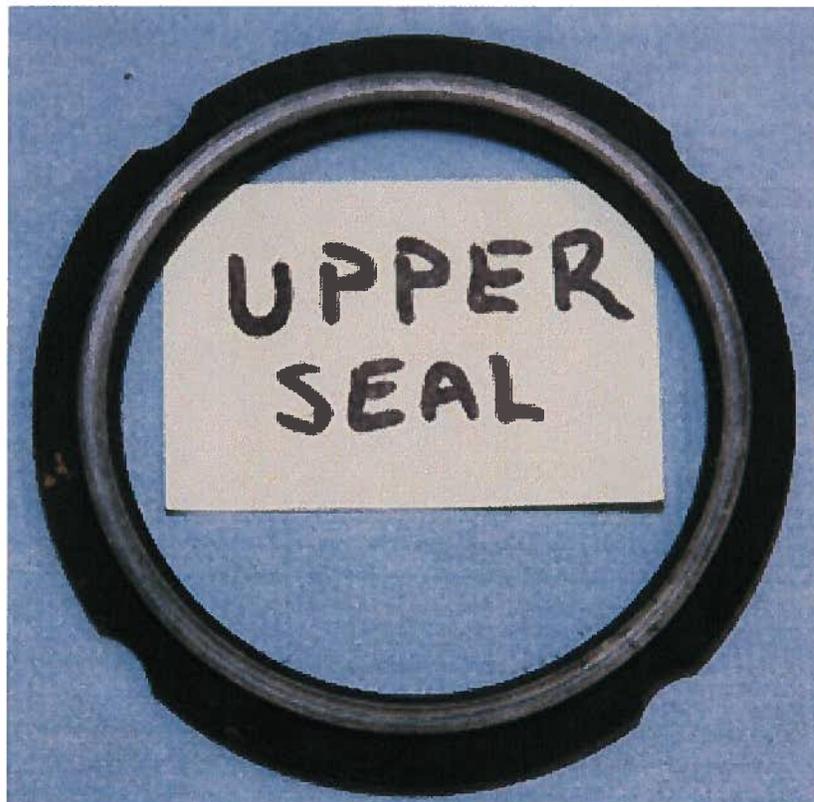
Figure 41. Rotary Joint Carbon Face of Upper Seal

A picture of the carbon seal face from the top seal of the rotary joint is shown in Figure 41 with a 4X magnification shown in Figure 42. The high polish on the center area is indicative of the seal operating at least partially dry. This operating mode was expected as the discharge from the rotary joint is currently located in the middle of the two seals thus allowing air to be trapped at the top seal. It is recommended that the discharge from the rotary joint be raised to minimize the trapping of air during operation of the filter.

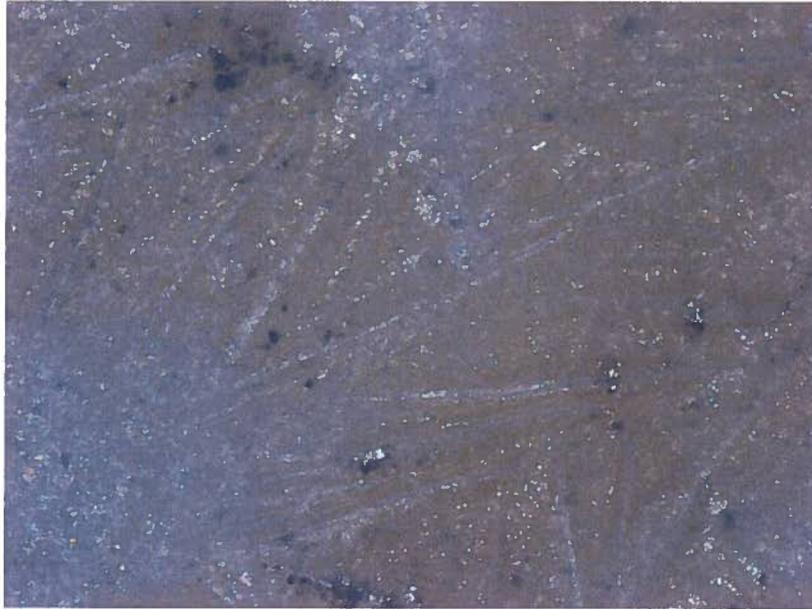
Figure 45 is a photo of the ceramic (alumina) face from the lower seal of the rotary joint outside of the seal area. The photo shows fluid that has passed between the seal faces and dried.

Figure 45. Alumina Seal Face from Bottom Seal of Rotary Joint Showing Dried Salt Outside of Sealing Area

Thickness measurements showed that both seals wore at relatively the same rate. Hand micrometer measurements ranged between 0.2572 and 0.2576 inches for the upper seal and between 0.2569 and 0.2574 inches for the lower seal. The range in thickness around the circumference of the seal indicates that the weeping of both seals was primarily due to the lack of flatness across the seal faces. This wear pattern is consistent with wear due to excessive vibration. The reduction in the vibration would greatly extend the life of both seals.

Several upgrades are recommended for the rotary joint to increase expected lifetime. These recommendations include raising the location of the discharge port to minimize trapped gas; providing drip protection to the bearings through the use of forsheda rings or similar design; increasing the size of the weep area to allow any weeping filtrate to discharge more readily; and using stainless steel components in all bearings to prevent corrosion.

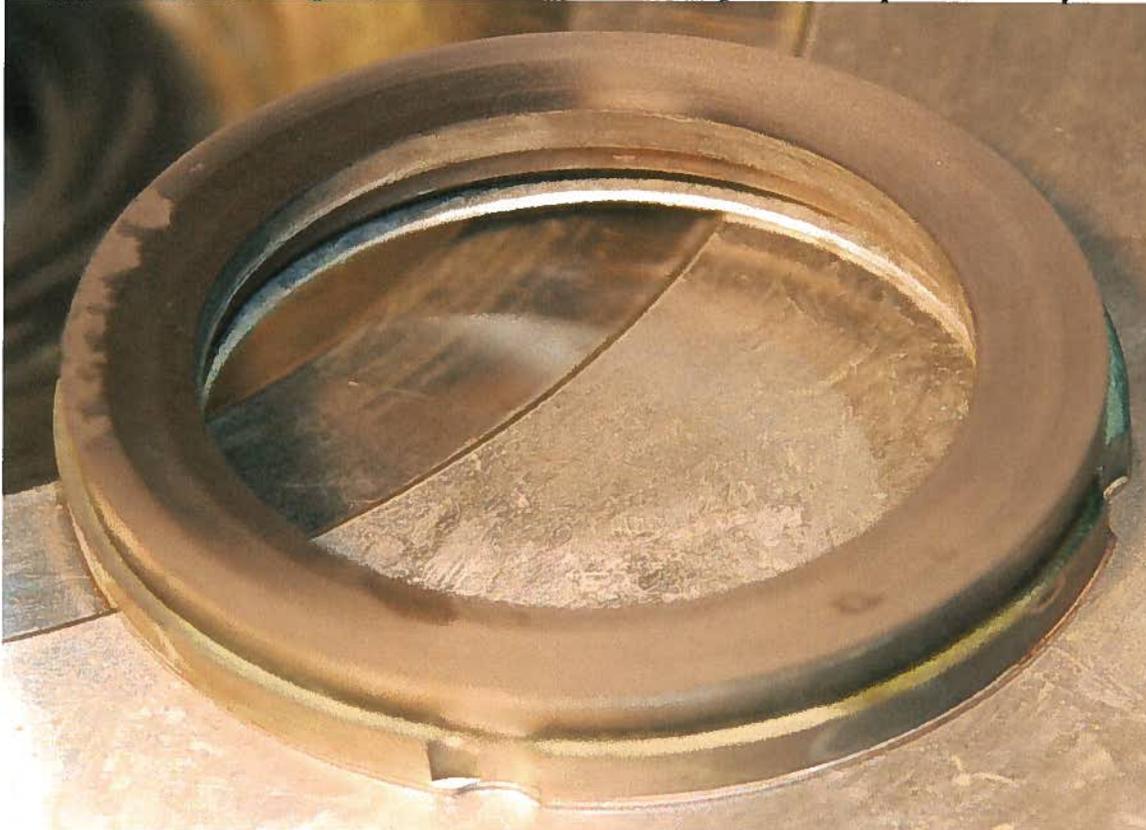
The chipping that is observable at the 9:00 position is the root cause of leakage. These are what are referred to as "Blisters" and occur in much the same manner as "Gauling" of metal. Normally something of a viscous nature gets between the faces and causes an adhesion that leads to pullout of surface particles. This is not uncommon in certain services where the nature of the product is viscous in nature but to occur in one single confined segment of the carbon ring as this is, is not easily explained. None of those who have observed this type of damage have seen this effect before. For lack of another explanation we believe this is an anomaly that has occurred and is due to some foreign substance being drawn between the faces. If the general process fluid had caused this we would expect the damage to be random in multiple quadrants not confined and excessive at just one point. The substructure of the carbon appears consistent and if this was a defect in the material itself it would be extremely odd that it would occur strictly in one extensive wear area showing as multiple blisters.

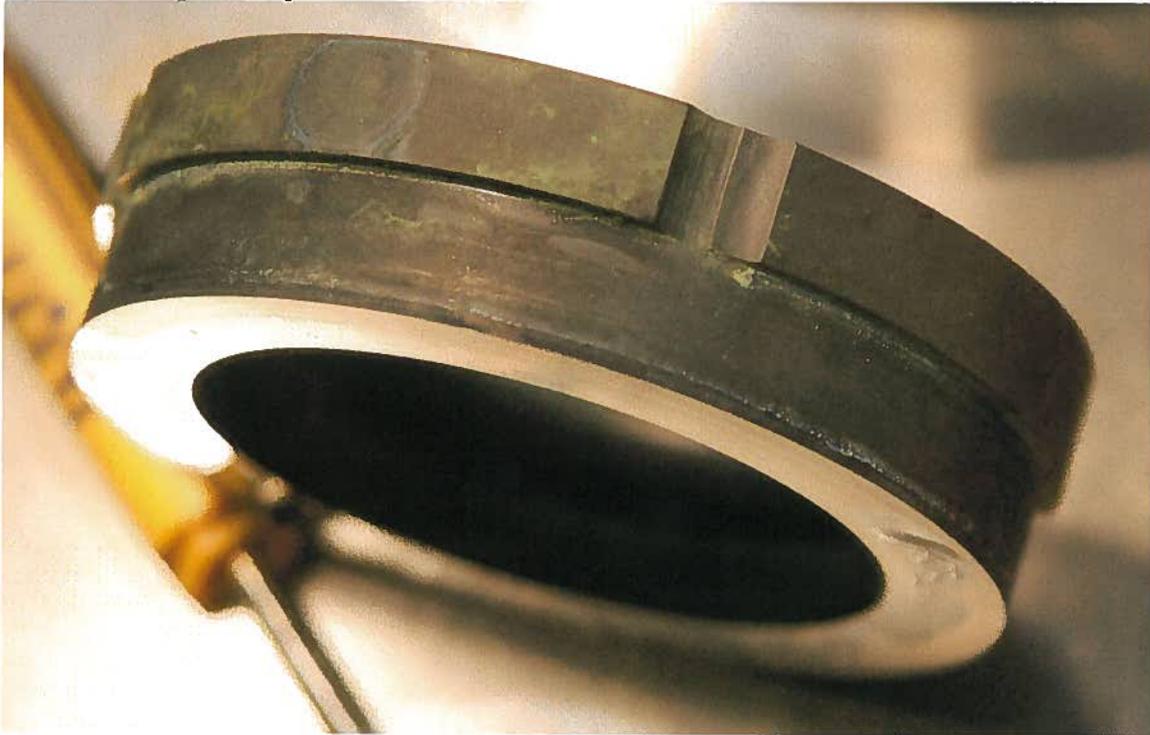
The additional traces of the Silicon Carbon faces have indicated no problems. We had feared that abrasive wear might have affected them but as you can see that is not the case:
