**DETERMINATION OF CORROSION INHIBITOR CRITERIA FOR
TYPE III/IIIA TANKS DURING SALT DISSOLUTION OPERATIONS –
SUMMARY DOCUMENT (U)**

B. L. Garcia-Diaz
J. I. Mickalonis
B. J. Wiersma

OCTOBER 2009

Savannah River National Laboratory
Savannah River Nuclear Solutions
Aiken, SC 29808

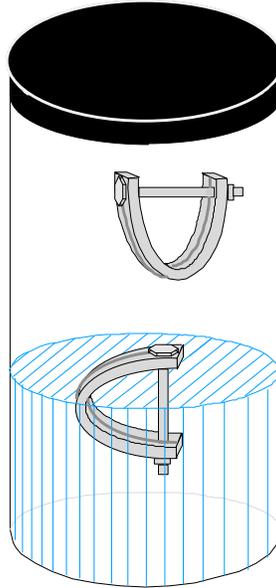
removal, they were allowed to dry so that salt crystals formed. Figure 3-1 is a picture of the coupons in their respective positions in the test vessel.

Figure 3-1 Positions of U-bend Coupons in Test Vessel for Long-Term Non-Polarized Tests

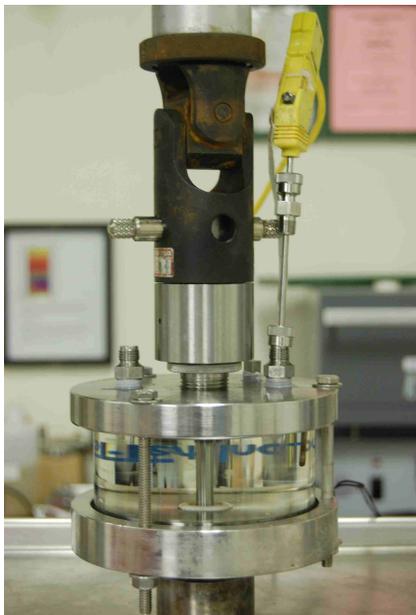
Figure 3-2 Test set up of slow strain rate test for exposure to oil

The polarization was conducted using a computer-controlled Gamry PC4-750 potentiostat with a Ag/AgCl reference electrode and a 304L stainless steel mesh cylinder as a counter electrode. The cylindrical diameter was that of the inner diameter of the test cell wall. The test cell, as shown in Figure 3-2, had a borosilicate glass wall with a top and bottom plate made of Hastelloy

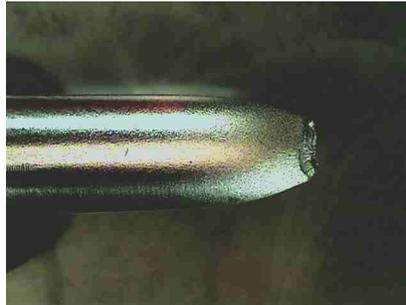
After each test, samples were visually examined by low power microscopy to identify secondary cracking along the gage length of the sample and changes in the failure surface from that observed in oil. A cup and cone type of failure was observed in the specimens tested in oil, indicating a ductile failure as shown in Figure 3-3.

Figure 3-3 Cup-cone failure morphology of A537 pulled in oil

Initial testing was performed in oil at temperature to determine the baseline for comparison with the other data. The sample failure was ductile with a standard cup –cone morphology as shown previously in Figure 3-3. In the low inhibitor solutions ((0.01M OH⁻ and 0.01M NO₂⁻), only AR samples were used since U-bend coupons had failed in these solutions previously. The load-time plots for the low inhibitor solutions are shown in Figure 4-8 along with the baseline oil plot. As can be seen in the figure and Table 4-5, the maximum load and time to failure for the polarized sample are reduced from those values in oil and at the OCP. The polarized sample had an RIA that dropped to 37% from the approximately 50% for oil and non-polarized samples. Figure 4-9 shows a scanning electron micrograph (SEM) of the cracks along the gage length below the failure point of the polarized sample. Note the intergranular nature of the attack, which is typical for nitrate SCC. The samples also experienced general corrosion, although pitting was not observed.

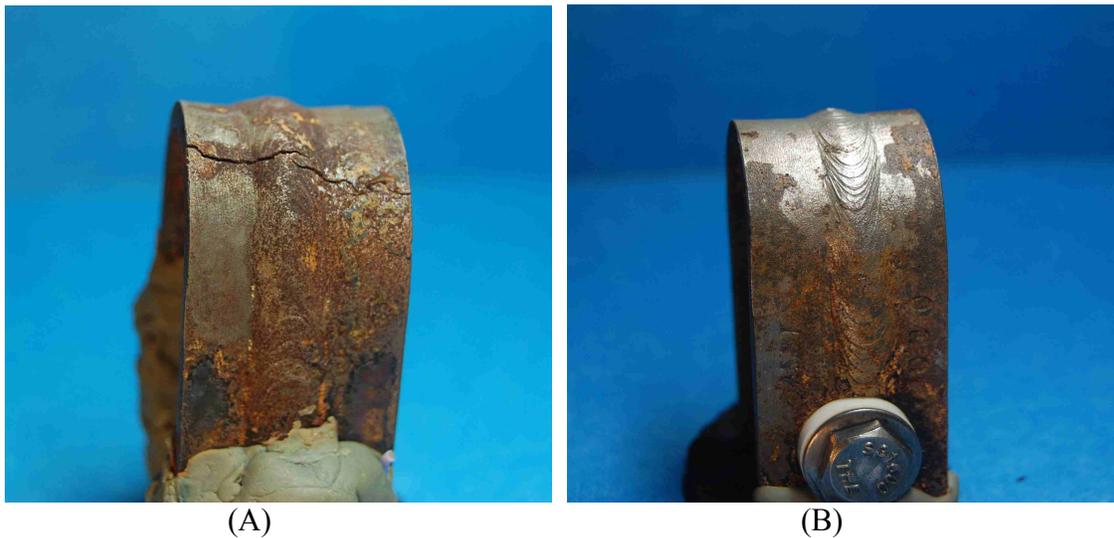
After eighteen months, all U-bend coupons in both the VS and LAI were pitted and many had experienced SCC. Figure 4-1 has photographs of the coupons exposed to the 8.5M NaNO₃ solution with 0.1 M each of NaOH and NaNO₂. The results of the visual evaluation are given in Table 4-1. Only the modes of corrosion are given since they were not quantitatively evaluated, i.e. pit depths or number of cracks, etc. The corrosion was prevalent on both the sides and the top surface of the U-bend coupons. Inside surfaces of the U-bend coupons, which were corroded, were not closely examined.

Figure 4-1 Corrosion on as-received U-bend coupons exposed during long-term non-polarized testing at 50 C in 8.5M NaNO₃, and 0.1 M each NaOH and NaNO₂ for 18 months: (A) Liquid-air interface exposure; (B) Vapor space exposure

These data demonstrate that VS SCC occurs with initiation and growth of cracks. These cracks occurred primarily on the U-bend coupons which had mill scale and were not heat treated. Multiple crack indications were observed on some samples, but only one crack grew across the width of the U-bend coupon. The HT U-bend coupons had fewer pits and areas of general corrosion than AR coupons and were free of cracks. One HT coupon had crack indications, which were groove-like features in the side of the U-bend coupon. A correlation of corrosion

morphology with the presence of indents could not be made, which may be due to the large amount of general corrosion that occurred. For the LAI coupons, the degree of pitting and general corrosion appeared to be more significant on the immersed portion.

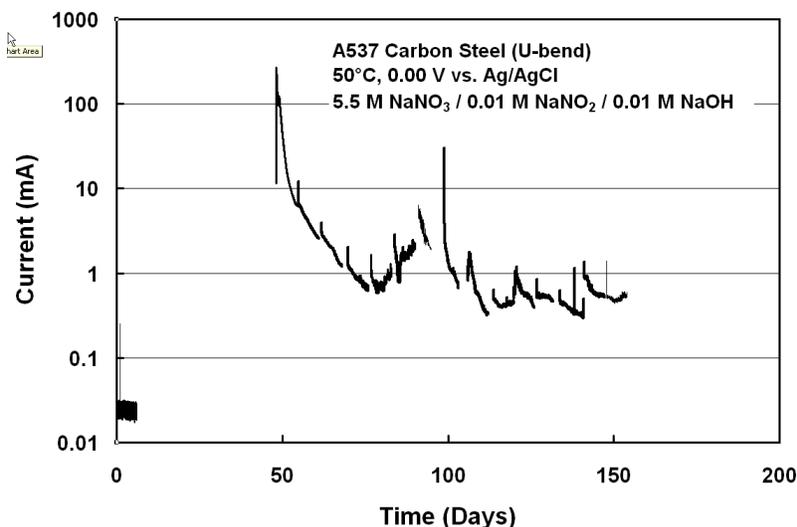
Figure 4-2 Long-term polarization of U-bend coupons at 50 °C in 5.5M NaNO₃, and 0.01 M each NaOH and NaNO₂

The results of the long-term U-bend polarization in 5.5 M nitrate with low inhibitor levels (0.01 M OH⁻ and 0.01M NO₂⁻) in Figure 4-2 showed an increase in current from 0.6 mA to 6 mA from day 80 to day 90 of testing. This protracted increase in current may be associated with the cracking that occurred in the U-bend coupons. The current from this U-bend coupon decreased back to 0.3 mA from day 90 to day 112 days of testing. This decrease in current is attributed to the formation of a diffusion barrier inside the newly formed crack and on the U-bend exterior surface.

All of the coupons tested started with currents greater than 100 mA and the currents decreased below 1 mA within 1 month of continuous testing. The decrease in current is mostly caused by the build up of corrosion products on the coupon surface that creates a diffusion barrier for reactants in the electrolyte to reach the surface.

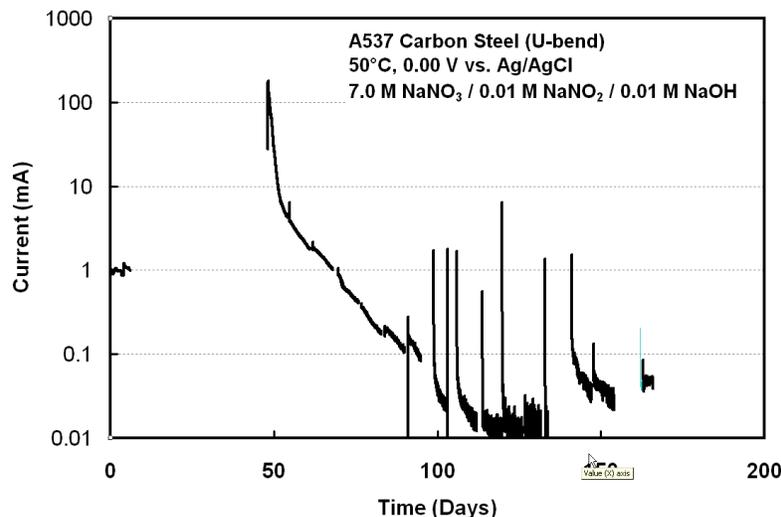
Figure 4-3 displays the results for the 7.0 M nitrate solution with low inhibitor levels. The current for the U-bend in this solution steadily dropped to 0.01 mA and stayed constant at that value until day 140. After day 140, the current slowly started to increase until the end of the test where the current was approximately 0.06 mA. This increase may correlate with the beginning of crack formation that was observed on the U-bend coupon. The rate of current increase in this solution was much slower than for the 5.5 M nitrate solution and the current magnitude was smaller.

Figure 4-3 Long-term polarization of U-bend coupons at 50 °C in 7.0M NaNO₃, and 0.01 M each NaOH and NaNO₂

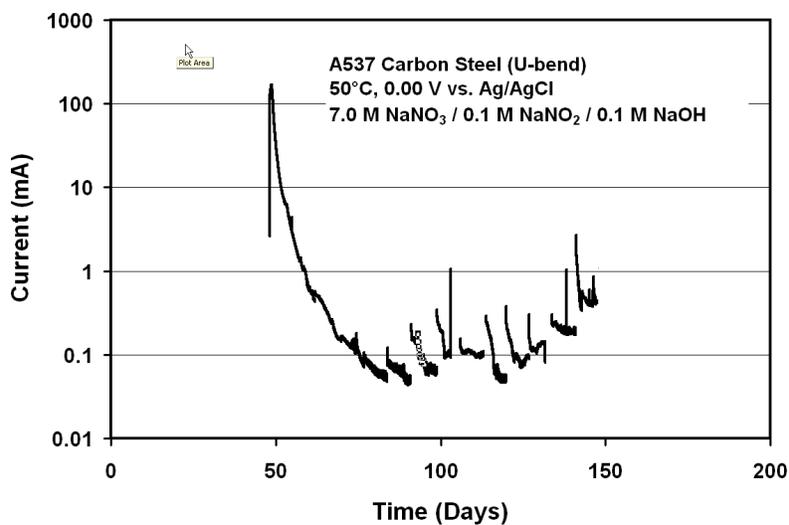
Figure 4-4 shows the current data for the polarized U-bend in 7.0 M nitrate solution with high inhibitor levels (0.1 M OH⁻ and 0.1M NO₂⁻). The current for this U-bend coupon decreased to 0.045 mA by day 85 before increasing to 0.11 mA by day 110. The increase was most likely caused by the development of a small crack. The current data suggest that a second crack started near day 120 when a second increase in the current started.

Figure 4-4 Long-term polarization of U-bend coupons at 50 °C in 7.0M NaNO₃, and 0.1 M each NaOH and NaNO₂

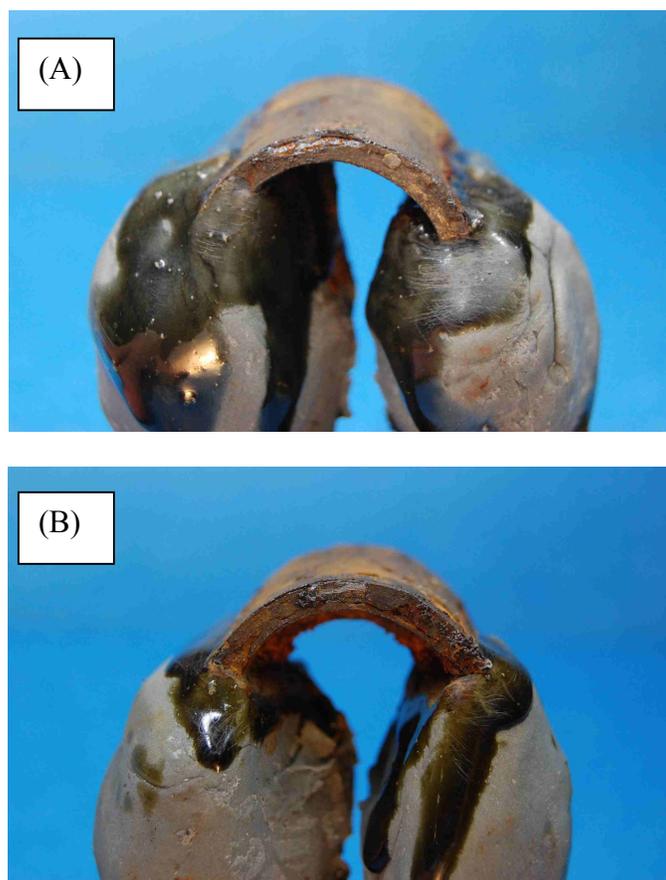
Figure 4-5 Photographs of polarized U-bend coupons after 150 days at 50 °C in: (A) 7.0M NaNO₃, and 0.01 M each NaOH and NaNO₂ and (B) 7.0M NaNO₃, and 0.1 M each NaOH and NaNO₂

All the polarized U-bend coupons had a similar corrosion morphology and showed signs of cracking, although no major through wall cracking occurred. Figure 4-5 shows photographs of the U-bend coupons after testing in the 7M NaNO₃ solutions. All samples showed some degree of end-grain type attack where the grain boundaries were preferentially attacked into the rolling plane of the metal. This attack appears to have produced an exfoliation of corrosion product layers as can be observed in the photographs. Small cracks running perpendicular to the coupon stress were also observed. The U-bend coupons did not show significant pitting like the non-polarized U-bend coupons, but these coupons had significant corrosion products indicative of a high corrosion rate at the polarized potential of 0.0 V.

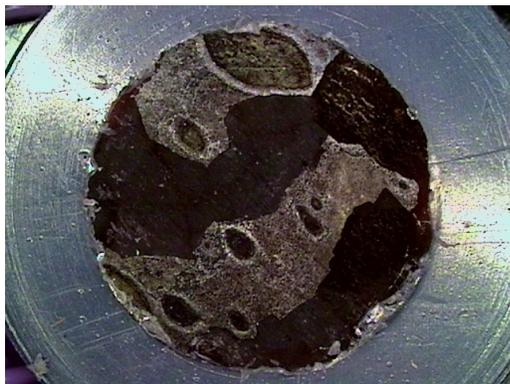
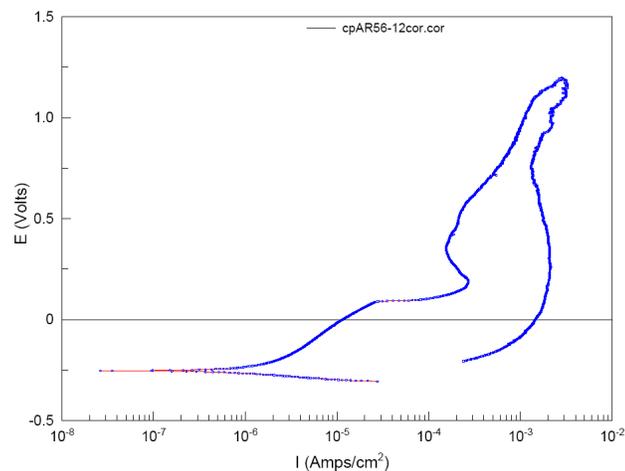
Figure 4-6 Polarization results for mill scale coupon exposed at 50 °C in 5.5M NaNO₃, and 0.6 M NaOH and 0.2M NaNO₂: (A) Post-test photograph of coupon; (B) Polarization scan showing a negative hysteresis with a high BP

Several trends are apparent in Table 4-3. As shown by the predominance of a negative hysteresis, most samples were susceptible to pitting, which was verified by the post-test visual examination of the test coupons. The hysteresis for the ground samples was larger than that for the mill scale samples indicating a greater degree of pitting.

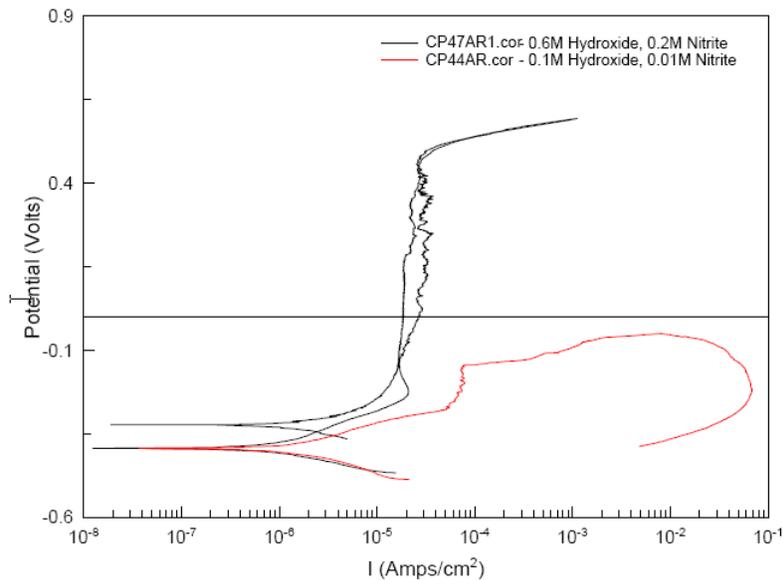
In solutions with low levels of corrosion inhibitors (0.01M OH^- and 0.01M NO_2^-), coupons were susceptible to pitting independent of temperature or surface preparation. In Figure 4-7, the polarization scans are shown for both the low and high inhibitor of the ground coupon at 50 °C. The BP values were below 0.0 V indicating the easy onset of localized corrosion. The polarization scans had large negative hysteresis loops. At 50 °C only, coupons did not have a RP so CP was above the RP indicating that carbon steel readily pits in these solutions.

Figure 4-7 Polarization scans for ground weld coupons at 50 °C in 5.5M NaNO₃, and different inhibitor concentrations

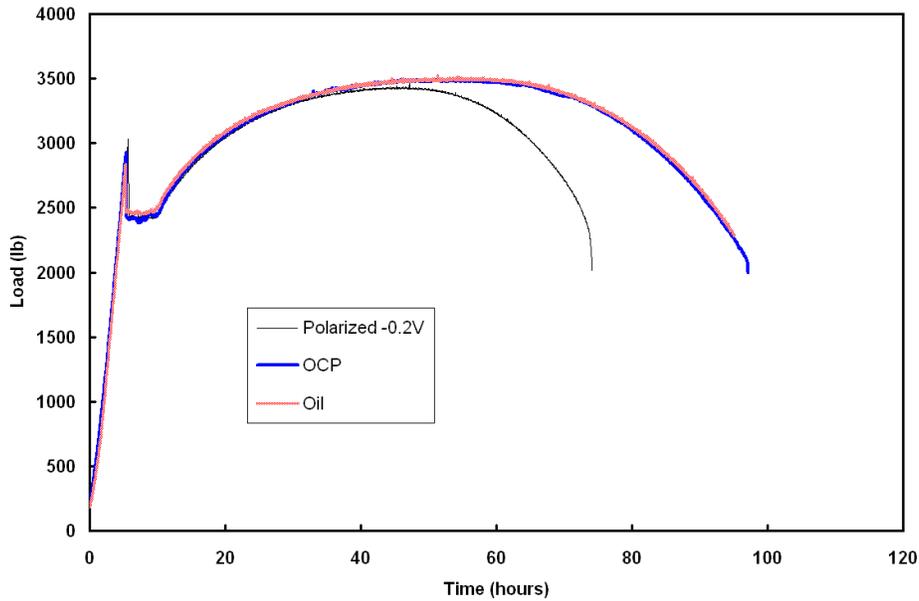
Figure 4-8 Load-time plots from SSRT for A537 tensile bars in solutions containing 7.0 M NaNO₃, 0.01M NaOH, 0.01M NaNO₂ at 50 °C and in oil

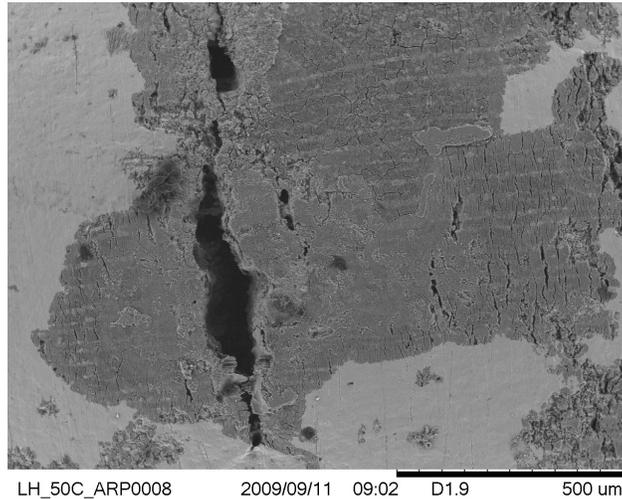
Figure 4-9 SEM micrograph of cracks in gage length of A537 tensile sample exposed to solution containing 7.0 M NaNO₃, 0.01M NaOH, 0.01M NaNO₂ at 50 °C

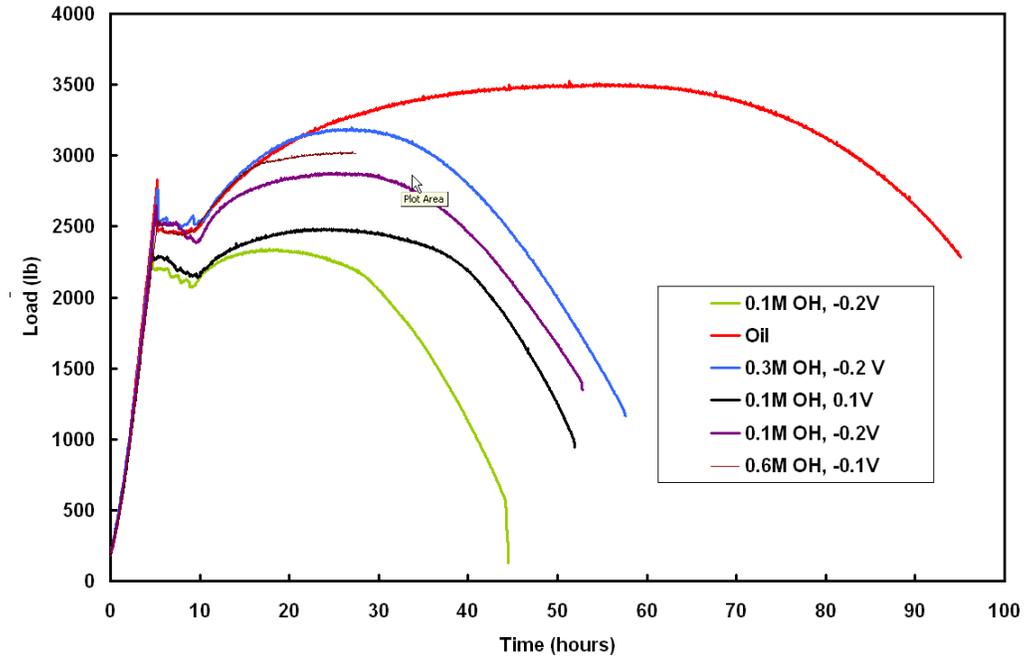
Figure 4-10 Load-time plots from SSRT for A537 tensile bars in solutions containing 7.0 M NaNO₃ and various inhibitor levels

were examined and found to have cracks indicating the start of the SCC. The load-time plots for these samples along with those tested with inhibitor level of 0.1M NaOH and 0.1M NaNO₂ are shown in Figure 4-10. Figure 4-11 shows photographs of the failed tensile bars for both the 0.1M and 0.3M OH⁻ inhibitor levels polarized at -0.2V. Note the corroded cracks near the tip of each sample.

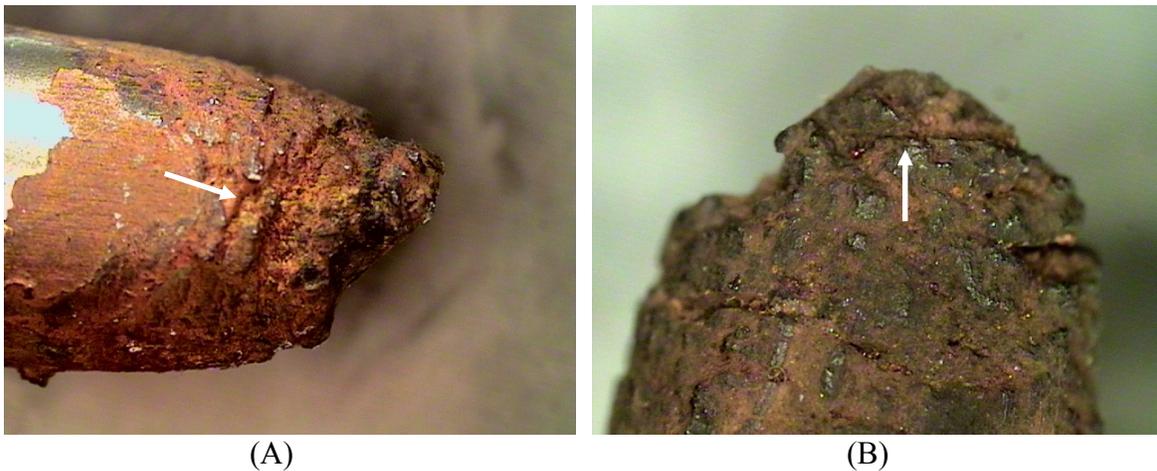
Figure 4-11 SSRT samples after testing at 50 °C in: (A) 7.0 M NaNO₃, 0.3M NaOH, 0.1M NaNO₂ and (B) 7.0 M NaNO₃, 0.3M NaOH, 0.1M NaNO₂ (arrows indicate corroded cracks)
