**POTENTIAL FOR STRESS CORROSION CRACKING OF A537 CARBON STEEL
NUCLEAR WASTE TANKS CONTAINING HIGHLY CAUSTIC SOLUTIONS[†]**

Materials Science and Technology
Savannah River National Laboratory (SRNL)
Aiken, South Carolina 29808, USA**ABSTRACT**

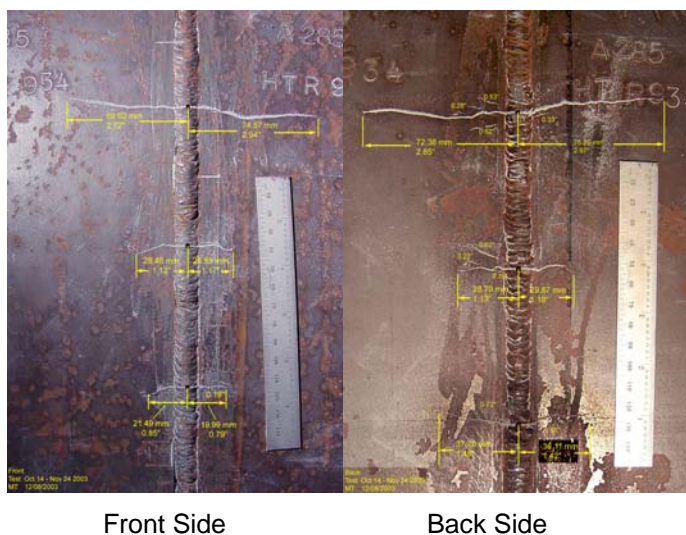
Fig. 1 Nitrate stress corrosion cracking of the as-welded A285 plate [1].

In an earlier study [1], the nitrate stress corrosion cracking in A285 carbon steel nuclear waste tanks was shown to be effectively eliminated by relieving the welding residual stress through heat treatment. Figure 1, magnetic particle testing (MT) results, shows the stress corrosion cracks growing from the initial, machined seed cracks in an as-welded, non-heat treated A285 plate, which was submerged in a 5 M sodium nitrate solution at 90 °C. Meanwhile, no cracking could be found even by ultrasonic testing (UT) in the companion test plate which had been heat treated. The stress corrosion cracking was initiated from the seed cracks as early as two weeks following immersion in the aggressive solution (no inhibitors were present).

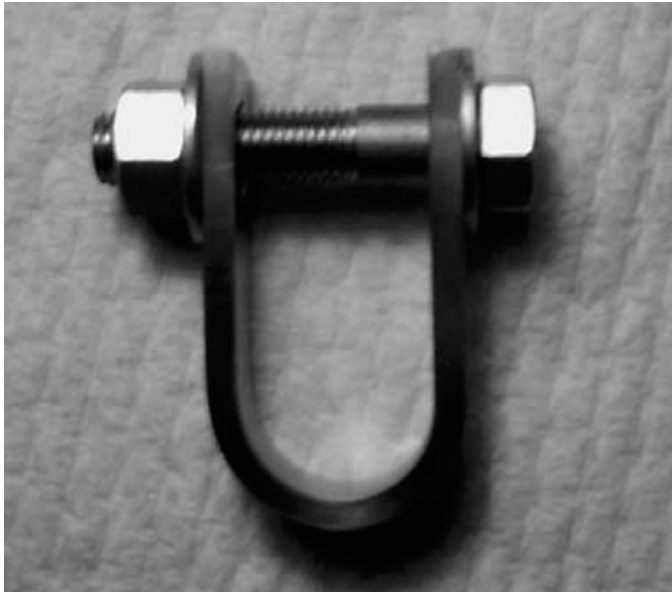
Fig. 2 U-bend specimen made from a 12.7×2.54×3.18 mm strip.

Two types of specimens were used: 1) small scale U-bend (Fig. 2) made from a strip of 12.7 cm (5 in.) long, 2.54 cm (1 in.) wide, and 3.18 mm ($\frac{1}{8}$ in.) thick; and 2) large plate of dimensions 30.48×30.48×2.54 cm (12×12×1 in.) with machined

Prior to submerging in the test solution, each pair of the specimen legs was bent approximately parallel. To maintain the shape without relaxing the elastic tensile strain, the legs were tightened by nuts and a screw which are properly insulated with PTFE washers and sleeve to avoid the galvanic effects between two different materials (Fig. 2).

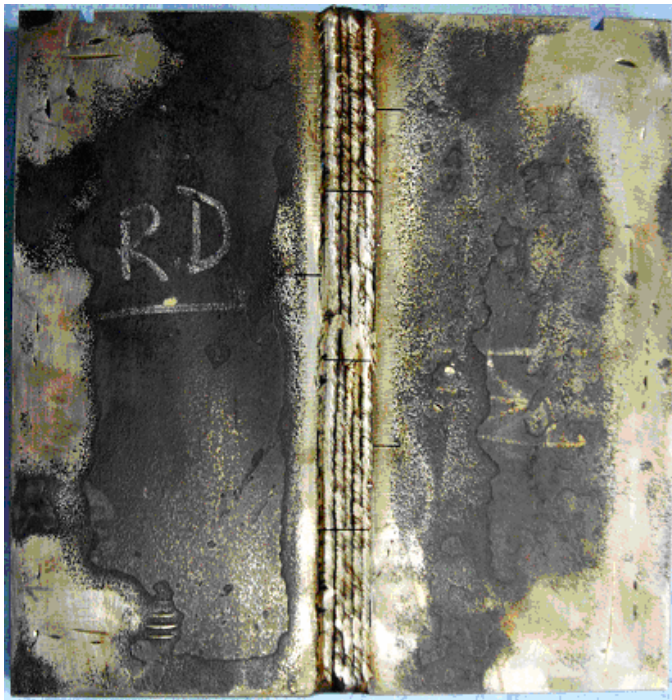
Fig. 3 Large-plate specimen (30.48×30.48×2.54 cm).

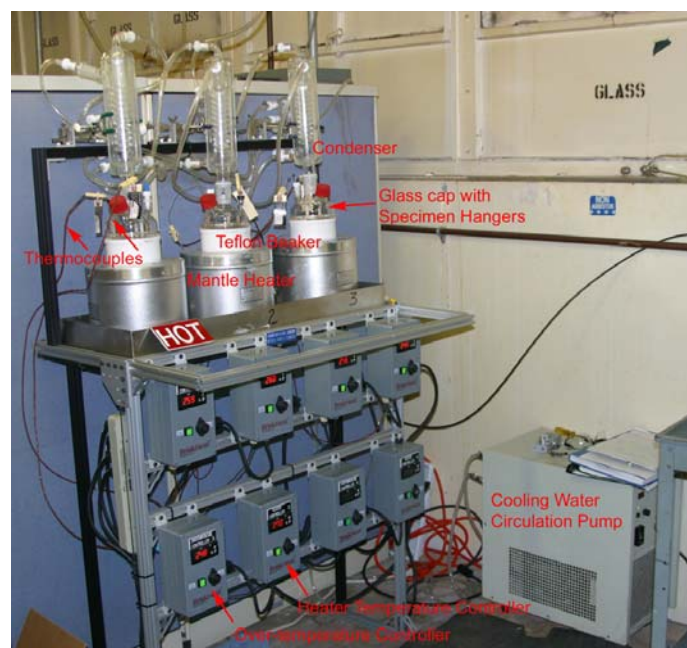
Fig. 4 U-bend test station.

The overall laboratory setup can be seen in Figure 4. The duration of the testing was 21 days. The U-bend specimens were examined periodically for cracking during the test period.

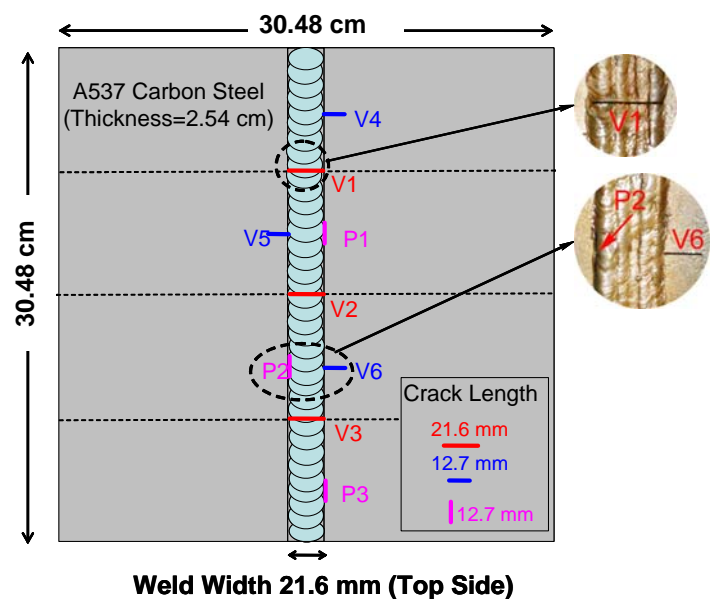
Fig. 6 Welded large plate specimen with machined cracks.

The schematic seed crack placement and crack types can be seen in Figure 6. The actual seed cracks are shown in the insets of the figure. The electric discharge machining (EDM) was used to fabricate these cracks so the crack tips can be as sharp as possible. Due to the EDM wire or electrode size, the crack tip maintains a small but finite radius (e.g., 0.38 mm or 0.015 in.).

The three types of machined cracks are (see Figure 6):

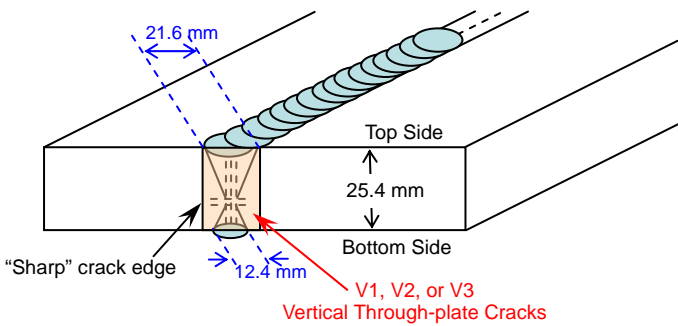
Fig. 7 Through-the-plate cracks across the weld (V1, V2, and V3).

- 1) V1, V2, and V3: vertical cracks through the thickness of the plate and across the weld (Fig. 7);
- 2) V4, V5, and V6: vertical cracks partly through plate in the heat affected zone perpendicular to the weld (Fig. 8); and
- 3) P1, P2, and P3: cracks parallel to the weld and partly through plate in the HAZ along the edge of the weld (Fig. 9).

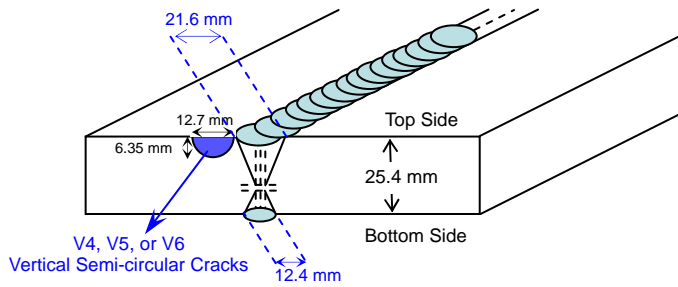
Fig. 8 Semi-circular surface cracks perpendicular to the weld (V4, V5, and V6).

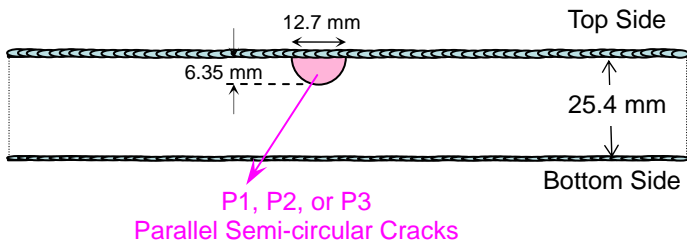
Fig. 9 Semi-circular surface cracks parallel to the weld (P1, P2, and P3).

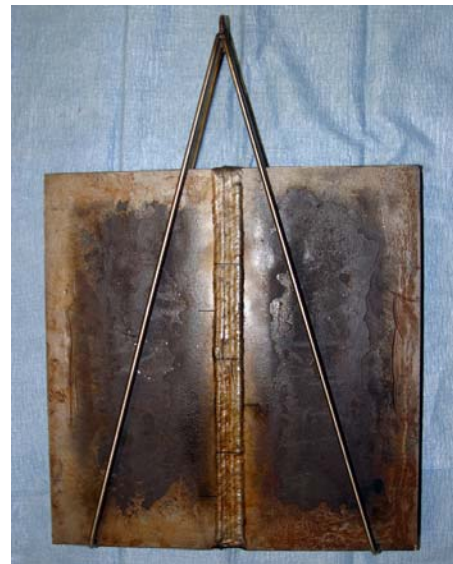
Fig. 10 Positioning of the test plate on the rack (hanger).

Because the weight of each large plate specimen is about 18 kg (40 lbs) and the specimens are lifted periodically above the heated caustic solution for visual inspection for cracking, a small manual rigging device is included in the design for safe operation during the test. Each carbon steel plate is suspended in a cradle (i.e., hanger or rack, see Fig. 10). The rack is made

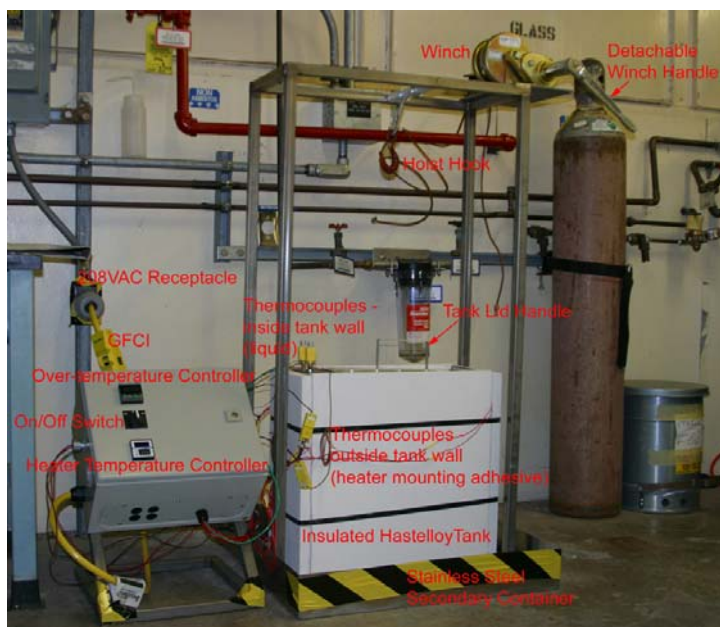
Fig. 11 Large plate experimental station.

All the components of the large plate experimental station and the laboratory layout are shown in Figure 11.

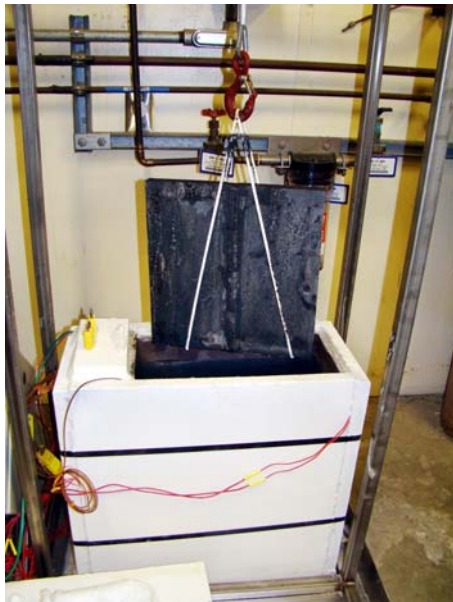
Fig. 12 Periodic inspection for cracking by lifting plate above the test solution.

After the plate specimen was submerged in the test solution, periodic inspections were performed by lifting the plate above the test solution with the winch and hoist hook (Fig. 12). The total exposure time of the large plate specimen was set to 12 weeks. No evaporation control was attempted (e.g., such as the condensers in the U-bend test). However, a small amount of insulation material was used to cover the seam around the lid of the test tank after the lid was closed. This practice has proven to be very effective in minimizing evaporation. To maintain the test temperature at 125 °C, distilled water must be replenished periodically because the electrical power to the heaters would be cut off had the liquid dropped below the preset level at 35.56 cm (14 in.) above the tank bottom.

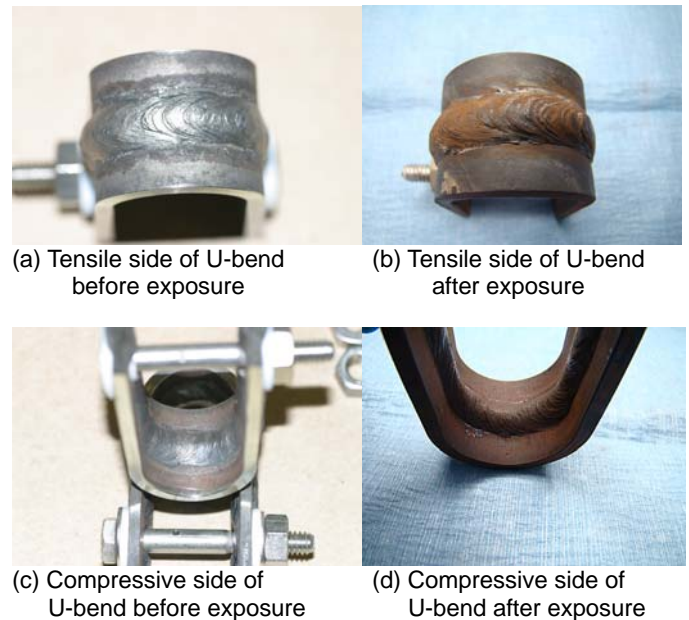
Fig. 13 As-welded Specimen (No. 247) exposed to caustic solution for 95 days.

The planned test time was 21 days, but some specimens were left in the heated beakers up to 95 days. During the first 21 days of testing, all specimens were inspected once a week for evidence of cracking. However, it should be noted that the salt concentrations might have been altered due to the loss of water for those specimens tested beyond 21 days even though Graham Condenser was installed for each test beaker. In all cases, no stress corrosion cracking could be found in the U-bend specimens. Typical photographs of specimens before and after exposure are shown in Figures 13 and 14 for as-welded and for heat-treated specimens, respectively. Both the outer side of the U-bend (tensile side) and the inner side (compressive side) are documented. Although the SCC on the compressive side is highly improbable, it is reported here for completeness.

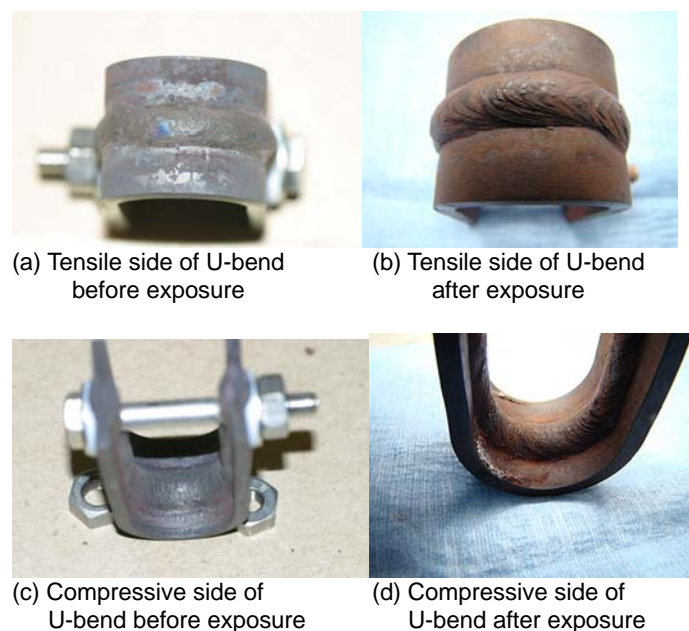
Fig. 14 Heat-treated Specimen (No. 243) exposed to caustic solution for 95 days.

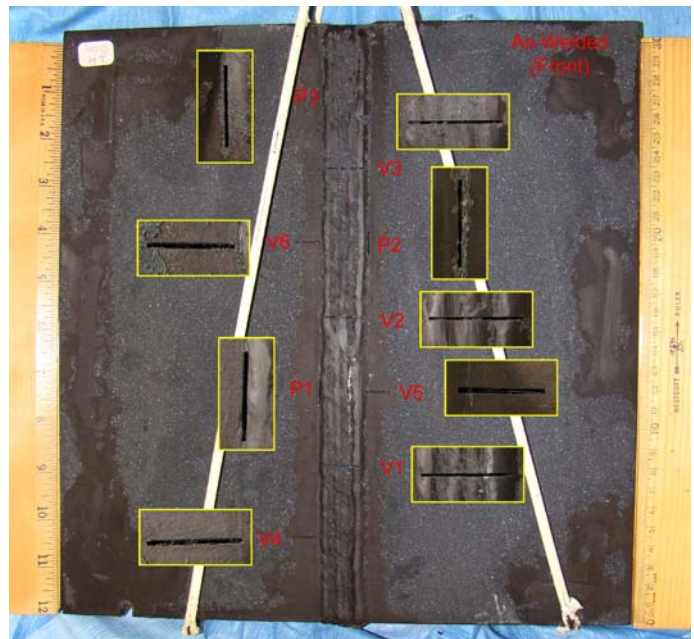
Fig. 15 As-welded plate after exposure to test solution for 12 weeks (Front side, insets show close-up machined cracks).

The large plates had been submerged in the test solution at 125 °C for 12 weeks at the end of the test. No stress corrosion cracking was found either in the as-welded plate or in the stress relieved/heat treated plate. The pre-exposure conditions of the plates can be seen in Figure 3 or Figure 10. Figures 15 and 16 are, respectively, the front and back sides of the as-welded plates after exposure for 12 weeks. The close-ups of the nine machined cracks in their post-test condition are shown in the insets. For the heat-treated plate, the post-test photographs are shown in Figures 17 (front side) and 18 (back side). Note that in Figures 15 to 18, V1, V2, and V3 are through-the-plate

cracks and are across the width of the weld (vertical cracks); V4, V5, and V6 are also vertical cracks (perpendicular to the weld) but they are partly through plate (6.35 mm or ¼ in. deep thumbnail cracks) in the HAZ; and P1, P2, and P3 are part-through plate (6.35 mm or ¼ in. deep thumbnail cracks) cracks parallel to the weld and in the HAZ. On the back side of each plate, only three through-the-plate cracks are visible.

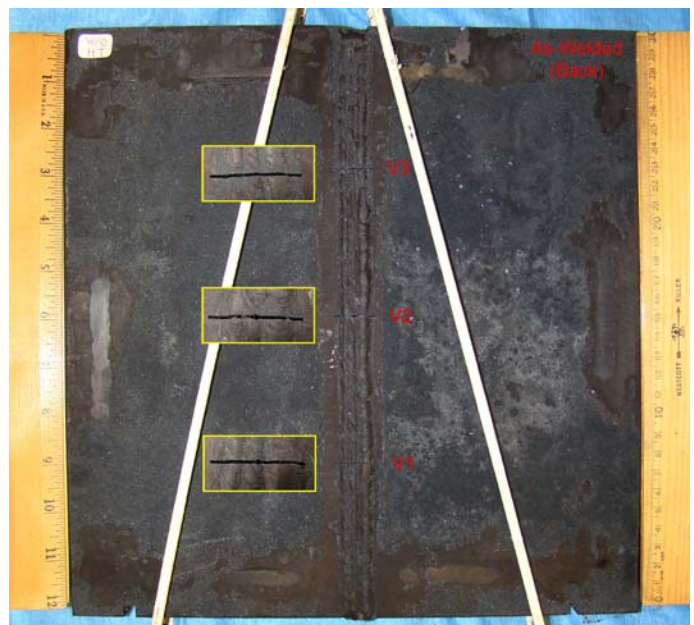
Fig. 16 As-welded plate after exposure to test solution for 12 weeks (Back side, insets show close-up machined cracks).

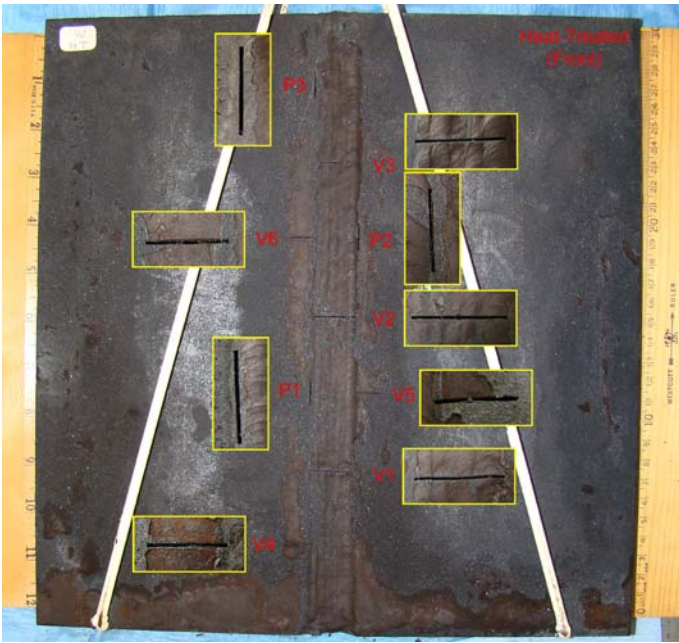
Fig. 17 Heat-treated plate after exposure to test solution for 12 weeks (Front side, insets show close-up machined cracks).

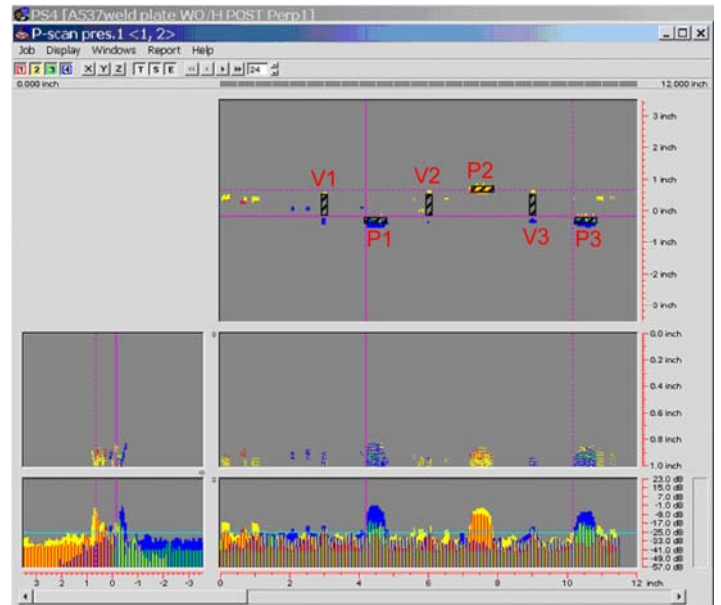
Fig. 19 P-scan for stress corrosion cracking parallel to the weld for the as-welded plate.

P-scan images in Figures 19 and 20 indicate that no caustic stress corrosion cracking had grown in the direction parallel to the weld, for both the as-welded and the heat-treated plates. Several machined cracks were marked on the figures (hatched rectangles) to identify the actual position of the ultrasonic signals on the plate. These figures also indicate that there were no crack length changes for the parallel machined cracks P1, P2, and P3. Ultrasonic scans were also performed parallel to the weld to detect any cracking perpendicular to the weld (see Fig. 21 for the as-welded plate). As concluded earlier by Figures 19 and 20, Figure 21 also shows no evidence for stress corrosion cracking. Since no cracking could be found by the ultrasonic scans in all directions, it can be concluded that stress corrosion cracking did not occur inside the plates.

It should be noted that the UT-inspection applied directly over the uneven surface of the weld beads is impractical and therefore was not performed. Should stress corrosion cracking occur in machined cracks V1, V2, and V3 (through-the-plate cracks across the weld), the indication of crack extension would have been detected by the scans in the heat-affected zone immediately next to the weld (such as in Figures 19 to 21).

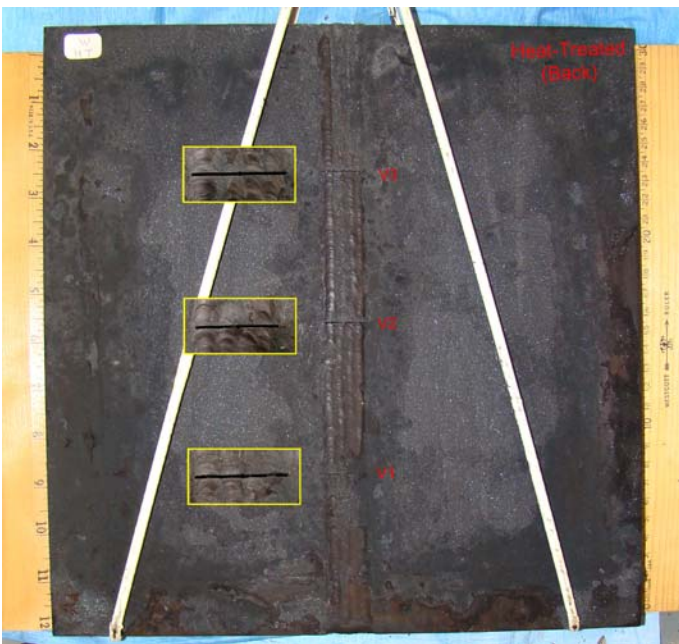
Fig. 18 Heat-treated plate after exposure to test solution for 12 weeks (Back side, insets show close-up machined cracks).

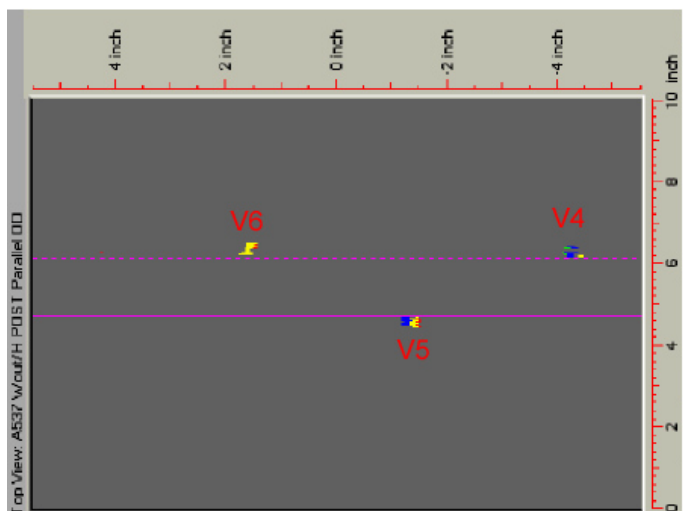
Fig. 21 P-scan for stress corrosion cracking perpendicular to the weld for the as-welded plate.
