Potential Impact of Tank F Flush Solution on H-Canyon Evaporator Operation

E.A. Kyser
F.F. Fondeur
S. D. Fink

September 2010

Savannah River National Laboratory
Savannah River Nuclear Solutions
Aiken, SC 29808

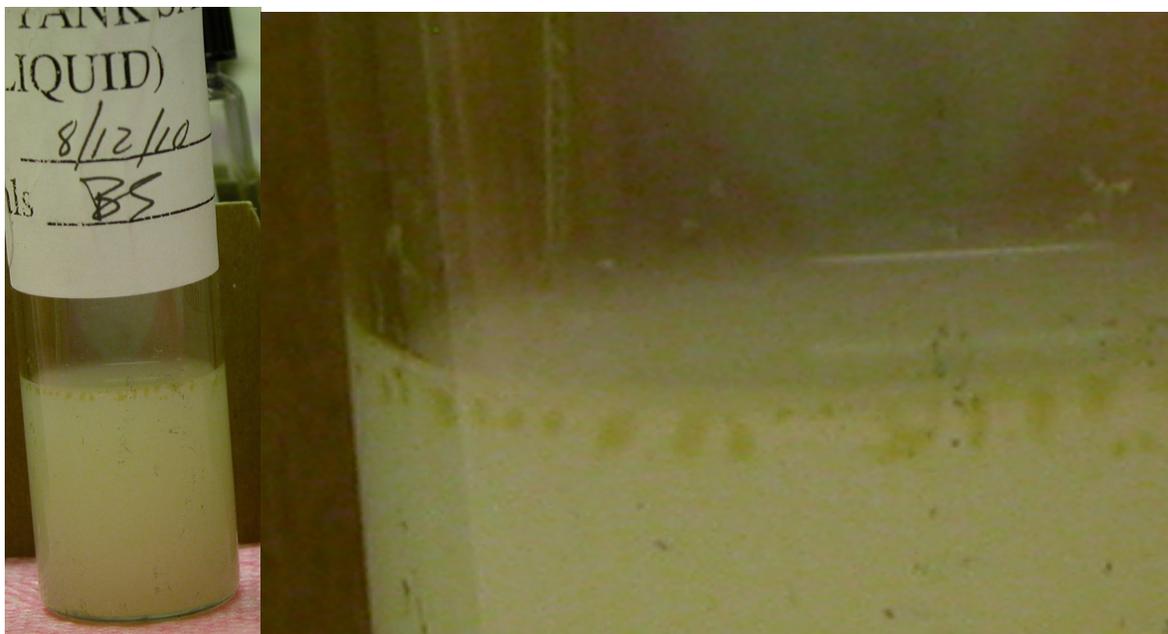
Figure 1. As-received Tank F Sample (HAD in F/H Laboratory).

The HAD liquid heel from F/H laboratory was provided to SRNL on August 12, 2010. A picture of the sample (picture taken on August 20) sent to SRNL is shown in Figure 1. As seen in Figure 1, the sample has a white and hazy (turbid and opaque) appearance. Also, the top surface of the liquid sample near the glass edge has the appearance of suspended, spherical droplets (slightly yellow in color) approximately one millimeter in size. The liquid sample has maintained its suspension (liquid-insoluble structure) despite the long undisturbed time in the laboratory.

Note the small yellow droplets at the liquid surface in the magnified cropped picture.

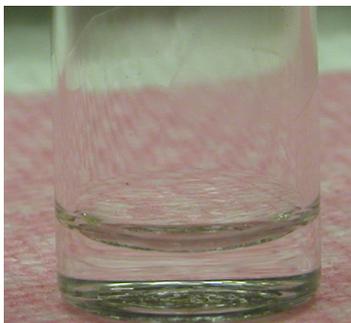
Figure 2. Results of Filtration Treatment of Tank F Sample.

Approximately 1 mL of the sample was filtered through a 0.45 micron nylon filter. The filtrate still had a hazy and translucent appearance. The test was repeated by filtering the sample through a 0.2 micron nylon filter and the filtrate was transparent as shown in of Figure 2. Analysis of the filtrate by FTIR revealed that the bulk of the organic constituents were no longer in the solution. It is presumed that the nylon filter removed the organic components by filtration but it is possible that some may have been absorbed.

- 0.2 micron nylon filtered the liquid heel to clear transparency
- 0.45 micron did not filter the liquid heel to complete transparency

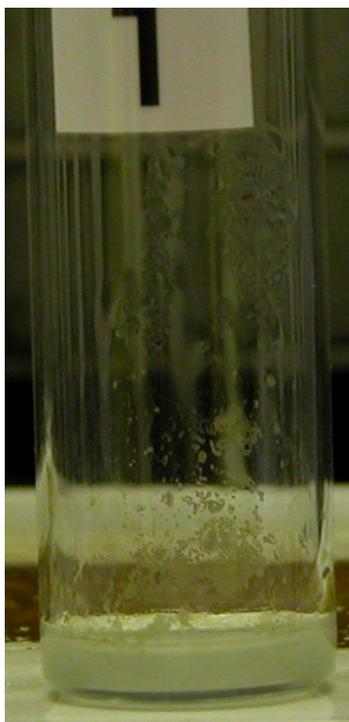
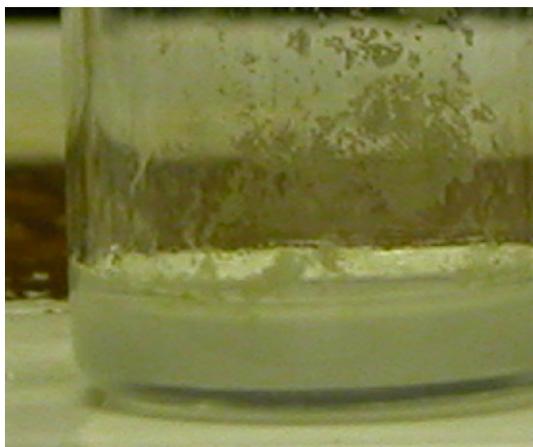
Figure 3. Results of Heat Treatment of Tank F Sample.

In another test, 1 mL of the liquid heel was placed on a heater plate and heated from 27 °C to 81 °C in 2.3 hours while allowing evaporation. A 26% volume reduction in the sample volume was performed (see Figure 3). At approximately 68 °C, personnel noticed the formation of brown colored skin (typically associated with oxidized organic) floating on the top surface of the heated liquid heel. H-Canyon is expected to evaporate this solution at a temperature in excess of 100 °C for a volume reduction of 95 to 99%. Organic residue that reaches the evaporator will likely be oxidized to a much greater extent than observed in this laboratory test. Volatile and semivolatile components and reaction by-products will be steam-stripped to the overheads. The overheads from the evaporator that processes laboratory residue returns are eventually fed to the Acid Recovery Unit (ARU), so volatile liquid components could be recycled into the HM process via the recycled acid stream. Evaporator bottoms will be neutralized and sent to the tank farm. Alternatively if the ARU is not operational the overheads from the evaporator may be transferred to the Effluent Treatment Facility (ETF).

- Heated the sample from room temperature to 27 °C to 81 °C in 2.3 hours.
- A brown film developed near 68 °C around the glass vial

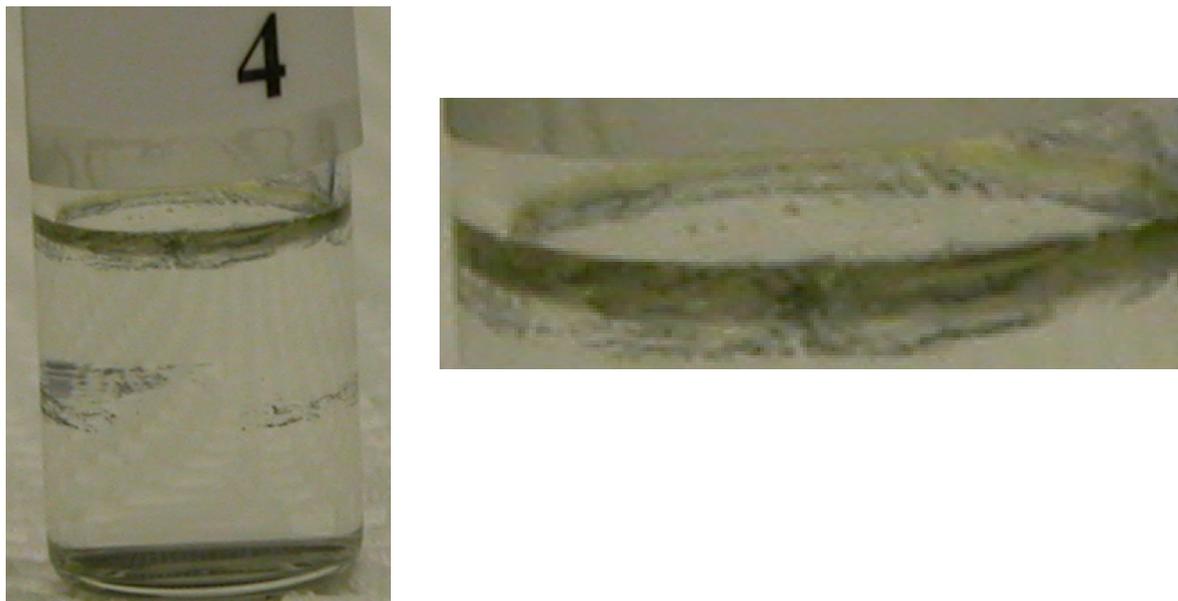
Figure 4. Results of Acid Treatment of Tank F Sample (after 16 hours settling).

The recommended treatment (i.e. that produced the most transparent resulting sample) was the addition of 2 M nitric acid (yielding an nominal concentration of ~0.75 M nitric acid). Four hours after this treatment was performed, significant cloudiness was still apparent but after 16 hours, the solution had cleared and no solids were observed. A yellow floating organic phase had separated and was visible as a ring around the vial at the liquid surface (see Figure 4). A similar treatment may be performed in either the HAD Tank F (to allow inspection of the tank bottom) or in one of the H-Area tanks to allow for decanting of the solution. The cloudiness of the initial solution is presumed to be due to the nature of the colloidal micelles of organic-aqueous material. Preparation of surrogate solutions showed that DIN alone at very low concentrations (< 100 ppm) made the solution cloudy. The length of time to “break” the emulsion is likely due to surface tension effects and the limitations of gravity alone in aggregating these small structures into larger ones which can separate. Once the initial separation is complete, such small structures are more difficult to reform although it appears that DIN is easily dispersed into the solution and causes additional cloudiness (see Figure 5) which took some

Note that no settled solids were observed but yellow organic phase separated at surface. Black marks are volume marks placed on the outside of the vial.

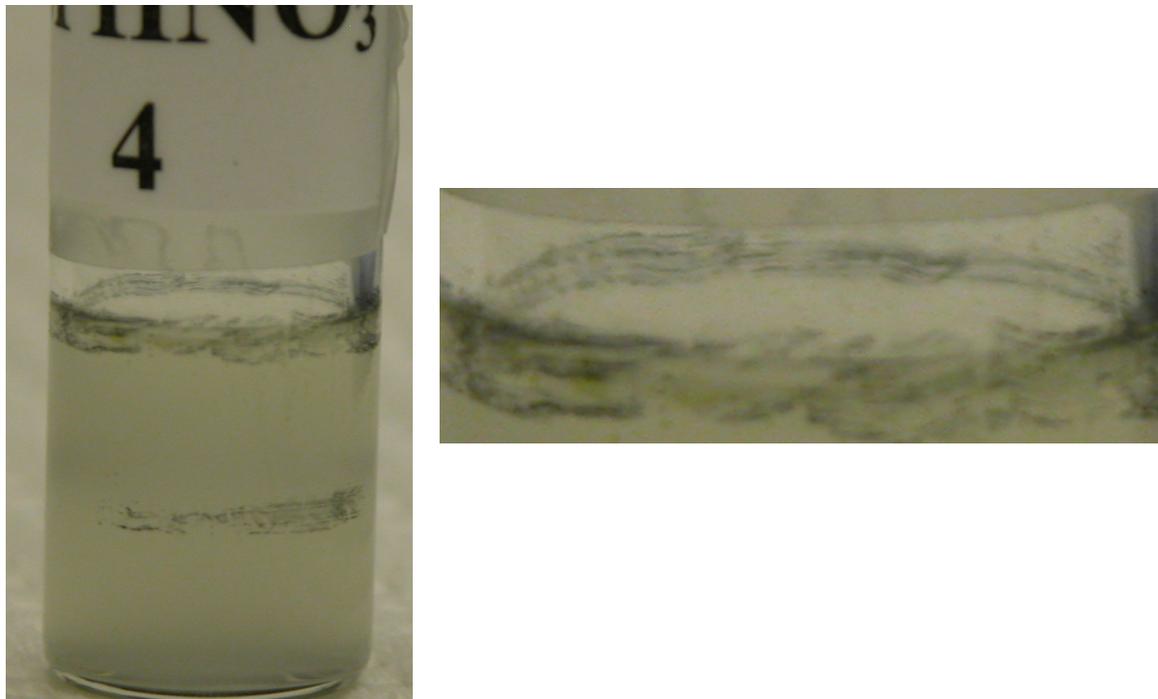
Figure 5. Results of Acid Treatment of Tank F Sample (immediately after remixing).

time to clear. Figure 5 also shows the yellow droplets of separated organic phase which did not disperse when the sample was shaken.

Note that after remixing the separated yellow phase immediately separated at the surface. Black marks are volume marks placed on the outside of the vial.

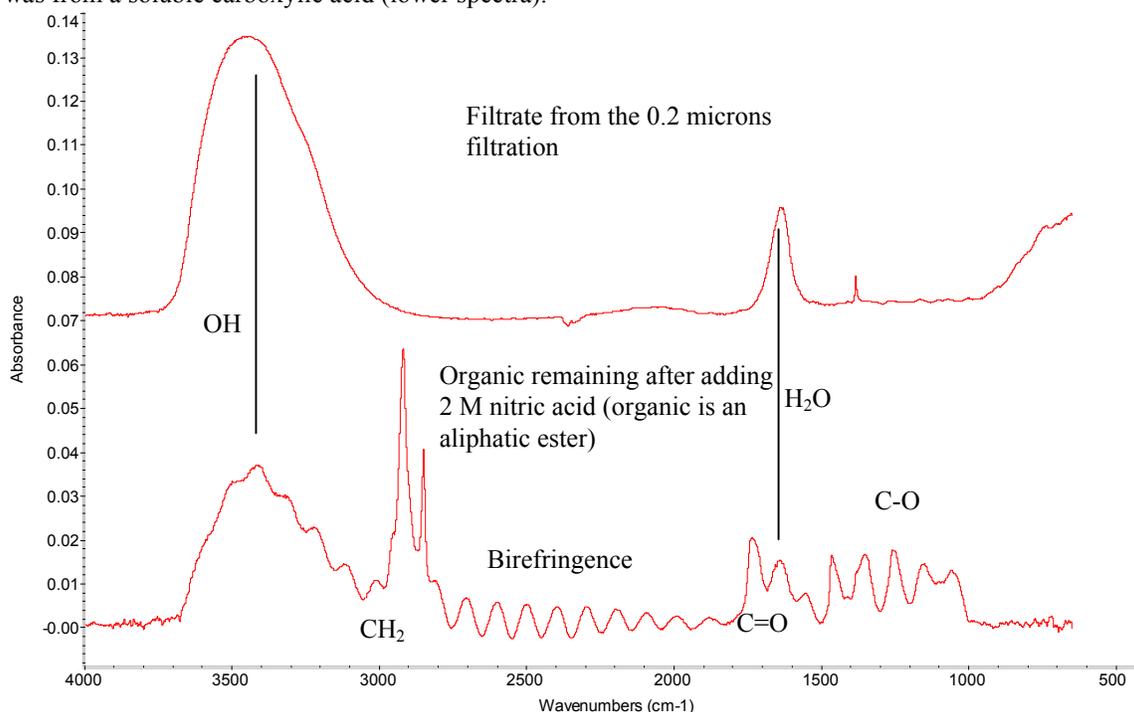
Figure 6. FTIR Spectra of the Filtered Sample Aliquot and the Acid Treated Aliquot.

A filtered sample and acid-treated sample were both analyzed by FTIR. The FTIR spectra (shown in Figure 6) suggest that the filtration removed the organic constituents below the detection limit of the method (upper spectra). After the acid-treated sample cleared, the only remaining FTIR organic signal (from the clear phase) was from a soluble carboxylic acid (lower spectra).

FTIR analysis of a sample of DIN and comparison with the spectra from the original sample found many of the same features of the spectra that were initially attributed to the vinyl-ester compound from the tank lining. It is considered likely that both DIN and vinyl ester are present in small amounts in the flush solution.
