H-Canyon Air Exhaust Tunnel Inspection Vehicle Development

Richard L. Minichan, Robert F. Fogle and Athneal D. Marzolf

Savannah River Nuclear Solutions

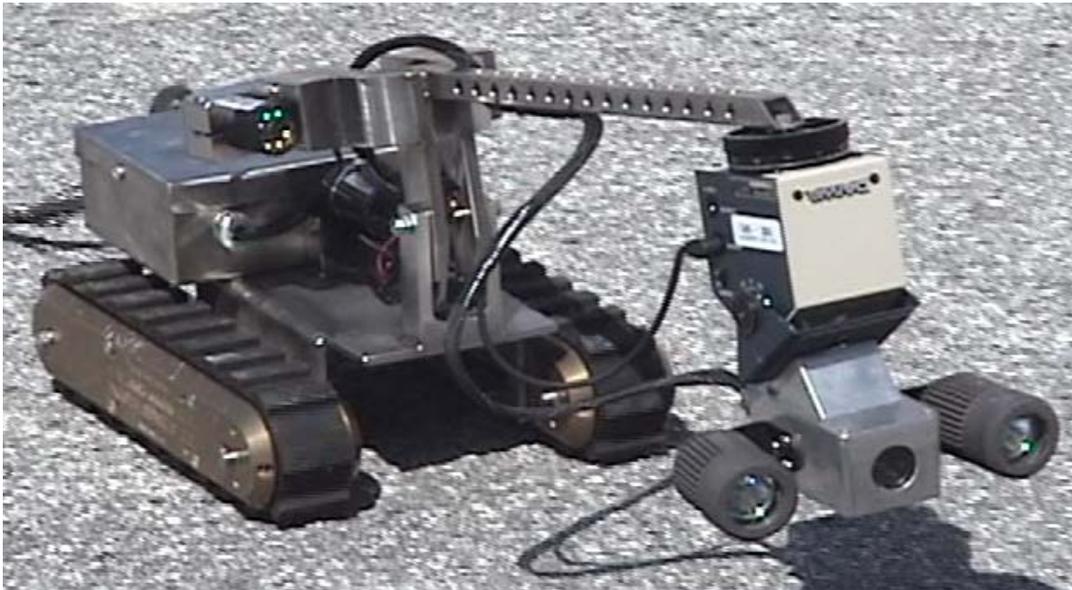
Figure 3 – 2003 H-Canyon Inspection Crawler

A vehicle was designed for this specific purpose. Since the crawler would be abandoned in place after the inspection, a simple design was used with mostly inexpensive parts. The Inuktun Mini Tracs, the most expensive component, were used to provide motion for the crawler. These tracks were chosen because of their reliable performance in other similar applications and ability to maintain traction in challenging situations. A picture of this crawler can be seen in Figure 3 below. It has two cameras. One fixed camera pointing forward and a pan tilt zoom (PTZ) mounted on an arm that can be raised and lowered as required.

The original inspection path for this crawler was to lower it through the access hole to the next level and travel less than 100 feet to the retention curb at the drop off ledge. At this point, the camera on the vehicle's arm would be extended over the ledge to inspect the OHBL duct tie-in which would be about 10 feet below in the crossover tunnel. The decision was made in the middle of the project to extend the design features of this crawler by adding an extension cable to allow the crawler to negotiate the ledge to obtain a closer look at the duct tie in point. Once at the bottom of the ledge, a more detailed view of the conditions in the crossover tunnel would be possible.

The actual inspection went well and the crawler was able to successfully land at the bottom of the ledge and provide closer views and video of the duct tie in point and the crossover tunnel condition. These locations were previously unable to be seen.

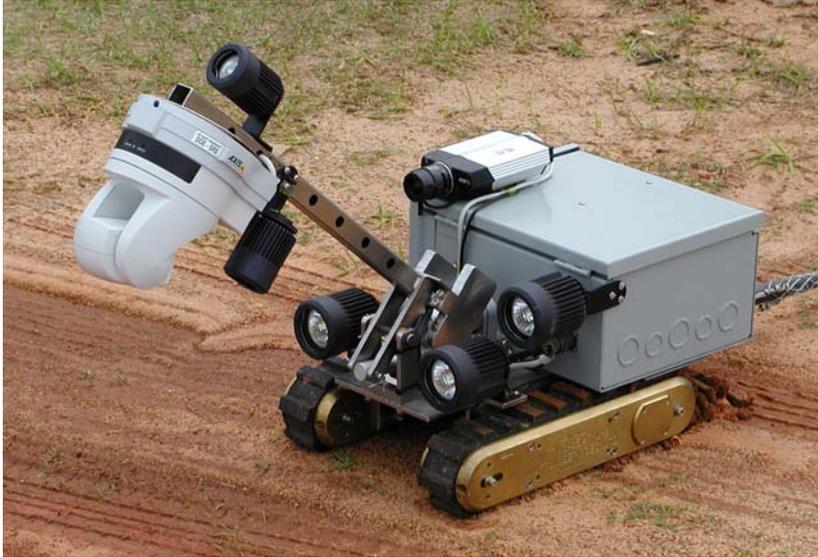
Figure 4 - H-Canyon Inspection Crawler

Vehicle Platform - The locomotion for the crawler was provided by commercially available Inuktun Mini Tracs. These tracks are sealed and include integral 48 volt drive motors and gearing. The tracks are very rugged and have been successfully used at SRS in numerous applications. In this application, the crawler platform supports two video cameras. One camera was mounted toward the back of the crawler that has a fixed position, pointed forward. This camera was used for driving the crawler and general viewing. The fixed camera cannot be controlled remotely; however, it has an automatic iris control to compensate for changing light conditions. A second pan, tilt and zoom (PTZ) camera is mounted on an arm that can be raised and lowered remotely (driven by a Warner electric actuator). The camera features include an 18X zoom lens, +/- 170° pan and 120° tilt. The arm provides the ability for the camera to look over ledges and be elevated for better views. There are five lights on the crawler to provide illumination for the visual inspections. One of the lights was aimed downward for viewing over ledges, while another was mounted to the arm for directional lighting. The number of lights that can be on simultaneously is limited to three due to power availability. The system has the

capability to record all video signals to a dedicated computer hard drive. In addition, one video signal may be selected and recorded on a mini-DV tape which provides a better image than a VHS. A picture of the inspection crawler is shown below in Figure 4.

Tether - In order to keep the tether as small and light as possible a unique control technique was used on this crawler. The unit was controlled using a small PLC with communication through an Ethernet cable. The tether required only enough wire capacity for two Ethernet signals and power. Network cameras were employed to permit transmission of the video signal over a separate Ethernet connection, eliminating the need for two co-axial cables in the tether.

Vehicle Drive - The Inspection Crawler is powered by a Kepco 500 watt power unit supplying 48 V dc through two pair of 18 awg conductors in a Belden cable. The 48 V dc supply voltage powers the Inuktun drive tracks and is converted internally to 12 V dc and 24 Vdc through Astrodyne DC/DC converters. The WAGO PLC, camera arm actuator, and vehicle lights utilize the 24 V dc signal. The Axis cameras, ethernet extender, and WAGO Ethernet switch are powered by 12 V dc. The GPOC and crawler are connected with a tether that delivers power and Ethernet signals to the crawler platform. Since the crawler is intended for two applications, a tether was made for each application. The fan discharge exhaust tunnel is expected to require about 200 feet of travel so a 250 ft tether was made for this application. The canyon exhaust tunnel deployment could require as much as 400 feet of travel, therefore a 450 ft tether was made for this deployment. The additional 50 foot of tether allows the operator console to be placed in a clean location during crawler operations.

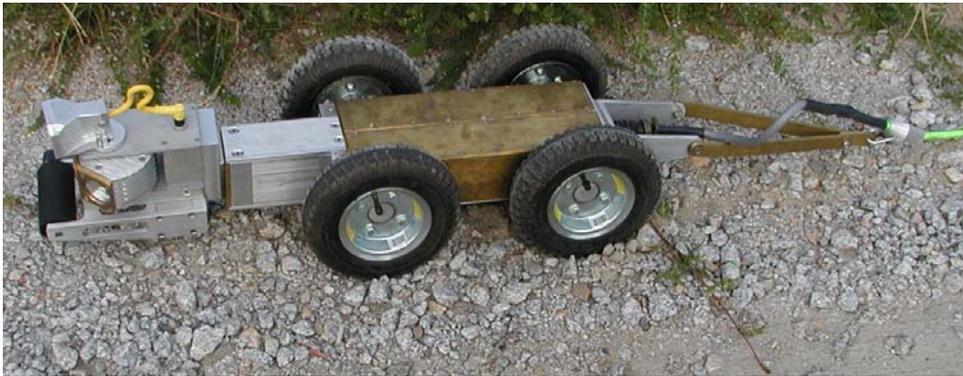
Figure 6 Powervision Crawler by Power Equipment Manufacturing

After some investigation, several viable commercial tethered pipe inspection crawlers were identified. Ultimately, a unit made by Power Equipment Manufacturing Inc. as seen in Figure 6 was purchased for this task. This crawler is a four wheeled crawler with one PTZ camera and lights. A power roller was added to their typical crawler design to help pull the front away from the wall when landing at the bottom of the ledge. The tether is a Kevlar reinforced five hundred foot cable with a tensile strength of around 2400 pounds. The tether has a low friction jacket to reduce the drag on the crawler as it is pulled during inspections. The tether not only protects the conductors controlling the crawler, but it also provides the support needed to control the descent of the crawler over the 14 ft, 6 in inch ledge.

Once the mobile inspection vehicle was received, a number of functional tests were performed to assure its suitability of performing the intended mission. The first test demonstrated its ability to pull the entire 500 foot tether down a gravel road with a surface similar to the one expected in the H-Canyon air tunnel. The crawler was able to pull the entire cable length with little problem. At long tethered lengths, it was observed that the crawler's ability to easily turn was compromised. In order to turn while pulling tethers greater than approximately 300 feet, the crawler must be driven backwards first to provide some slack in the cable.

The second test showed the crawler's ability to travel about 80 feet and then make a 90° turn continuing down the gravel road while pulling the full five hundred foot tether. (80 feet, 90° turn, 420 additional feet) Lastly, a scaffold was set up with plywood secured to one side. This served as a mockup to demonstrate the 14 ft, 6 in drop. The mockup also included a pile of sand at the bottom of the ledge to simulate the buildup of concrete aggregate which is a known condition from previous entries. A four inch pipe was embedded in the sand to simulate an existing drain pipe in place in the actual inspection location. Preliminary testing showed the need to make some modifications to the crawler in order to increase confidence in its ability to recover at the bottom of the ledge.

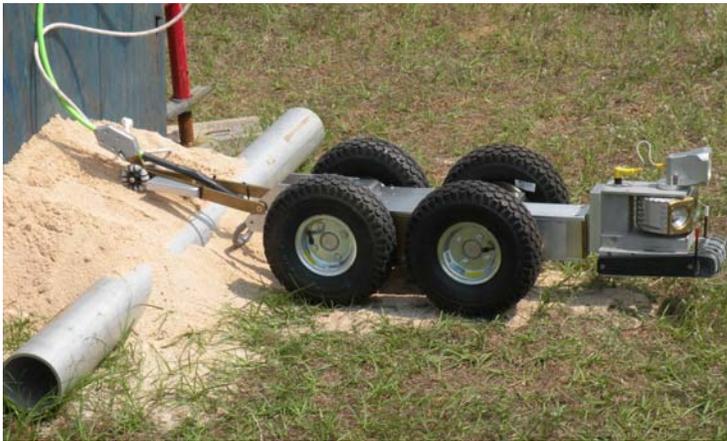
Figure 7 Modified Crawler at the Bottom of the Mockup Wall

Modifications to the crawler include:

- Larger tires to increase ground clearance and improve traction.

- A modified tether attachment point to help the crawler land with its front forward at the bottom of the ledge.
- A level bubble visible at the bottom of the camera view was added to help orient the operator.
- Colored flags were added to help the operator center the camera right and left. i.e. red flag 45° right, white flag 45° left)
- Traction ridges were added to the front power roller.

With the modifications described above, the inspection crawler consistently recovered as expected after negotiating the 14 ft, 6 in drop. The modified crawler shown below in Figure 7 is now ready for the field deployment, which will take place whenever the facility can work the structural inspection into their schedule.
