DESTRUCTIVE EXAMINATION OF SHIPPING PACKAGE 9975-03431

Savannah River National Laboratory
Materials Science & Technology

Publication Date: May 2012

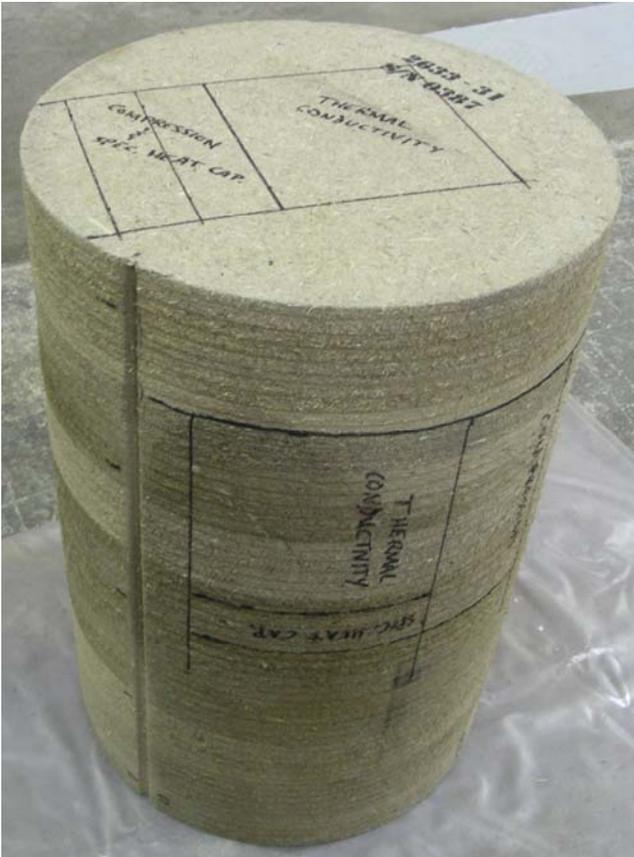
Figure 4. Lower fiberboard assembly (upside down) marked for removal of test samples

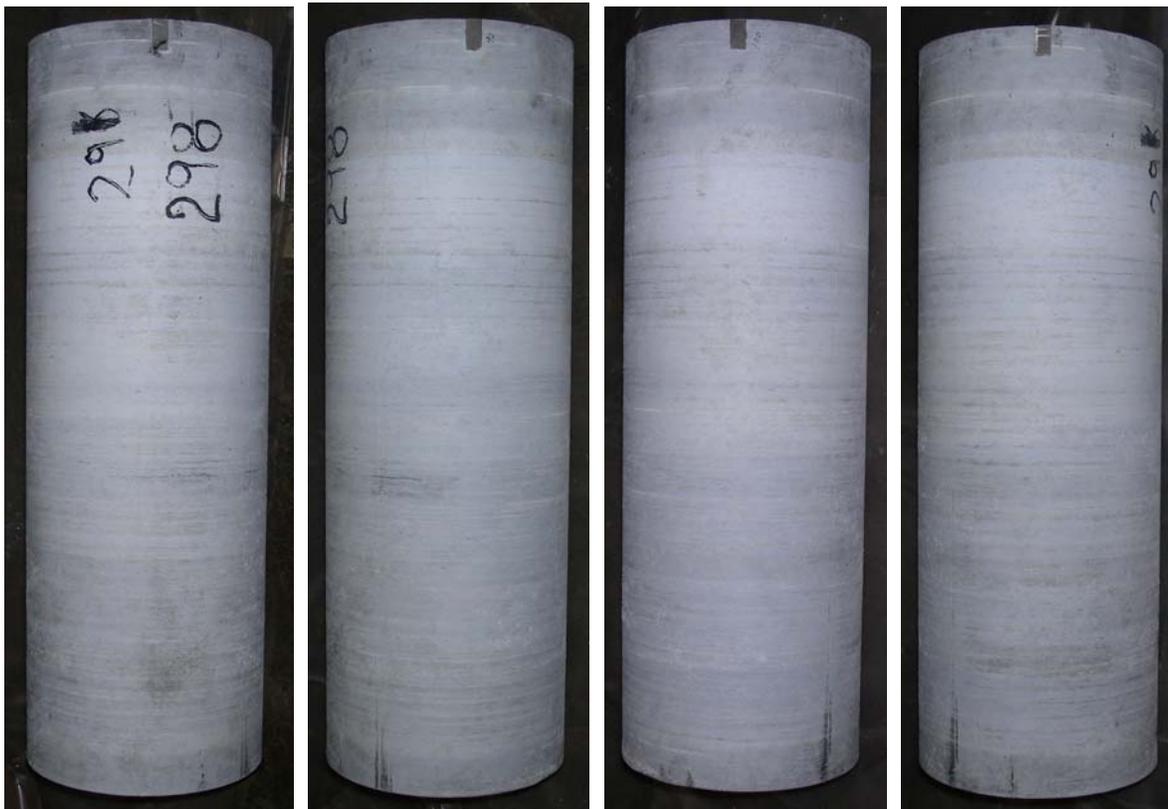
The entire surface of the lead shield was visually examined. It was found to be free from significant deformation and physical damage, but the outside surface (in contact with the fiberboard) was covered with a light to moderate layer of white corrosion product (Figure 9). No flaking or blistering of the corrosion product was observed. From prior examination of the shield from package 9975-02234, the corrosion product was identified as basic lead carbonate (hydrocerrusite), $Pb_3(CO_3)_2(OH)_2$ [8]. No further characterizations of the corrosion product were performed.

Figure 9. Lead shield with corrosion product.
