Ballistics Testing of the 9977 Shipping Package for Storage Applications

Bradley M. Loftin, PE, Glenn A. Abramczyk, and Richard E. Koenig, II
Savannah River National Laboratory
Savannah River Nuclear Solutions
Aiken, South Carolina 29808

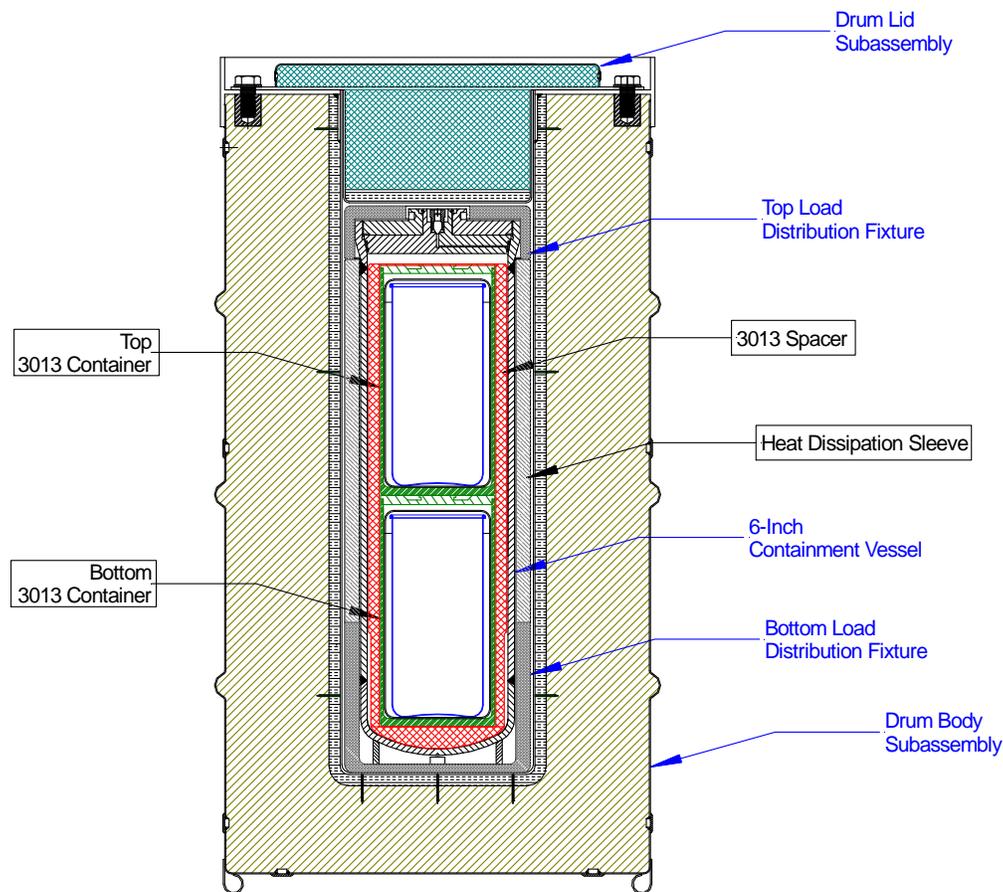
Figure 1 – Model 9977 Configuration with Two 3013 Containers

In order to test the 9977 Shipping Package, the storage configuration had to be determined. It was decided that the storage configuration to be used for this testing was the same as the configuration used within one of the facilities at the SRS. This configuration included both an inner aluminum tube within the package 6-inch diameter containment vessel (6CV), known as a 3013 Sleeve, and also another aluminum tube outside of the containment vessel, known as a Heat Dissipation Sleeve (HDS). Although these sleeves have other safety functions, their properties also aid the 9977 shipping package in passing the ballistics testing. The tested configuration, as seen in Figure 1, includes (from the outside-in) the stainless steel drum body, polyurethane foam, a ceramic fiber insulating blanket, the stainless steel drum liner, the aluminum HDS (or the bottom Load Distribution Fixture (LDF) at certain heights), the stainless steel containment vessel, the aluminum 3013 Sleeve, the stainless steel 3013 container, and simulated contents. Since the purpose of these tests was to demonstrate that no damage occurred to the 3013 Containers that would cause them to release RAM, the 3013 Containers were modified for leak testing by the installation of a threaded port in their lids. Prior to any package testing, all 3013 Containers were leak tested and confirmed to be "leaktight" per ANSI N14.5.

The final testing of the 9977 Shipping Package used a new HDS, a new 6CV, a new 3013 Sleeve, and two new 3013 containers that are of the same material of construction as previously tested and again met the conditions of the certified drawings, see Figure 1. This testing was performed to meet the exact requirements of the DSA.

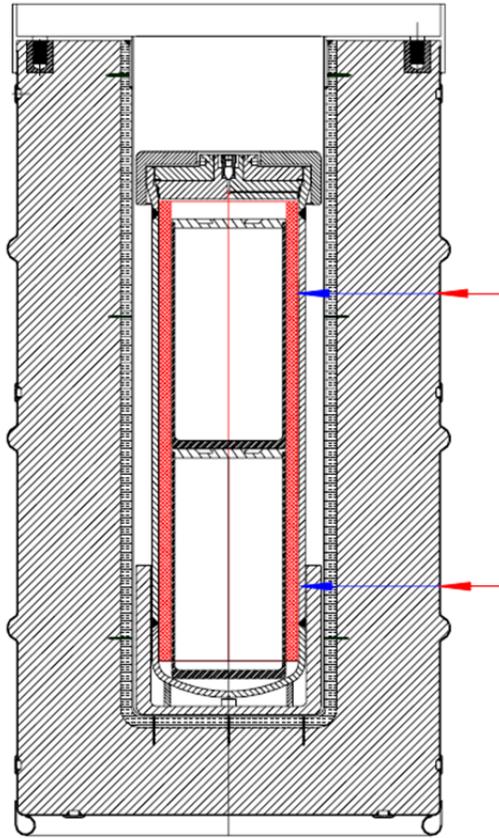
Figure 2 – Locations of Preliminary Test Shots

The first shot was fired at the upper drum elevation with the .223 caliber ammunition. The second shot was also with the .223 ammunition but was aimed at the lower elevation, (See the “Red” arrows in Figure 2). The third shot was aimed at the lower drum elevation, with the large caliber ammunition. The fourth shot was taken at the upper elevation with the large caliber ammunition.

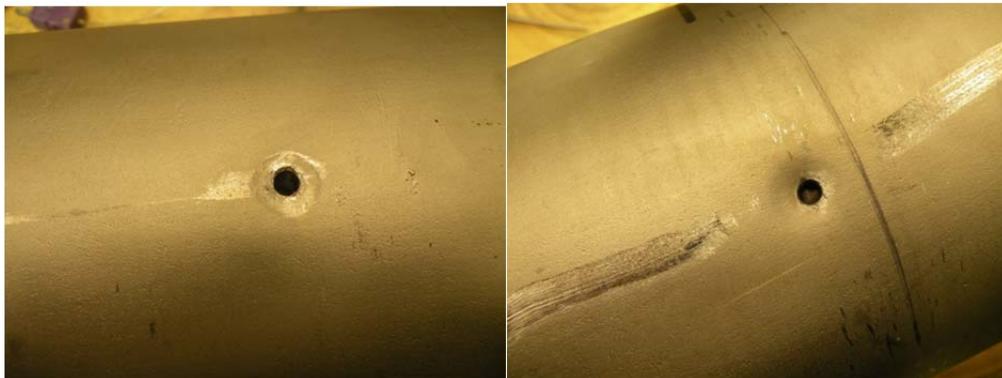
Figure 3 – Upper Shot

The package was prepared for destructive examination and the HDS and 6CV were removed from the drum liner. Once the HDS and 6CV (now wedged together) were removed from the drum it was noticed that there was a chance that the large caliber round penetrated the top 3013. The HDS was then removed from the 6CV. A metal probe was inserted into the hole made by the first shot (see Figure 3). The depth that the probe was inserted into the hole was measured and it was determined that the top 3013 had been punctured. The hole made by the second shot (the lower shot, see Figure 4) was also examined and the probe was again able to be inserted to a depth that indicated the bottom 3013 was most likely punctured as well.

Figure 4 – Lower Shot

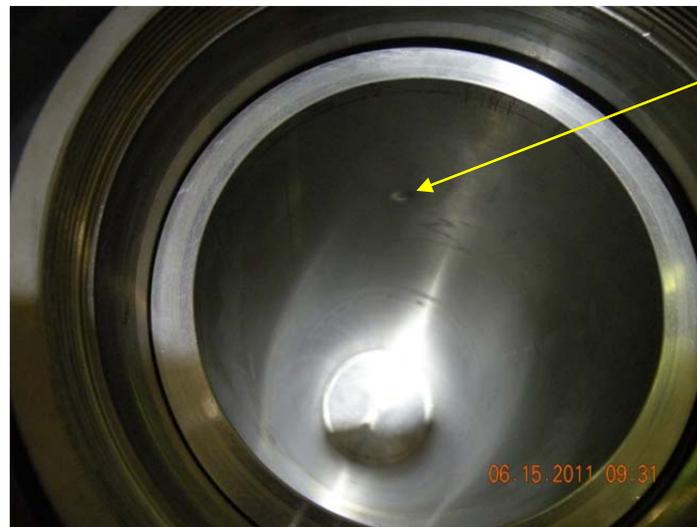
Figure 5 – Inside View of the 3013 Sleeve

Figure 5 shows the inside of the 3013 sleeve after the final testing. There is a small protrusion on the inside of the 3013 Sleeve where one of the four rounds impacted the drum and traveled through to the 3013 Sleeve, but the 3013 Sleeve was not penetrated. Only one shot produced a protrusion of this size. Figures 6 and 7 show the surfaces of the 3013 containers, adjacent to the point of impact by the rounds, after removal from the 6CV and the subsequent leak testing. There are no indications on the 3013 where the shots impacted the containers nor are there any abrasions on the containers made upon removal from the 3013 sleeve.

Protrusion on inside of 3013 sleeve
