Evaluation of Saltstone Mixer Paddle Configuration for Improved Wear Resistance

M.M. Reigel
M.D. Fowley
B.R. Pickenheim

September 12, 2012

Savannah River National Laboratory
Savannah River Nuclear Solutions, LLC
Aiken, SC 29808

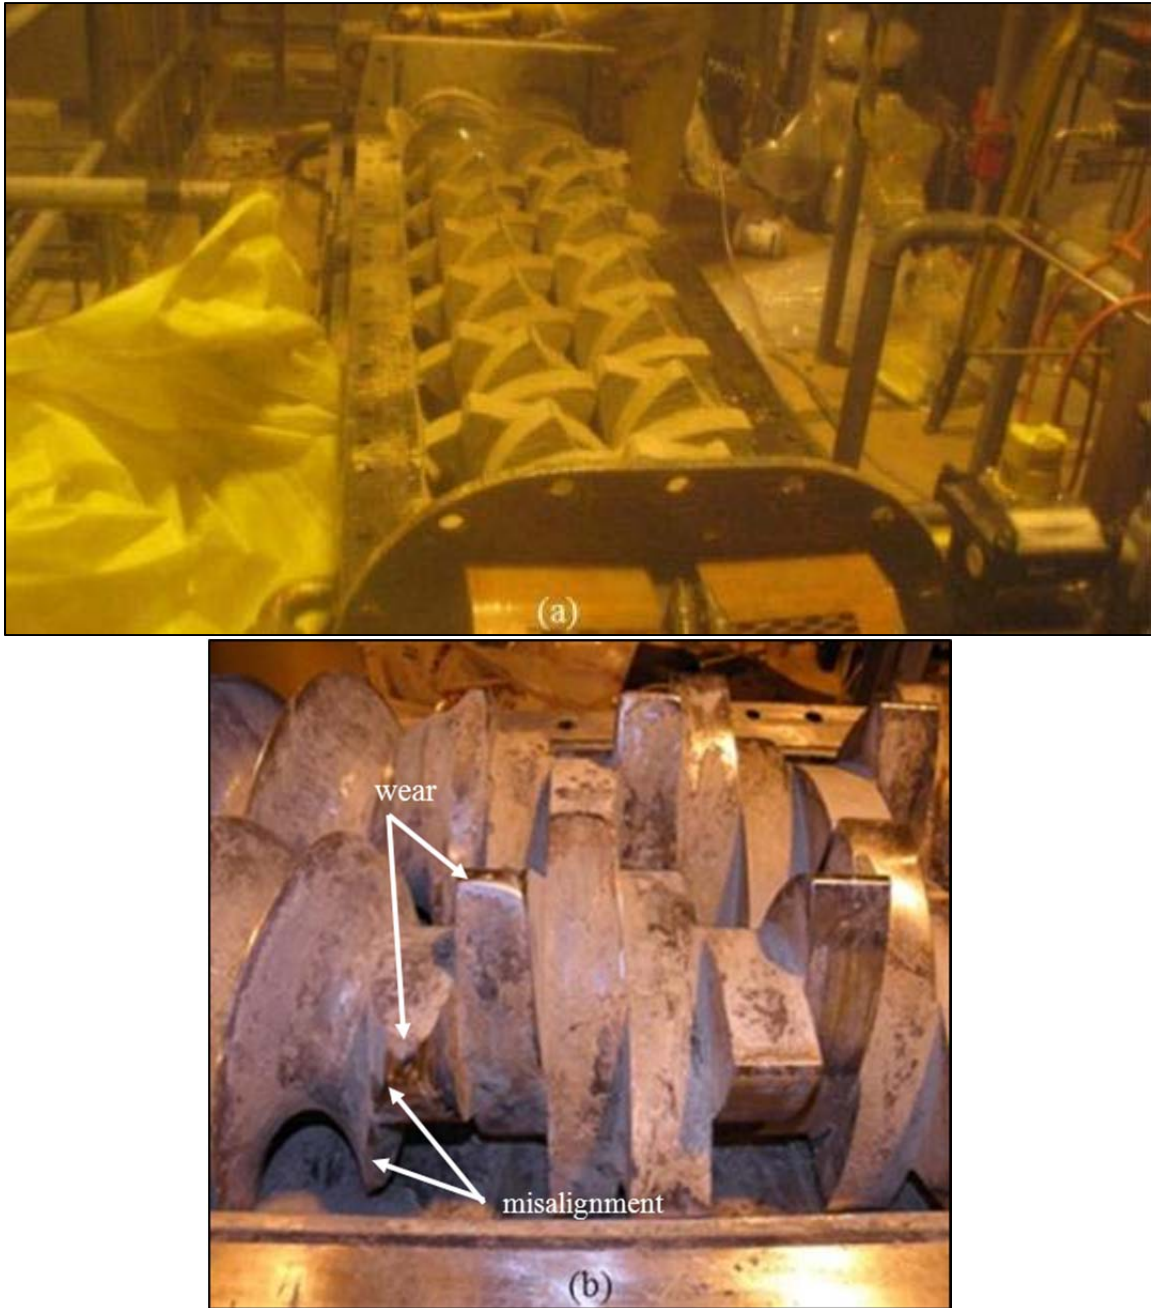
Figure 1-1. Inspection of the 10-inch Readco-Kurimoto mixer in the SPF showing (a) all the flat mixer paddles (note the tight clearance between the paddles and barrel), and (b) the misalignment of the auger and the first paddle as well as the wear on the last auger flights and first paddles^{5,6}

In the 10-inch mixer recently removed from service, the dry feeds were fed onto the augers which provided the driving force to move the material into the mixer barrel. The LLW salt solution entered the mixer over the first mixing paddles after the augers.⁵ During inspection of the mixer in May 2011, significant wear was found on the last flight of the augers and the first mixing paddles, while the downstream paddles had no visible wear (Figure 1-1).⁶ During this inspection, measurements were taken of the clearances between the mixing elements and the barrel and compared to measurements taken in September 2010 (Table 1-1).⁶ The first two paddles showed a large change in the clearance between the paddle and the barrel, such that the measured spacing is outside the vendor recommended clearances (Table 1-2); however, other paddles further down the mixer had little or no change in the clearance and are within the specified tolerance.

Based on the Saltstone 10-inch mixer that was recently removed from service, only the discharged areas of the augers and the first two paddles showed any significant wear (Figure 1-1 b). The downstream paddles had no visible wear; therefore, for both wear tests, the original stainless steel (SS) paddles in stages 2 through 5 were replaced by aluminum wear paddles. The wear paddles were fabricated out of 6000 series aluminum in order to increase the paddle wear rate¹⁴ and decrease the test run time, since 6000 series aluminum is a soft metal with low wear resistance. Both mixing (flat) and conveyance (helical) paddles were fabricated out of aluminum. Each wear paddle was laser etched with a unique number to aid in reassembly and identification post testing.

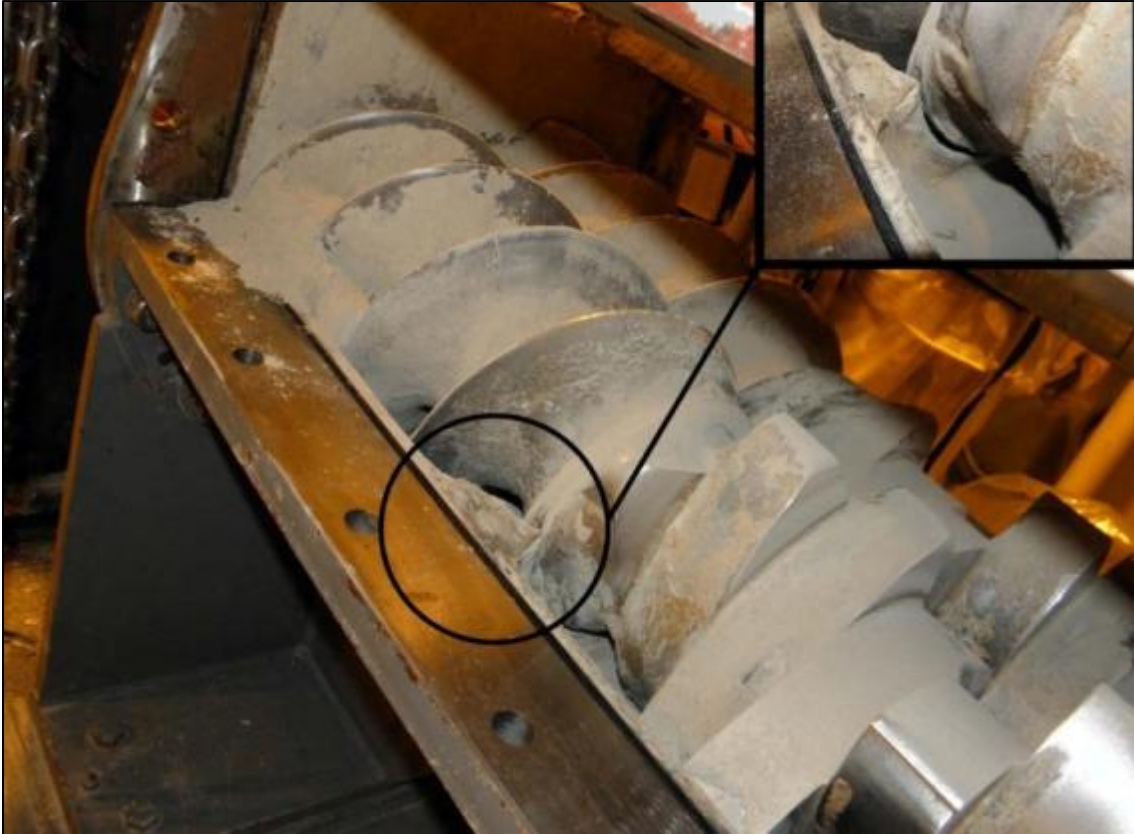
Figure 1-2. Grout build up at the auger/paddle interface in the saltstone 10-inch mixer⁶

As shown in Table 1-2, the machined clearances between shaft elements and the inside of the barrel are tightly controlled to maximize the self-wiping capability. Wear on any element that would cause the clearance to be out of the specified range would allow for product buildup since the self-wiping capabilities have been lost. This is especially detrimental in the SPF, since the cementitious slurry being processed will set up and harden. Therefore, minimizing wear on the mixing elements is crucial to maintaining throughput and maximizing operational lifetime of the 10-inch mixer. In the mixer removed in 2011, the buildup of cured grout led to the decreased throughput capability of the mixer (Figure 1-2) by creating an orifice at the discharge section of the auger.

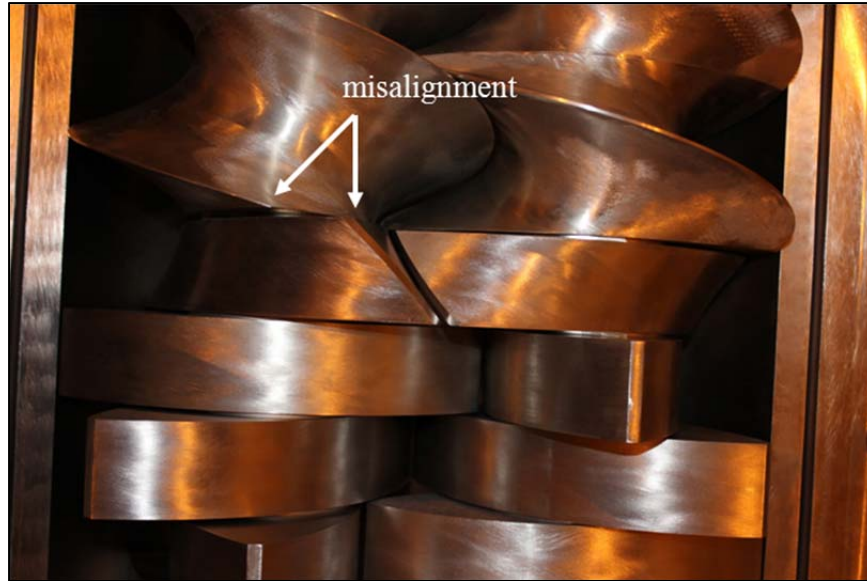
Figure 1-3. Paddle configuration for first five stages (augers at stage 1) for the ELAWD mixer installed in the SPF in 2012 (note the helical paddles at the second stage and the misalignment with the auger).

The testing in the report was performed on the previous mixer design (removed in 2011) to establish a baseline and to ensure that the wear issues can be duplicated before changing mixer designs. The mixer installed in 2012 as part of ELAWD (and its identical spare) has a slightly different design than the mixer that was removed from service and tested in this report (Appendix A). The mixer barrel is longer since the auger screws are 24 inches rather than 16 inches while still maintaining the 28 paddles on each mixing shaft. The entrance for the dry feeds is circular rather than rectangular, which moved the liquid inlet over the sixth and seventh stage paddles rather than the second and third stage paddles. Currently, all the paddles are flat, except for stage 2, which is helical; however, it is not aligned with the auger flight (Figure 1-3).

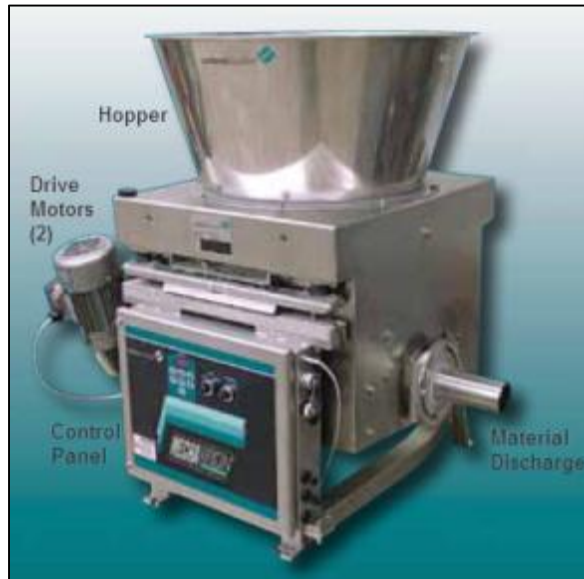
Figure 2-2. Schenck Accurate, Inc. Mechatron dry feeder

The dry material feeder was provided by Schenck Accurate, Inc. The Mechatron® midrange Coni-Flex™ dual-drive feeder (Figure 2-2) provides a consistent and reliable feed of dry material to the scaled mixer. The feeder discharges dry feed using a 1.73 inch diameter helix auger into the mixer inlet. A drive motor rotates the helix and another drive motor oscillates the agitation paddles on the outside of the flexible hopper. The helix auger is continuously feeding material into the dry feed chute; however, the material disengages from the end of auger in irregular sized clumps. The reason for this is that the slag and premix are not considered free flowing materials due to their particle size. The micron size particles have cohesive (or electro-static) forces that result in clumping flow and by how the discharge of the dry hopper is designed. The agitation paddles are used to mitigate bridging of the dry powders. The speed of each drive motor is variable through the control panel. A hopper extender is attached to the feeder to provide a total hopper volume of 8.7 cubic feet. For the wear testing, the feeder was operated in the volumetric mode; the helix motor was set at a constant speed to provide the required dry feed rate. Prior to testing the dry feed rate was calibrated to obtain a feed rate (mass basis) versus helix speed curve and the speed that provided the necessary mass flow rate was selected. The feed rate was checked as needed to verify the mass flow rate of dry solids.

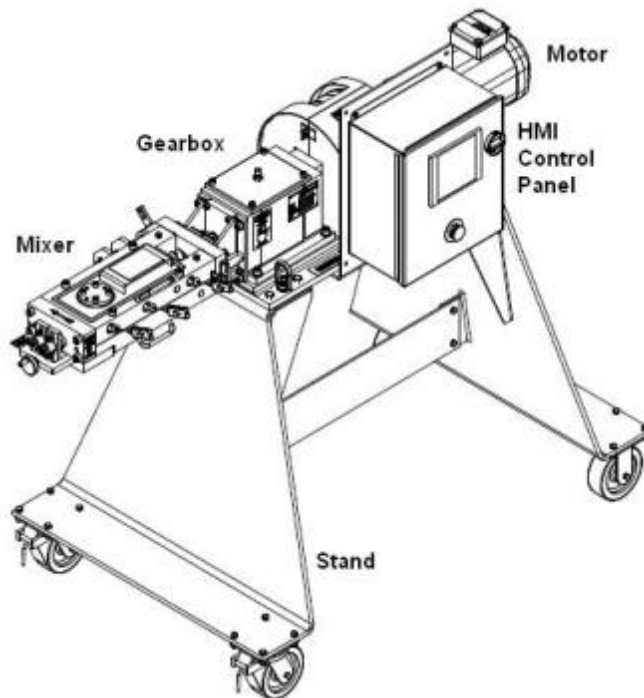
Figure 2-3. Readco Kurimoto 2-inch co-rotating twin-screw continuous mixer assembly

The 2-inch co-rotating twin-screw continuous mixer assembly was manufactured by Readco-Kurimoto LLC. The assembly consists of a 5 hp motor, a 1.4:1 ratio gearbox, a Human Machine Interface (HMI) control panel, and the scaled mixer on a sturdy steel frame with castors (Figure 2-3). The mixer is cantilevered from the frame and is level relative to the floor.

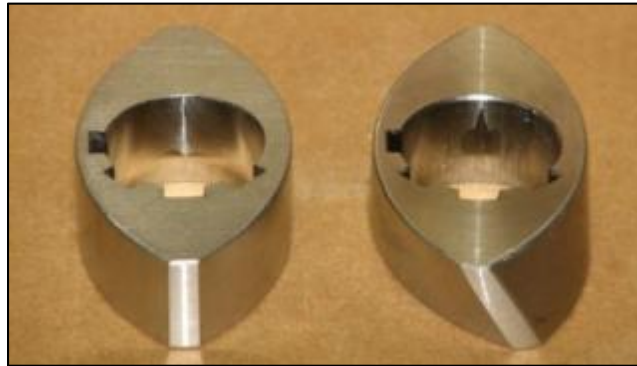
Figure 2-4. Two types of paddles flat (left) and helical (right) for the Readco-Kurimoto continuous mixer

The shaft design for the 2-inch mixer had 26 stages of mixing elements. The first stage is the inlet auger, which conveys the dry material into the barrels that enclose part of the auger and the mixing paddles. Stages 2 through 26 are occupied by paddles. The paddle configuration on the shaft is variable by changing paddle design and orientation, as defined by the material being processed. There were two types of paddles, a mixing (flat) paddle and a conveying (helical) paddle. Both paddle designs were lens shaped with flat tips (Figure 2-4) and the volumes of each are the same. The flat paddles produced high mixing intensity but no conveying action. The helical paddles produced moderate mixing intensity compared to the flat paddles and low conveying action compared to the auger. The orientation of the paddles on the shaft was adjustable in 45° increments by means of multiple keyways in the paddle shaft hole (Figure 2-4). The intermeshing dual shafts required that a paddle on one shaft was oriented 90° with respect to its mating paddle on the other shaft. This allowed each shaft to rotate without obstruction and to maintain the self-wiping action. Two example shaft assemblies are illustrated in Figure 2-5.

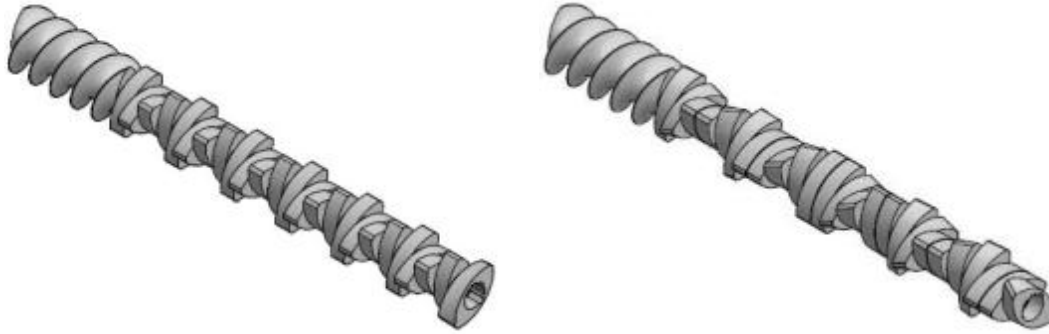
Figure 2-5. Example paddle configurations and orientations for the Readco continuous mixer; all mixing (left) and combination of mixing and conveying (right)

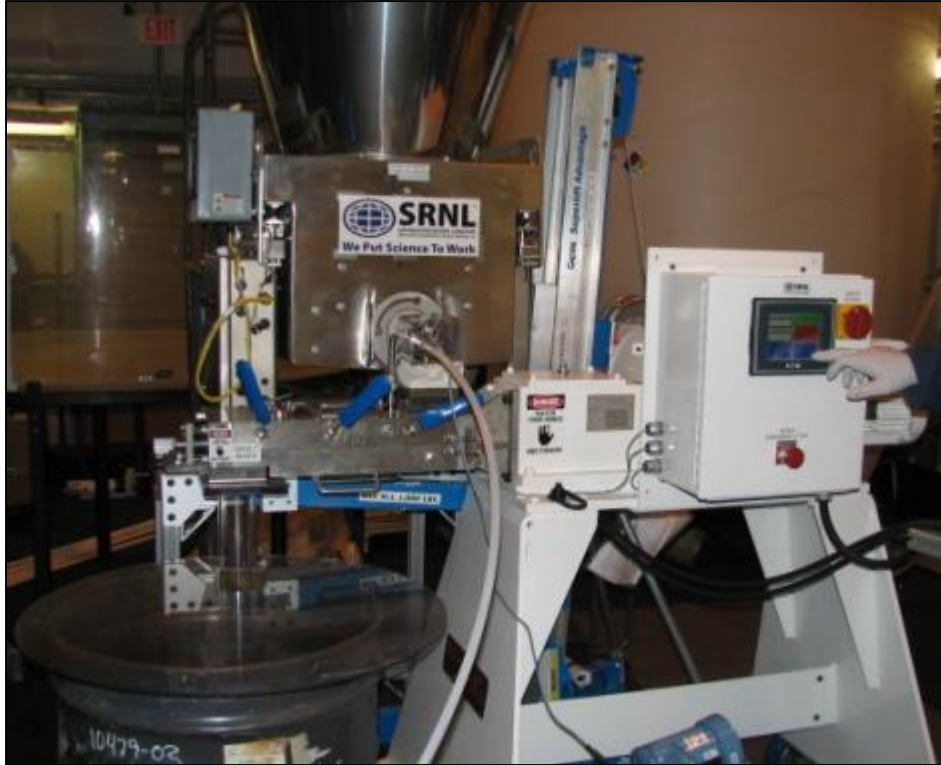
Figure 2-6. Scaled saltstone set up of the dry feeder, 2-inch mixer, and collection vessel used in the paddle configuration wear testing

Other instrumentation and equipment used for the wear test included platform scales to weigh dry material, a precision balance to weigh paddles, a Genie Lift™ to raise the dry material feeder above the mixer, and a Coppus® blower and HEPA filter to remove dry material dust from the work area. Figure 2-6 shows the actual set up of the dry feeder, 2-inch continuous mixer, and grout receipt vessel as used during testing.

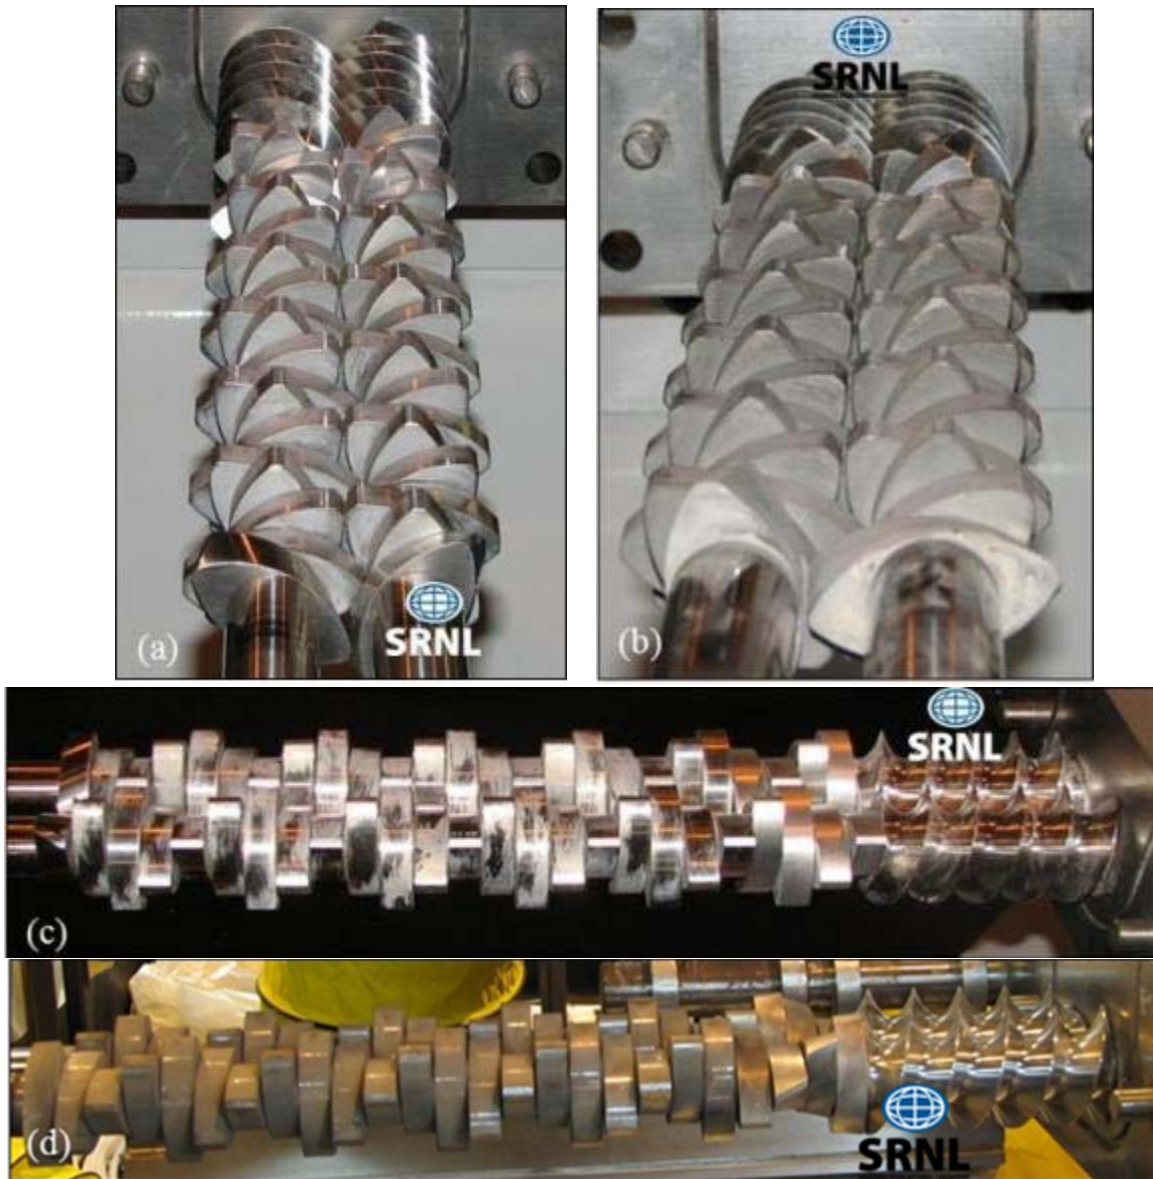
Figure 2-7. Paddle configurations for wear test 1 (a and c) and wear test 2 (b and d)

The orientation of the paddles in both configurations was such that each successive paddle was offset 45°, with the sequence repeating itself every fifth paddle (Figure 2-7). The direction of offset was clockwise (looking towards the motor), opposite of shaft rotation. The summary of the differences in the two configurations is listed in Table 2-1.

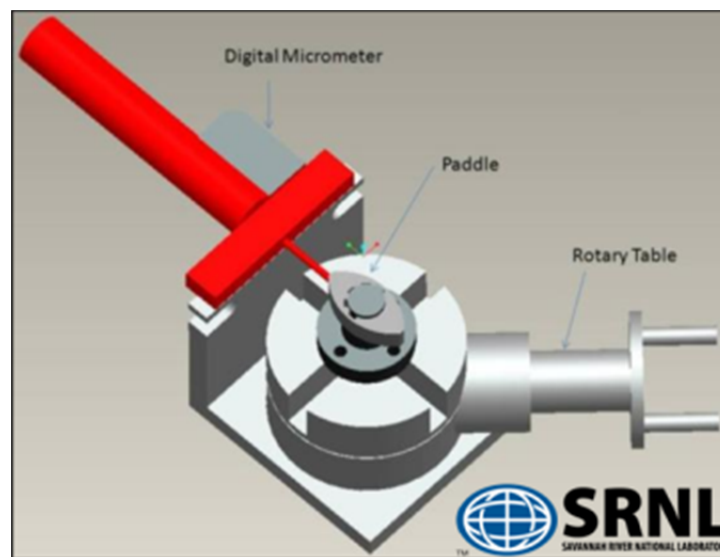
Figure 2-8. Paddle fixture for measuring critical paddle dimensions

The critical dimensions of each paddle were measured prior to being placed on the mixer shafts. The critical paddle dimensions were measured using a micrometer and a rotary table (Figure 2-8).*

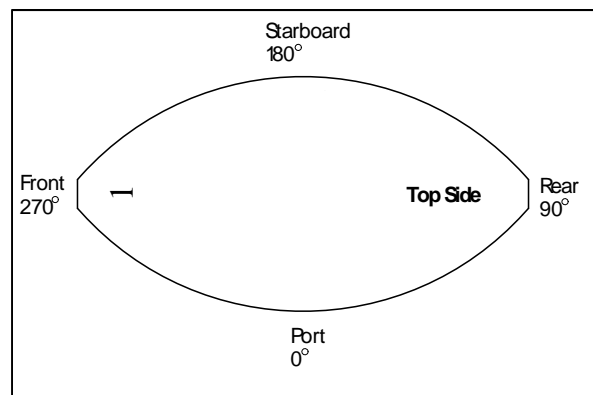
Figure 2-9. Paddle angular position for the measuring fixture

The paddle fixture measured the radial dimension of the paddle contour at various angular locations around the paddle. Figure 2-9 defines the angular position relative to the paddle contour. Readings were concentrated around the tips (90 and 270°) since it was expected that the majority of the wear would occur in those locations. The micrometer was zeroed on the fixture shaft and the micrometer reading plus the shaft radius provided the radial dimension of the paddle. The radial dimension and the angular location provided polar coordinates that defined the contour of the paddle. The polar coordinates were translated to Cartesian coordinates and plotted to provide before and after comparisons.

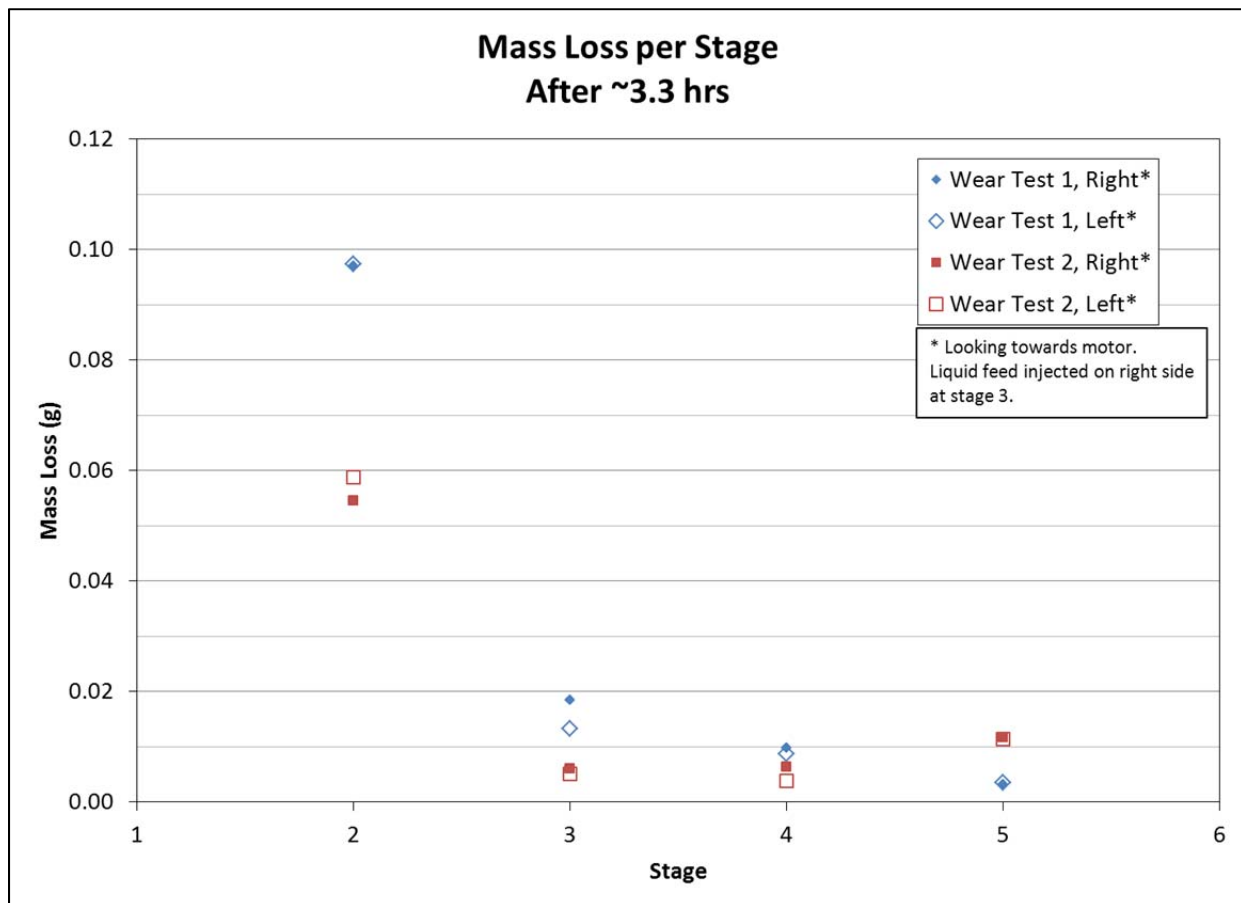
Figure 3-1. Paddle mass loss at each stage after approximately 3.3 hours of testing

The majority of the mass loss occurred in the second stage paddles for both wear tests 1 and 2. The second stage paddles are directly upstream of the liquid feed inlet, which enters the barrel above the stage 3 paddle on the right side (looking towards the motor). The stage 2 area is where the dry feed transitions from dry to wet and is also the transition between the auger and 1st set of paddles. Figure 3-1 shows the actual mass loss of the stage 2-5 paddles in wear test 1 and wear test 2 after approximately 3.3 hours (total run time of wear test 1 versus the mid-phase run time of wear test 2).

As shown in Figure 3-1, the paddle mass loss at stage 2 is approximately 40% less than the mass loss of the paddles at the same location in wear test 1. It is hypothesized that this is primarily due to the

The mass loss of the third stage paddles (where the liquid feed enters the mixer) was approximately 50% less for wear test 2 than test 1. At this stage in the mixer, the slurry has not been subjected to a lot of shear, so the material will be more viscous at the second and third stage than at stage 26 where it is discharged from the mixer. The flat paddles used in wear test 1 are designed to shear rather than convey material, so the viscous slurry has no directional force to move through the mixer other than additional material supplied by the augers. Therefore, it can be assumed the viscous mixture would reside in that location longer, causing more wear, than it would if a helical (conveying) paddle replaced the flat paddle. For wear test 2, it is hypothesized that the viscous mixture is conveyed past the liquid inlet by the helical paddles, reducing the contact time with the paddles, resulting in a lower mass loss. The paddles at stage four had comparable mass loss for both tests. The paddles at stage 5 for wear test 1 had almost no mass loss. For wear test 2, the paddle at stage 5 showed a greater mass loss relative to stage 4 for wear test 2. This is likely because stage 5 was the transition point from the helical paddle design to the flat paddle design in wear test 2.

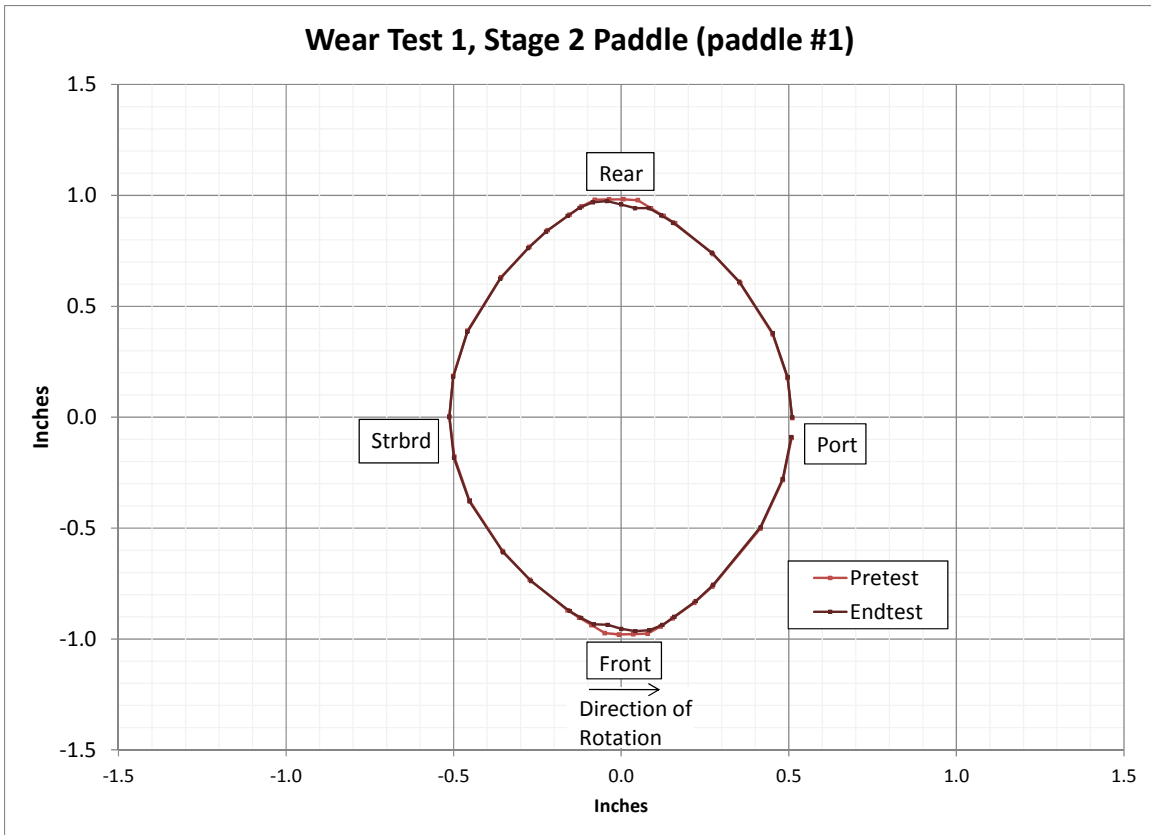
Figure 3-2. Pre- and post-test contour plot for wear test 1, stage 2 flat paddle on the right shaft.

The contour plots confirmed that a greater amount of wear occurred on the first wear test flat paddles. The extent of tip wear for the second stage paddle on the right shaft from wear test 1 is shown in Figure 3-2. The second stage paddle on the right shaft from wear test 2 is shown in Figure 3-3. Shown are the pretest and post-test contours. The contour in Figure 3-2 was measured at the middle height of the paddle; the contour in Figure 3-3 was measured at the upper height. These heights represent the location of greatest wear.

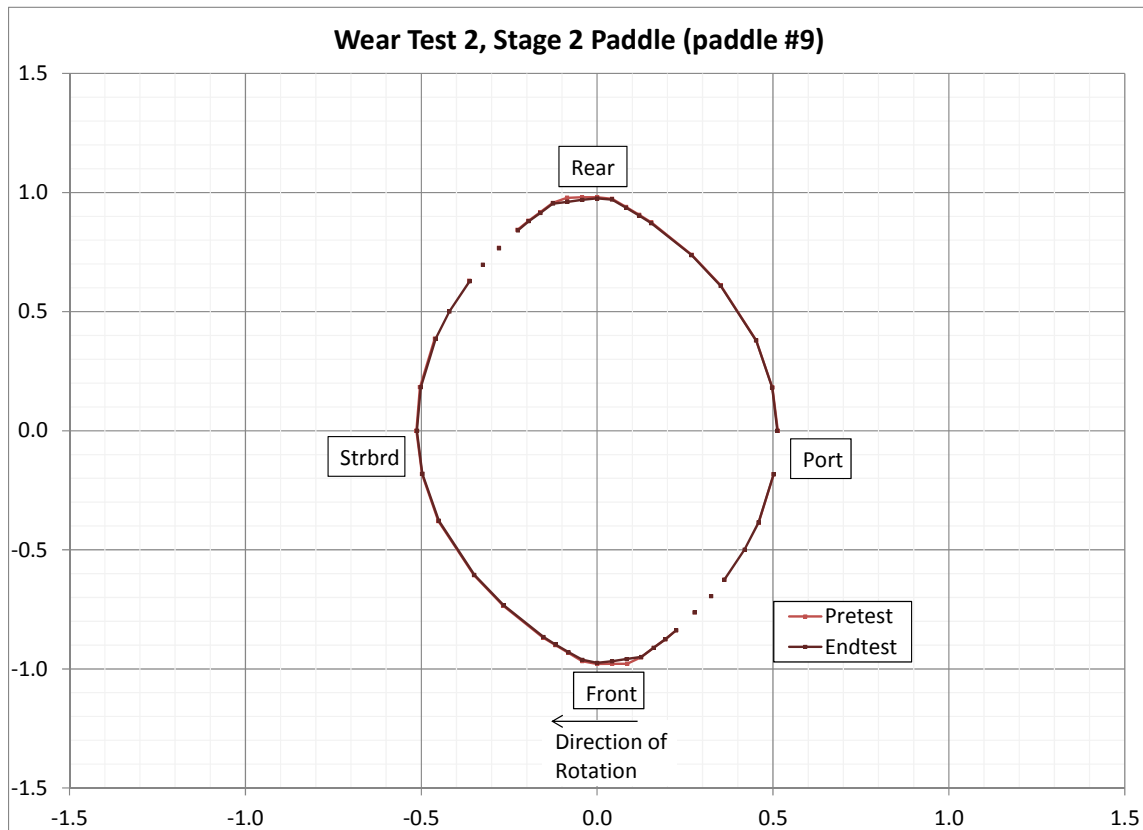
Figure 3-3. Pre- and post-test contour plot for wear test 2, stage 2 helical paddle on right shaft.

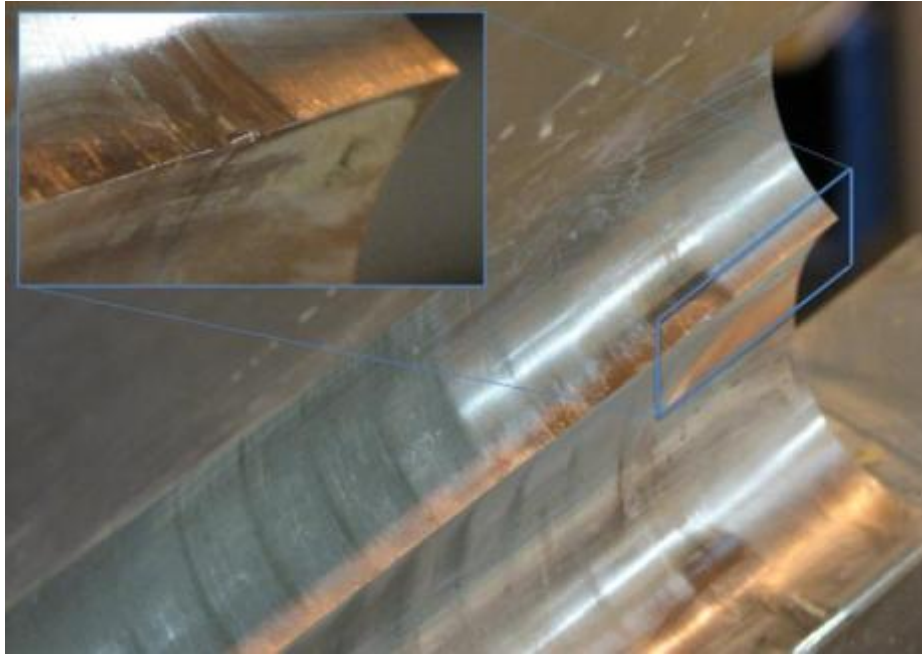
Figure 3-4. Wear at the junction of the inner barrel diameters

The mixer barrel is made of stainless steel and was not expected to show any significant wear within the time frame of this testing. However, wear was evident at the junction of the two barrels mostly at stage 2, with some wear at stage 3. The wear was evident on the upper housing clamshell and the lower housing clamshell. Figure 3-4 shows the wear at the junction on the upper clamshell.

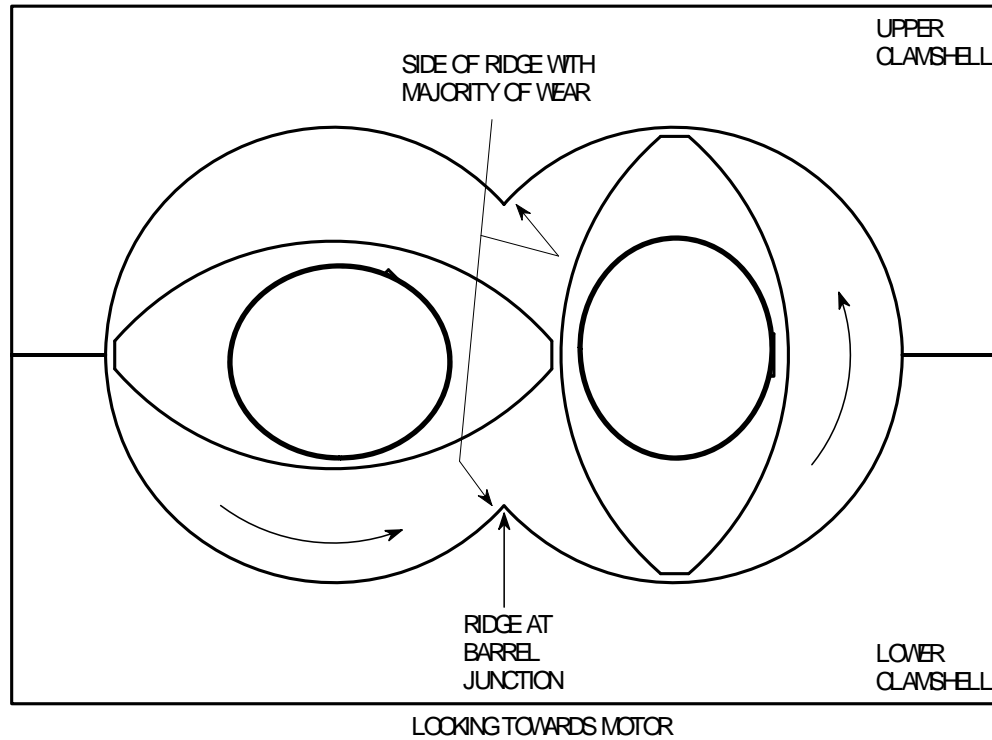
Figure 3-5. Diagram of paddle rotation relative to the measured wear on the inside of the mixer barrel

The majority of wear occurred on one side of the ridge. Figure 3-5 illustrates the side where the wear occurred. The depth of wear was measured by laying a straight-edge along the junction and inserting the edge of a feeler gage between the housing and the straight-edge. The largest gap was at stage 2 and measured 0.009 inches.

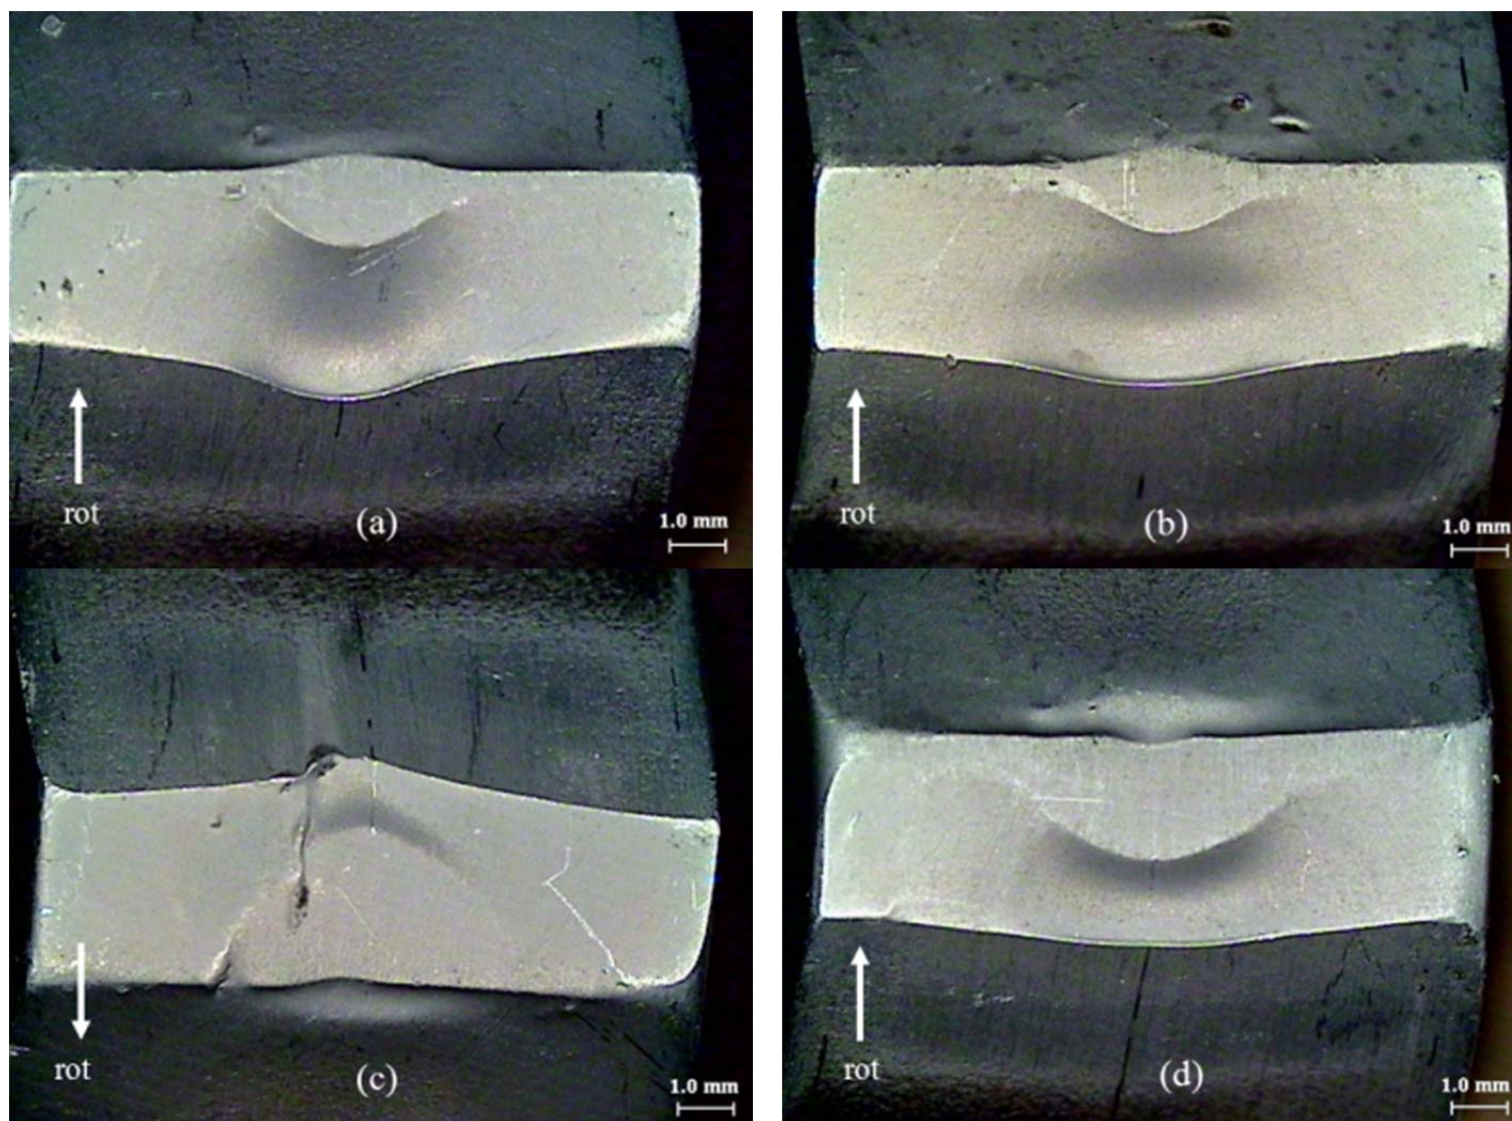
Figure 3-6. Macrographs of second stage flat wear paddles after wear test 1 showing damage to the tip and polishing due to wear on the leading edge for (a) paddle 1, front tip (b) paddle 1, rear tip (c) paddle 5, front tip (d) paddle 5, rear tip

As shown in Table 3-1, the areas of wear on the flat and helical paddles are different. For the second stage paddles, the majority of the wear occurs at the middle of the flat paddles (Figure 3-6), while the helical paddles wear more at the edges (Figure 3-7). In addition to wear at the tips, the wear is on the leading face of the paddles in the direction of rotation as evidenced by surface polishing; however, the machining marks are still visible on the trailing edge for all the helical paddles. The polishing effect is pronounced on the stage 2 and 3 paddles but not on the stage 4 and 5 paddles (Appendix B). As shown in Figure 3-6 and Figure 3-7, there is some polishing on both sides of the leading and trailing faces of the flat paddles, but only on the leading face of the helical paddles.

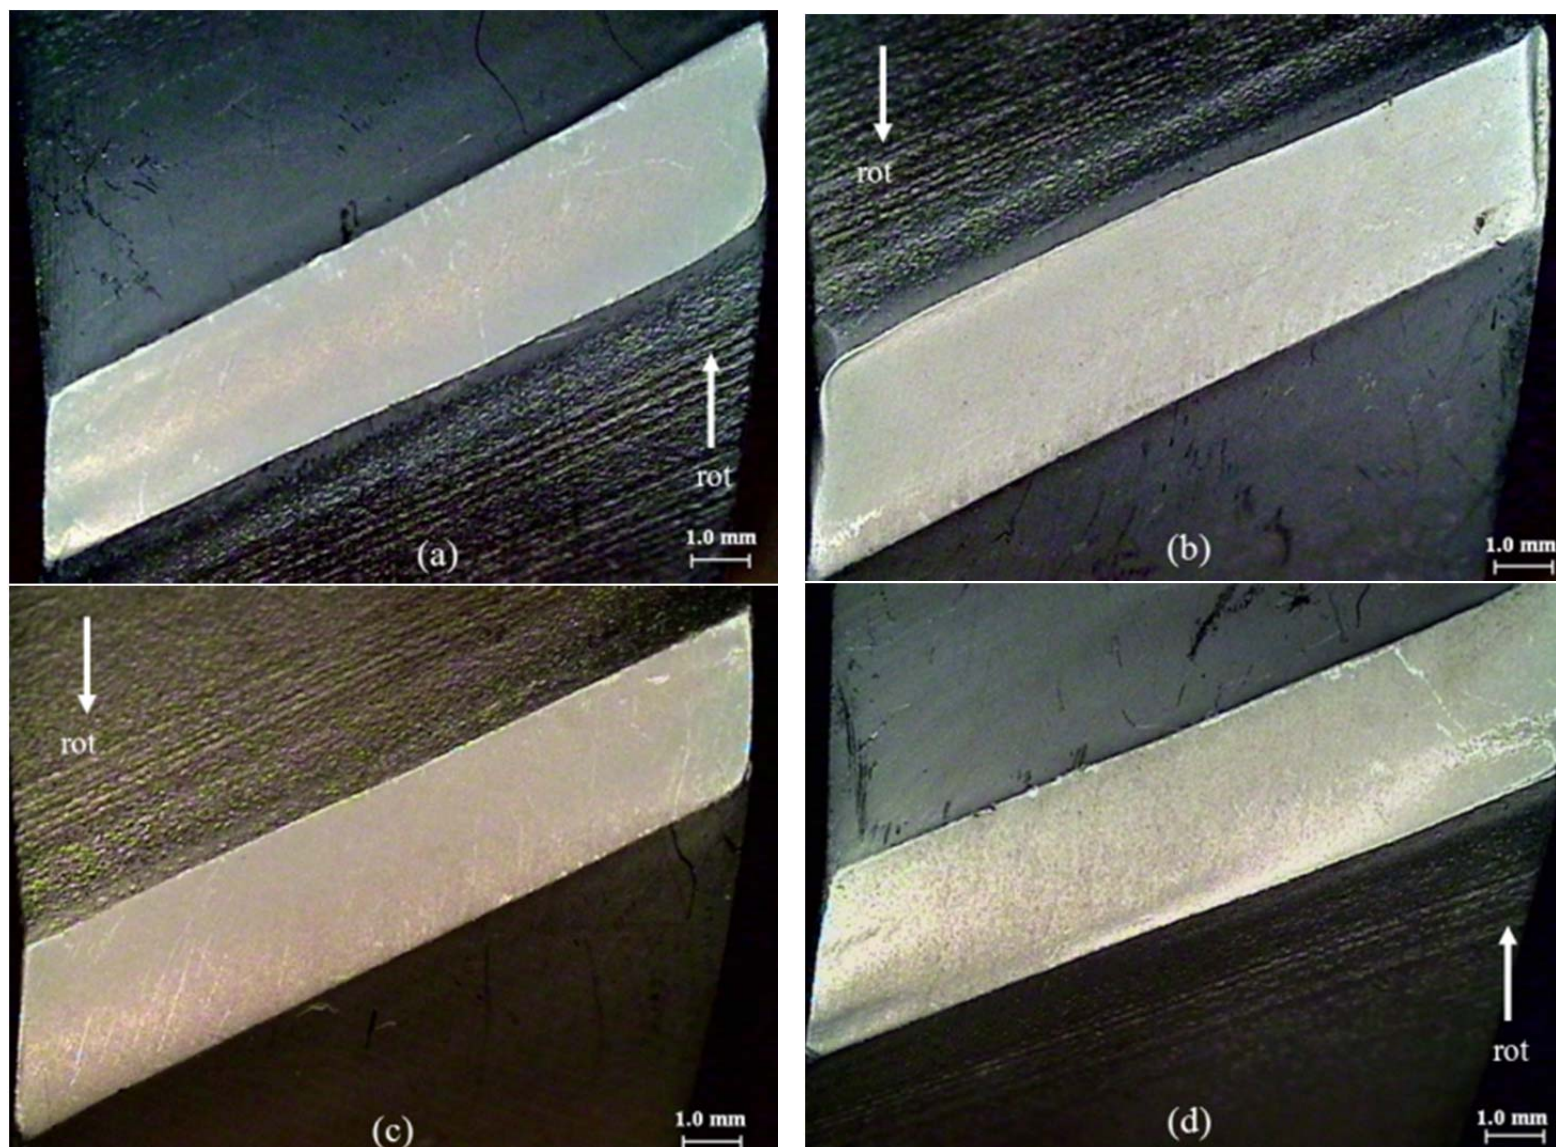
Figure 3-7. Macrographs of second stage helical wear paddles after wear test 2 showing damage to the tip and polishing due to wear on the leading edge for (a) paddle 9, front tip (b) paddle 9, rear tip (c) paddle 13, front tip (d) paddle 13, rear tip

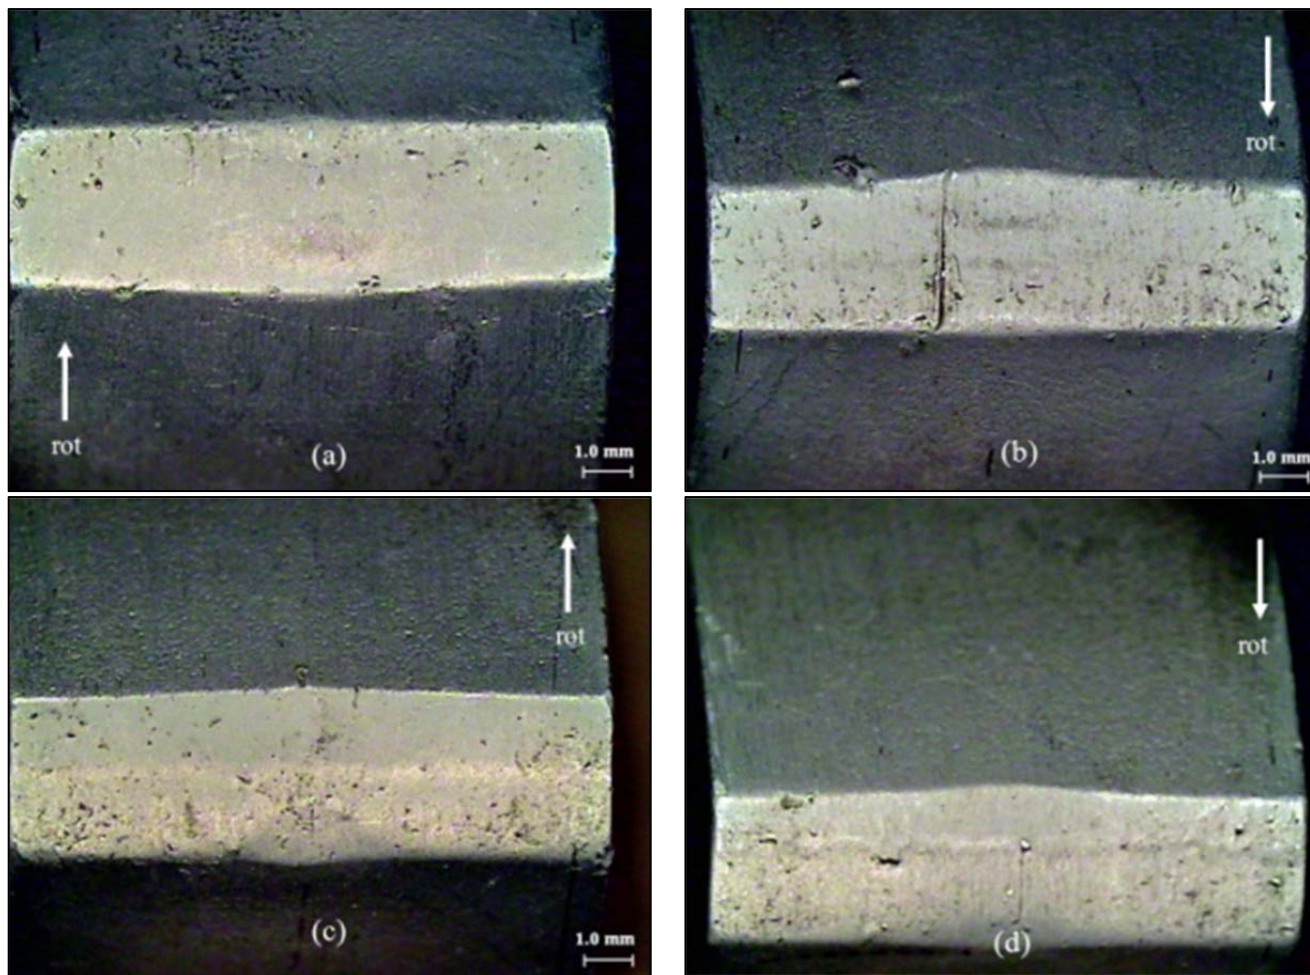
Macrographs of third stage flat wear paddles showing damage to the tip on (a) paddle 2, front tip (b) paddle 2, rear tip (c) paddle 6, front tip (d) paddle 6, rear tip.

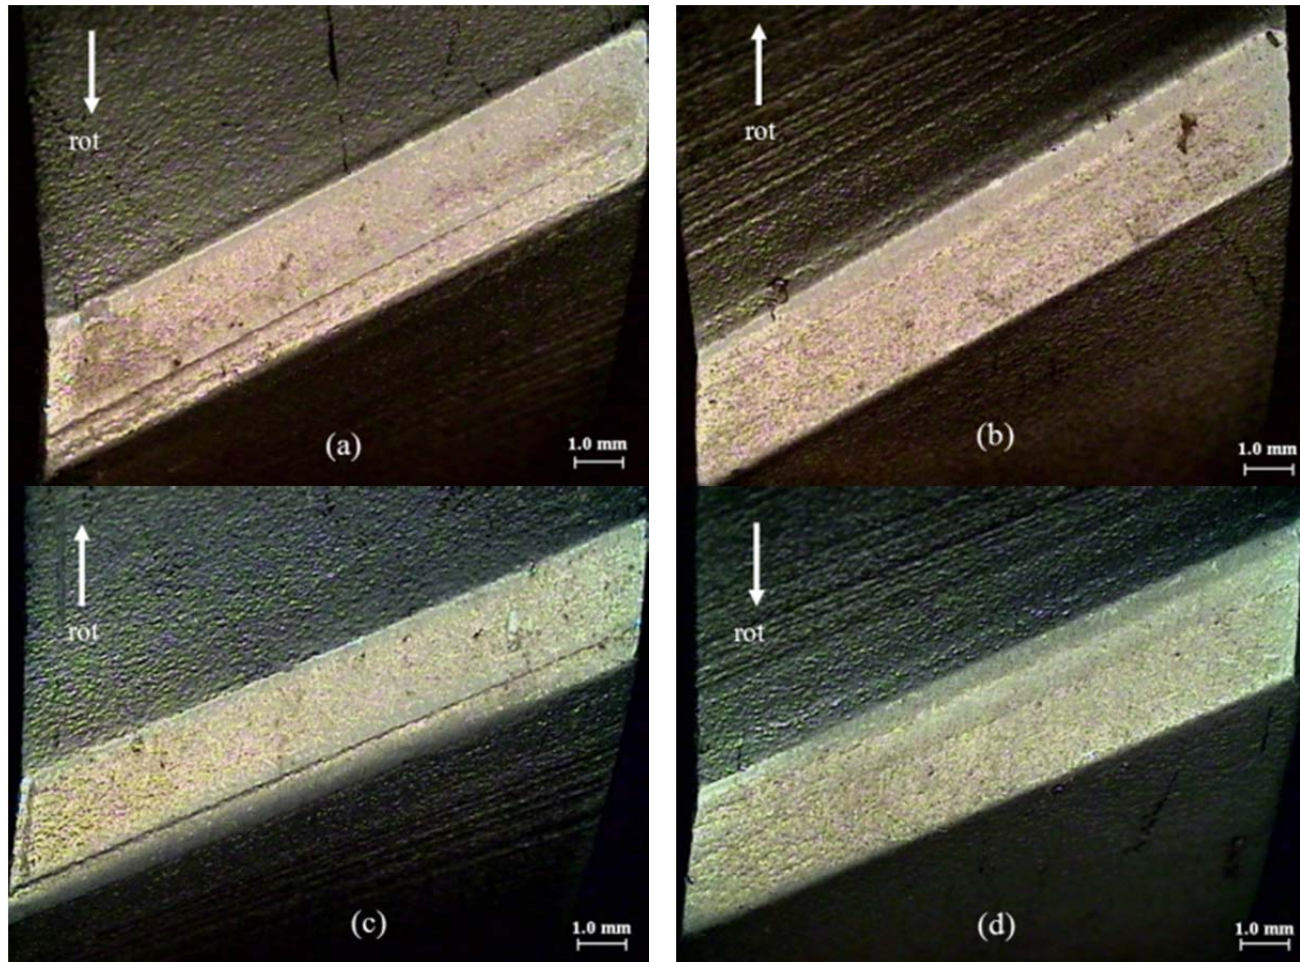
Macrographs of third stage helical wear paddles showing slight damage to the tip at the edges and minimal polishing due to wear on the leading edge for (a) paddle 10, front tip (b) paddle 10, rear tip (c) paddle 14, front tip (d) paddle 14, rear tip. Note the horizontal machining marks still visible on all the paddles, specifically on the trailing face.

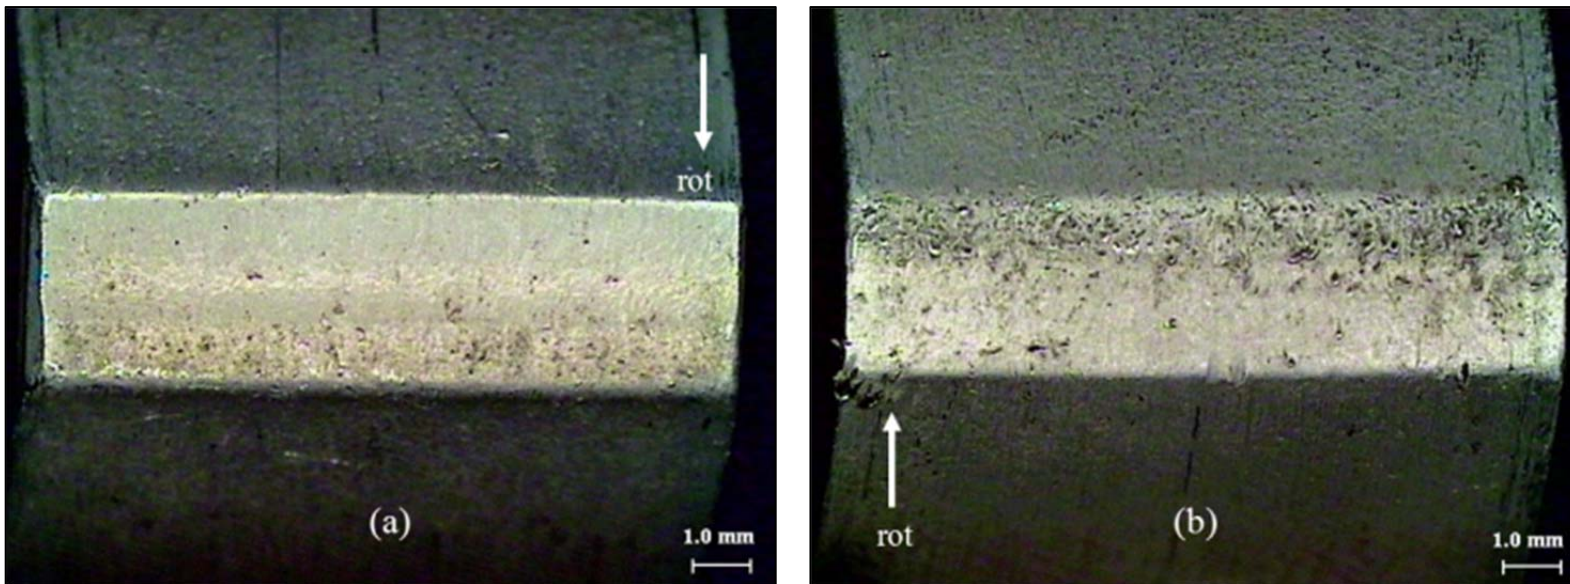
Macrographs of fourth stage flat wear paddles showing slight damage to the tip at the edges and minimal polishing due to wear on the leading edge for (a) paddle 7, front tip (b) paddle 7, rear tip. Macrographs of paddle 3 are not available. Note that wear is more localized to leading edge of the paddle tip, rather than wear occurring on the entire paddle tip.
