Evaluation of Saltstone Mixer Paddle Configuration for Improved Wear Resistance

M.M. Reigel
M.D. Fowley
B.R. Pickenheim

September 12, 2012

Savannah River National Laboratory
Savannah River Nuclear Solutions, LLC
Aiken, SC 29808

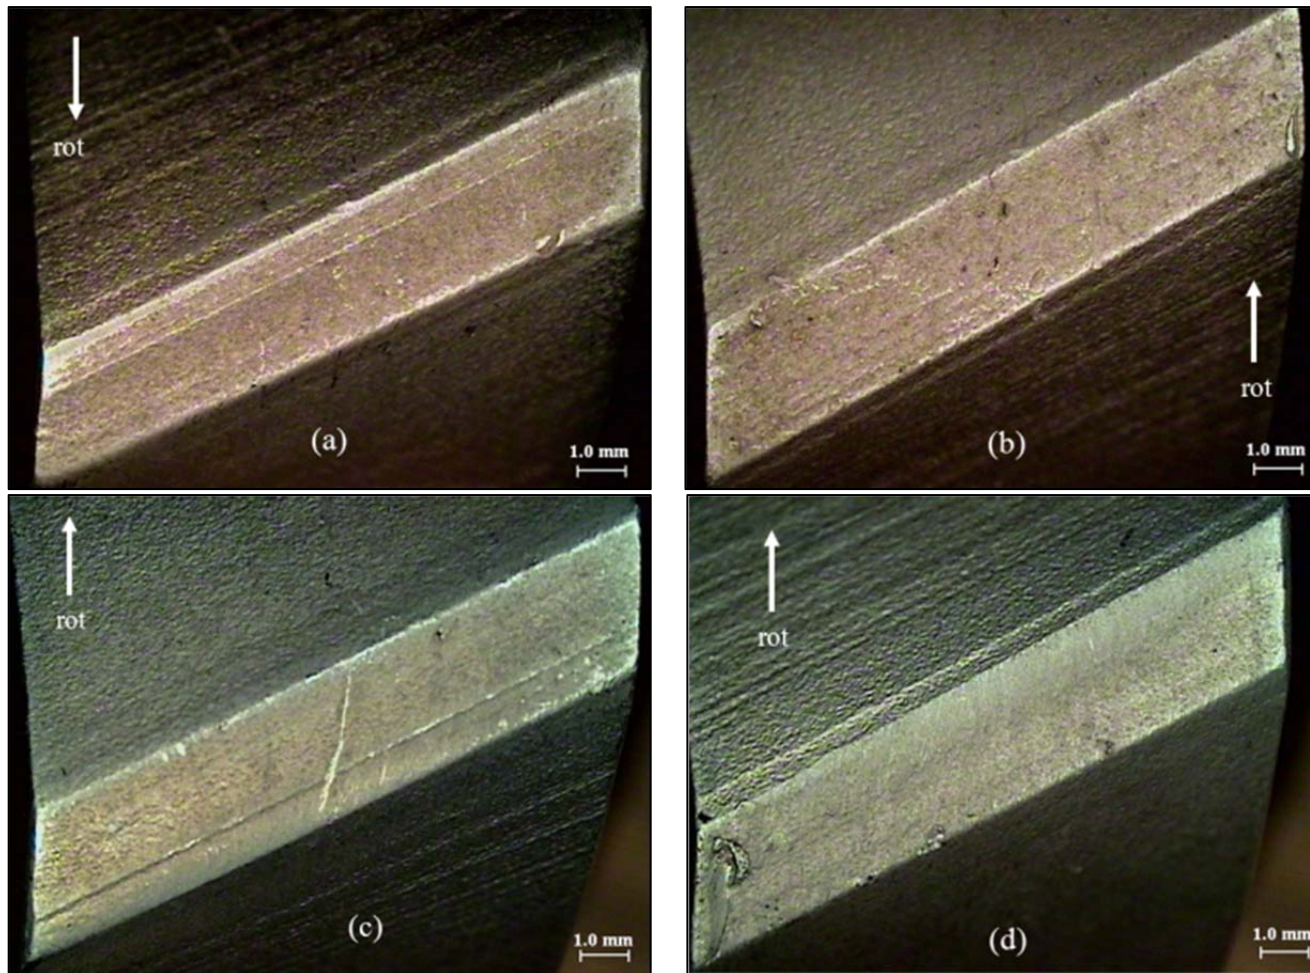
Macrographs of third stage helical wear paddles showing slight damage to the tip at the edges and minimal polishing due to wear on the leading edge for (a) paddle 11, front tip (b) paddle 11, rear tip (c) paddle 15, front tip (d) paddle 15, rear tip. Note the horizontal machining marks still visible on all the paddles, specifically on the trailing face, also the ridge in the middle of the paddle tip is an artifact of machining.

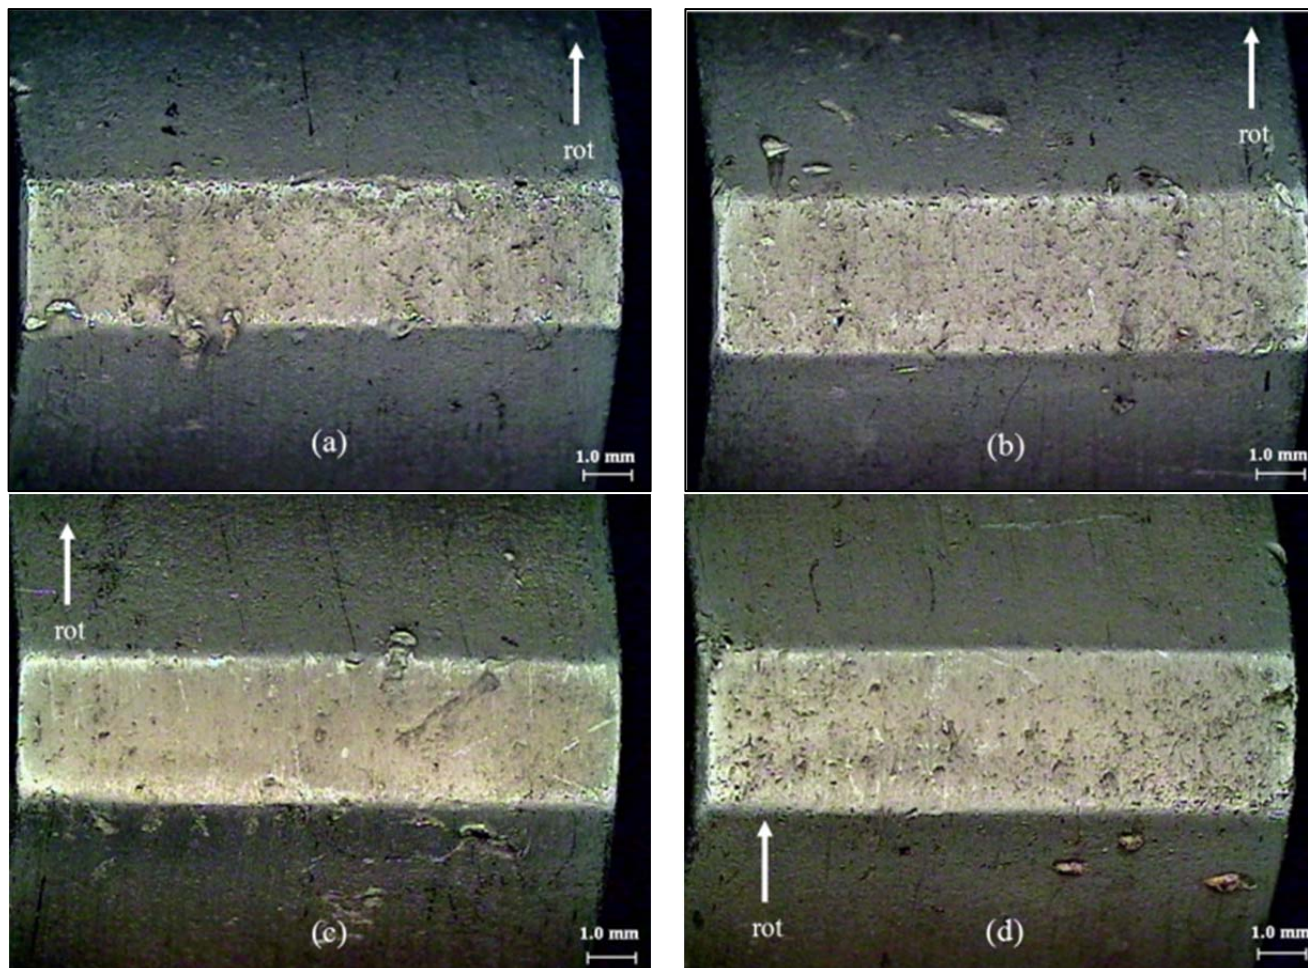
Macrographs of fourth stage flat wear paddles after two wear tests (a) paddle 4, front tip (b) paddle 4, rear tip (c) paddle 8, front tip (d) paddle 8, rear tip.

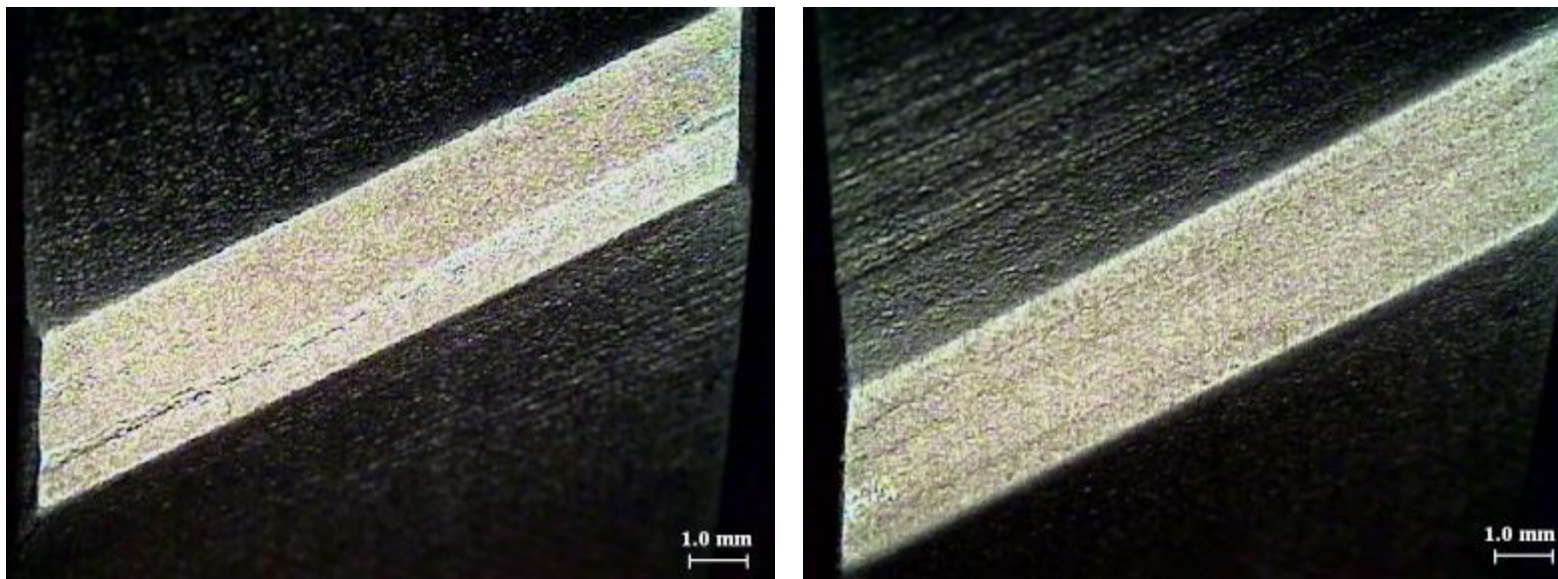
Macrographs of the (a) front tip (b) rear tip of an aluminum helical paddle that was not run in the mixer.
