# Alternate Paddle Configuration for Improved Wear Resistance in the Saltstone Mixer

September 2013

SRNL-STI-2013-00523

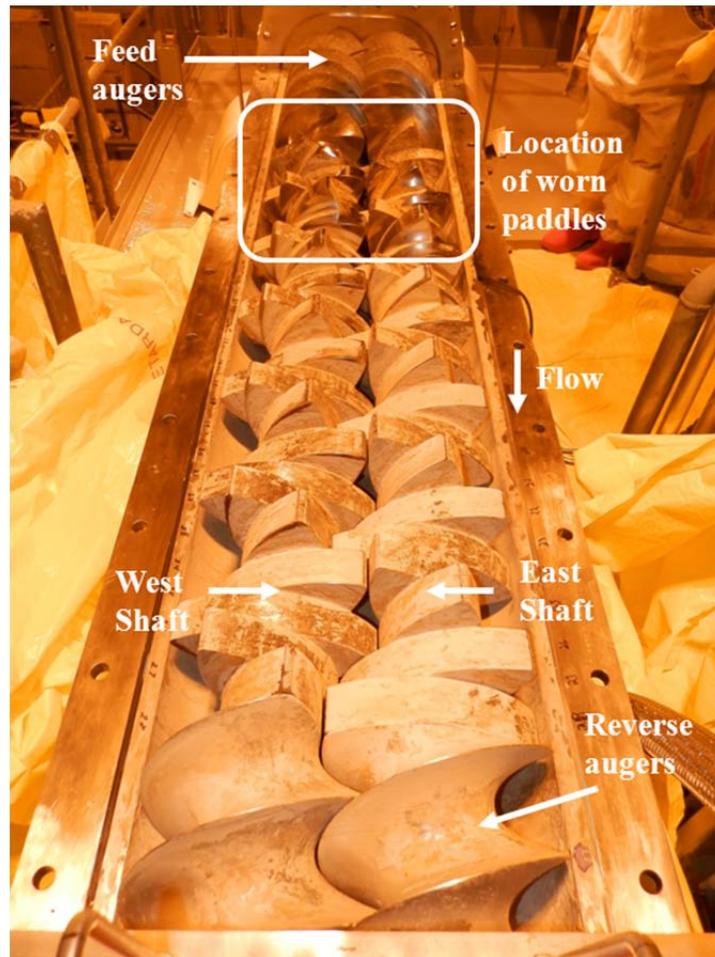
The 10-inch Readco-Kurimoto mixer installed in the SPF is a continuous co-rotating twin-screw mixer. The co-rotating shafts contain multiple intermeshing lens-shaped mixing paddles that have tight clearances between the paddles and the inside diameter of the barrel which promotes a “self-wiping” capability. Also on the shafts are augers that provide the flow of premix into the paddles and they also have the tight clearance between the outside flight diameter and barrel. As shown in Figure 1-1, the paddles on the co-rotating shafts are paired and off-set by ninety degrees. For the duration of this report, the paddles at each position in the mixer will be referred to as paddle pair and the respective position number.

**Figure 1-1. 10-inch Readco-Kurimoto mixer installed in the SPF showing the feed augers, the co-rotating shafts with pairs of intermeshing mixing paddles, and location of worn paddles.**

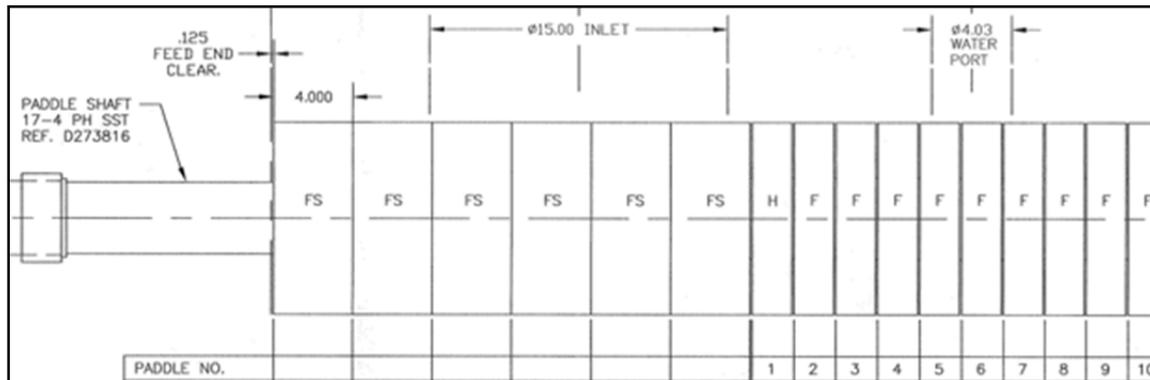
In December 2011, the saltstone mixer was removed from service and replaced with a new 10-inch Readco-Kurimoto continuous mixer as part of the Enhanced Low Activity Waste Disposal (ELAWD) changes to the SPF. In FY2012, SRNL tested the actual and SRNL recommended paddle configuration of the mixer removed from the SPF as part of the ELAWD project.<sup>1</sup> The new mixer installed in the SPF as part of ELAWD has a different configuration; specifically the liquid inlet location is above paddle pairs 5 and 6 rather than above paddle pairs 1 and 2 as in the previous mixer design. The new design also includes a longer feed auger section and 28 paddle pairs rather than 26 in the previous design.<sup>1</sup> Reverse augers replace the pair of reverse helical paddles in the previous design at the discharge of the mixer. The mixer configuration currently installed in the SPF is the focus of this report (Figure 1-2), specifically paddle pairs 1 – 6.

**Figure 1-2. A portion of the 10-inch mixer paddle configuration installed in the SPF in December 2011.**

Two paddle configurations were tested using the 2-inch mixer. The first paddle configuration tested was the same as the 10-inch mixer configuration currently installed in the SPF (Figure 1-2) to provide baseline wear. The feed augers were followed by a helical paddles at paddle pair 1 and flat paddles at paddle pairs 2 – 25, ending with a reverse helical paddle at paddle pair 26. The helical paddles at paddle pair 1 are offset at a 45 degree angle to the last flight of the auger, creating a misalignment in the flow path of the dry feeds from the auger into the mixer barrel (Figure 2-2). The reverse helical paddles conveyed the grout in the reverse direction away from the seals at the end of the shaft and aided in discharging the grout from the mixer. It should be noted that the 2-inch mixer cannot be configured with the reverse auger due to available space in the mixer barrel.

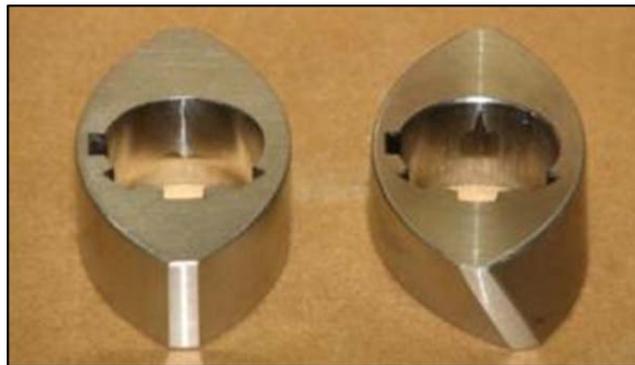
The SPF mixer contains shearing and conveying paddles (Figure 1-3). The shearing paddles are flat and designed for mixing the constituents in the mixer. The conveying paddles have a helical curvature and are designed to help move the material through the mixer. Throughout this report, the shearing and conveying paddles will be referred to as flat and helical paddles, respectively.

**Figure 1-3. Two types of paddles shearing or flat (left) and conveying or helical (right) for the Readco-Kurimoto continuous mixer**

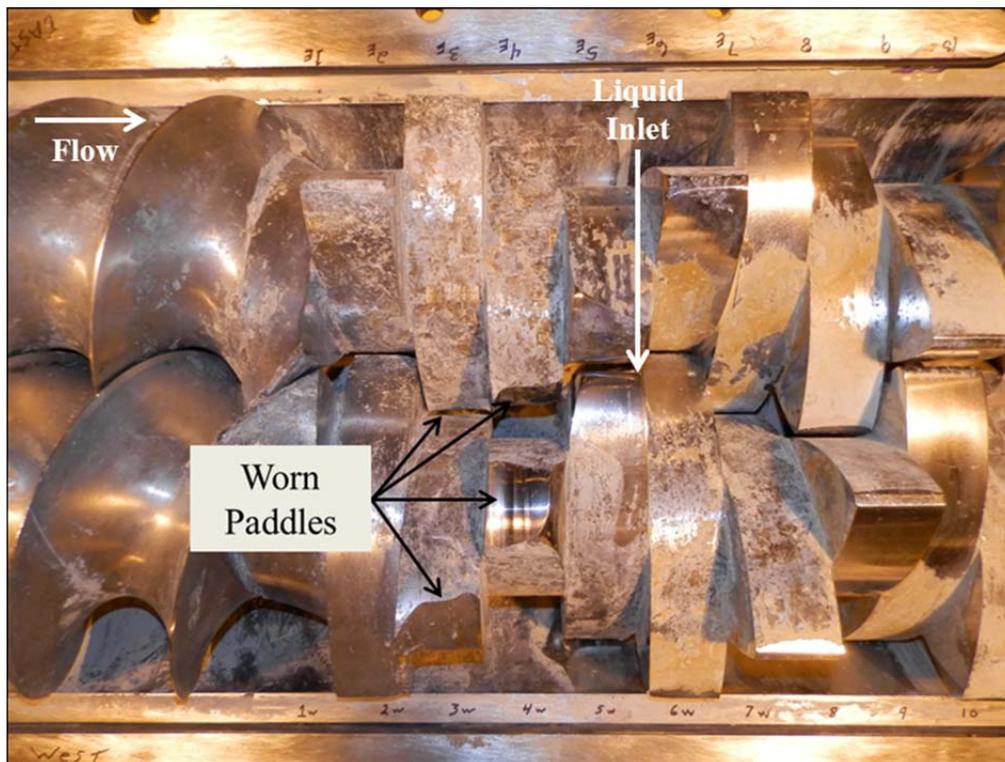
In January 2013, a routine inspection of the SPF mixer showed there was more wear on the mixer paddles below the liquid inlet than what was anticipated based on previous mixer inspections and testing at Savannah River National Laboratory (SRNL) (Figure 1-4). As a result of this increased

**Figure 1-4. Paddles 1 – 9 in the 10-inch mixer after cleaning during the January 2013 inspection with worn paddle tips showing on paddles 3 and 4.**

During the mixer inspection in January 2013, pictures and measurements were taken of the paddles. The clearances between paddle pairs 1 – 7 and the inside barrel were measured and documented (Table 1-1). These paddles were selected since they were anticipated to have the most wear based on the location of the liquid inlet.<sup>5</sup> Other selected paddles were measured during the inspection to determine whether wear was occurring elsewhere in the mixer. The as-machined clearances for the as-built 10-inch Readco-Kurimoto mixer are shown in Table 1-2. Comparing the measured gap distances in Table 1-1 to the machined paddle to barrel wall tolerance in Table 1-2, paddle pairs 3, 4, and 5 on both the east and west side show the most wear. The clearances between the paddle tip and the barrel wall for paddle pairs 1, 2, 6, and 7 fell within or close to the machined tolerances of the 10-inch mixer. Selected paddles in the rest of the mixer (paddle pairs 8 – 26) had little or no change in the clearance and were within the specified tolerance listed in Table 1-2.

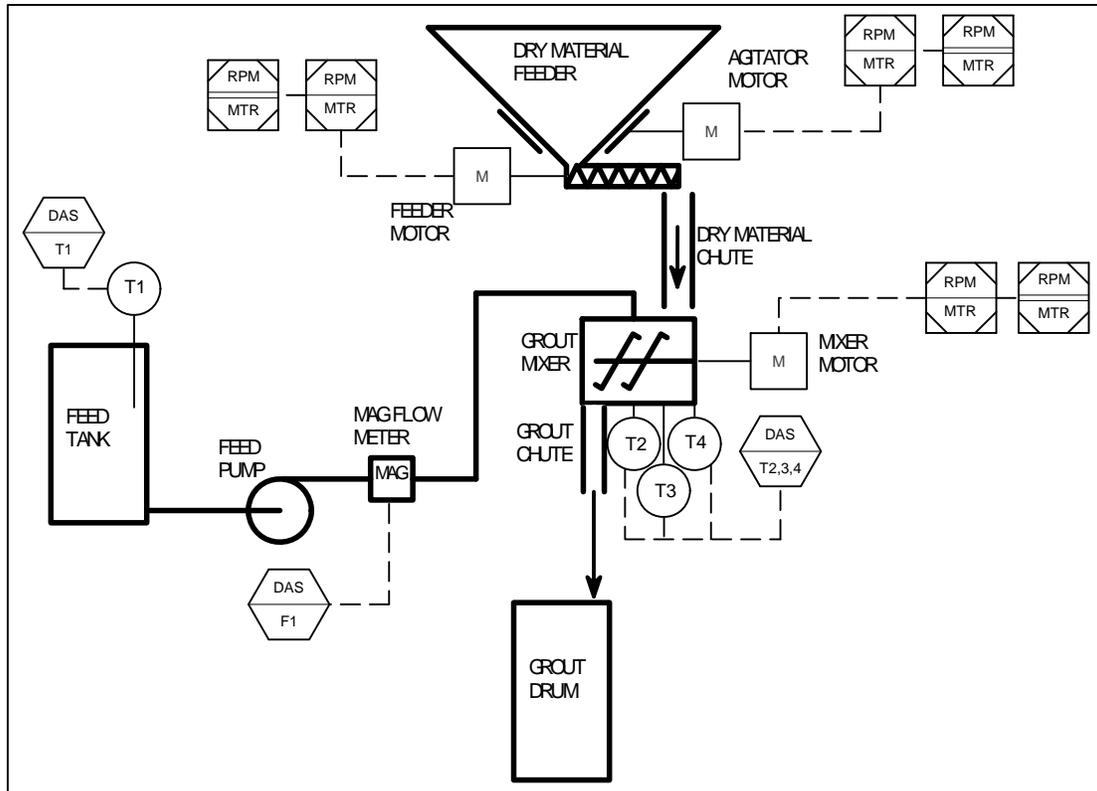
SRNL has developed a pilot scale system of the SPF at Savannah River Site (SRS) known as the Scaled Continuous Processing Facility (SCPF) (Figure 2-1).<sup>4</sup> The scaled system consists of a Mechatron “MC” dry material feeder coupled to a Readco-Kurimoto 2-inch co-rotating twin-screw continuous processor (mixer) which mixes the dry feeds with liquid supplied by a feed tank. The liquid inlet on the 2-inch mixer was located on the top of the mixer over paddle pairs 5 and 6, centered between the east and west shafts to mimic the 10-inch mixer configuration in the SPF. Grout is made from the mixing of the dry feeds with water and is discharged from the end of the mixer into a receipt tank (grout drum). Water was used for this testing rather than salt solution due the expense of batching salt solution. In addition, it has been shown in previous testing that corrosion is not a cause of wear in the mixer, so salt solution is not required to determine the relative wear of the two paddle configurations.<sup>6</sup>

**Figure 2-1. SRNL Scaled Continuous Processing Facility as configured for wear testing (dashed lines indicate instruments and collections points for the data acquisition system)**

Details of the unit operations of the SCPF as well as the scaling and comparisons between the 2-inch and 10-inch mixers are captured in other reports.<sup>1,4,7</sup> For the wear testing, the feeder was operated in the gravimetric mode; the helix motor was set to provide the required dry feed rate based on mass loss in the hopper. In gravimetric mode, the helix auger is continuously feeding material into the dry feed chute. A ¼” mesh screen fitted over the discharge tube of the feeder delivered dry feed evenly and without clumps.

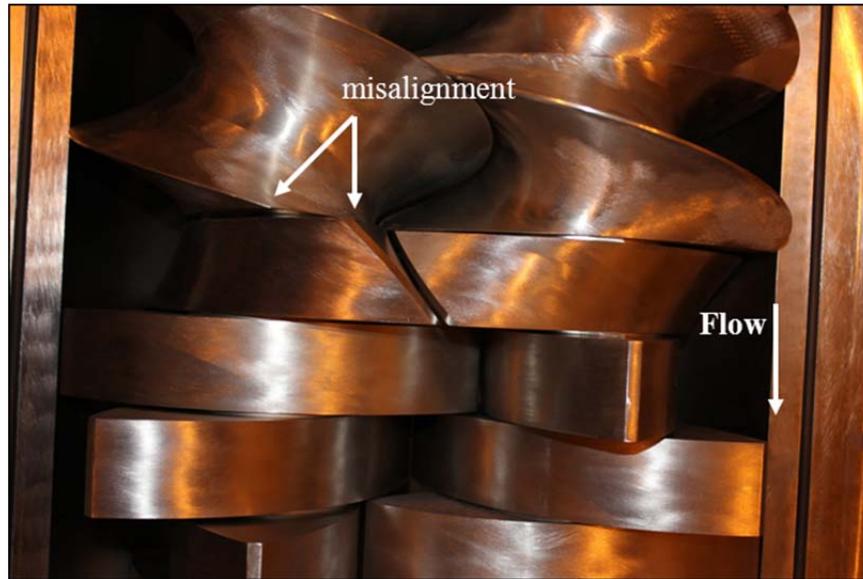
**Figure 2-2. Paddle configuration for the mixer currently installed in the SPF (note the helical paddles at paddle pair 1 and the misalignment with the auger).**

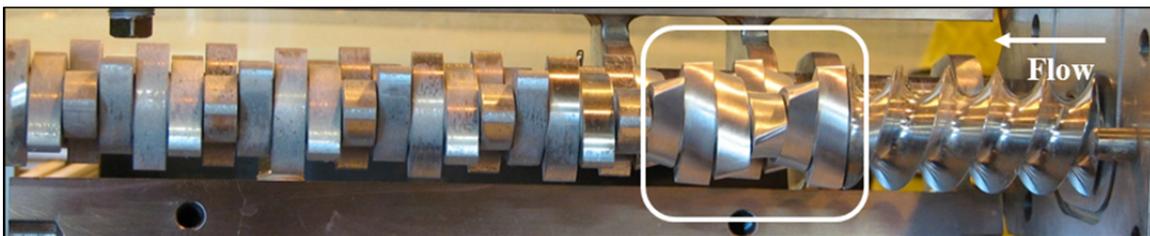
followed by flat paddles at paddle pairs 7 – 25 (Figure 2-3). The helical paddles at paddle pair 1 are aligned with the end of the feed augers. The intent of the reconfigurations was to more effectively convey the partially wetted dry feeds through the transition region and into the liquid feed where paddle wear is reduced due to the lubricating effects of the liquid feed. The alignment with the auger is aimed to provide a smoother transition (minimizing the discontinuity between the auger and paddle pair 1) into the paddles and the helical paddles should provide conveyance through the transition region to the liquid feed inlet. The reverse helical paddles are at paddle pair 26. It should be noted that the current SPF mixer has 28 paddle pairs as part of the new design; however, the 2-inch mixer barrel cannot be changed to include more paddles. The difference of two paddle pairs between the 2-inch and 10-inch mixer will not impact the testing as well as the conclusions and recommendations made in this report.

**Figure 2-3. Second paddle configuration with aluminum helical paddles at paddle pairs 1 - 6 (outlined) after the feed augers and stainless steel paddles for paddle pairs 7 – 26.**

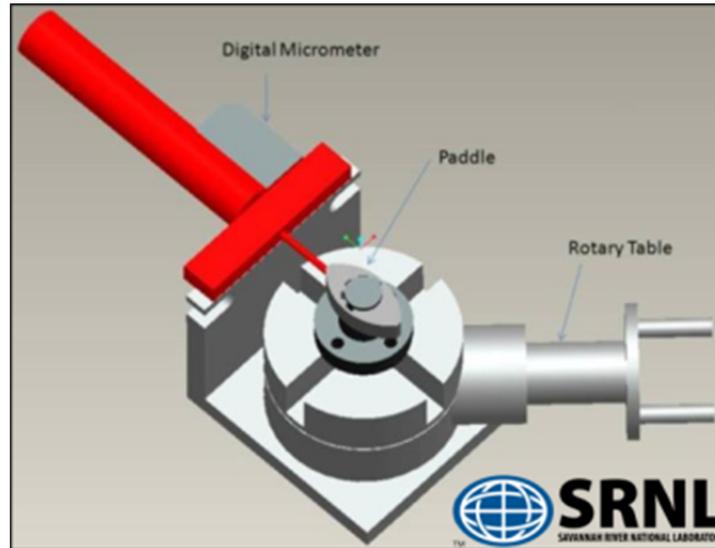
The critical dimensions of each paddle were measured prior to being placed on the mixer shafts. The contour of each paddle was measured with a specially designed fixture<sup>a</sup> consisting of a micrometer and a rotary table (Figure 2-4) and the length, width, and height of each paddle was measured with a vernier caliper.

**Figure 2-4. Paddle fixture for measuring critical paddle dimensions**

The paddle fixture measured the radial dimension of the paddle contour at various angular locations around the paddle. In addition, the contour measurements were taken at three locations along the thickness of the paddle: bottom, middle, and top. Figure 2-5 defines the angular position relative to the paddle contour. Readings were concentrated around the tips ( $90^\circ$  and  $270^\circ$ ) since it was expected that the majority of the wear would occur in those locations. The micrometer was zeroed on the fixture shaft and the micrometer reading plus the shaft radius provided the radial dimension of the paddle. The radial dimension and the angular location provided polar coordinates that defined the contour of the paddle. The polar coordinates were translated to Cartesian coordinates and plotted to provide before and after comparisons.

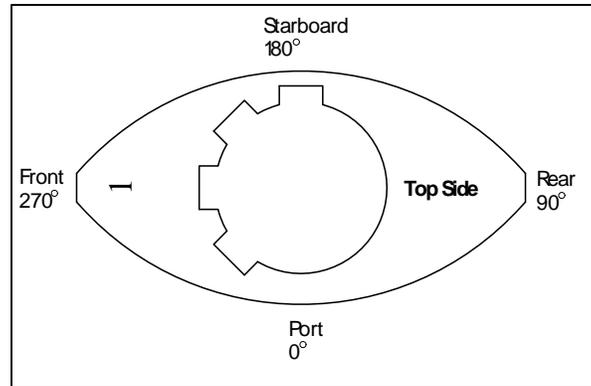
**Figure 2-5. Paddle angular position for the measuring fixture**

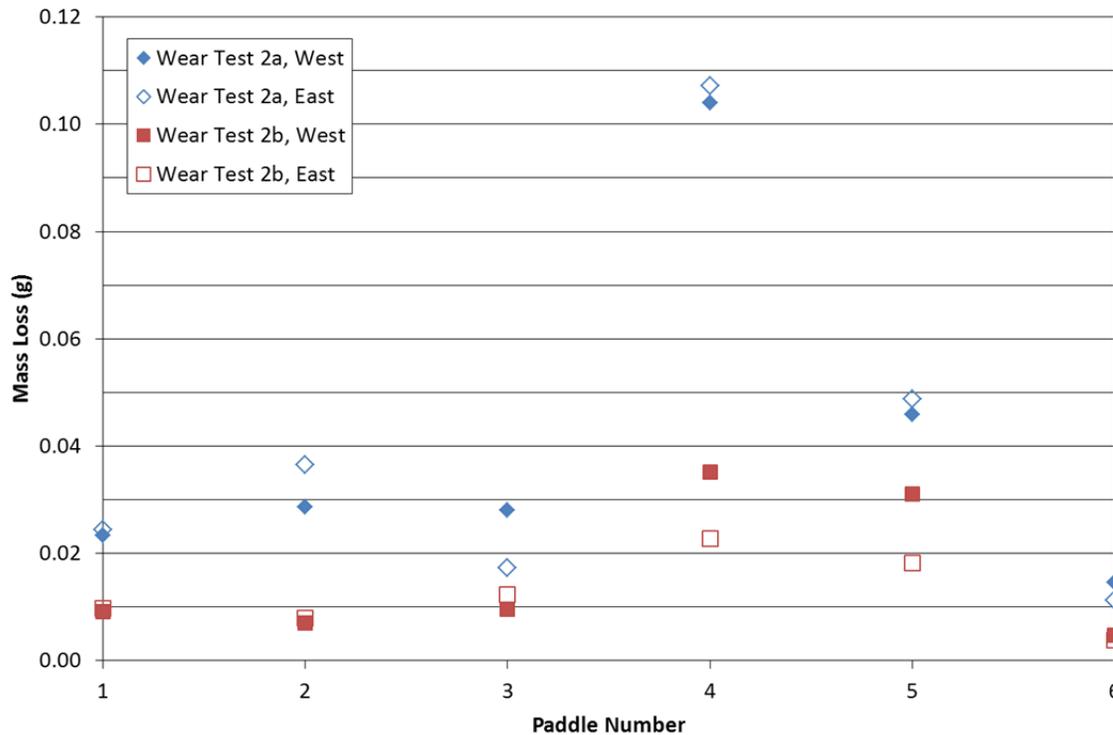
The majority of the mass loss occurred in paddle pairs 4 and 5 for the baseline wear test (2a) as well as the alternate helical configuration (2b) (Figure 3-1). This is expected based on the clearance measurements taken from the 10-inch SPF mixer. As shown in Figure 1-2, the liquid inlet is centered over paddle pairs 5 and 6; however since the liquid wicks back towards the dry feed augers, the transition region occurs where the dry feeds are first wetted over paddle pairs 3 and 4 in the 10-inch mixer. The flat paddles used in wear test 2a are designed to shear rather than convey material, so the viscous and abrasive grout in the transition region has no directional force to move through the mixer other than additional material supplied by the augers. Therefore, it can be assumed that the viscous mixture imparts more force on the paddles in the transition region, causing more wear on the shearing (flat) paddles than it would if a conveying (helical) paddle replaced the flat paddle due to the inherent design of the paddles (Figure 1-3). For wear test 2b, it is hypothesized that the viscous mixture is conveyed through the transition region past the liquid

inlet by the helical paddles, reducing the contact force and time with the paddles, resulting in a lower mass loss. The mass loss is presented as a wear rate in Figure 3-1 which demonstrates how destructive the thick grout mixture is at paddle pairs 4 and 5 as opposed to the fully wetted grout over paddle pair 6 and the dry feed at paddle pairs 1 - 3.

**Figure 3-1. Mass loss for paddle pairs 1 – 6 after wear testing in the SPF mixer configuration (2a) and the alternate helical paddle configuration (2b).**

As shown in Figure 3-1, the mass loss and subsequent wear rate on paddle pair 1 is more in wear test 2a than 2b. It is hypothesized that this is primarily due to the misalignment of the helical paddles with the augers in the current saltstone mixer. As demonstrated by this testing, as well as the testing in 2012, aligning paddle pair 1 in the mixer with the discharge of the feed augers reduces the wear on those paddles.<sup>1</sup>

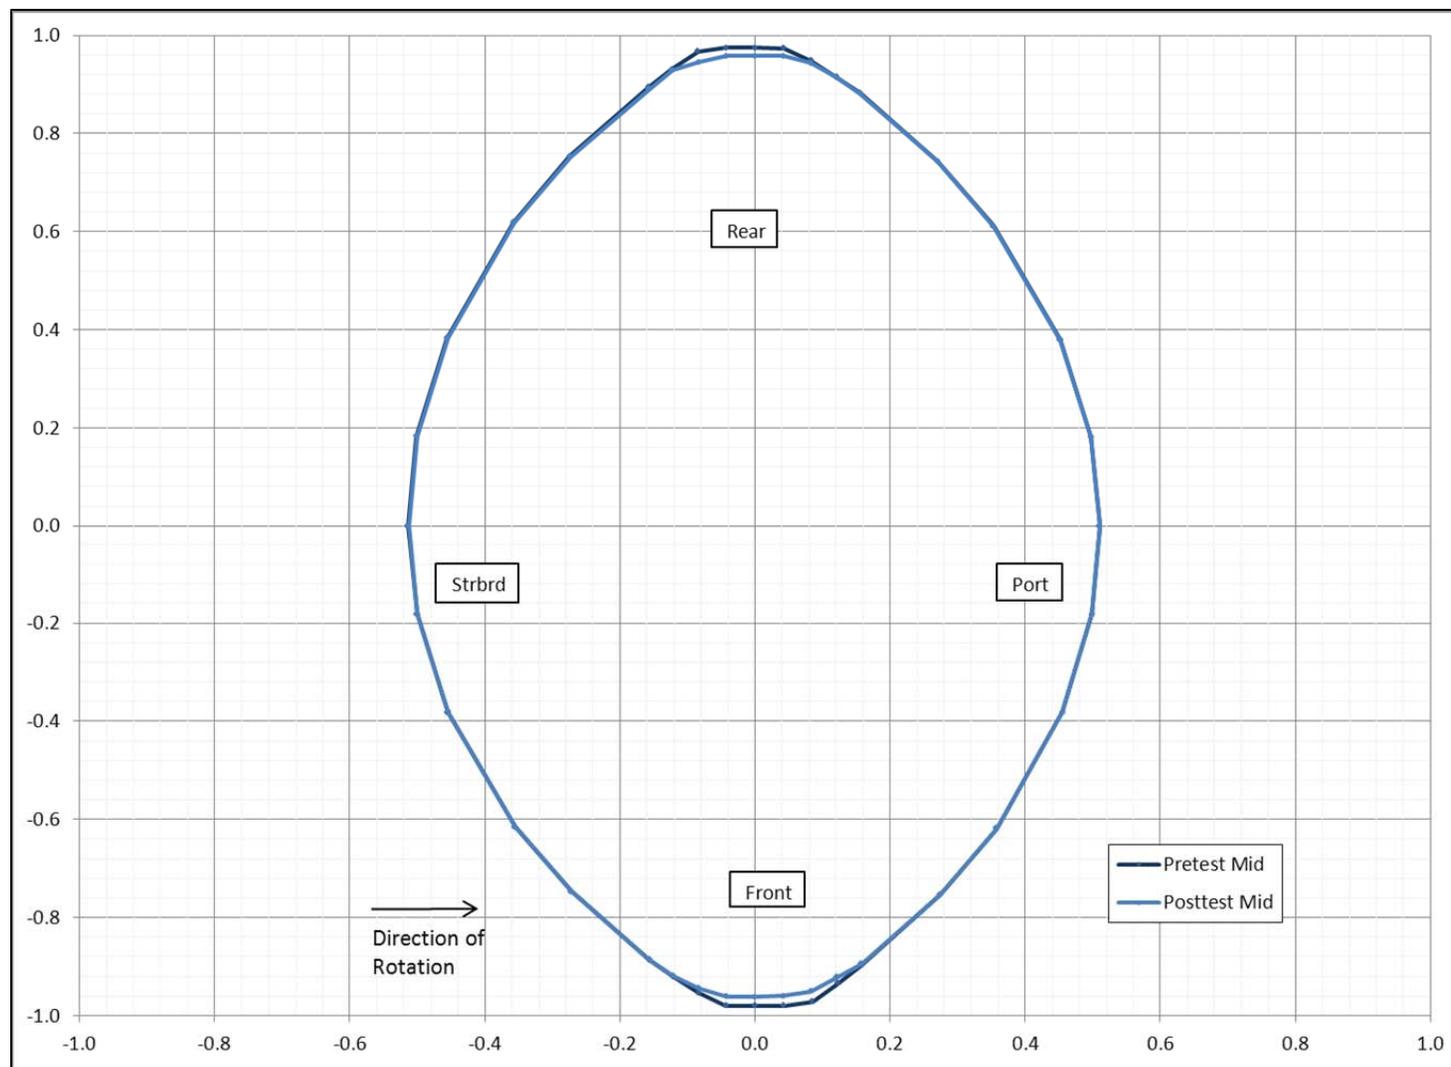
When the mixer was opened at the end of wear test 2a, a significant amount of wear had visibly occurred at the tips of paddle pairs 4 and 5 and a lesser but noticeable amount of wear occurred on paddle pairs 1, 2, 3, and 6. The post-test paddle contours were plotted and, when compared to the pre-test contours, established a baseline wear pattern. Wear test 2b was then conducted with the alternate paddle configuration. The pretest and post-test paddle contours were plotted and compared to the results of wear test 2a. The contour plots confirmed that a greater amount of wear occurred with the flat paddle configuration currently in the SPF mixer compared to the proposed helical paddle configuration. The extent of tip wear for paddle 4 on the east shaft (paddle #35) from wear test 2a is shown in Figure 3-2. Paddle 4 on the east shaft (paddle #52) from wear test 2b is shown in Figure 3-3. Shown are the pre- and post-test contours. The contour

**Figure 3-2. Pre- and post-test contour plot for wear test 2a, paddle 4 on the east shaft (flat paddle #35).**

- The wear depth is approximately twice as great in wear test 2a stage 2b paddles.
- Wear occurs mostly in the middle of the flat paddles.
- Wear occurs mostly at the trailing edge of the tip on both paddle designs as evidenced by polishing.

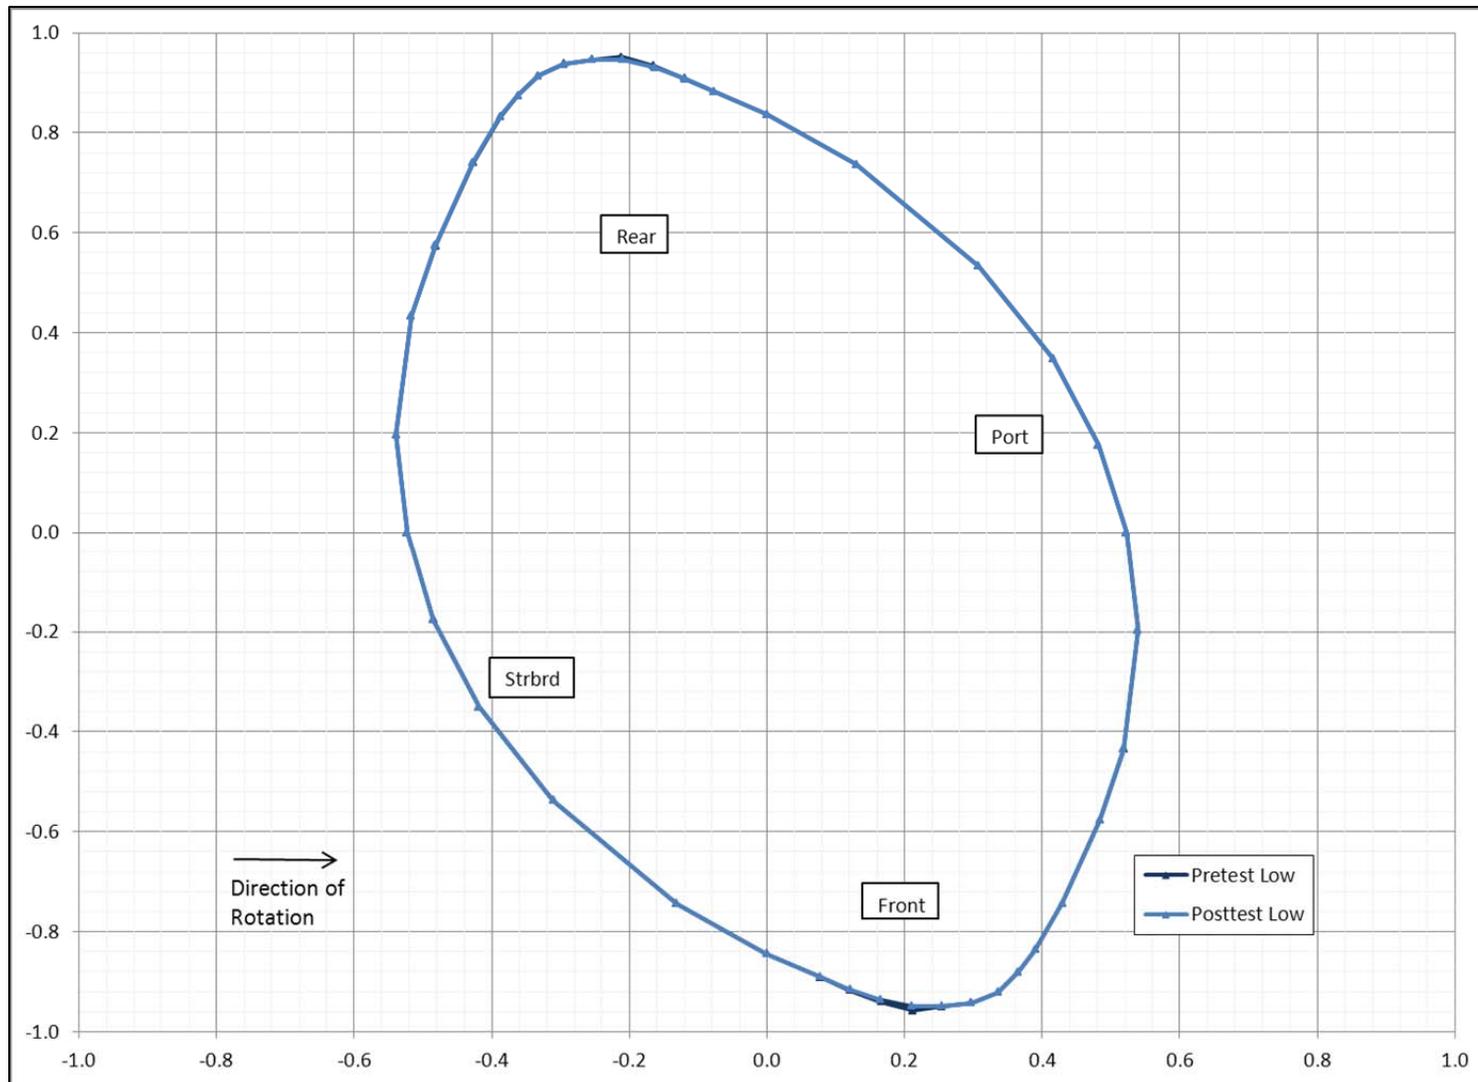
measurement was taken at mid-height on the flat paddle and the lower height on the helical paddle. These heights represent the location of greatest wear. Contour plots for paddle pairs 1, 2, 3, 5, and 6 from both wear tests are shown in Appendix A.

Figure 3-3. Pre-and post-test contour plot for wear test 2b, paddle 4 on the east shaft (helical paddle #52)

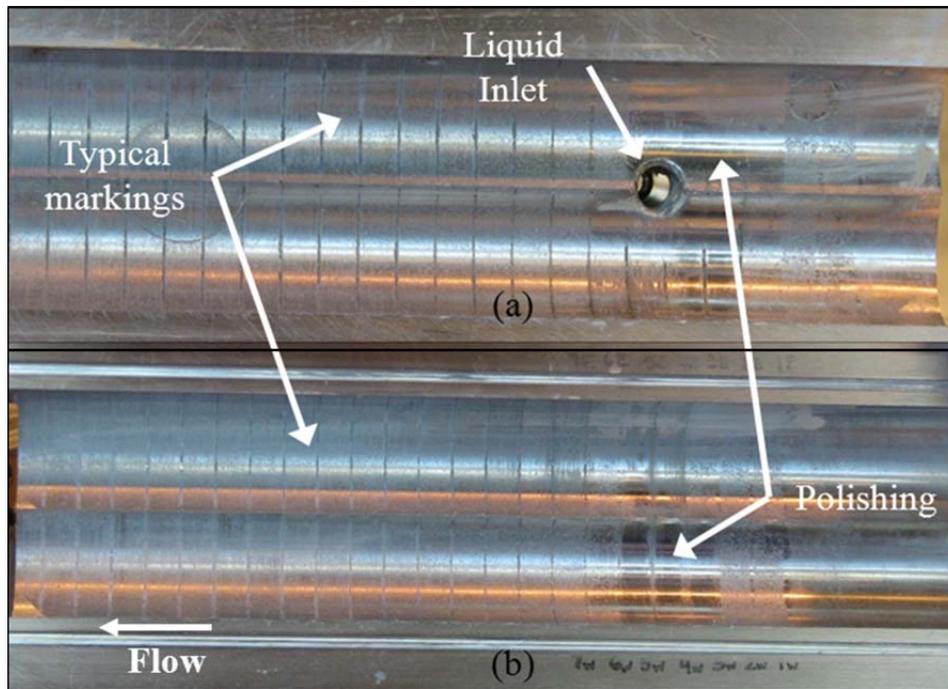
The mixer barrel is made of stainless steel and was not expected to show any significant wear within the time frame of this testing. However, wear is evident before the liquid inlet in the form of polishing (Figure 3-4). The polishing wear is evident on the upper housing clamshell and the lower housing clamshell primarily at paddle pairs 4 and 5. As shown in Figure 3-4, the paddles “mark” the inside of the barrel due to processing the grout. These marks are typical for both the 2-inch and 10-inch mixers. However, the polishing that occurs on the barrel around paddle pairs 4 and 5 is a result of the viscous grout mixture wearing the inside of the barrel as well as the paddles.

**Figure 3-4. Wear on the inner diameter of the (a) upper and (b) lower clamshells.**

Wear on the inside diameter of the mixer barrel can also reduce the self-wiping capability of the mixer paddles on the mixer barrel and lead to grout build up. As the gap between the barrel and the paddles increases, the more grout can build up over time and could affect the operation of the mixer. The grout buildup restricts the orifice for the dry feeds to enter the mixer and eventually leads to dry feeds backing up in the feed chute as demonstrated in the previous SPF mixer.<sup>1,12</sup> Similar wear patterns on the inside barrel of the mixer were also noted on the 10-inch mixer (Figure 3-5). Since the mixer barrel cannot be reconfigured or replaced in the SPF, the method for mitigating wear on the barrel is to move the more viscous grout through the transition region as quickly as possible. Based on the results documented in sections 3.1 and 3.2, paddle pairs 1 – 6 should be helical rather than flat paddles to aid in moving the grout through the mixer.

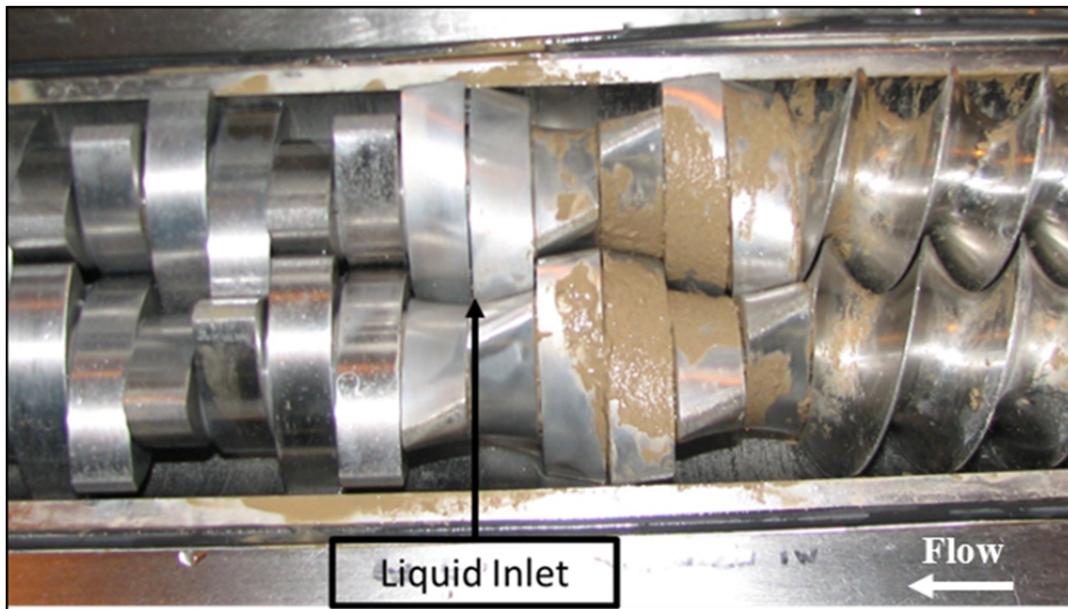
At the end of each wear test, the dry feeds were turned off and water was used to flush the mixer of any residual grout. The water entered the mixer through the liquid inlet. The flushing sequence lasted for several minutes until the liquid at the mixer discharge was clear. After flushing, the mixer was opened for more extensive cleaning and to remove the paddles for measurements. As shown in Figure 3-6, the location of the liquid inlet does not allow for sufficient cleaning of the mixer since residual grout remains on paddle pairs 1 – 4. As the paddles continue to wear and the self-cleaning capability of the paddles is lost, the lack of sufficient flushing would allow grout to build up between the barrel and the paddles (Figure 3-5). The grout build up could also contribute to additional wear on the paddles during startup of the mixer.

**Figure 3-6. Extent of cleaning in the 2-inch mixer due to flushing using the liquid inlet.**

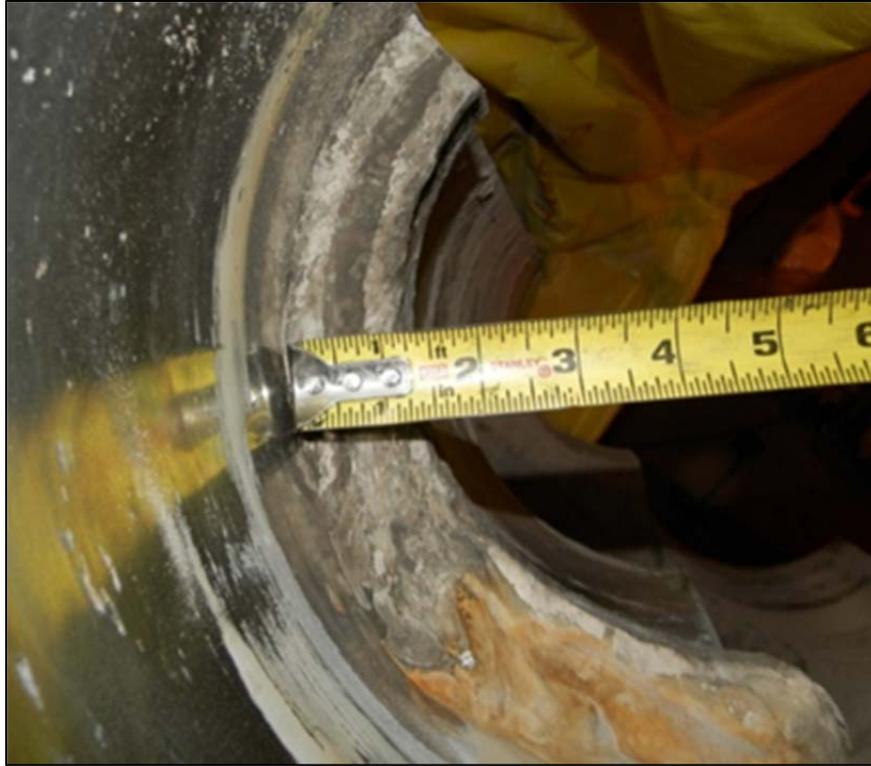
As discussed in section 3.3, wear on the paddles and the mixer barrel causes grout to build up and reduces the area for the dry feeds to enter the mixer. Figure 3-7 shows the thickness of the grout build up (approximately 1.5 inches) on the inside of the upper clamshell as measured during the January 2013 mixer inspection. This reduces the barrel opening from approximately ten inches to approximately seven inches in diameter. As the paddles and mixer barrel continue to wear, and the grout buildup becomes thicker, dry feed throughput will decrease and eventually cause the process to shutdown.<sup>1,12</sup> As shown in Figure 3-5, the grout build up occurs before the liquid inlet where flushing is minimal. Additional testing should be performed to determine an optimum position for additional liquid inlets into the mixer to aid in flushing at the end of processing and reduce or eliminate another potential source of wear in the mixer.

**Figure 3-7. Thickness of grout build up (approximately 1.5 inches) in January 2013 on the inside diameter of the upper clamshell of the 10-inch SPF mixer.**

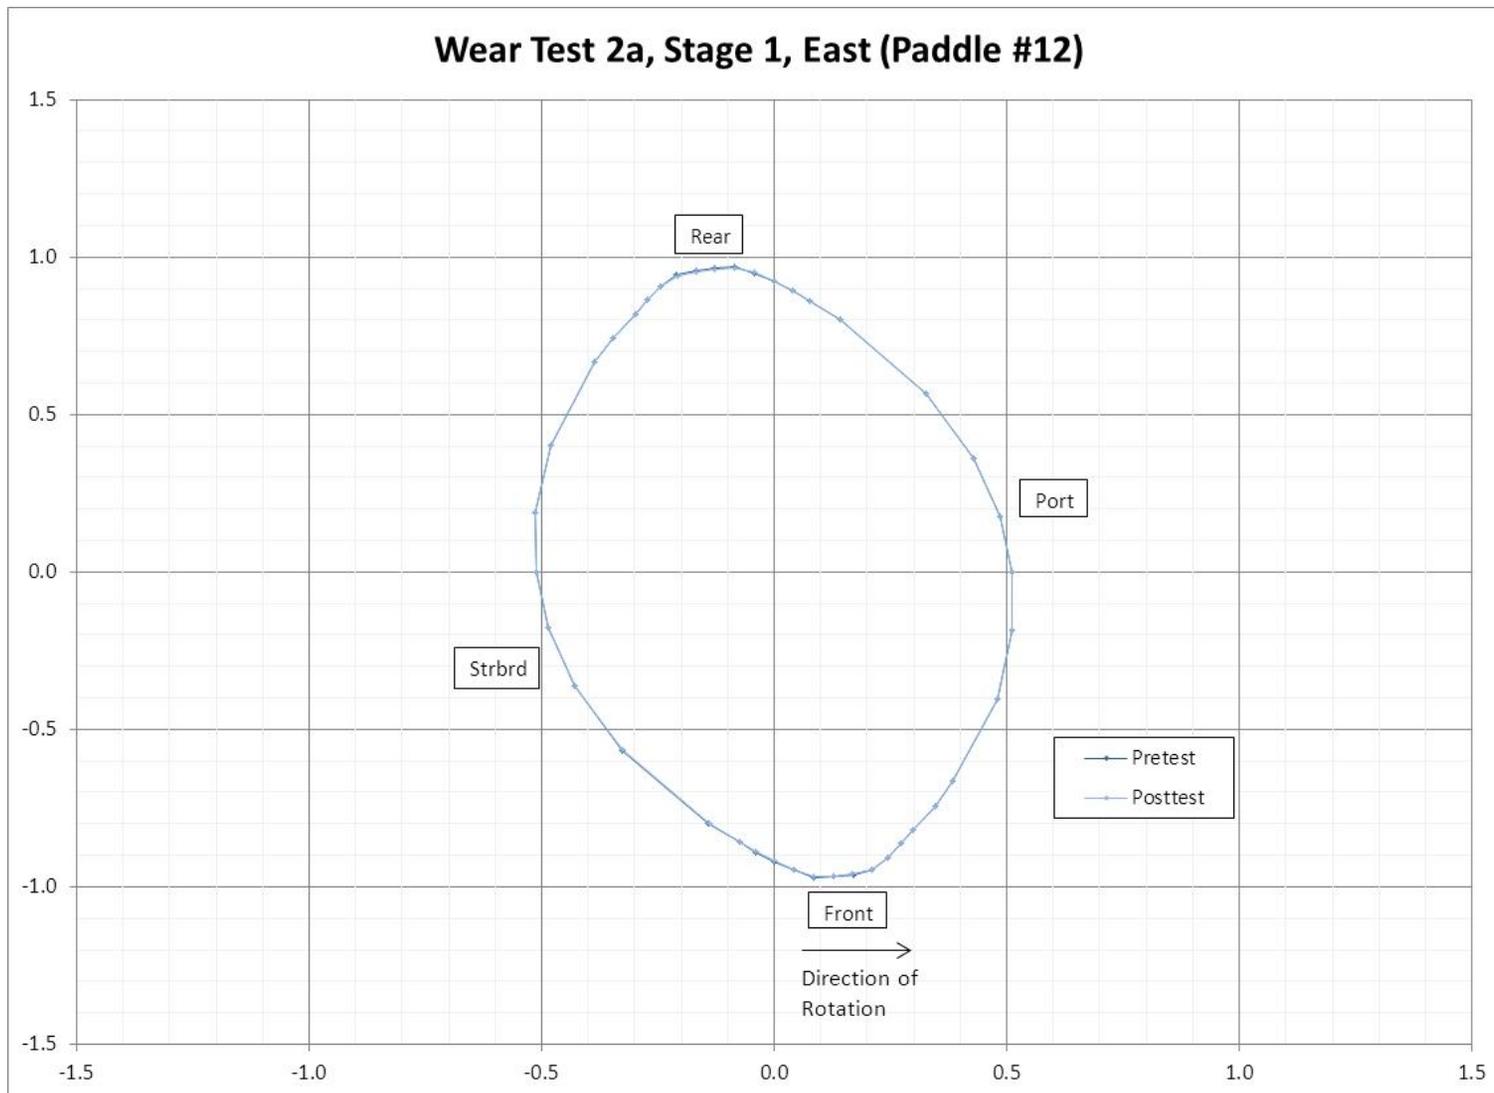
Figure A-1. Paddle 1, East, Mid Height, Test 2a, Paddle #12, Helical

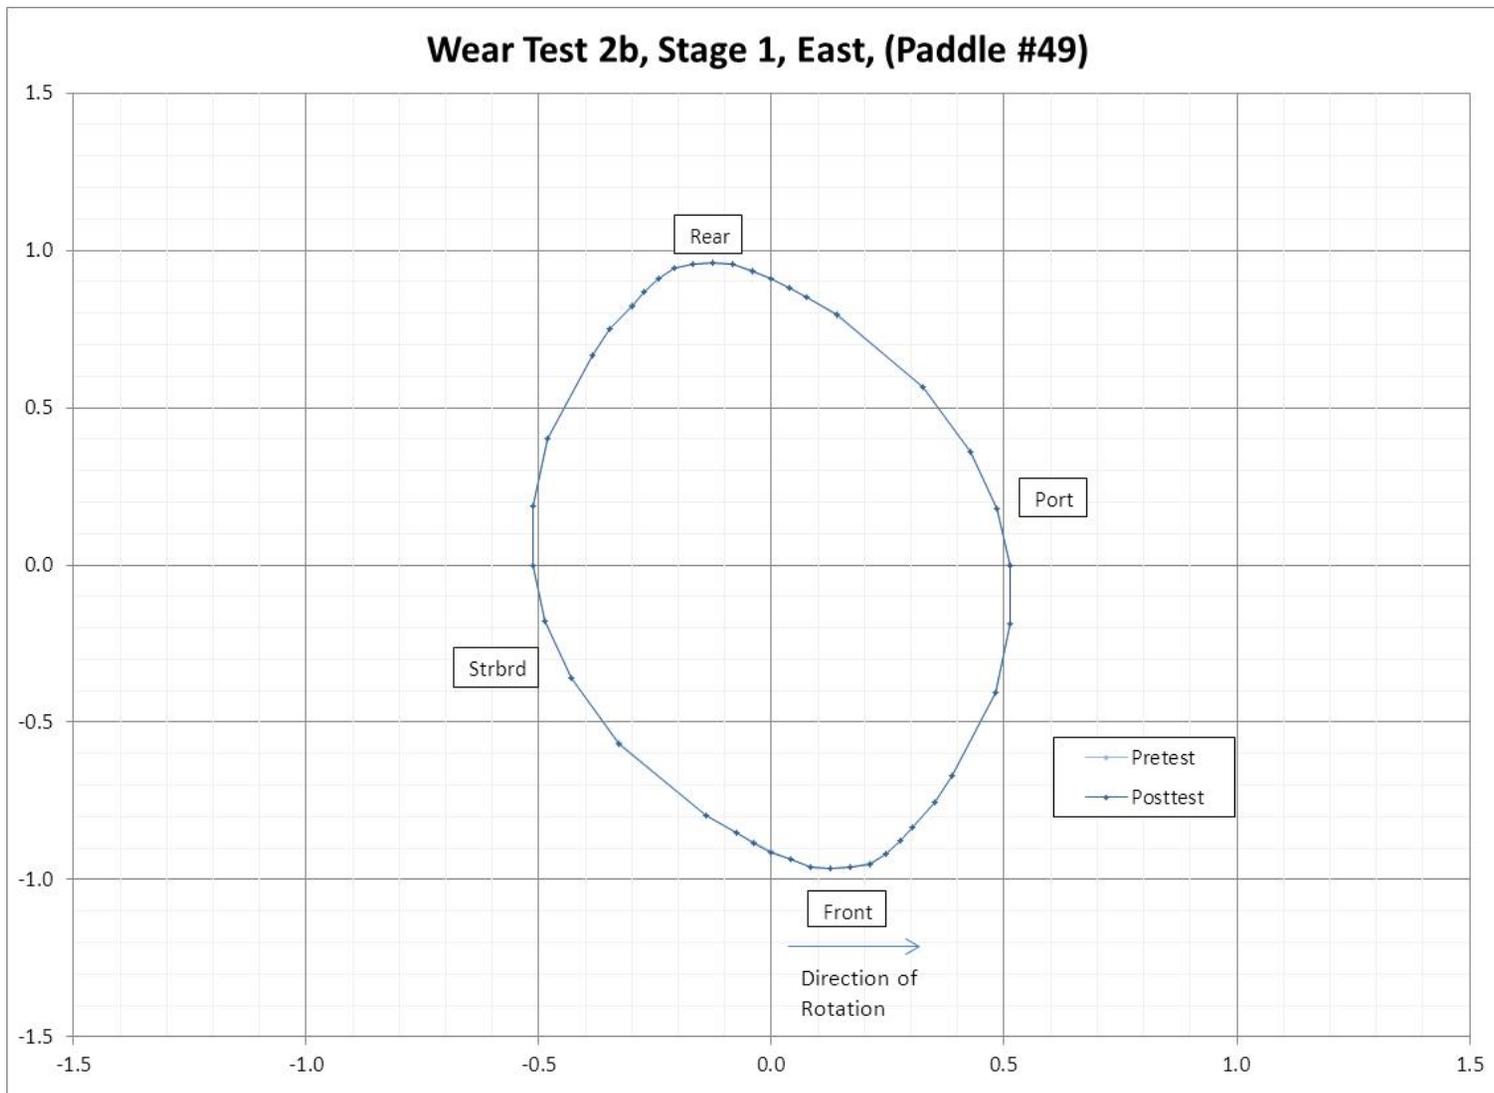
**Figure A-2. Paddle 1, East, Mid Height, Test 2b, Paddle #49, Helical.**

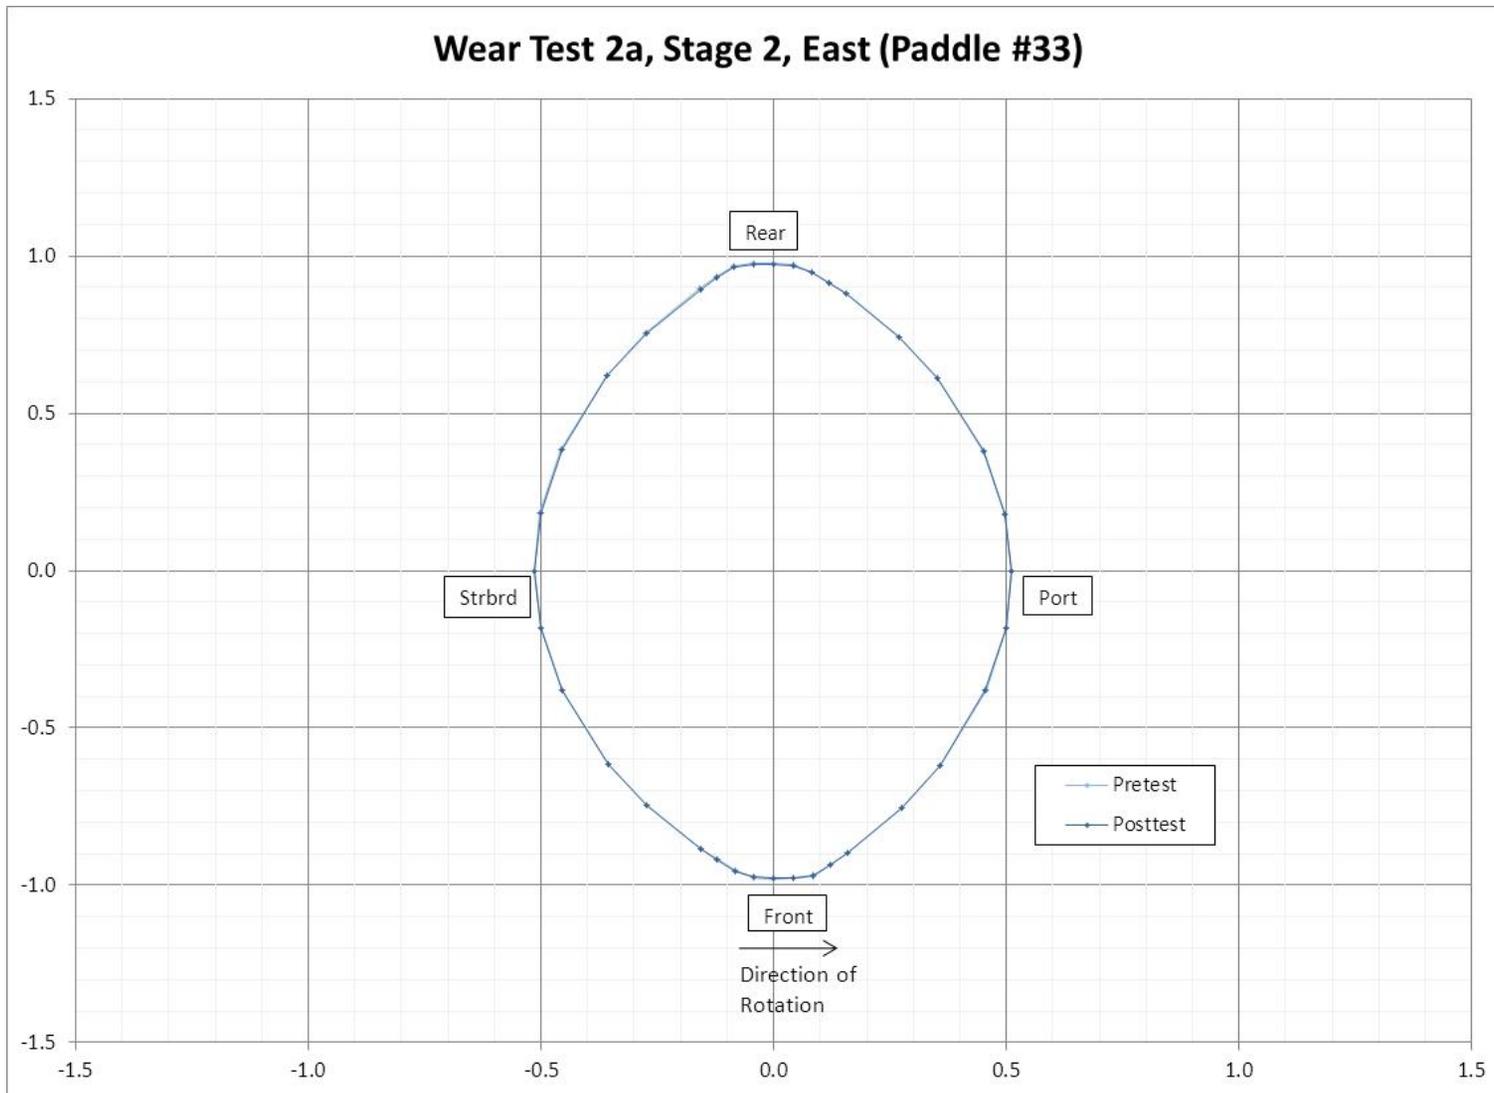
Figure A-3. Paddle 2, East, Mid Height, Test 2a, Paddle #33, Flat

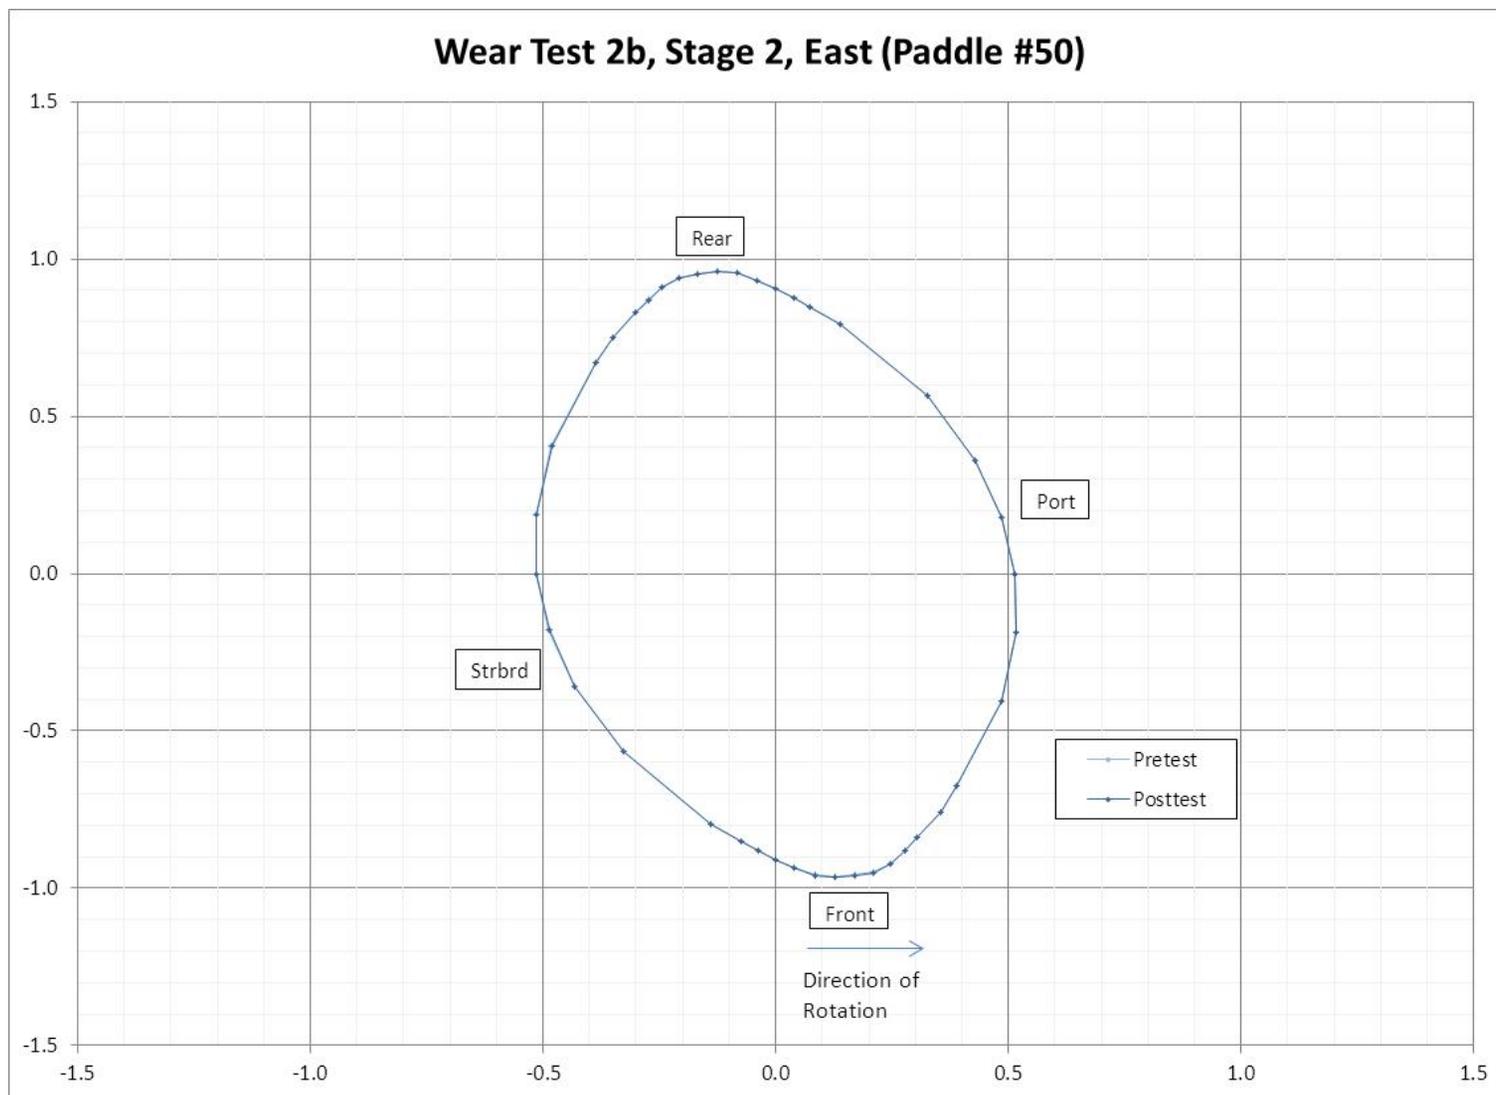
**Figure A-4. Paddle 2, East, Mid Height, Test 2b, Paddle #50, Helical**
