# Alternate Paddle Configuration for Improved Wear Resistance in the Saltstone Mixer

September 2013

SRNL-STI-2013-00523

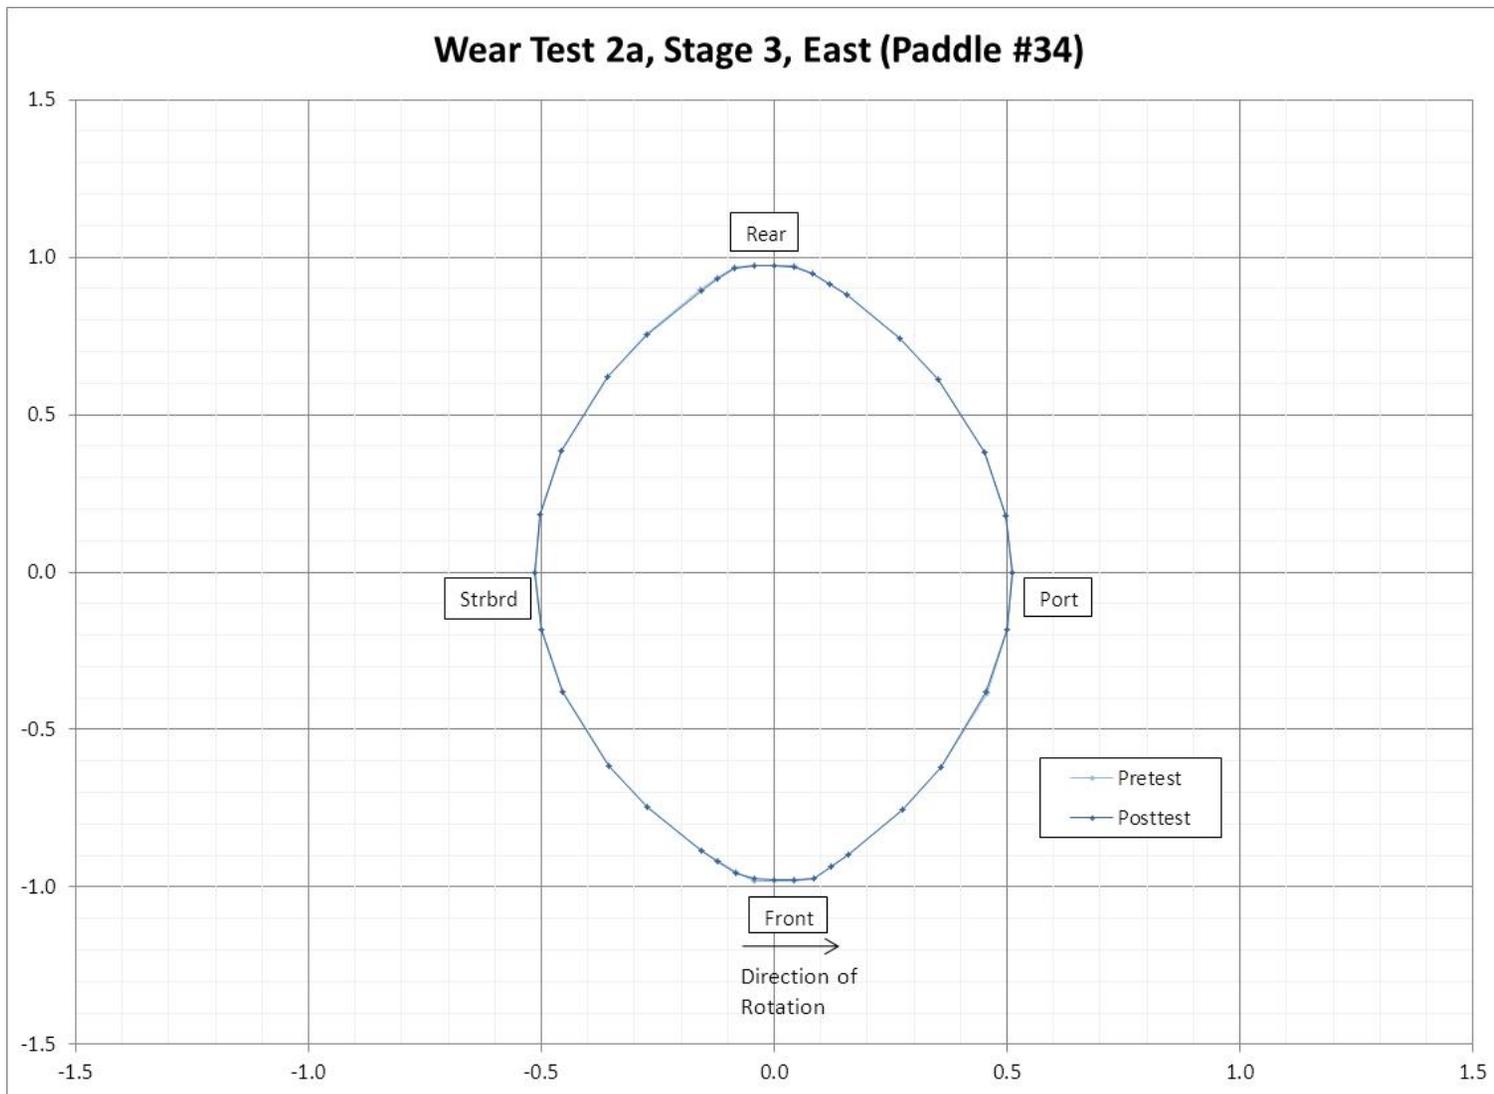
Figure A-5. Paddle 3, East, Mid Height, Test 2a, Paddle #34, Flat

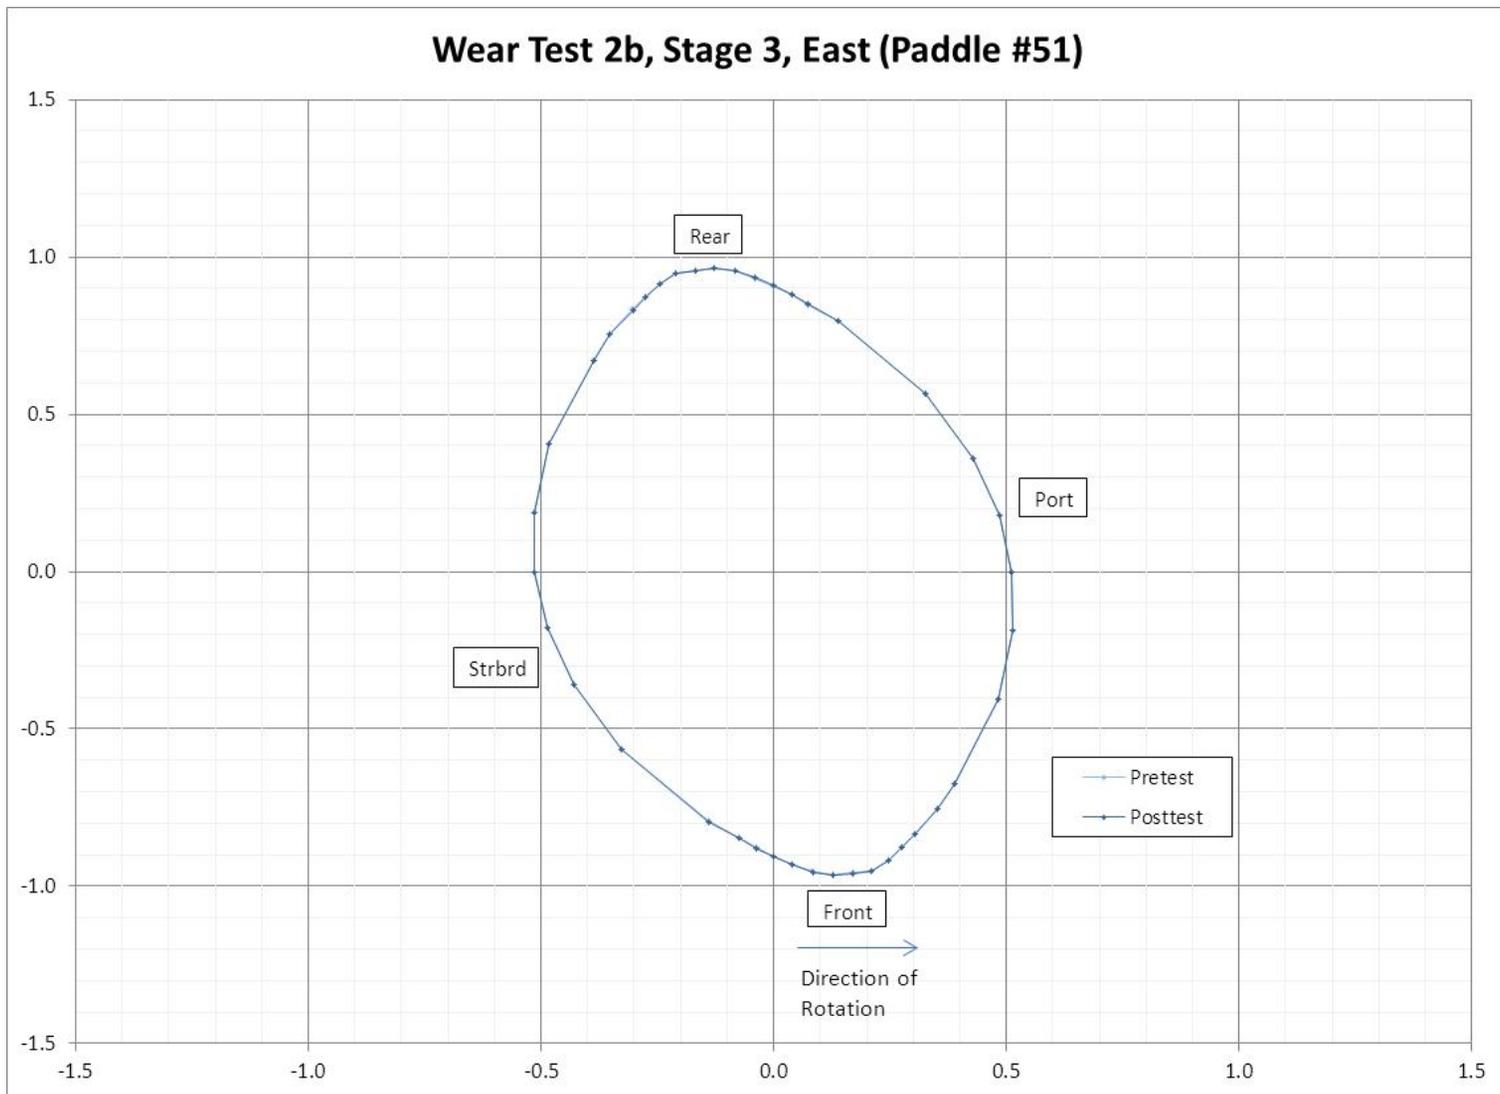
Figure A-6. Paddle 3, East, Mid Height, Test 2b, Paddle #51, Helical

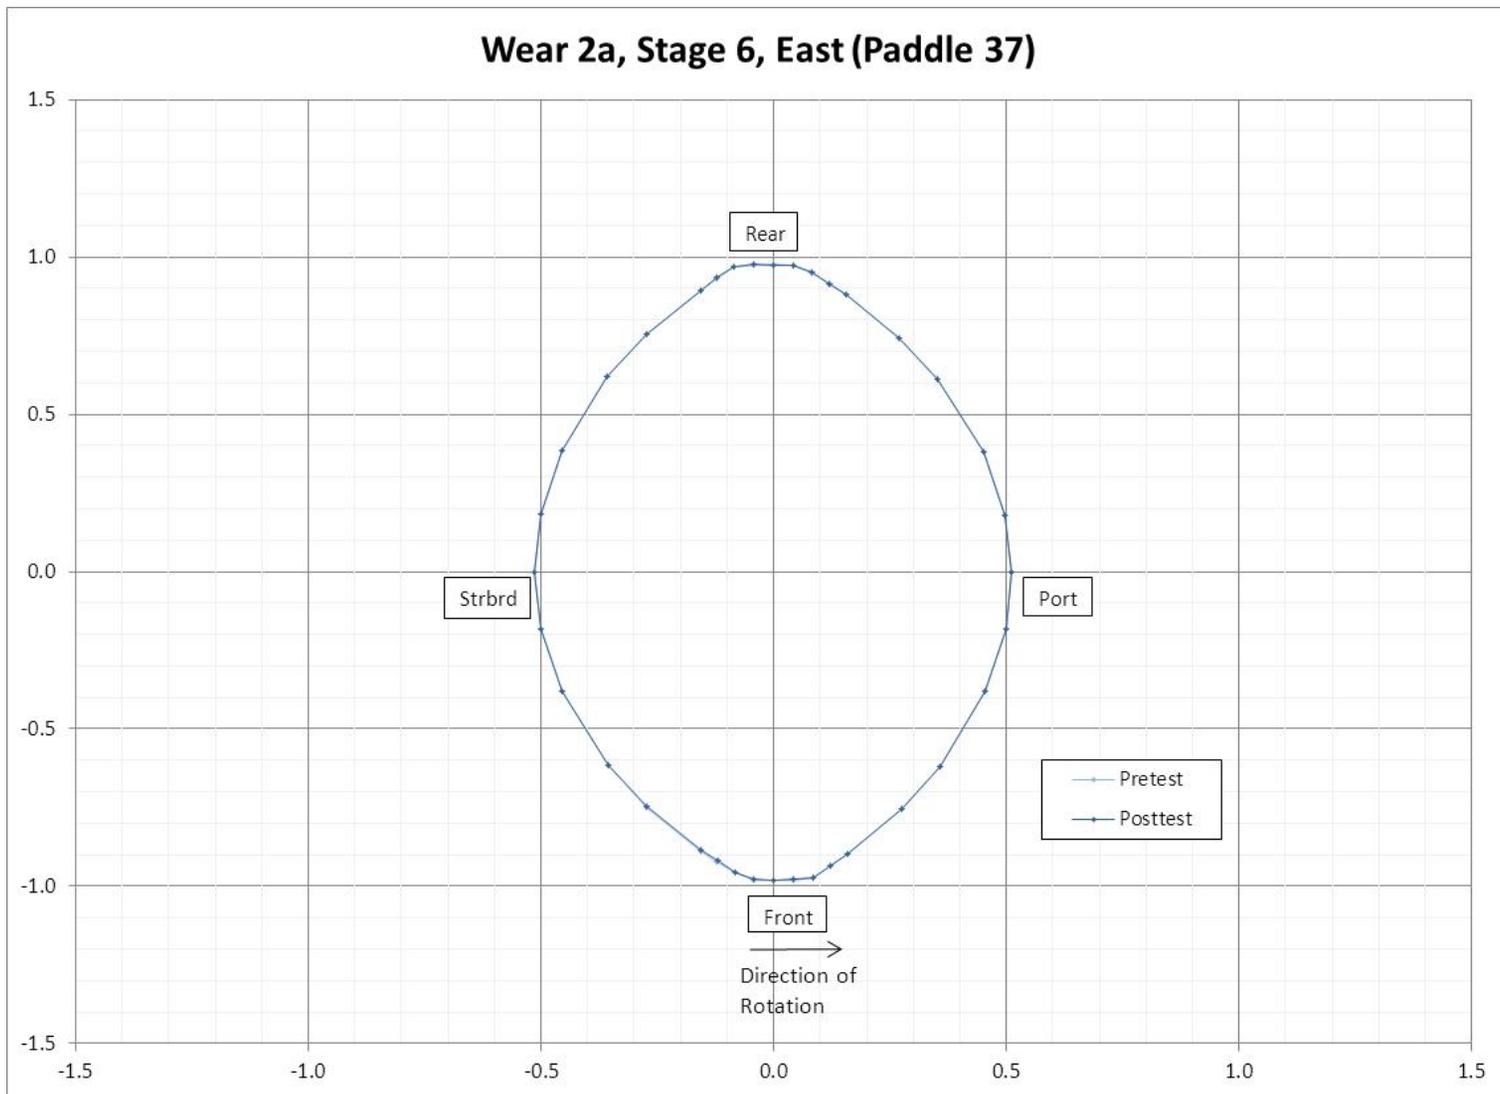
Figure A-7. Paddle 6, East, Mid Height, Test 2a, Paddle #37, Flat

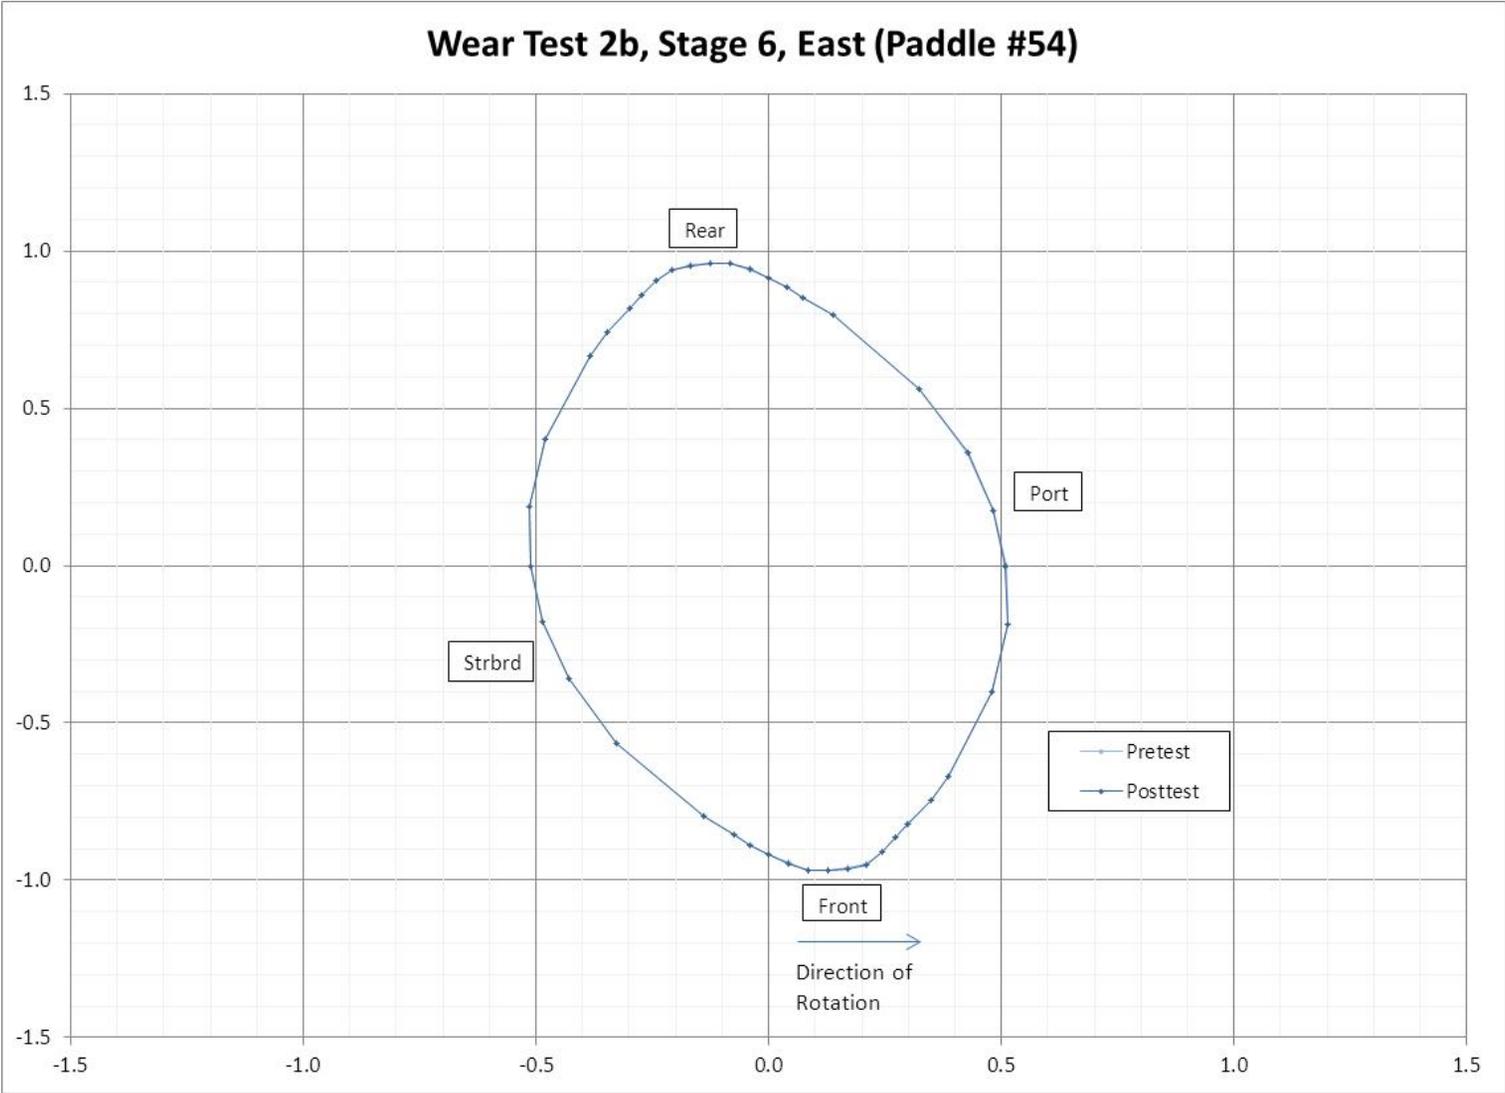
Figure A-8. Paddle 6, East, Mid Height, Test 2b, Paddle #54, Helical

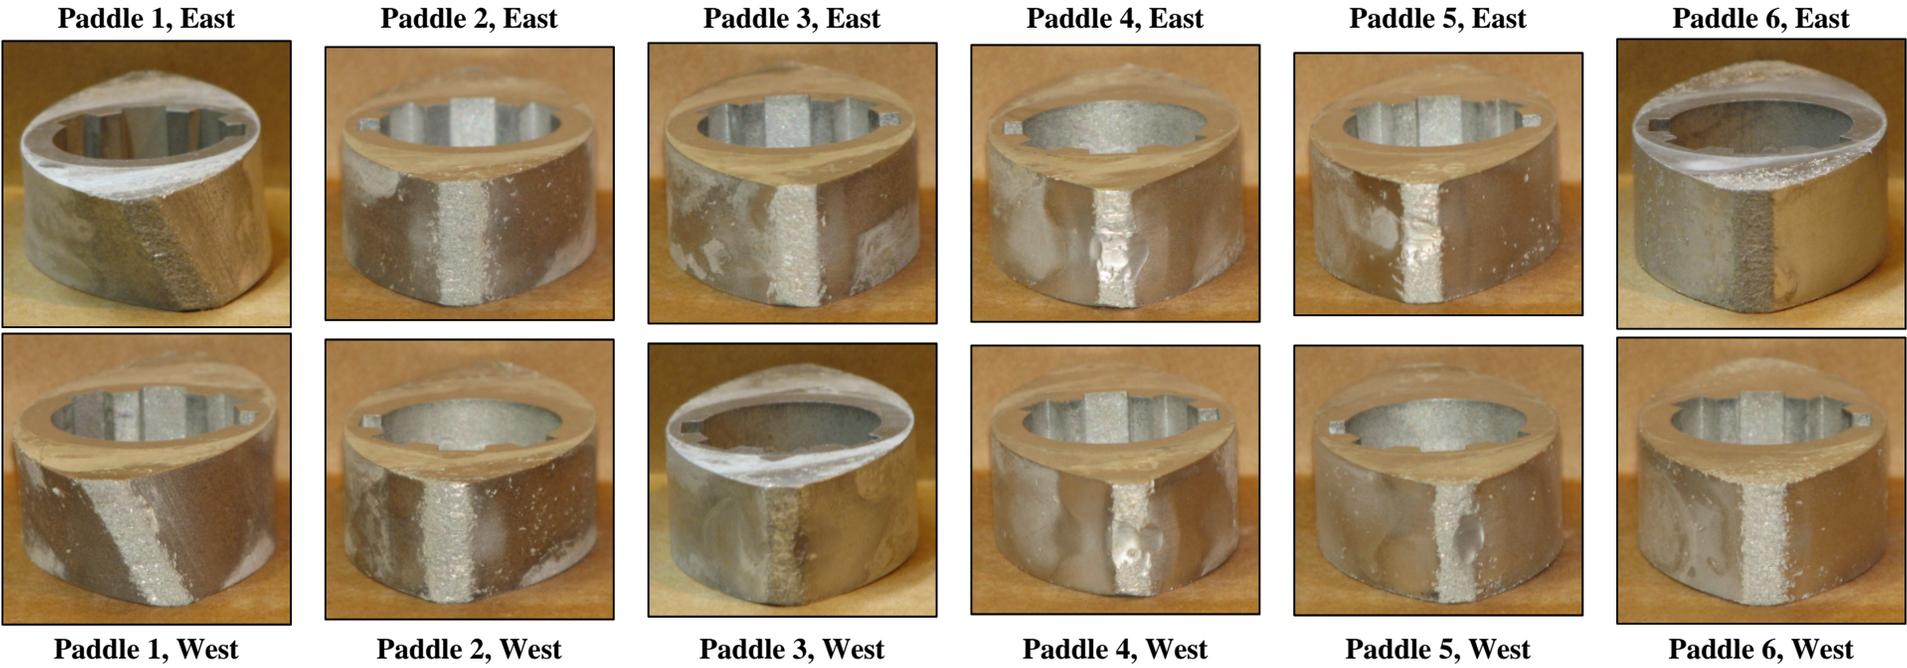
**Figure B-1. Images of paddle pairs post-testing for wear test 2a**

Table 3-1, the areas of wear on the flat and helical paddles are different. The majority of the wear occurs at the middle of the flat paddles, while the helical paddles wear more at the edges. Additional images of paddle pairs 1, 2, 3, and 6 are shown in 1.1.1.1.1Appendix B.

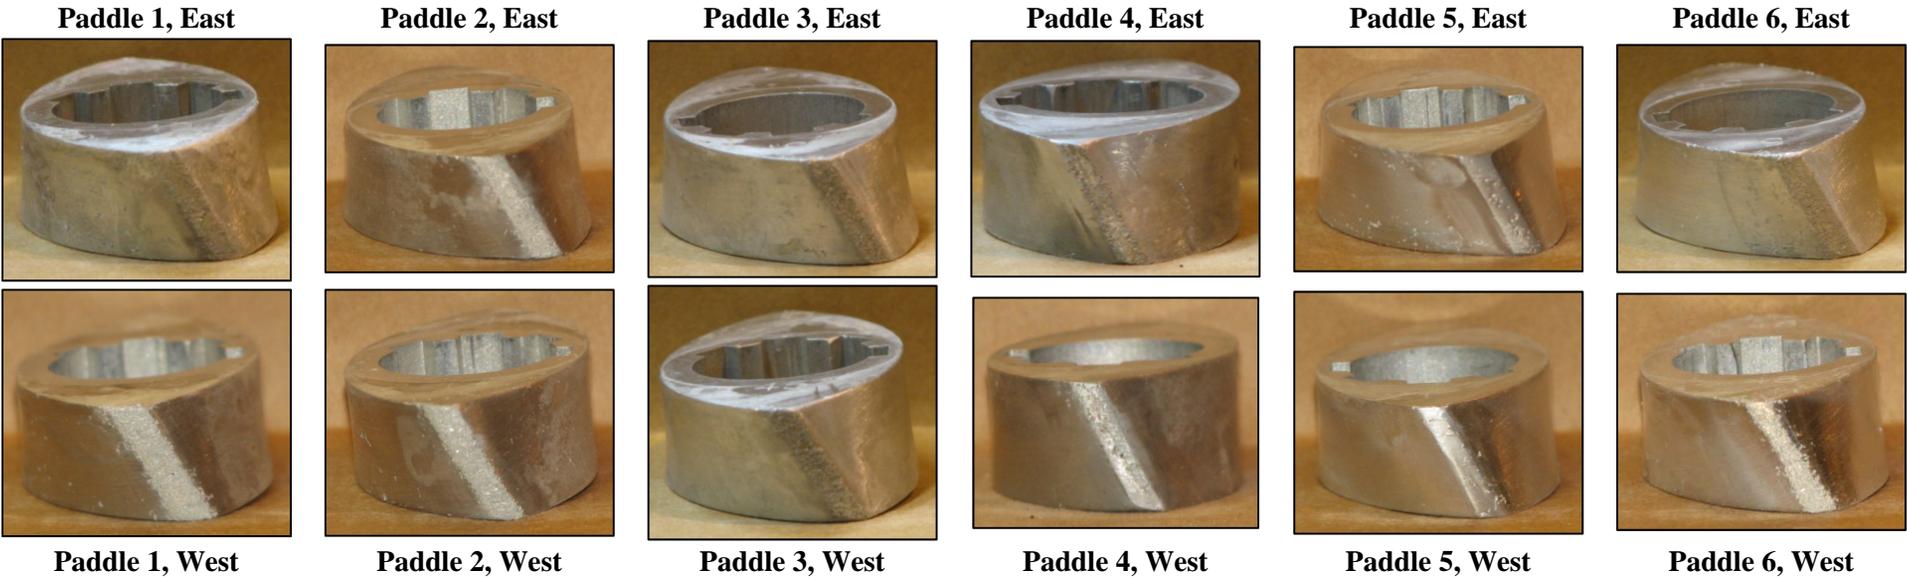
Figure B-2. Images of paddle pairs post-testing for wear test 2b
