LIQUID-AIR INTERFACE CORROSION TESTING SIMULATING THE ENVIRONMENT OF HANFORD DOUBLE-SHELL TANKS

J. R. Gray
B.L. Garcia-Diaz
T. H. Murphy
K. R. Hicks

December 2013

SRNL-STI-2013-00743, Revision 0

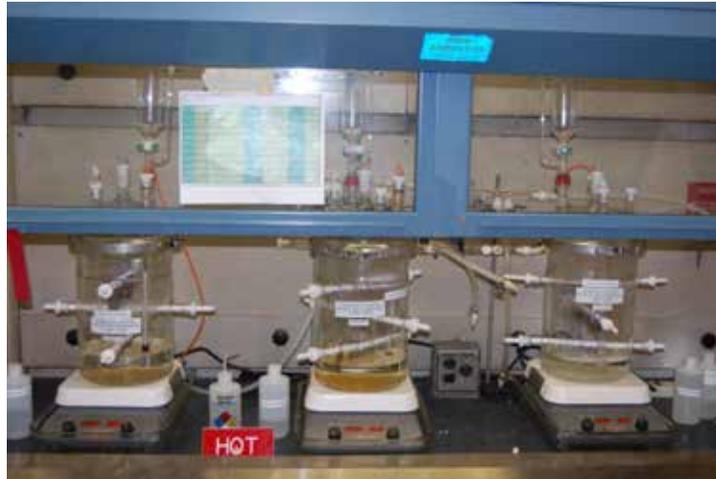
Figure 3-1. Experimental Setup for Performance of LAI Tests for Solutions # 1, #2, and #3.

Coupons of Alloy A537 were taken from stock acquired previously from Metal Samples and cut into rectangular sections (1" x 2" x 1/8"). These sections were polished to a 600 grit finish and allowed to air dry for minimum of 1 day prior to the beginning of the exposure tests. The tests for Effort 1 were conducted in custom designed glass cells as shown below in Figure 3-1. Each rig was set for independent direct control of the hotplate via a thermocouple which was placed below the surface of the liquid solution. Each rig also had a drop funnel to allow the solutions to be topped off with deionized water if solution was lost due to evaporation at the slightly elevated temperatures used in the current study, such that the samples were approximately half-way immersed in solution to mimic the LAI effect.

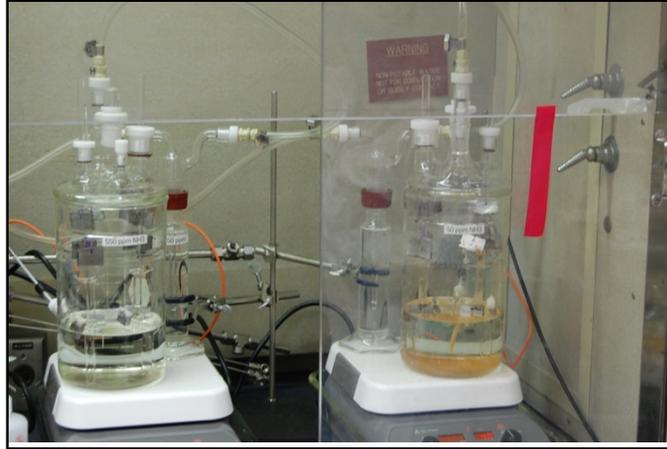
Figure 3-2. Coupon test cells for evaluating effect of ammonia gas on carbon steel corrosion over a simulated Hanford waste.

The test cells that were used are shown in Figure 3-2. Each test cell consisted of a thermocouple controlled hotplate set to 40°C and a test solution volume of approximately 1.5L. The coupons were suspended on glass sample holders attached through a 3/16" hole drilled in the sample. Ammonia was procured mixed to the desired concentrations of 50 and 550 ppm in air. The gas feeds were then routed through electronic flow meters (Sierra Instruments) which were set to bleed in the cover gas at 5 scc/minute. The gas lines were fed into bubblers which were filled with the same solution as was present in the test cells in order to humidify the gas prior to entering the test cell vapor space. Gas was fed on a constant basis over the four month test duration.

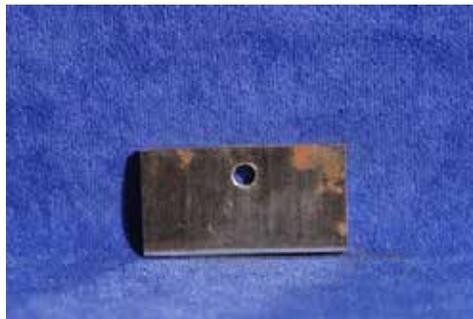
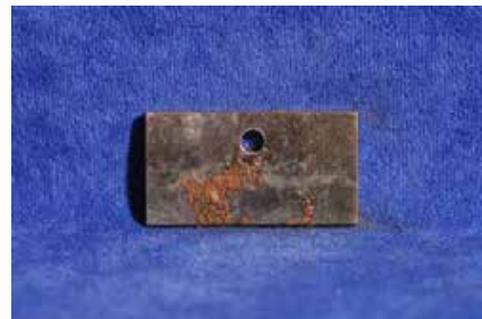
Figure 4-1. Coupons from LAI Corrosion Test at the New Chemistry Limits Prior to Cleaning. Dashed line, where shown, indicates approximate location of the LAI.

The worst corroded side after four months exposure for each solution is shown in Figure 4-1 for comparison. Indications of LAI attack were observed at the lower two nitrate concentrations, Solutions 1 and 2, respectively, while no distinct LAI attack was observed at the highest nitrate concentration, Solution 3. For Solutions 1 and 2 the attack primarily initiated near the LAI and appeared to wick up into the vapor space region. The solutions can be ranked in order of most aggressive as 1 > 2 > 3. The complete set of before- and after-cleaning photographs for each coupon are shown Appendix B along with the coupon weight data (before testing, after testing and loss), pit depth measurements and qualitative assessments of the degree of corrosion.

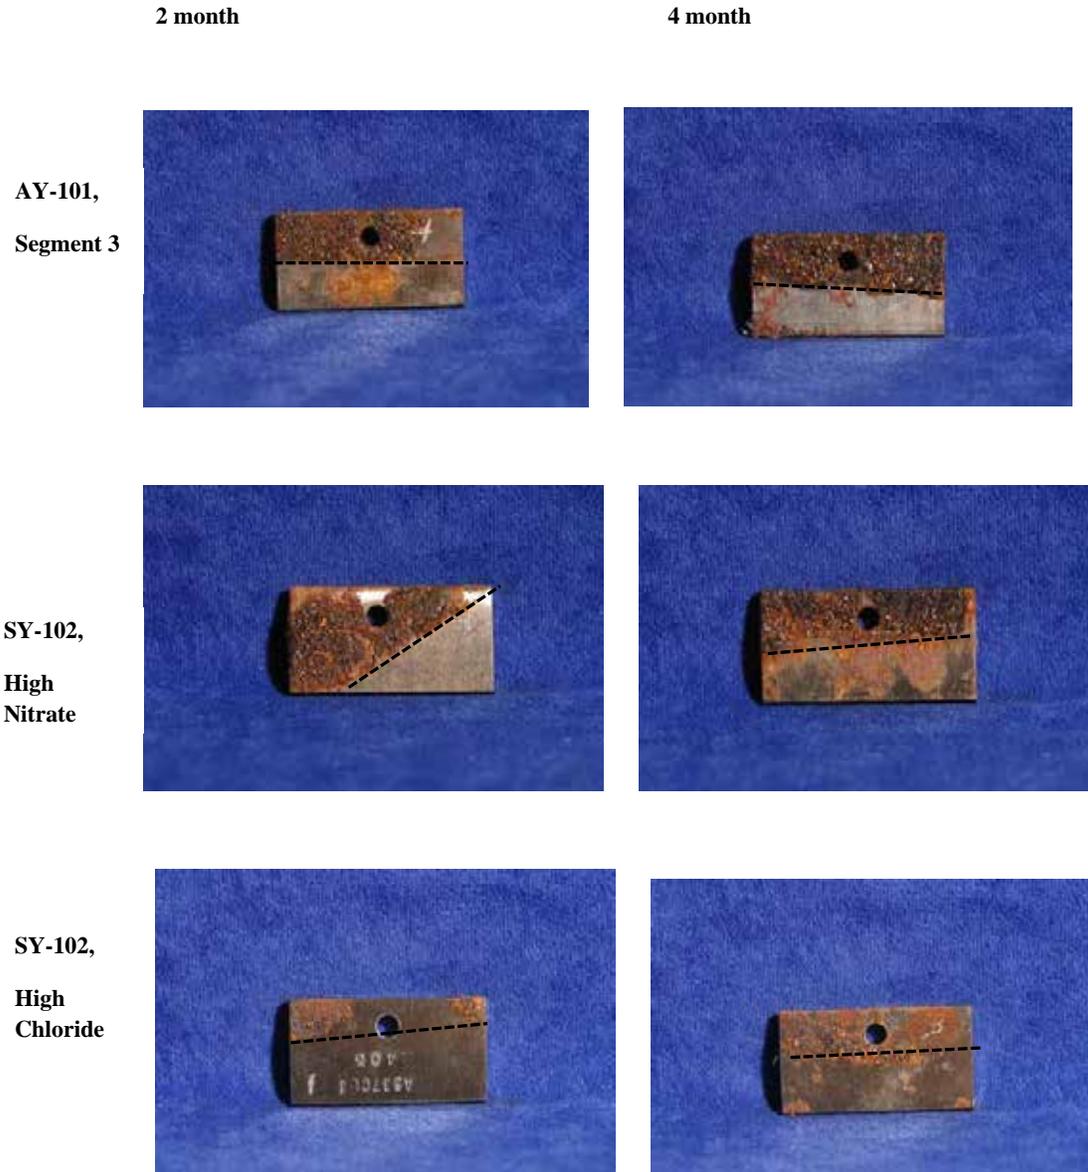
Figure 4-2. Coupons from LAI Corrosion Test Exposed to Hanford Simulants AY-101, Segment 3; SY-102, High Nitrate; SY-102, High Chloride; at Unevaporated (0%) Conditions. Dashed line indicates approximate location of the LAI.

The localized corrosion observations are summarized in Table 4-4 for each simulant for the 2 and 4 month exposures. The range of pit depths and depth/diameter ratios, and qualitative assessments are given. The pitting was found to initiate quickly in these solutions, which had low concentrations of the inhibitor nitrite. The deepest pit observed was approximately 4-5 mils deep after 4 months of exposure to AY-101, Segment 3 and SY-102, High Nitrate. The pit depths did not change significantly between 2 and 4 months. The depth/diameter ratios showed a range of pit dimensions, which were typically broad and shallow, but did not change significantly over the course of the 4 month test. In most cases, hemispherical, broad shallow pits appeared to initiate and then, after time, coalesce with neighboring pits to create an area of localized general attack. The pit depths and dimensions did not appear to be a function of the solution chemistry. The exposure time however, did increase the degree of surface area attacked and the depth of this

attack, especially for AY-101, Segment 3 and SY-102, High Nitrate. Coupons in simulant AY-102 were clearly the least attacked. The ranking, in order of most aggressive as AY-101, Segment 3 ~ SY102, High Nitrate > SY-102, High Chloride ~ AY-101, Segment 8 > AN-102 > AY-102, which was given above, would be the same based on the localized corrosion assessment.

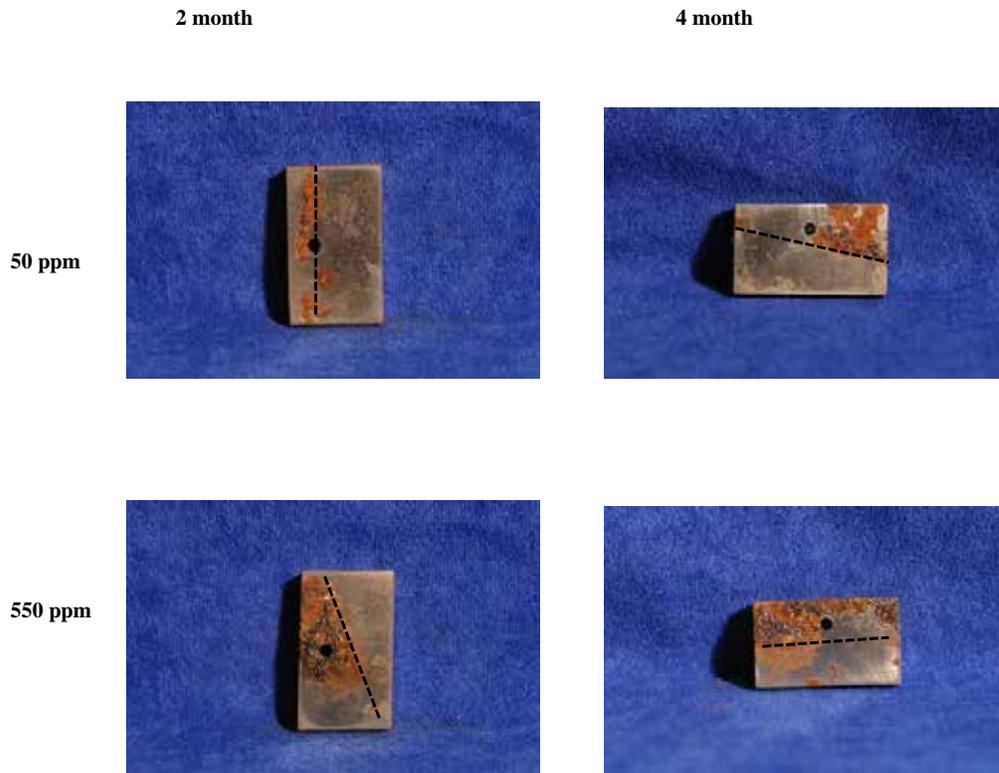
Figure 4-4 Coupons from LAI Corrosion Test of SY-102, High Nitrate, 33% evaporation, with an ammonia cover gas of 50 ppm concentration (1) and 550 ppm concentration (2) prior to cleaning. Dashed line indicates approximate location of the LAI.

Although, the ammonia did not completely eliminate attack at the LAI, the amount of corrosion in an extremely corrosive solution was significantly reduced. Only light general attack (< 1 mil) occurred on the coupon in the vicinity of the LAI. The concentration of ammonia (i.e., 50 ppm or 500 ppm) did not have a strong effect.

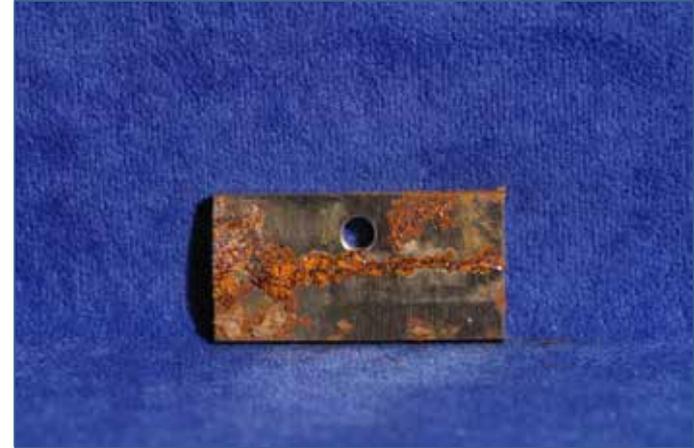
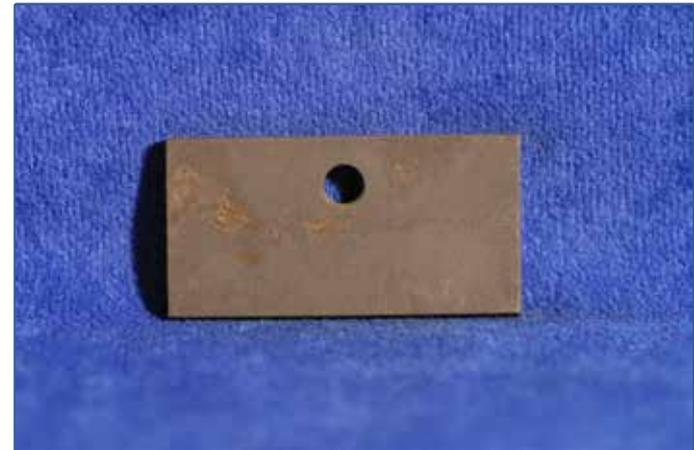
**Solution 1 – 2 Months
Coupon # 397**

Time (mo.)	Coupon #	Depth (mils)	Diameter (mils)	Depth/Diameter	Qualitative Density Estimate
2	397	4.9	24.5	0.20	Distinct LAI. Attack goes above LAI. Limited attack beneath LAI.
		3.1	9.9	0.31	
		4	12.5	0.32	
		4	NA	NA	
		1.5	7.5	0.20	
	398	2	10.8	0.19	Distinct LAI. Attack goes above LAI. Limited attack beneath LAI.
		2.1	5.4	0.39	
		2.1	NA	NA	
		2.4	9.6	0.25	
		2.6	7.8	0.33	
4	399	4.9	25.5	0.19	Distinct LAI. Attack goes above LAI. Limited attack beneath LAI.
		3.2	12.7	0.25	
		2.7	9.2	0.29	
		4.1	16.1	0.25	
		7.7	14.9	0.52	
	400	1.9	13.1	0.15	Distinct LAI. Attack goes above LAI. Limited attack beneath LAI.
		2.8	15.1	0.19	
		2.3	12.3	0.19	
		5.2	14.8	0.35	
		2.2	7.6	0.29

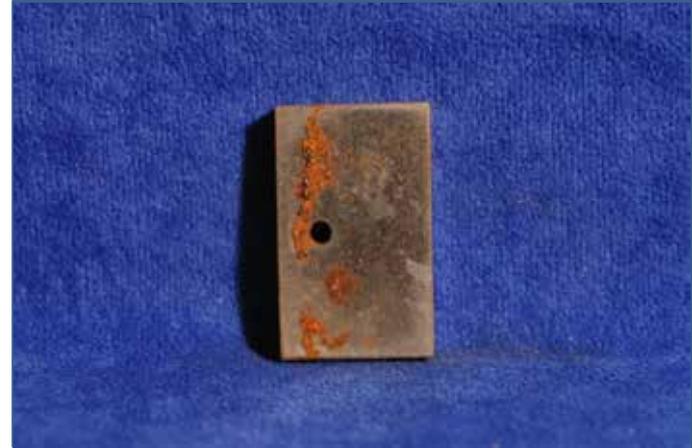
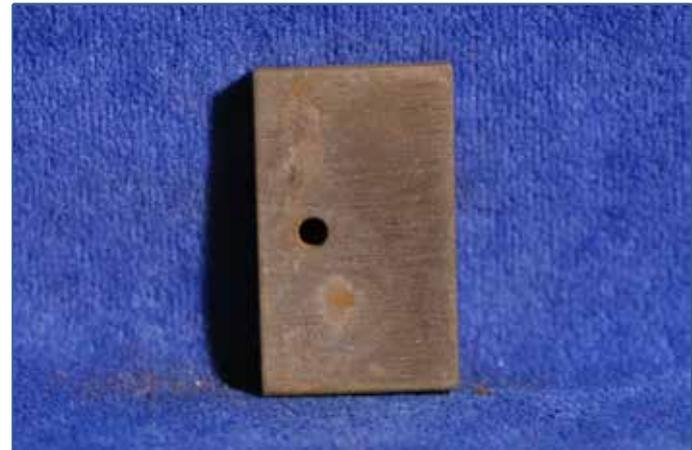
**SY102 High Nitrate – 33% Evaporation– 50 ppm NH₃
2 Months - Coupon # 519**

Time (mo.)	Coupon #	Depth (mils)	Diameter (mils)	Depth/Diameter	Qualitative Density Estimate
2	519	NA	NA	NA	No Pitting. Attack on less than 10% of area.
	521	NA	NA	NA	No Pitting. Attack on less than 10% of area.
4	504	NA	NA	NA	No LAI. No pitting.
	516	NA	NA	NA	No LAI. No pitting.
