# SDU6 Interior Liner Testing & Evaluation

SRNL-STI-2016-00568, Revision 0

**Keywords:** Saltstone, polymer, liner

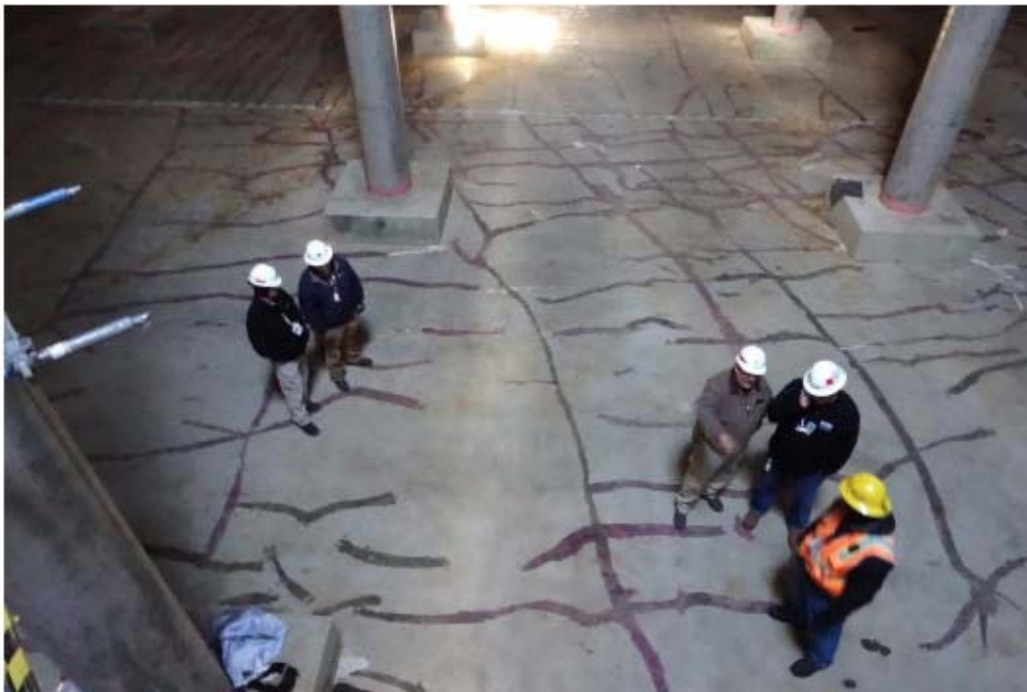
Figure 2. Interior view of SDU6 floor cracking and initial crack sealing attempts [8]

Draining the SDU6 began on November 11, 2015. Upon draining of the tank, cracks were observed on the interior tank floor (Figure 2). Subsequent investigation was performed by the U.S. Army Engineer Research and Development Center, Geotechnical and Structures Laboratory (ERDC-GSL) [5]. This evaluation, involving core sampling of the floor in five locations and petrographic analysis, revealed that several cracks extend completely through the floor slab, providing a pathway for water (and future Saltstone bleedwater) to reach the polyethylene barrier and work its way outward to the vault perimeter. The crack footage was estimated at ~10,000 linear feet. Similar cracking was also observed on the roof slab. A Nonconformance Report (2016-NCR-15-DZC-0005) was issued documenting that the floor slab cracks combined with the failure to pass leak tightness test yield SDU 6 indeterminate in meeting structural, leak tightness and Performance Assessment (PA)/SA (Special Analysis) requirements.

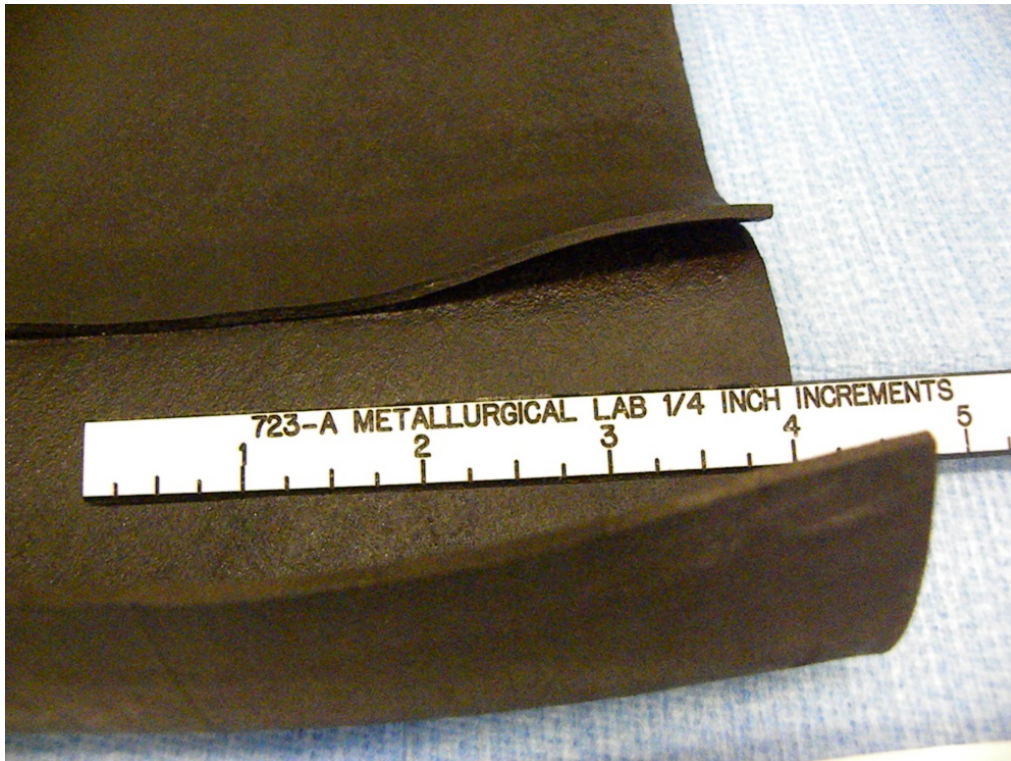
Figure 13. Post-immersion debonding of 2SREL-LS-MAR-050-052416  
(Marseal 3500, bonded, 50% S1 solution)

Several samples of the self-bonded Marseal M-3500 material exhibited regions of delamination and "puckering" to varying degrees on the as-received samples (Figures 12-13, 18-22). This was noted in the SREL test report to occur on day 35 of the immersion period [35]. It is unknown if this behavior occurred sooner, but the samples were inspected on a daily basis, including verification of sample chamber temperature (68 +/-2 °C). Similar behavior was also observed on the samples of Marseal M-3500 bonded to the Marseal® 2000 material (MRU samples), noted to occur on day 23 of the immersion period [35]. The delamination was observed to be slightly more severe for the 100% S1 solution samples than for the 50% S1 solution, with cause unknown. The Marseal M-3500 sample solutions were also noted to change color initially to a dark yellow and become a dark reddish brown over the course of testing, particularly in the 100% S1 solution. The cause of the discoloration was not investigated.

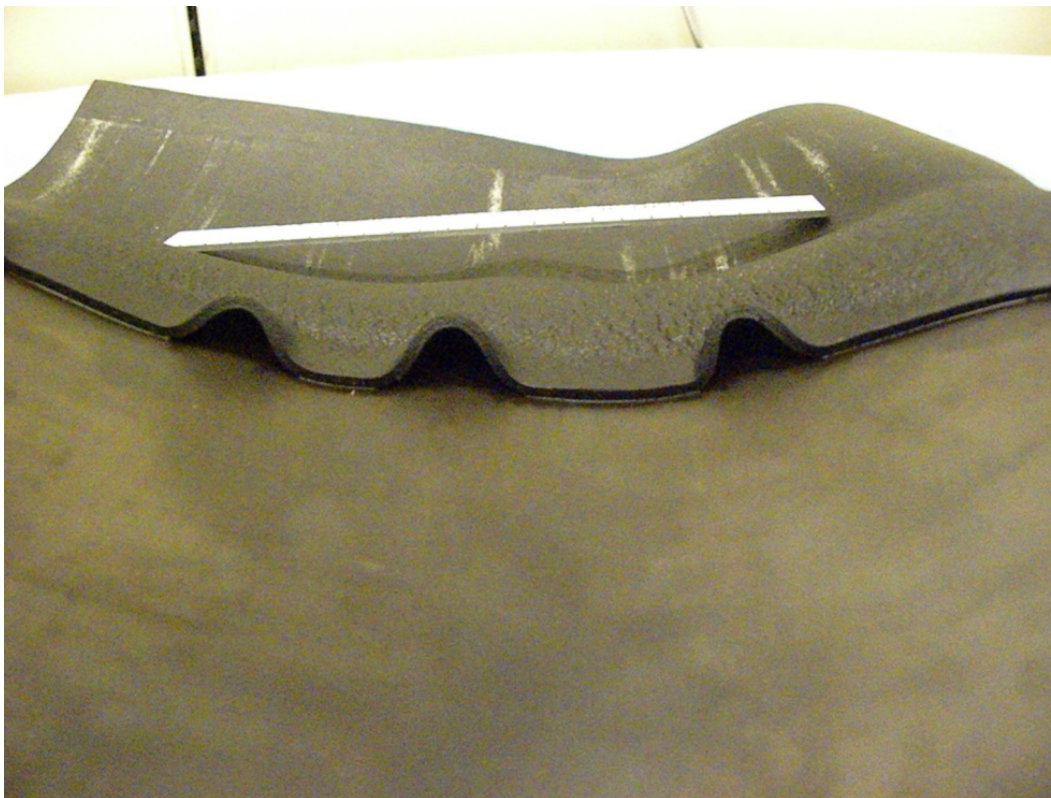
Figure 22. 12SREL-CS-MRU-100-052416 (note surface wrinkling and degree of warping)

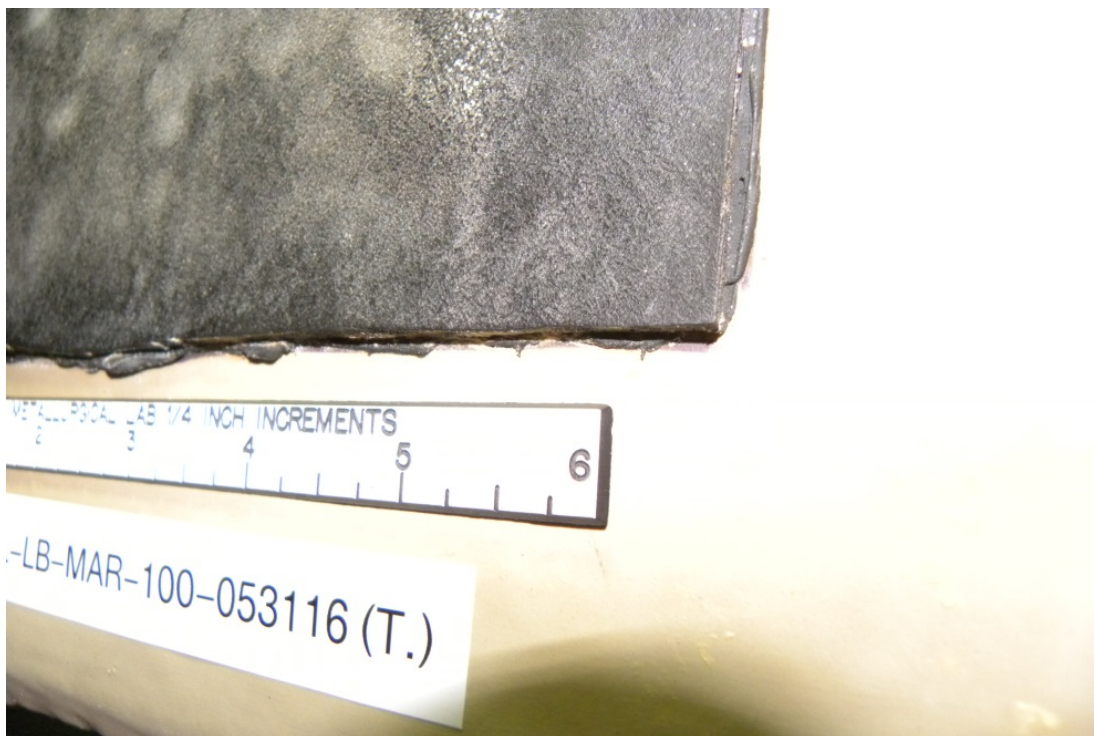
Figure 24. 13SREL-LB-MAR-100-053116  
(slight delamination/debonding at corners, as-received, no probing)

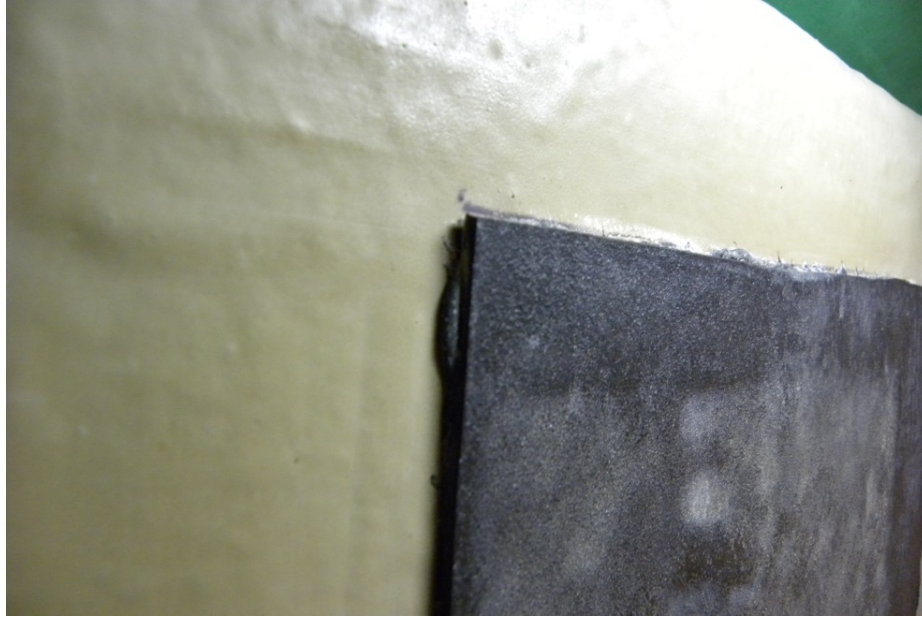
Figure 25. 13SREL-LB-MAR-100-053116  
(delamination/debonding at opposite corners, as-received, no probing)

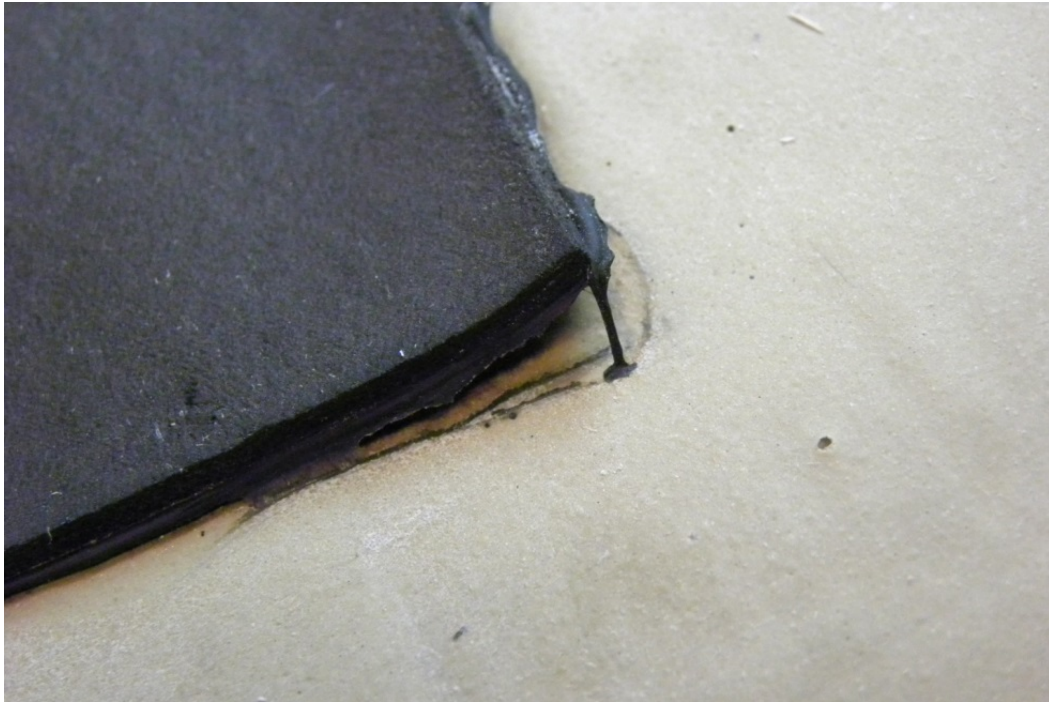
Figure 27. 14SREL-LB-MAR-050-053116 (note corner debonding, as-received, no probing)  
(Marseal M-3500 bonded to EC-66 epoxy/concrete, 100% S1 solution)

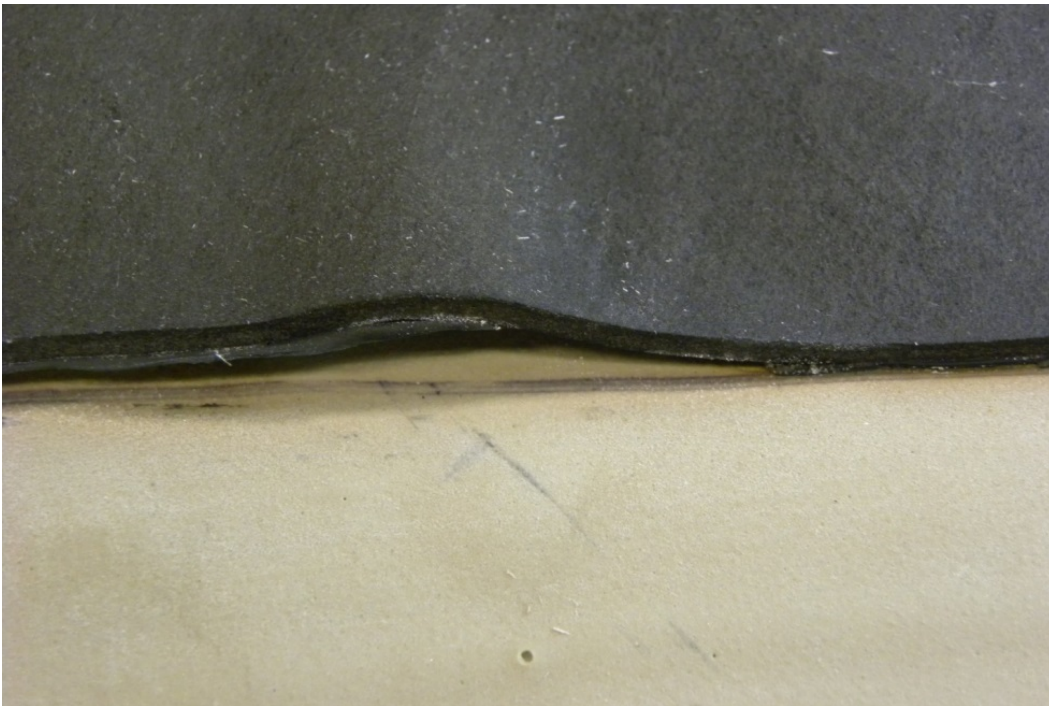
Figure 28. 14SREL-LB-MAR-050-053116 (mid-width debonding, as-received, no probing)  
(Marseal M-3500 bonded to EC-66 epoxy/concrete, 100% S1 solution)

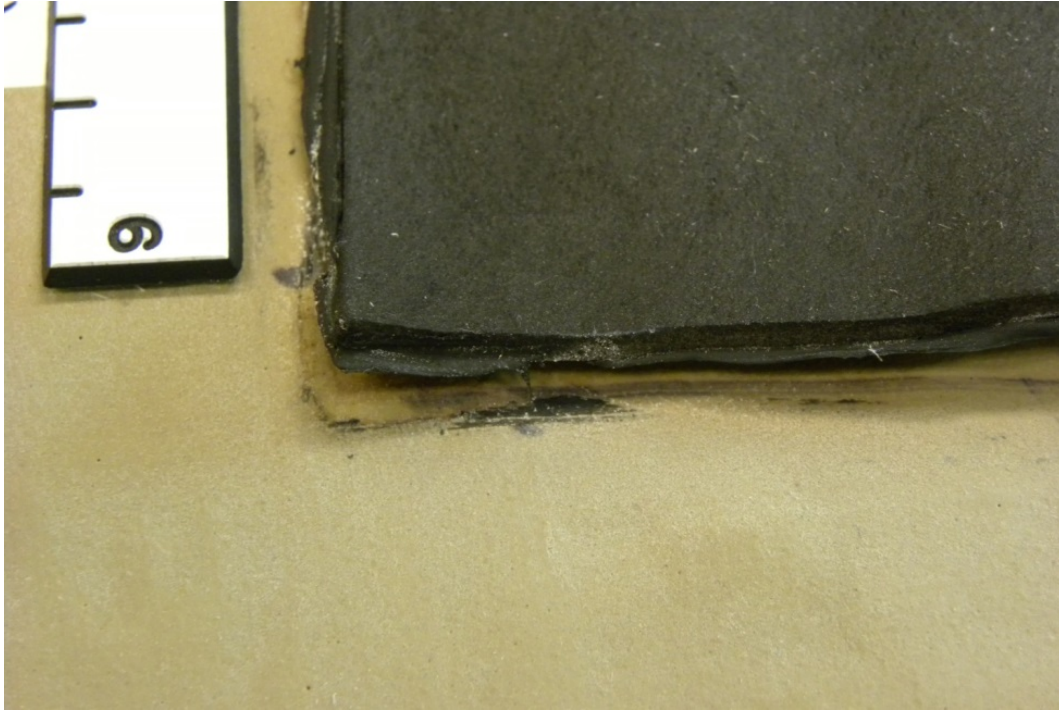
Figure 29. 14SREL-LB-MAR-050-053116 (corner debonding, as-received, no probing)  
(Marseal M-3500 bonded to EC-66 epoxy/concrete, 100% S1 solution)

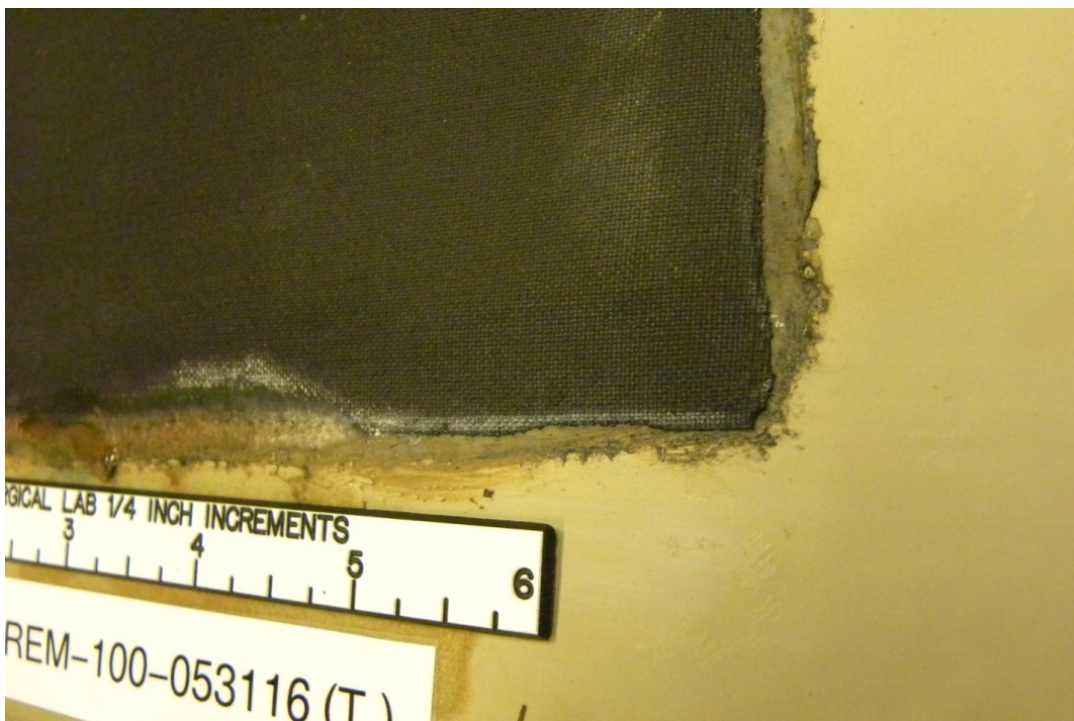
Figure 32. 15SREL-LB-REM-100-053116 (no delamination observed, representative of all corners)

In contrast, the REMA 4CN material did not exhibit any notable debonding, permanent deformation or any other signs of degradation or variation from baseline condition, with the exception of surface precipitation. The REMA 4 CN liner joints were more consistent and did not show evidence of deformation or warping due to the immersion exposure. This behavior is more desirable from a liner integrity standpoint. It is unknown whether the Marseal M-3500 liner joint behavior would result in leakage in a typical installation, particularly if actual service temperatures are reduced. However, the debonding observed in these tests is certainly undesirable for a liner.

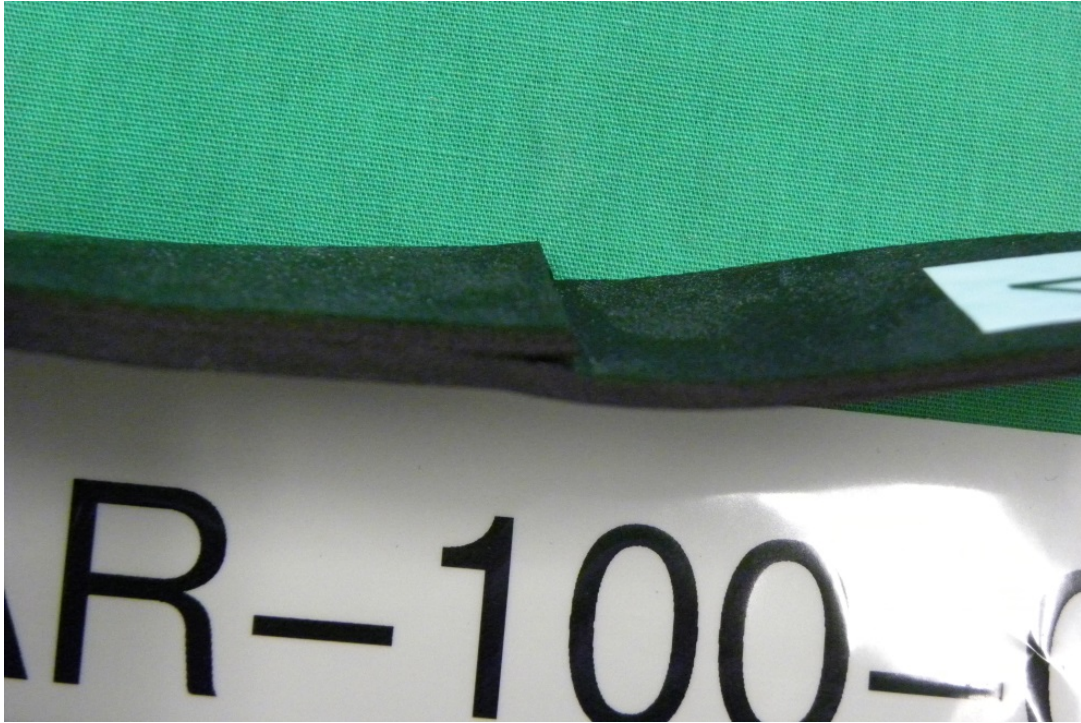
Figure 37. Marseal 3500 welded–lap-shear samples (100% S1 solution) – pre-test delamination

Photographs of the bonded lap-shear samples prior to testing are shown in Figures 36-45. Note the extent of debonding and deformation observed in the bonded Marseal M-3500 samples after immersion and prior to testing. Lap-shear samples for the Marseal M-3500 material were cut from sections with as little as debonding as possible. In some cases, debonding had already occurred on the lap-shear samples at the far edge.

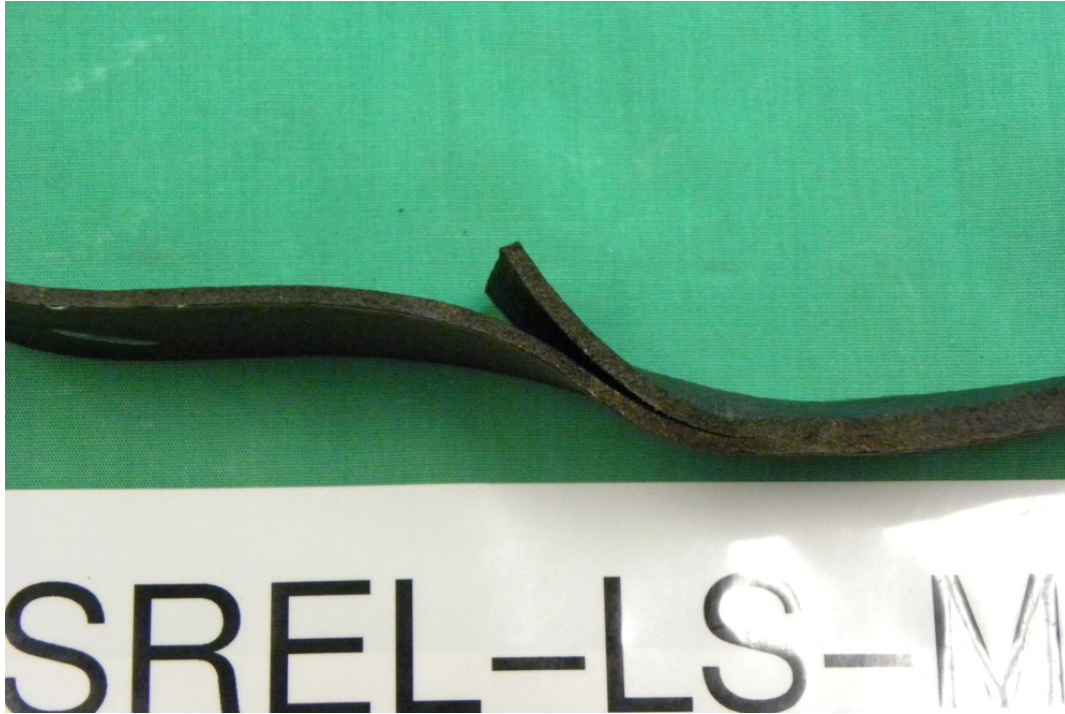
Figure 39. Marseal M-3500 welded- lap-shear sample#1 (50% S1 solution) – pre-test debonding

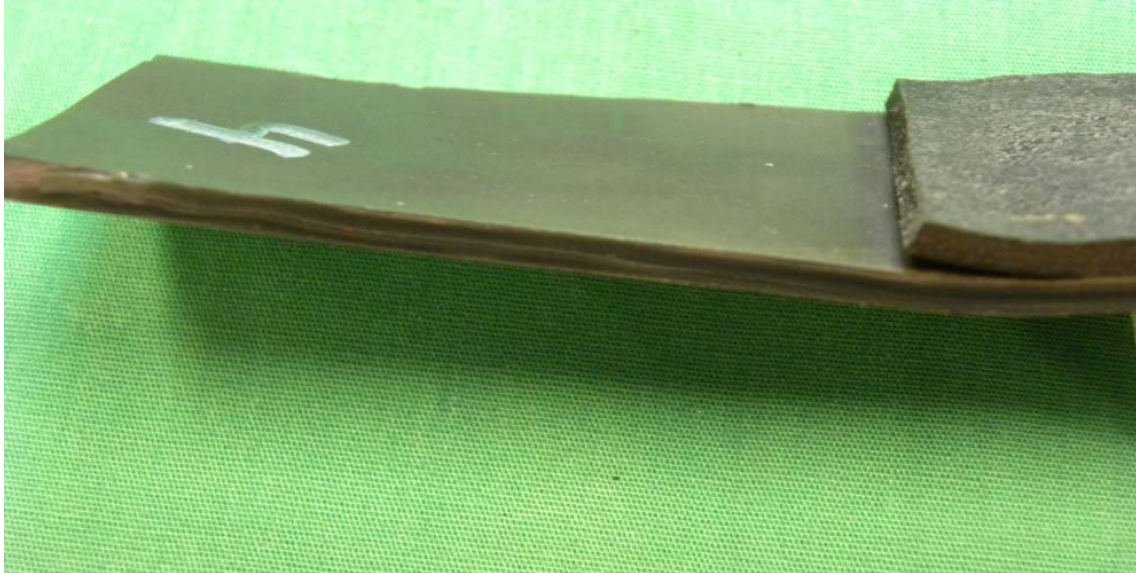
Figure 41. Marseal M-3500/Marseal 2000 lap-shear sample #4 (50% S1 solution) – pre-test debonding (note texture difference between Marseal M-3500 with polyester reinforcement and Marseal 2000)

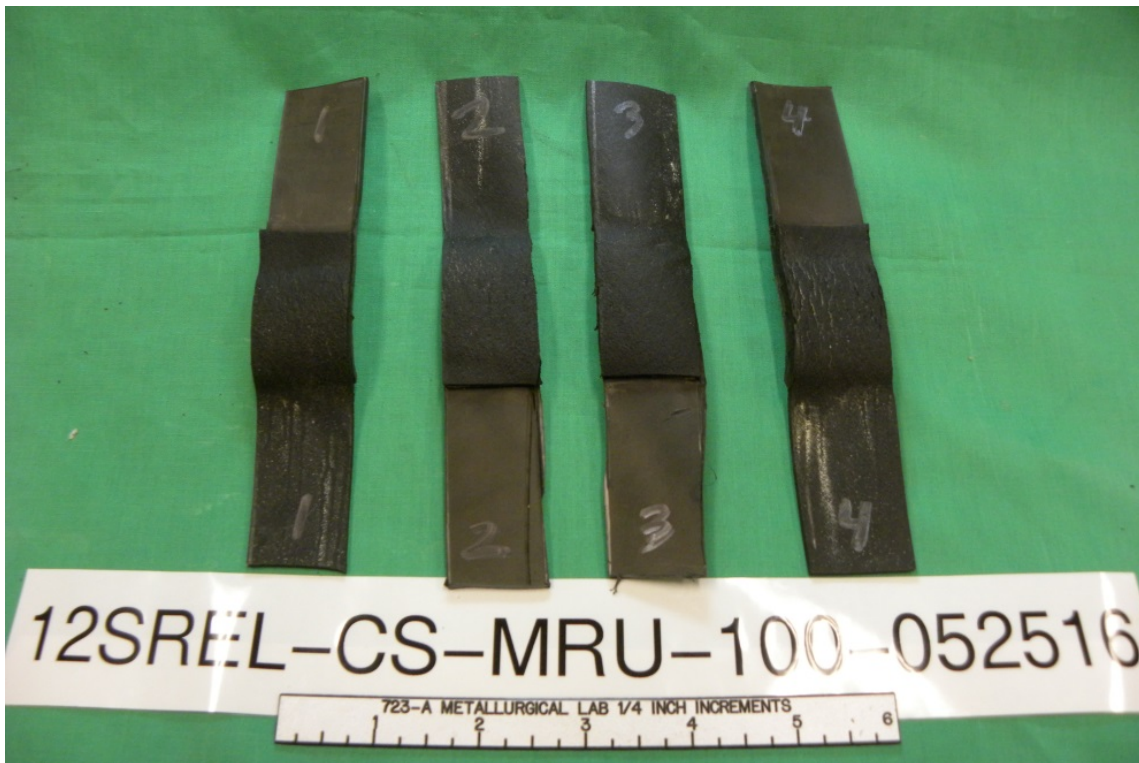
Figure 42. Marseal M-3500/Marseal 2000 lap-shear samples (100% S1 solution) – pre-test debonding

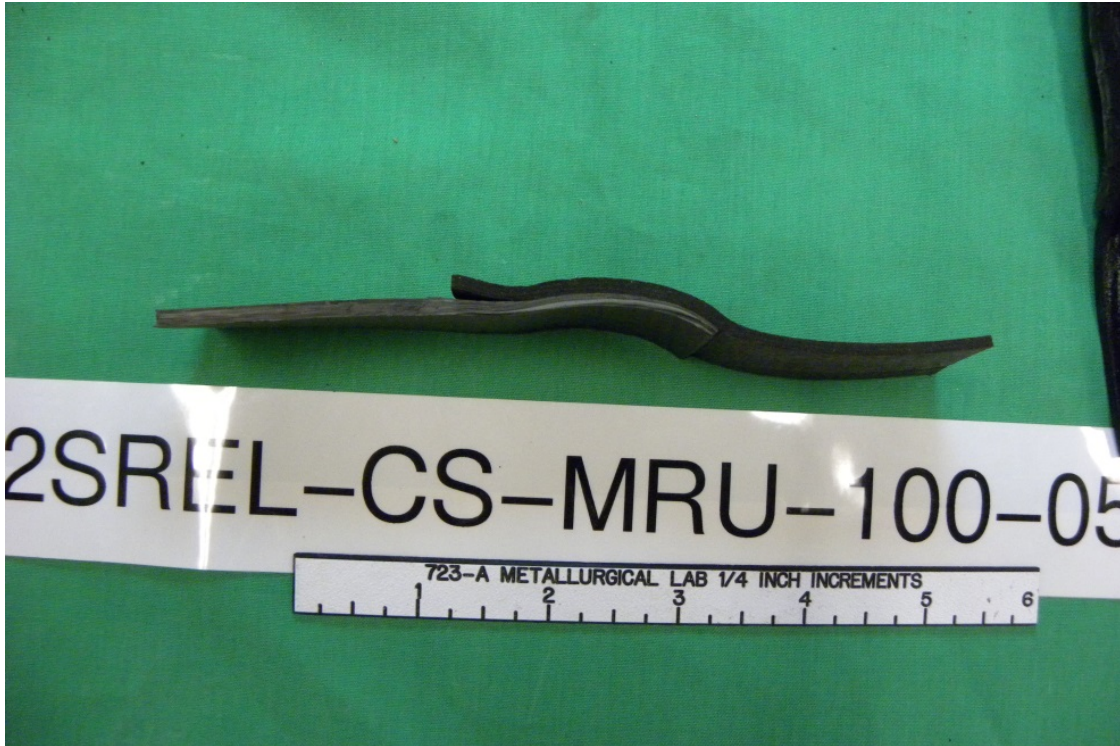
Figure 43. Marseal M-3500/Marseal 2000 lap-shear sample (100% S1 solution)  
(note deformation/debonding – pre-test)

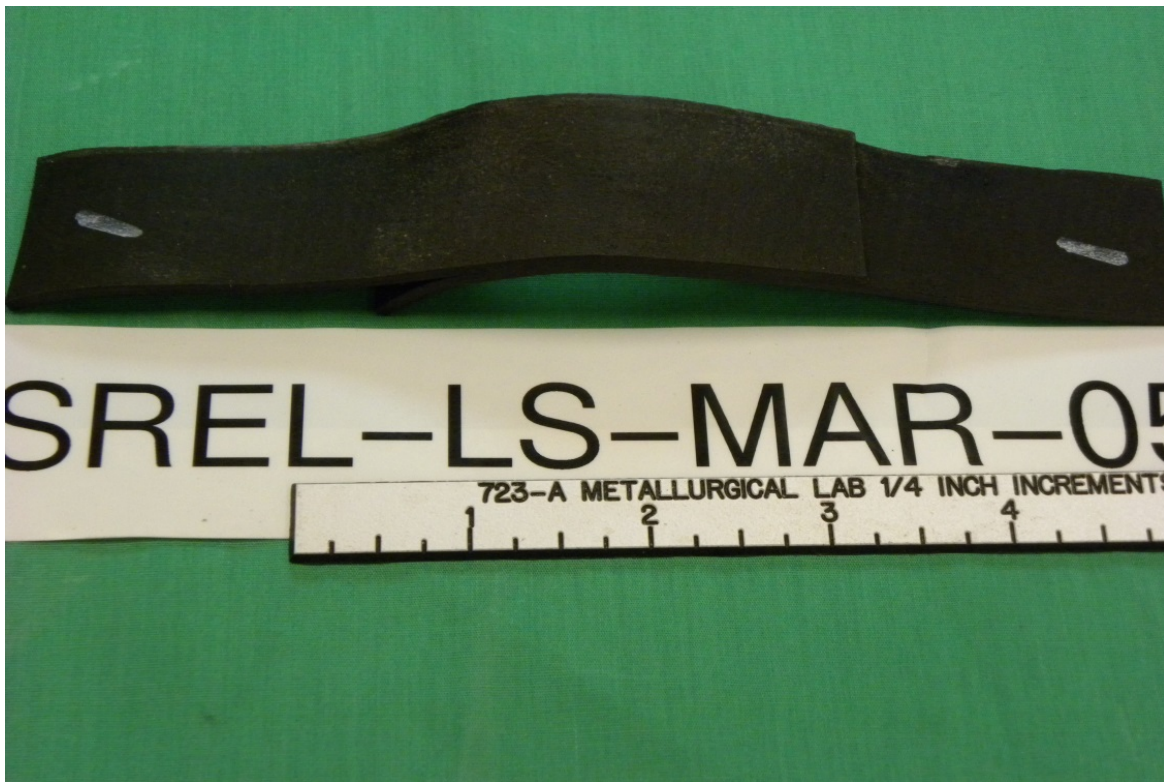
Figure 44. Marseal M-3500 lap-shear samples (50% S1 solution) – pre-test debonding  
(approximately 2.75" overlap, debonded length approximately 1/2")

Upon initial examination, the liner materials were found significantly different in terms of flexibility/stiffness and bonding configuration. The Marseal M-3500 material was bonded using a simple lap joint, with approximately 2.75" overlap. The REMA 4CN material was bonded using a 45° splice joint, with approximately ¾" bond length. The bonded materials are presumed to have been bonded as per normal installation instructions provided by the manufacturer. SRNL/MS&T did not verify the bond configuration with the vendor. Specific bonding parameters (temperature, pressure, cement type) were not disclosed.

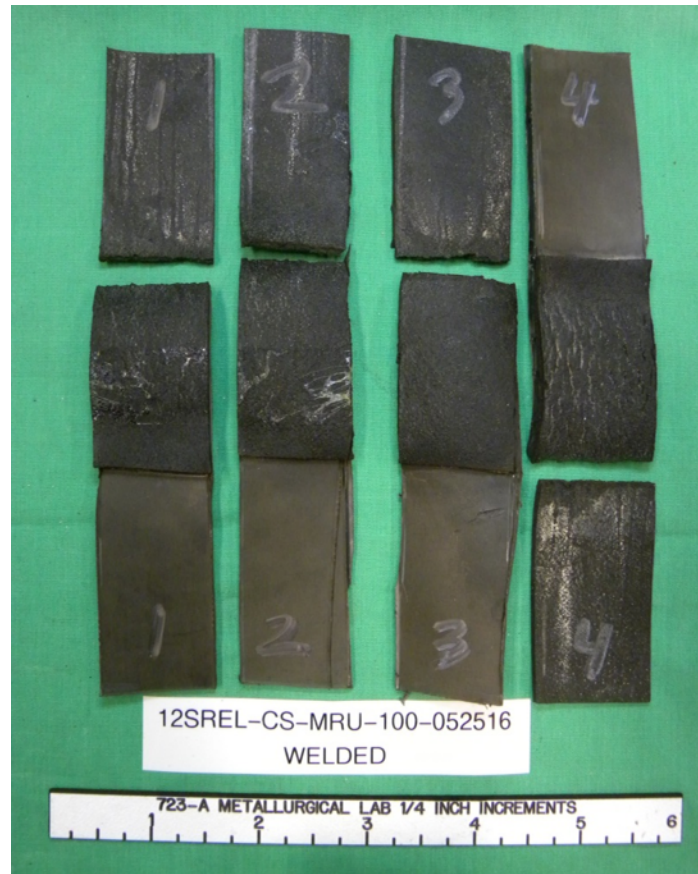
Figure 50. Marseal M-3500/Marseal 2000 lap-shear samples (100% S1 solution) – post-test (fractures in base material at joint edge)

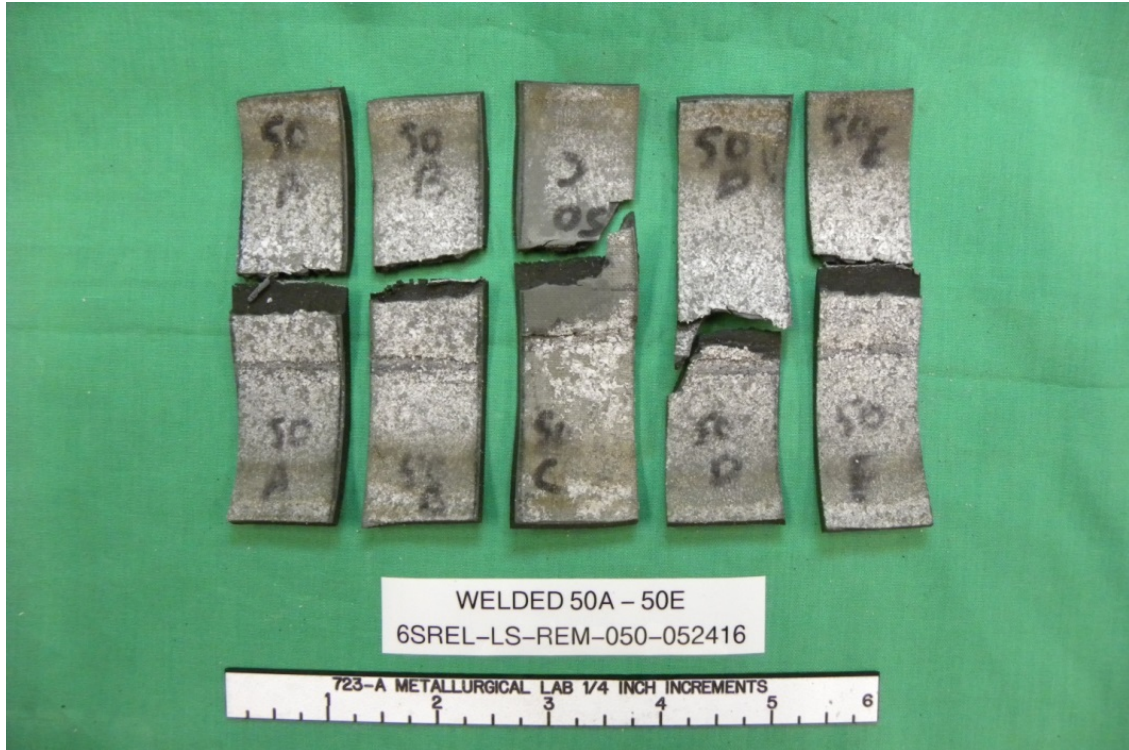
Figure 52. REMA 4CN lap-shear samples (50% S1 solution) – post-test (fractures in base material at joint edge or within joint)

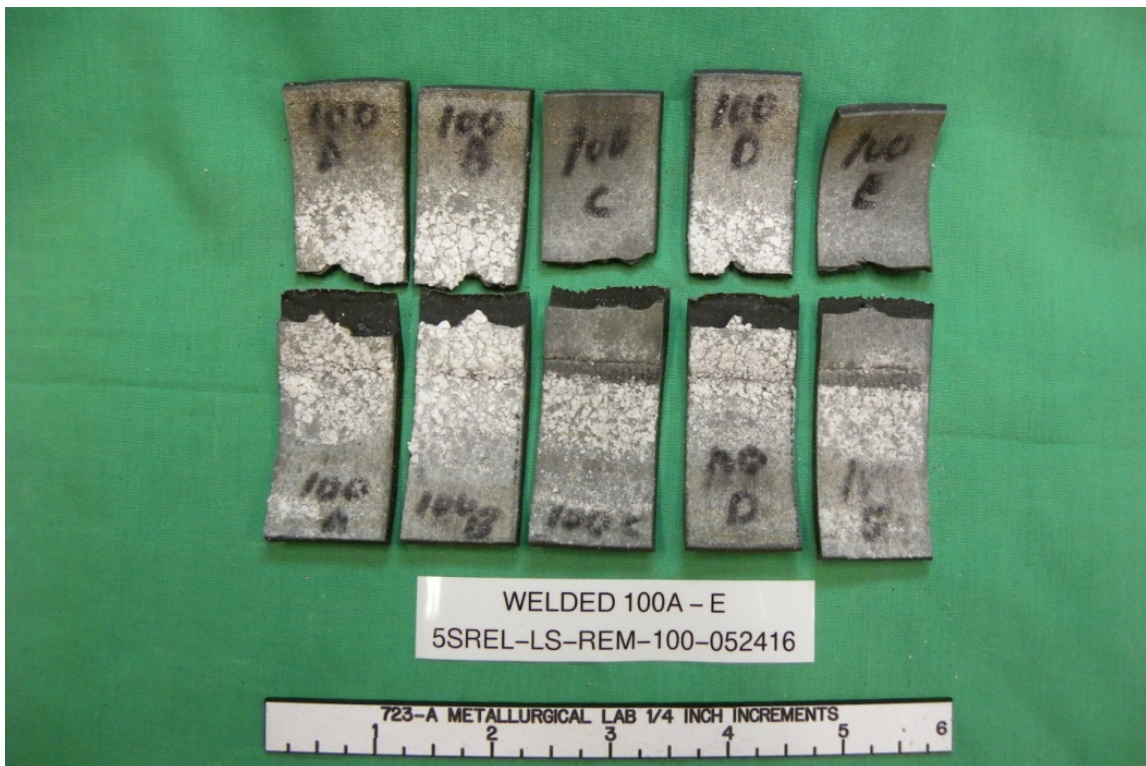
Figure 53. REMA 4CN lap-shear samples (100% S1 solution) – post-test (fractures in base material at joint edge or within joint)
