L-Basin Corrosion Surveillance Program Plan

J. I. Mickalonis

September 2014

SRNL-TR-2009-00140, Revision 3

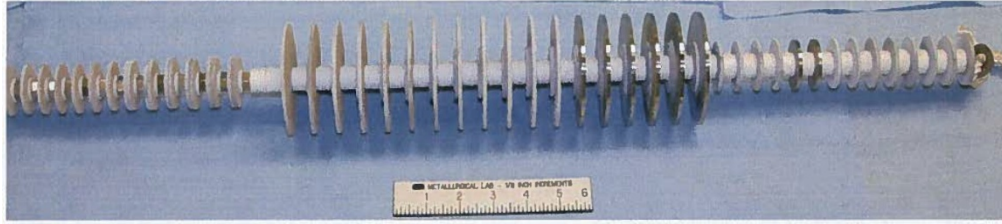
Figure 1 Ray gun removed from L Basin in 2004 showing the array coupon configurations

Figure 1 shows a picture of the ray gun that was removed in 2004. These coupons are separated by Teflon® washers to keep them isolated from other coupons and the rod as shown in Figure 3 for the junior ray gun. The ray gun has 70 coupons which are configured either individually, in galvanic pairs with 304SS coupons or a dissimilar aluminum alloy, and in creviced pairs with either a like coupon of the same alloy or a serrated washer.

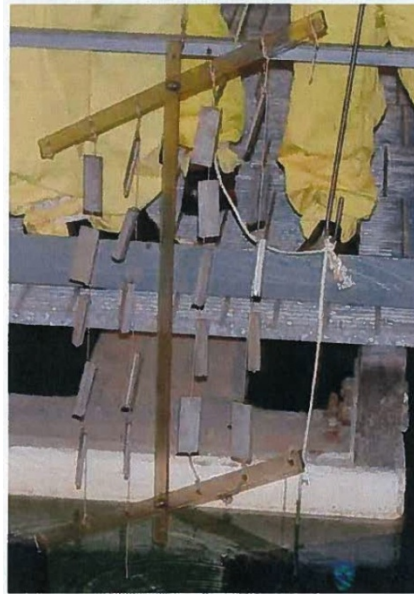
Figure 4 Chime rack with strings of furniture rack coupons made of rectangular plates and U-channels

The chime rack, which is shown in Figure 4, contains strings of furniture rack coupons^a with a string of five being removed at one time.

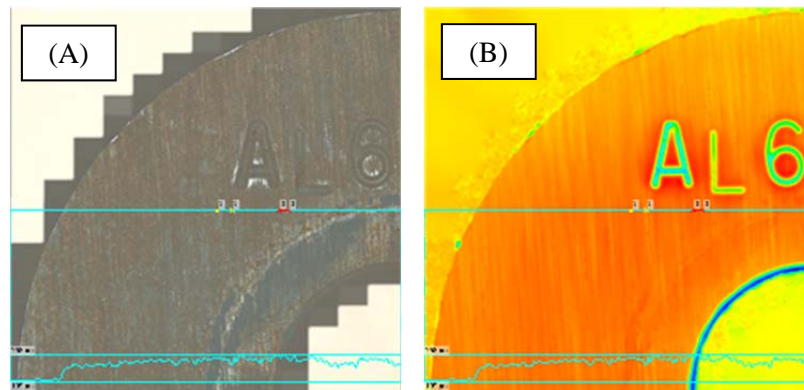
Figure 9 Laser confocal microscope images of the 2010 surveillance coupon Al6061 #044: (A) laser and optical scan, which highlights surface topography and (B) height scan, which highlights differences in elevation across the coupon (data on bottom of photograph shows the height profile for the line scan)

For future evaluations, a new laser confocal microscope (LCM) will be used in this evaluation, jointly with the SWM initially. During the next surveillance coupon analysis, this joint work will allow the new protocol for coupon analysis with the LCM to be tested and verified. The LCM has the capability of scanning at the external surface of the oxide-covered surveillance coupons and at the aluminum/oxide interface. If this capability proves effective, cleaning of the coupons may not be required during subsequent analysis. The type of data (optical and height) taken with a LCM is shown in Figure 9 for a cleaned 2010 surveillance coupon, which had previously been analyzed with the SWM [11]. This particular coupon had no significant pits (> 0.002 in).
