**DEGRADATION EVALUATION OF HEAVY WATER DRUMS AND
TANKS**

J. I. Mickalonis
P. R. Vormelker

JULY 2009

Savannah River National Laboratory
Savannah River Nuclear Solutions
Aiken, SC 29808

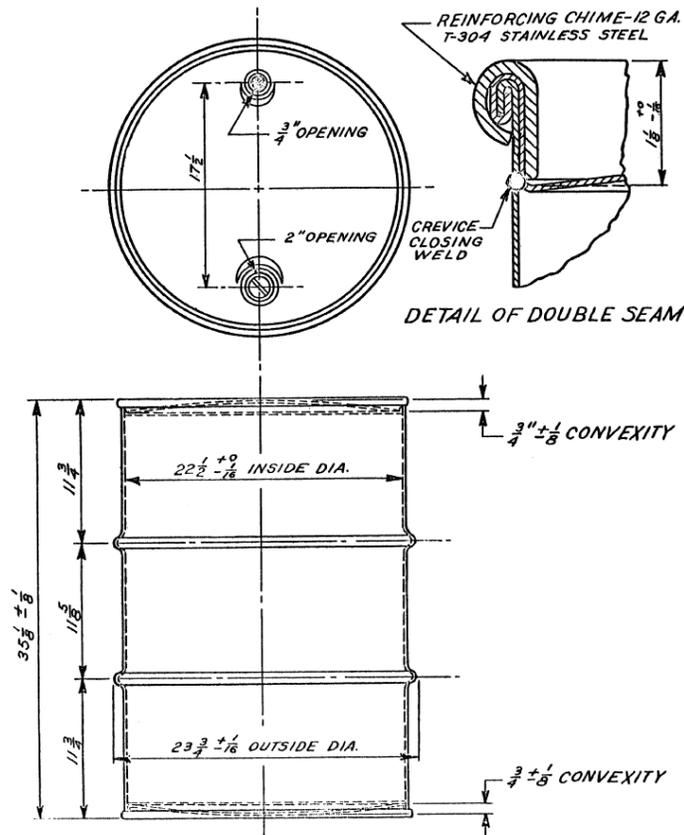
A drawing of a 5B drum is show in Figure 4-1 and the sizing requirements for each drum type are shown in Table 4-2.

Figure 4-1 Heavy Water 5B Shipping Drum (note detail of crevice closing weld)

Each drum has two openings in the top, 0.75 in and 2.00 in, which for all the drums are the same dimensions. The openings are located diametrically opposite one another. These openings have fittings or closures that must prevent leaking, which is determined by the threads per inch (tpi). All the drums have chimes on the top and bottom which prevent these sections from contacting surfaces.

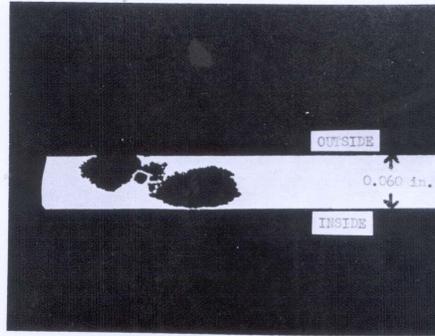
Figure 6-1 Metallographic cross section of a pit in drum corroded during outside exposure [14]

Up to 1975, only 12 stainless steel drum failures had occurred in over 10,000 handled, which resulted from mechanical defects or pitting caused by storage of a corrosive medium [14]. In 1975, pitting originating from the exterior surface started to occur. These pits were associated with fly ash deposits that occurred while the drums were stored outside. Outside storage was used for unfilled drums, which were positioned with their bottoms up to protect the bung threads. The pit morphology is shown in Figure 6-1. This morphology is typical for those associated with microbiological corrosion (MIC), i.e. the internal pitting is more extensive than what the external view indicates.

From late 1989 to 1993, five additional failures occurred due to corrosion including stress cracking, internal and external pitting, and crevice corrosion [18, 19]. The external pitting was attributed to sulfides which leached from fly ash that settled on empty drums stored outdoors. The corrosion morphology differs from that previously observed; compare Figure 6-2 to Figure 6-1.

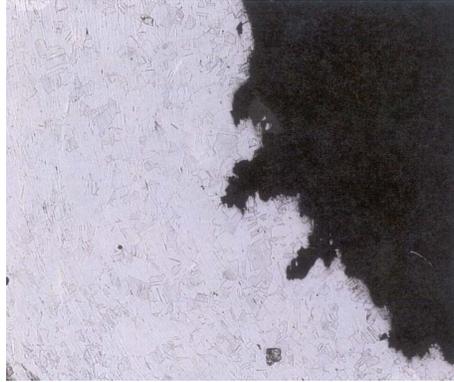
Figure 6-2 Fly ash pit morphology on drum failure in early 1990's [20]

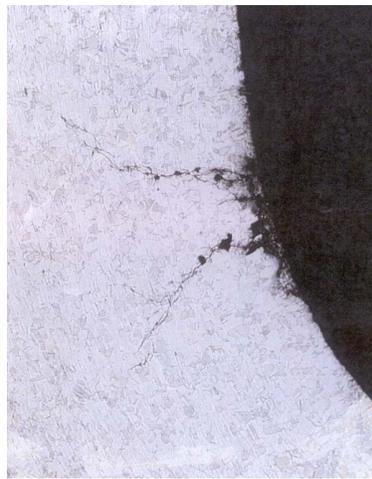
Cracking was also associated with some of this pitting as shown in Figure 6-3. Crevice corrosion was the cause of one failure at the bottom weld as shown in Figure 6-4.

Figure 6-3 Cracking associated with external pitting of drum [20]

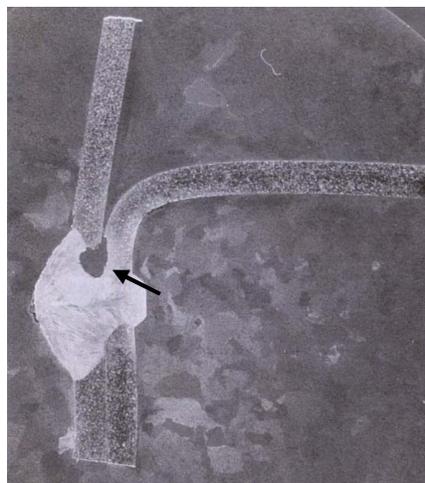
Figure 6-4 Crevice corrosion in bottom to side wall weld – arrow indicates corroding crevice [20, 23]

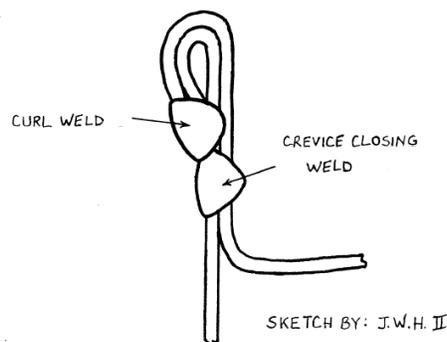
In 1987, failure of a weld during testing lead to a metallurgical investigation of a weld repair [22]. A recommendation resulting from that investigation required the use of a curl weld to close the open chimes as shown in Figure 6-5. This weld stopped some leaks through the bottom to sidewall weld while adding additional strengthening.

Figure 6-5 Schematic drawing of curl weld closure for heavy water storage drum [15]

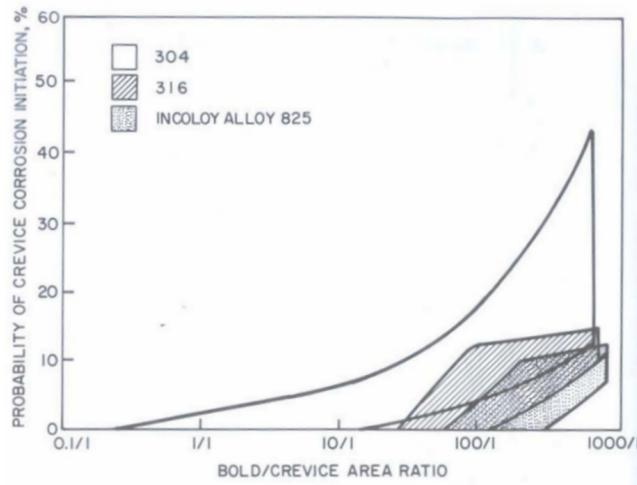
As referred to above, crevice size is a factor that contributes to the probability or likelihood of crevice corrosion occurring. Mathematical modeling has shown that the deeper the crevice and the narrower the opening or gap the more likely crevice corrosion will be to occur. The crevice size also affects the ratio of the cathode area to the anode area. Simplistically, the anode area is

the active corroding portion of the crevice where the dissolution or anodic reaction is occurring. The cathode is generally the area surrounding the crevice on the exterior. As this ratio increases or the cathode size increases, the probability of crevice corrosion increases as shown for stainless steels including 304 in Figure 7-1. The exposure was in flowing ambient temperature seawater for 30 days. The bold/crevice area ratio is the same as the cathode/anode surface area. However, the implication for the drums is still the same; crevice corrosion has a significant probability since the interior surface of the drum can be the cathode.

Figure 7-1 Probability of crevice corrosion initiation as a function bold/crevice area ratio [43]

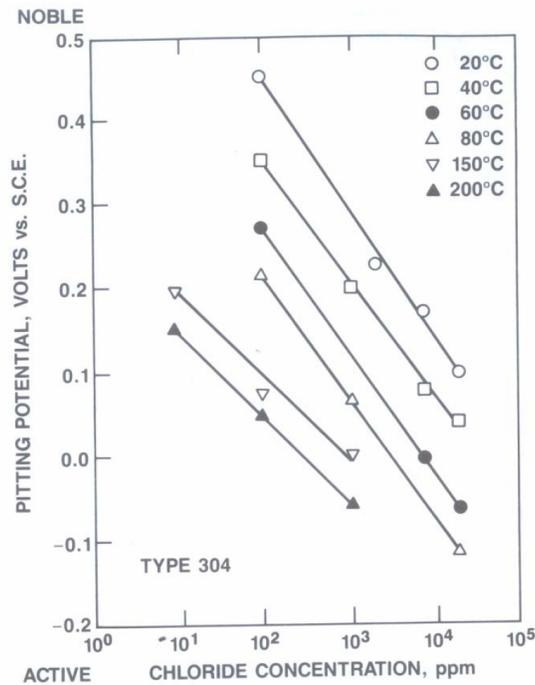
The pitting process is also affected by the environment including the temperature and water chemistry including aggressive species, oxygen and hydrogen ion (pH) concentrations. In the case of the heavy water aggressive species include chloride, thiosulfate (from manganese sulfides), mercury, copper and permanganate. For stainless steel the susceptibility to pitting increases with chloride concentration. A measure of this susceptibility is the pitting potential. The pitting potential is an electrochemical measure at which pitting is found to initiate and propagate in a given solution. As the concentration of chloride increases the pitting potential decreases logarithmically and pitting becomes more likely. The effect of chloride and temperature for 304 is shown in Figure 7-2 [46]. At a given chloride concentration, the pitting potential decreases and pitting susceptibility increases with a rising temperature. These electrochemical changes are a manifestation of the change in the protective nature of the oxide film.

Figure 7-2 Effects of chloride concentration and temperature on the pitting potential of 304 stainless steel [46]

A chloride concentration limit for pitting in the heavy water drums and tanks can not be absolute because of the complex chemistry but guidelines can be derived from available literature data. Figure 7-3 shows that for 304L pitting was unlikely for chloride concentrations less than 100 ppm [43]. The testing involved air-saturated solutions at 60 °C with pH values from 2-8. pH adjustments were made with sulfuric acid. The test temperature of 60 °C is far greater than expected storage conditions [47]. As shown in Figure 7-2, the pitting potential increases with decreasing temperature so the chloride limit would also increase with lower storage temperatures.

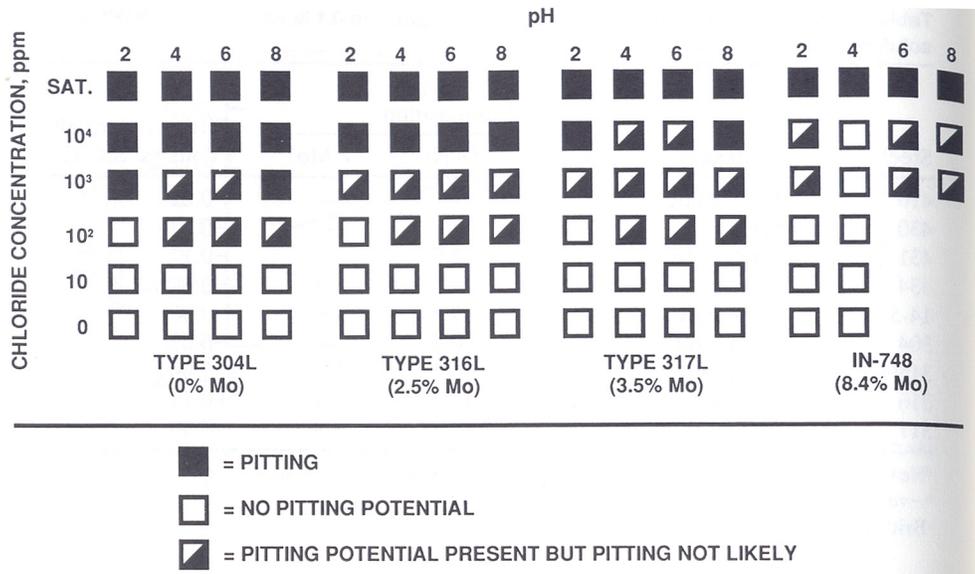
Figure 7-3 Pitting of nickel containing alloys as a function of chloride concentration and pH values in air saturated solutions at 60 °C [43]

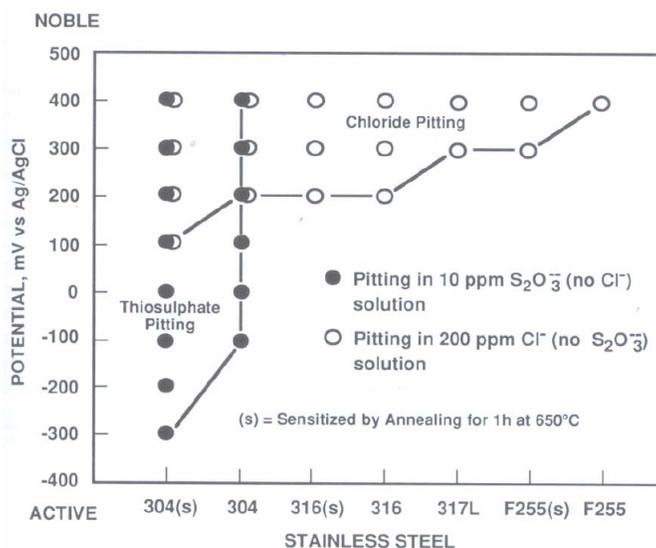
Figure 7-4 Pitting of stainless steels in chloride-containing and thiosulfate containing solutions at 24-hour potentiostatic tests [43]

The mercury, copper and permanganate ions all act as cathodic depolarizers, i.e. they accelerate the cathodic reaction for the corrosion process [43]. This acceleration results from either increase efficiency of cathodic areas or as an additional cathodic reaction. The increased efficiency results from metal ions that deposit on the stainless steel surface which have a smaller overpotential for the cathodic reaction, which is oxygen reduction at neutral and alkaline pH water or hydrogen reduction in acidic water. For mercury, the concentration must be greater than 0.5 ppm to aggravate the corrosion due to the amalgamation of the stainless steel surface [48].

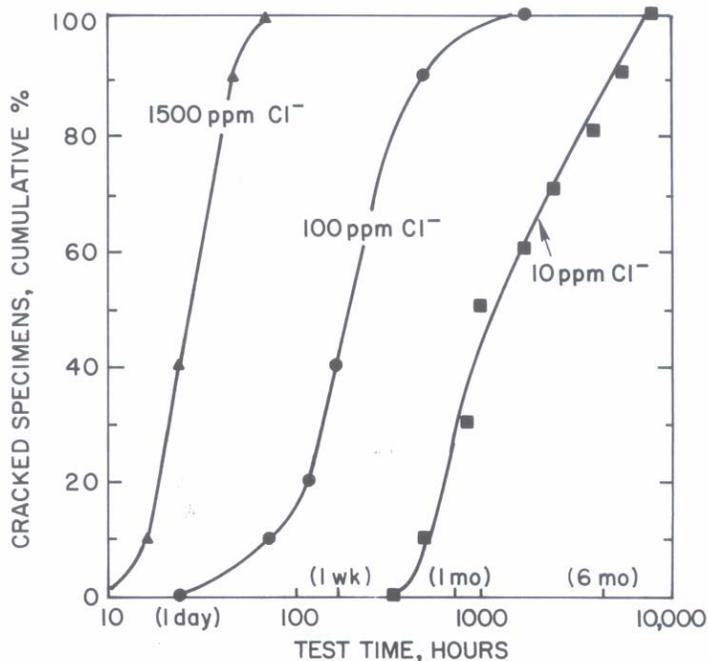
The occurrence of SCC is a function of chloride concentration. As chloride concentration increases, the time to failure increases. Figure 7-5 shows this effect for 304 stainless steels samples that were exposed at 100 °C under the concentration conditions of a Wick test where the salt solution is wicked to a heated surface allowing concentration of chlorides. In this test the

chloride solution is brought to the stainless steel surface through a porous medium. For the chloride concentrations shown, all the samples failed eventually.

Figure 7-5 Effect of chloride concentration on the SCC susceptibility of 304 stainless steel exposed at 100 °C under the concentrating condition of the Wick tests [43]

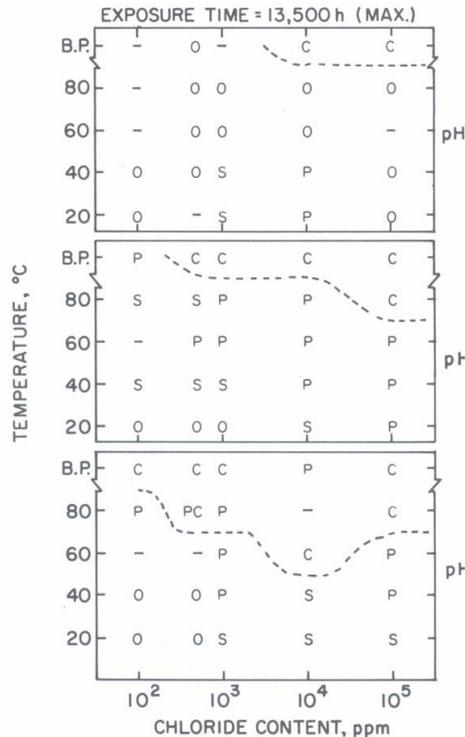
Temperature also has a significant effect on SCC. A temperature of 60 °C was once thought to be a lower limit below which chloride stress corrosion cracking did not occur. Service failures over swimming pools and near marine environments have shown SCC can occur at room temperature [52]. Increasing temperature does lead to decreases in time to failure but also a transition from pitting to SCC. Figure 7-6 shows the results of a study with 304 in which the chloride concentration, pH and temperature were varied. These tests were performed in sodium chloride solutions with pH adjustments made with additions of either sodium hydroxide or hydrochloric acid. From these data, SCC was not observed at 100 ppm in the temperature range of interest for heavy water storage (<85 °F).

Figure 7-6 Effect of temperature, pH and chloride concentration on SCC susceptibility of 304 stainless steel in sodium chloride solutions (C=SCC, P=Pits, S=stains, O=no effect) [52]
