**SEVENTH INTERIM STATUS REPORT: MODEL 9975 PCV O-RING FIXTURE
LONG-TERM LEAK PERFORMANCE**

Savannah River National Laboratory
Materials Science & Technology

Publication Date: August 2012

Revision Log**Document No.** SRNL-TR-2012-00181**Rev. No.** 0**Document Title** **Seventh Interim Status Report: Model 9975 PCV O-Ring Fixture
Long-Term Leak Performance (U)**

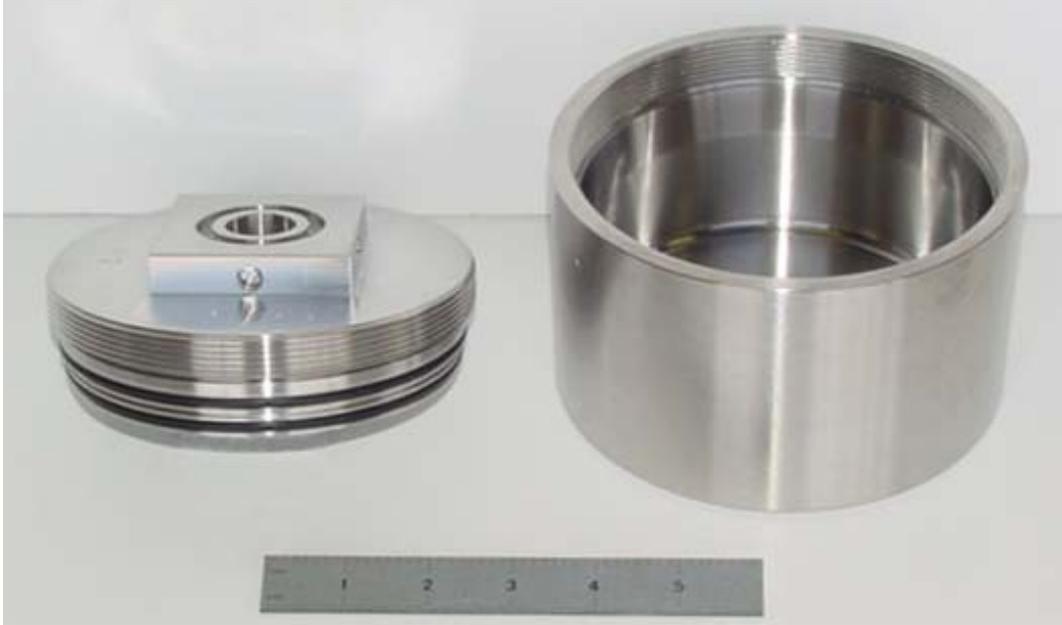
Figure 1. Mock-up PCV test fixture lid and body.

The two-piece lid of the mock-up PCV, consisting of the cone seal nut and cone seal plug, was machined to be identical to the actual PCV lid. The body of the mock-up PCV was shortened to 3.5 inches from the original design of 18.6 inches and a threaded hole was machined in the bottom to provide a port for evacuating and filling the vessel with gas and for in-situ leak testing of the O-rings. A PCV test fixture with the O-rings installed in the lid is shown in Figure 1.

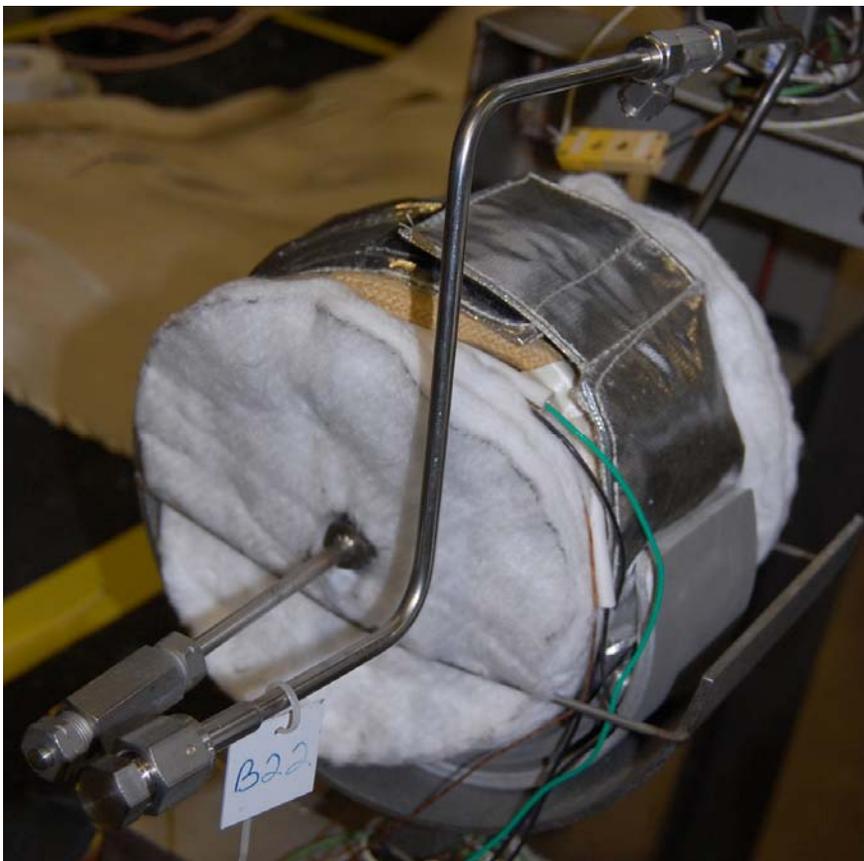
Figure 2. Assembled mock-up PCV.

The vessels are heated with a flexible, wound-wire heater wrapped around the vessel circumference. Ceramic fiberboard and fiber batting are used to insulate the exposed ends of the fixtures. Stainless steel tubing is attached to the port on the top of the fixture lid via a high-pressure fitting and to the hole machined into the bottom of the PCV body. A thermal fuse was added to each heater to prevent excessive temperature excursions. The heaters are controlled by a desktop computer running LabView™ software, with feedback via a type-K thermocouple attached to the PCV body. The final assembled fixture is shown in Figure 2.

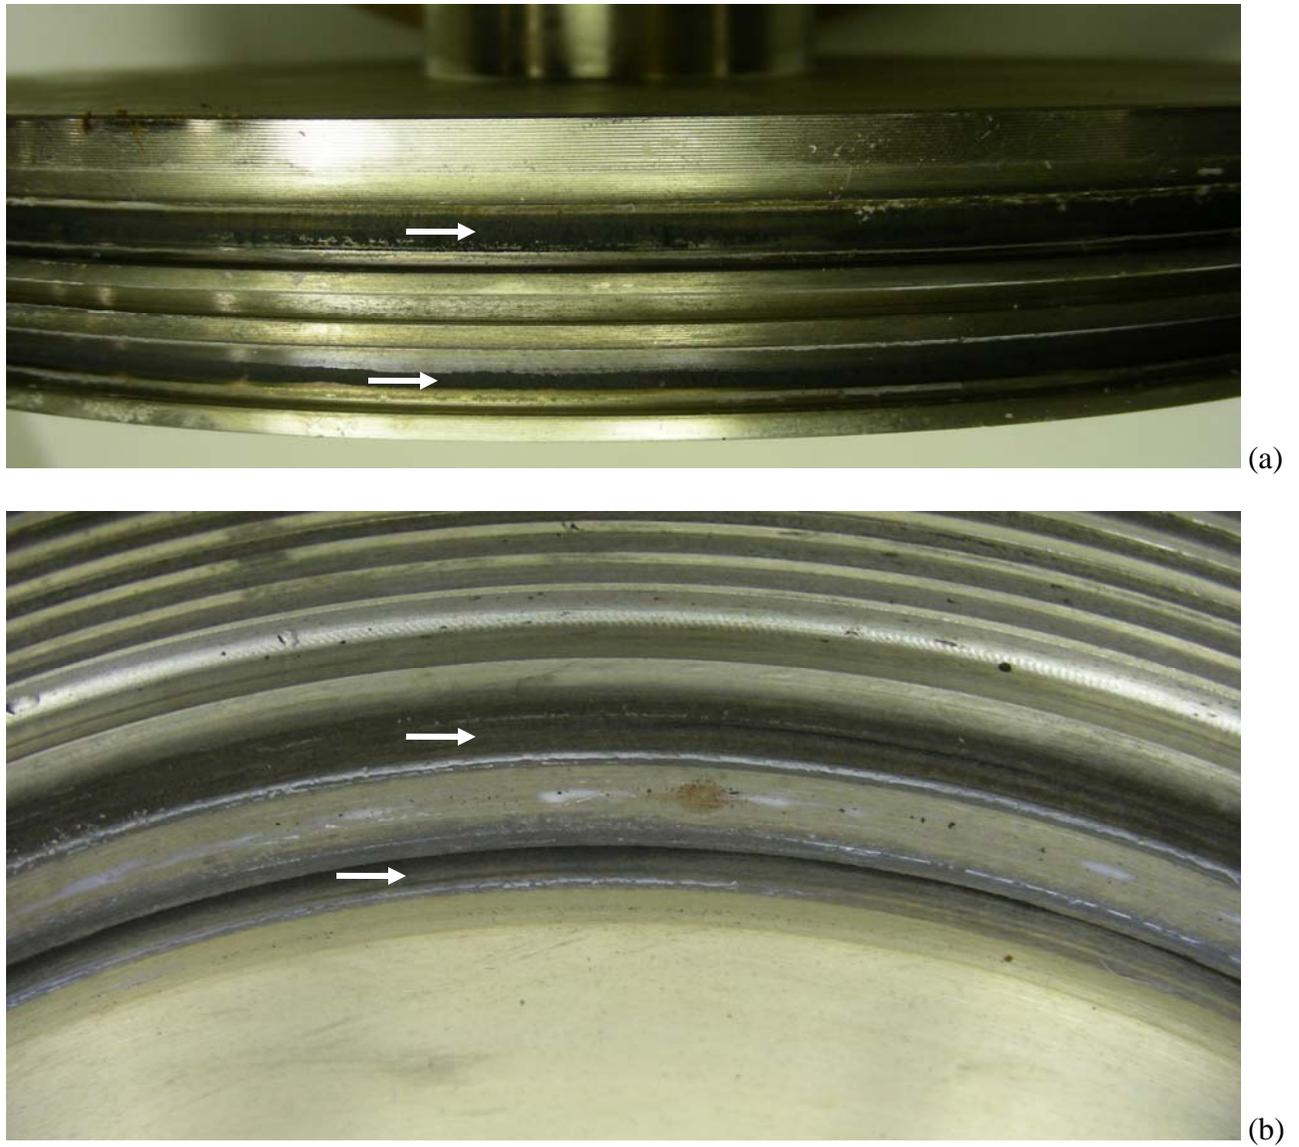
Figure 3. Black stain on fixture 8 plug (a) and body (b) following disassembly.

Fixture 8 was aged at 300 °F for 2082 days, and was disassembled in February 2012 following failure of both GLT O-rings. The following observations were made during disassembly:

- The inner O-ring was tightly adhered to the plug in one area. The outer O-ring was tightly adhered to the plug over the entire circumference.
- A black stain and/or some adhering O-ring material was observed on both the fixture body and plug where the O-rings contacted them. See Figure 3
- Both O-rings experienced material pullout from the surface facing the bottom of the O-ring groove. Some cracking was also observed on this surface of the outer O-ring. See Figure 4.

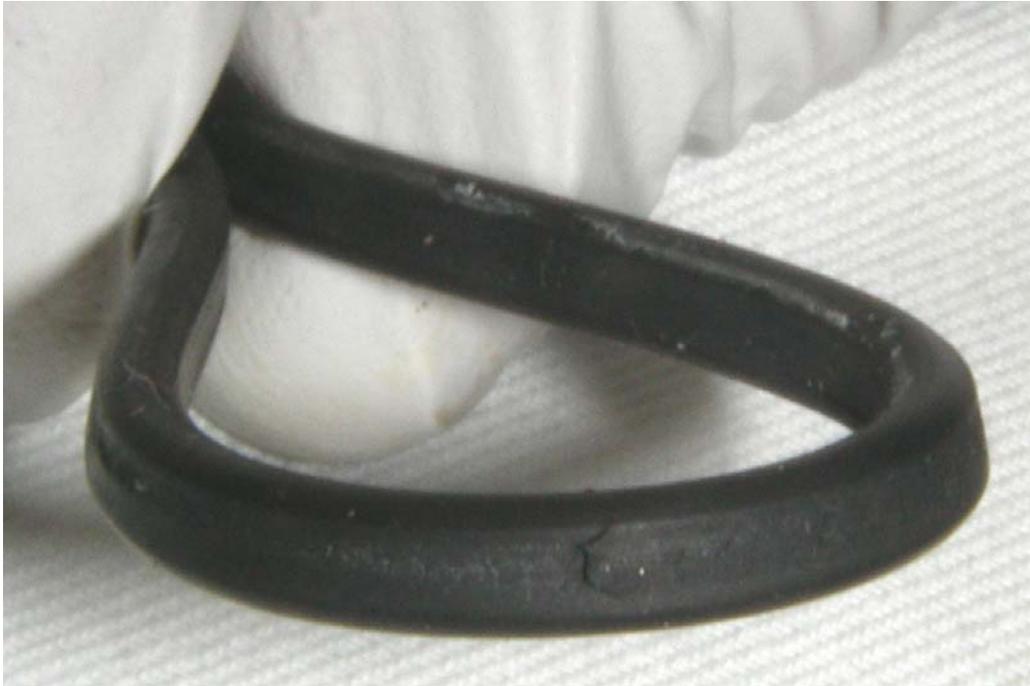
Figure 4. Fixture 8 outer O-ring after removal with cracking and pullout along the surface facing the bottom of the groove.

Both O-rings removed from fixture 8 received dimensional and hardness measurements. Average hardness readings for each O-ring were 78 to 79 Durometer M. The hardness of new O-rings is specified as 75 +/- 5 Durometer A. While there is no exact conversion between the A and M scales, they are generally very similar in value. The hardness increased slightly (~2 points) from baseline measurements for each of these O-rings. This difference is not considered significant. Aside from the cracking and tearout observed on the O-rings, which likely resulted from removal, there was no obvious indication of defect or cause of failure.

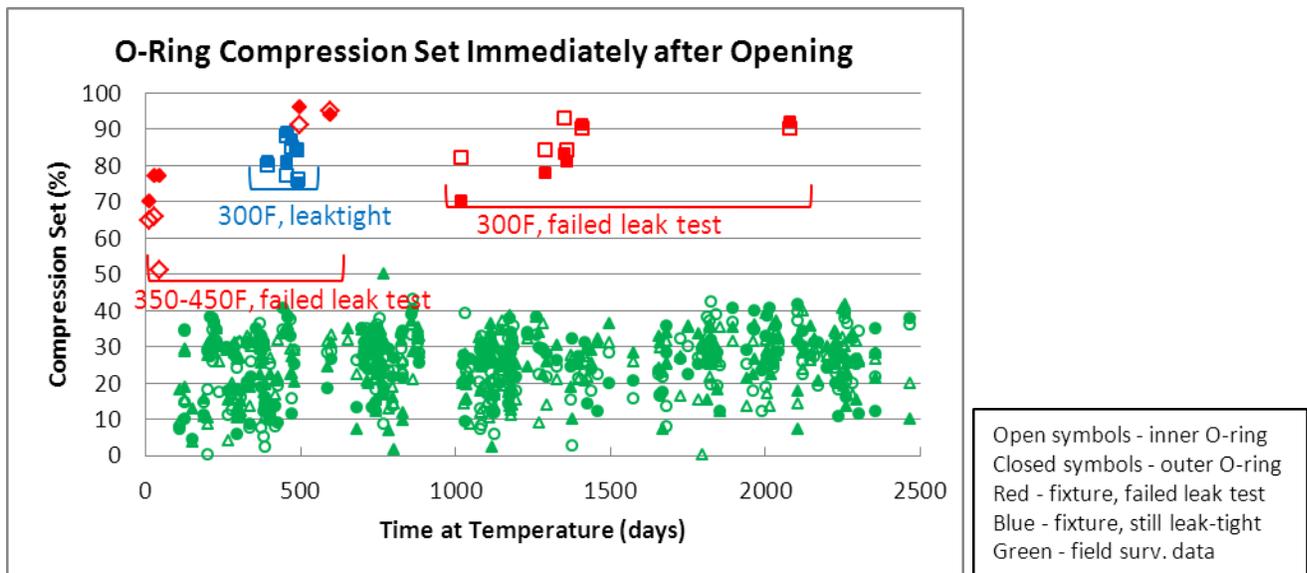
Figure 5. Compression set data for GLT O-rings based on measurements taken immediately after opening vessel (typically 30 minutes or less). The red symbols represent test fixtures aged at 300 °F or higher that failed to remain leaktight at room temperature. The blue symbols represent test fixtures aged at 300 °F removed from test due to difficulty with elevated temperature leak testing but remained leaktight at room temperature. The green symbols are from field surveillance PCV and SCV O-rings (presumed leaktight).

The compression set data are summarized in Figures 5 and 6. Figure 5 presents results from measurements taken immediately after opening the vessel (typically within 30 minutes), and includes 2 sets of data from test fixtures with GLT O-rings aged at 300-450 °F. In the first data set, fixtures that failed to remain leak-tight have compression set values of 70 – 93% (300 °F fixtures) or 51 – 96% (350 – 450 °F fixtures). The second set consists of 300 °F fixtures that were removed from test due to difficulties with high temperature leak testing, but that remained leak-tight at room temperature. These O-rings have compression set values of 75 – 89%, even though they were at temperature for a much shorter time than the first set. This indicates that a high compression set value is not necessarily an indication of imminent leak failure. In contrast, Figure 5 also shows the compression set data from field surveillance of SCV and PCV O-rings. The field surveillance data show a wide range of scatter due in part to the assumption of an initial nominal O-ring thickness. Nevertheless, the range of compression set data from field surveillance remains consistently at 50% or less, with time in service ranging up to ~7 years. Only 1% of the field surveillance compression set values are greater than 40%, so the typical compression set for O-rings in service to date is significantly less than that observed in O-rings which have failed to remain leak-tight. It is currently unknown whether the compression set for O-rings in service will gradually increase to a higher value prior to their failure, but the available evidence strongly indicates the O-rings in service are not yet close to reaching an end-of-life condition.

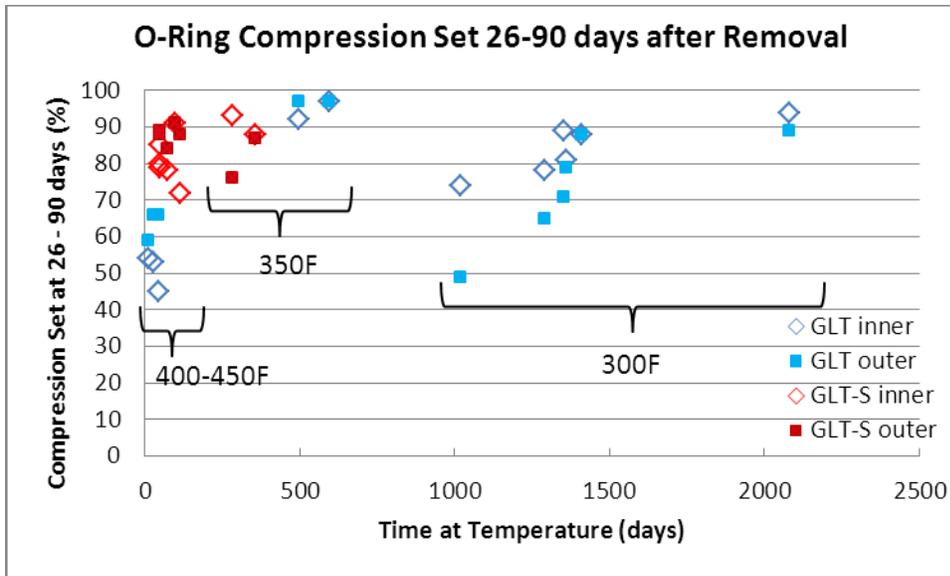
Figure 6. Compression set of GLT and GLT-S O-rings removed from test fixtures which failed to remain leaktight at room temperature. These results are based on re-measurements taken 26 – 90 days after opening the fixture.

The compression set data in Figure 6 include results from all fixtures that have failed to remain leak-tight, and show results based on re-measurements taken 26 – 90 days after opening the vessels. By this time, the O-rings have recovered about as much of their original dimensions as is likely. Results for the GLT O-rings appear to fall into separate groupings based on aging temperature, with different behavior at 300 °F than that at 350 °F or 400 – 450 °F. The compression set data for GLT-S O-rings at 350 and 400 °F are intermediate to the GLT data for these same temperatures.

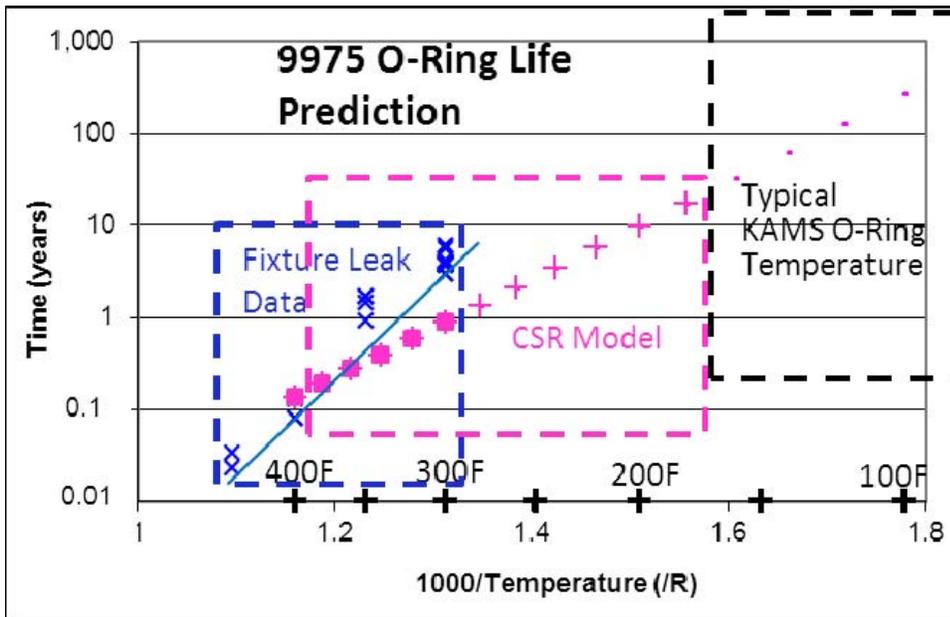
Figure 7 Leakage-based service life data for GLT O-rings (from fixtures with room temperature leak rate failures) compared to life predictions from GLT O-ring compression stress relaxation (CSR) data. The CSR data are distinguished by whether the sample reached a failure condition (90% loss of force, solid symbols), or whether the sample data were extrapolated to estimate a failure condition (+ symbols).

A separate task [2, 10] is underway to correlate the compression stress relaxation (CSR) of O-rings with aging temperature. CSR testing tracks material behavior independent of the factors involved in leak testing, and it is hoped that the time for the compressive force to relax to a specific value (such as 90% loss of initial force) may provide a degree of correlation with the service life based on leak-tightness. Lifetime estimates for GLT O-rings based on CSR data have been presented in Reference 11. With several room temperature leak failures of aged O-ring fixtures, an initial comparison is now possible to demonstrate whether CSR data correlate

with leak data. This comparison is shown in Figure 7 for GLT O-rings. Lifetime estimates based on the two parameters are similar at higher temperatures (~350 – 400 °F). Figure 7 also suggests that the CSR data provide a conservative life prediction at lower temperatures with regards to the actual time to leak failure of the O-rings. This observation should be viewed with caution, however, since the average O-ring temperature in storage is significantly lower than the temperature range for either the CSR or fixture data. Insufficient data currently exist to draw a similar comparison for GLT-S O-rings.
