**EIGHTH INTERIM STATUS REPORT: MODEL 9975 PCV O-RING FIXTURE  
LONG-TERM LEAK PERFORMANCE**

Savannah River National Laboratory  
Materials Science & Technology

Publication Date: August 2013

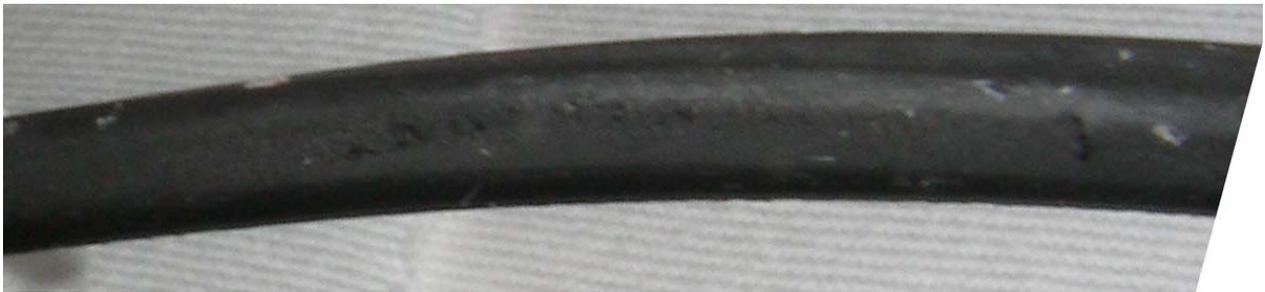
Figure 4. Fixture 7 inner O-ring after removal with pullout.

Each of the 4 fixtures most recently opened exhibited similar characteristics, including O-rings very square (conforming to their groove) and tight in the groove, and stains and residue left adhering to the plug and body (see Figures 3-5). These characteristics were more pronounced in the 3 fixtures that had not failed than in fixture 33 that had failed. Aside from the tearout observed on the O-rings, which likely resulted during removal, there was no obvious indication of defect or cause of failure.
