FY2017 Status Report: Model 9975 O-Ring Fixture Long-Term Leak Performance

W. L. Daugherty

July 2017

SRNL-TR-2017-00257, Revision 0

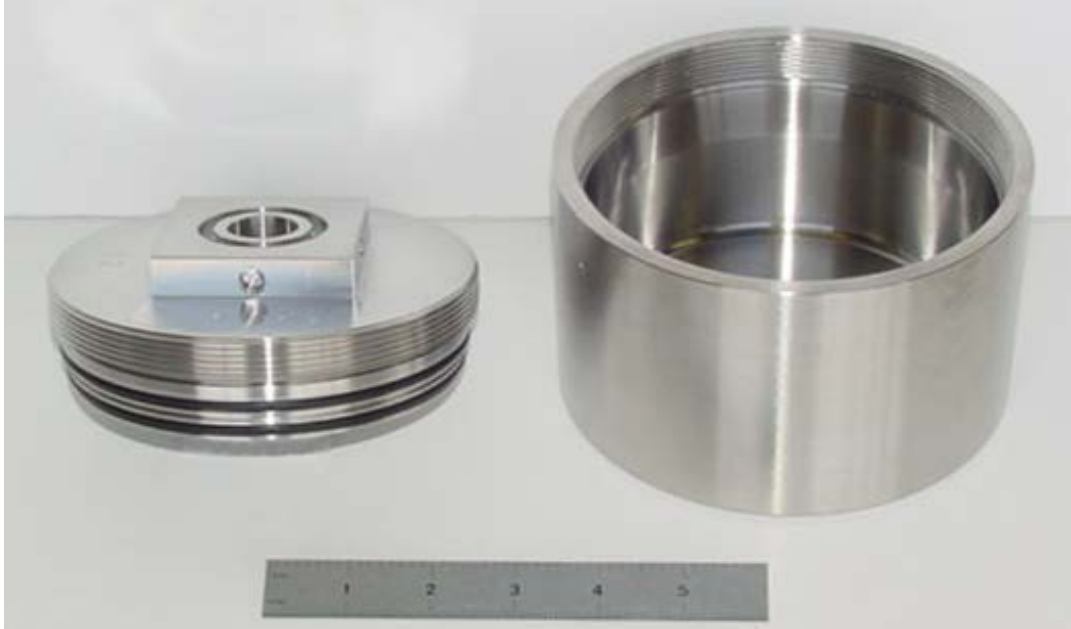
Figure 1. Mock-up PCV test fixture lid and body.

The two-piece lid of the mock-up PCV, consisting of the cone seal nut and cone seal plug, was machined to be identical to the actual PCV lid. The body of the mock-up PCV was shortened to 3.5 inches from the original design of 18.6 inches and a threaded hole was machined in the bottom to provide a port for evacuating and filling the vessel with gas and for in-situ leak testing of the O-rings. A PCV test fixture with the O-rings installed in the lid is shown in Figure 1.

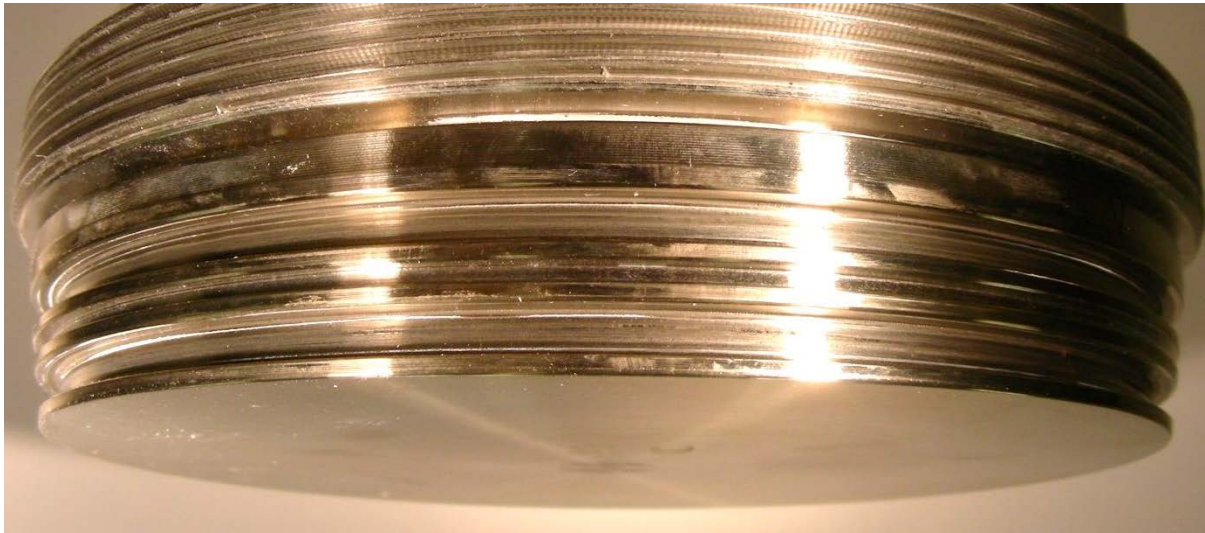
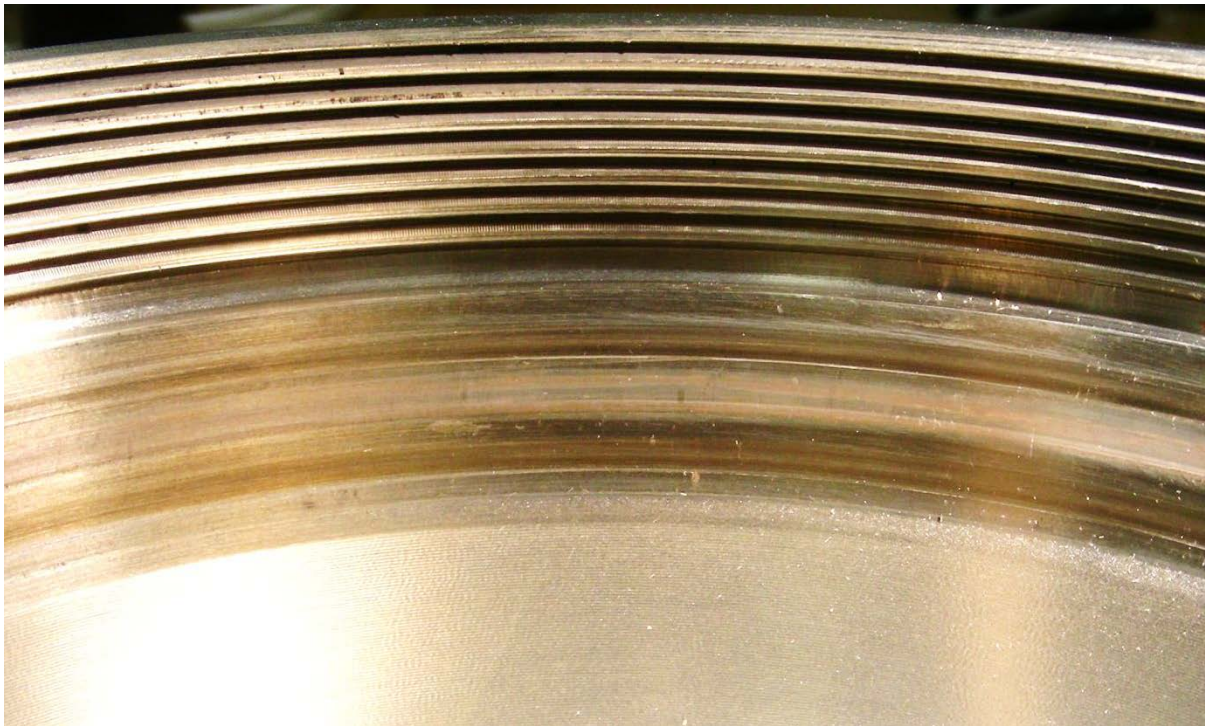
Figure 5. Stains on the plug (a) and body (b) from Fixture 29H.

- A vertical scratch was observed extending partially across the sealing surface of the outer O-ring (Figure 4).
- A varying degree of brown / black stain and residue was observed on the plug and fixture body, likely a combination of oxidized grease and material transferred from the O-rings. (Figure 5). This is typical of other failed fixtures.

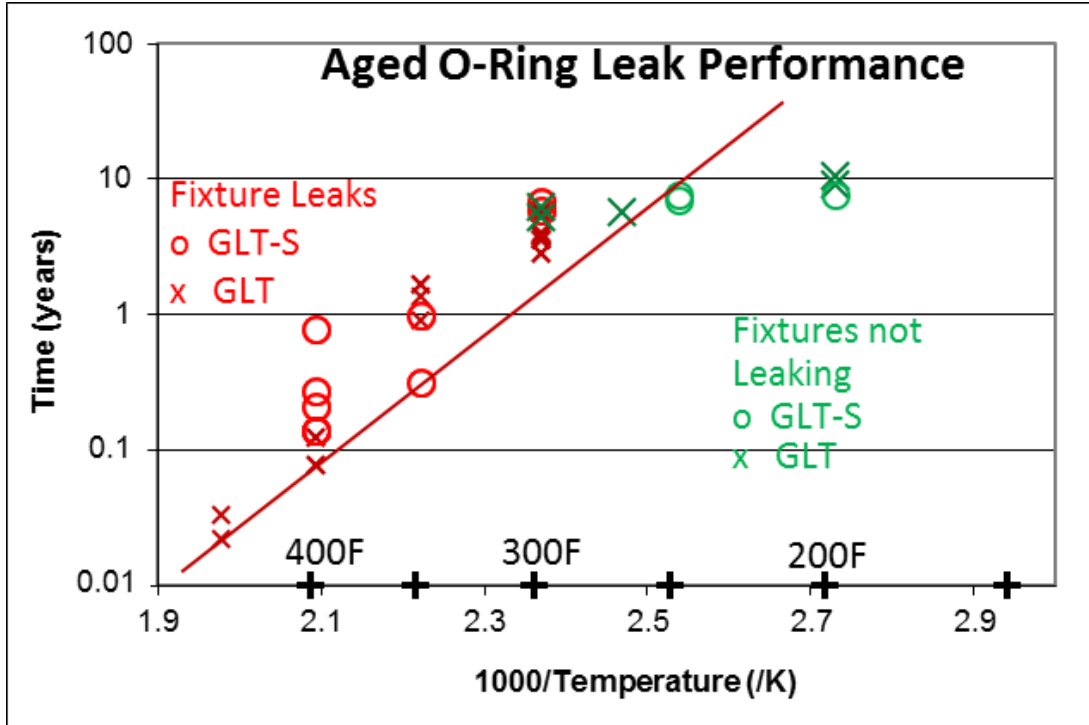
Figure 6. Summary of behavior for fixtures that failed the leak test and for fixtures still in test. The trendline (defined by $y=1.005 \text{ E-}11 * \exp(10.86x)$) illustrates a lower bound projection.

The times at temperature for the fixtures to fail the leak test are shown graphically in Figure 6. In addition, the times at temperature for the fixtures still in test are also shown. A trendline provides a lower bound to the failure data to illustrate a potential extrapolation of the observed behavior to temperatures below 300 °F. In addition, the O-rings aging at 270 °F have now accumulated sufficient time at temperature to exceed the lower bound trendline, demonstrating that the trendline maintains a lower bound to the data at least to that temperature. Note, however, that the degree of scatter in the data would suggest significant uncertainty for extrapolations over a large temperature range. Nevertheless, this trendline suggests the possibility that O-rings aging at 200 °F might maintain a leak-tight seal for up to 77 years, and O-rings at KAC storage temperatures have the potential for even greater service life.

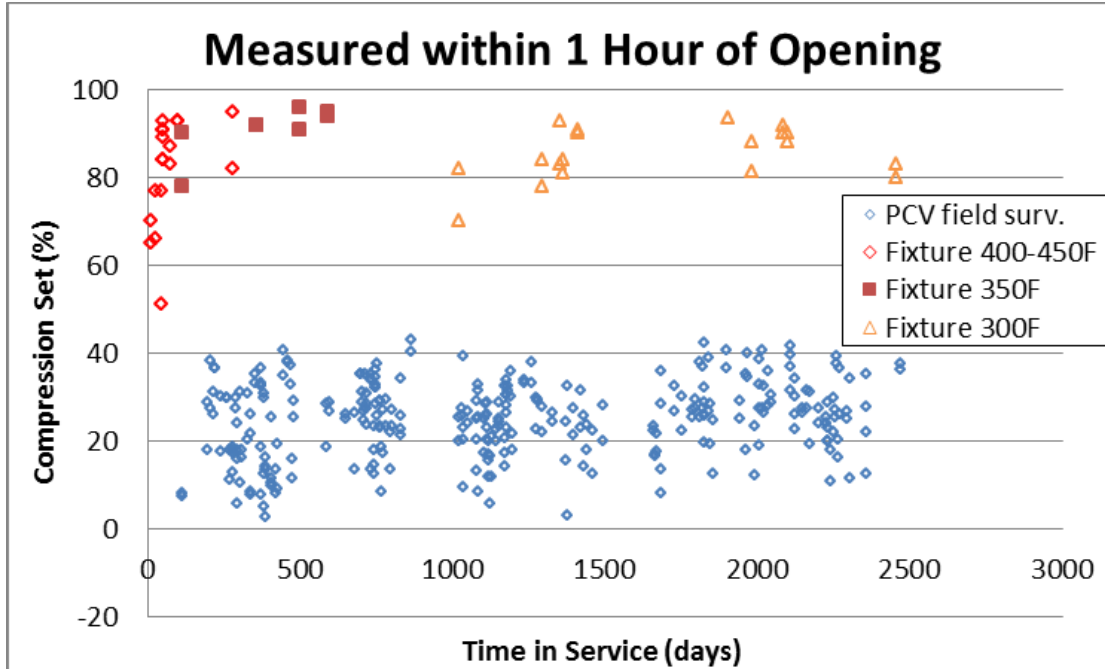
(a) All data in this graph were taken within 1 hour of opening the PCV or fixture.

Figure 8. Compression set values for field surveillance PCV O-rings (blue) compared with O-rings from the PCV fixtures (red – orange).

The compression set data from the failed fixtures are plotted in Figure 8, showing compression set values as a function of the aging time. Compression set values based on O-ring dimensions right after removal are shown in Figure 8a, while Figure 8b shows the final compression set values based on dimensions measured 26 days or more after removal. Also shown in Figure 8 are compression set values from surveillance O-rings. There is a clear separation in compression set values from surveillance and from failed fixtures. This separation is larger for the final compression set values than for the initial values.

The surveillance O-ring compression set values are compared to those from the test fixtures to show that there is margin between these two sets. While there are no data to specifically show how long it will take at storage conditions for the compression set to increase to that seen from the test fixtures, so long as surveillance O-rings continue to show a similar behavior, they likely retain significant margin to reaching a failure condition.

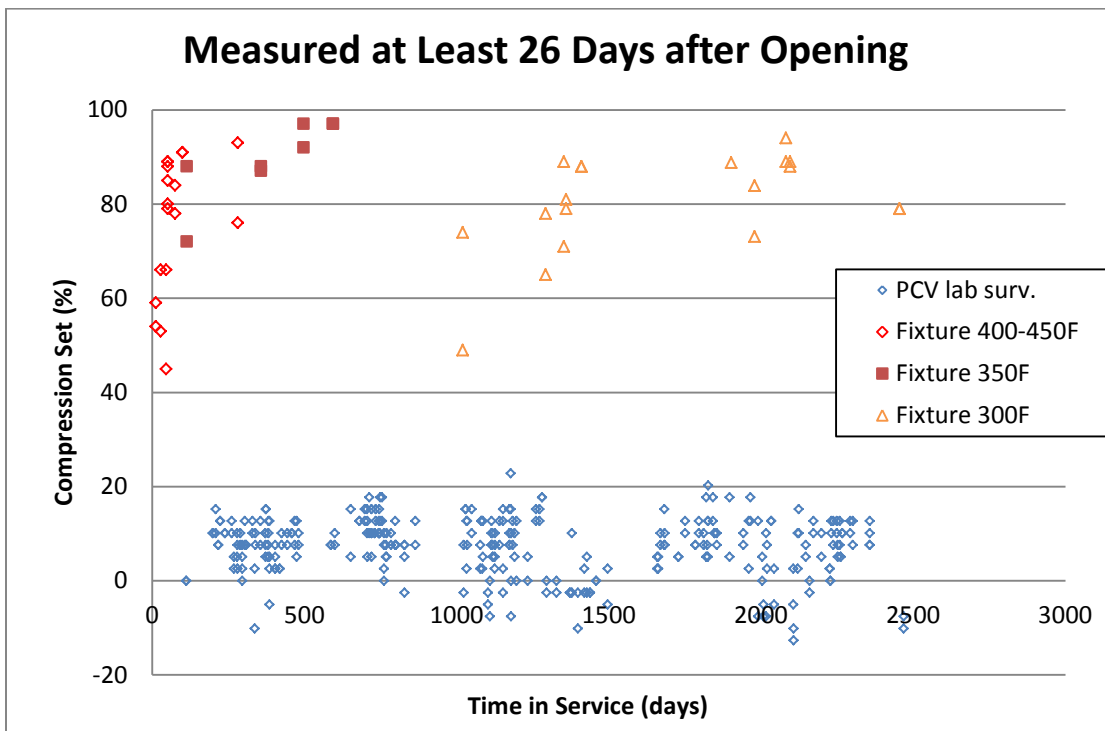
(b) All data in this graph were taken 26 days or longer after opening the PCV or fixture.
