**HELIUM-INDUCED WELD CRACKING  
IN IRRADIATED 304 STAINLESS STEEL (U)**

Westinghouse Savannah River Company  
Savannah River Site  
Aiken, SC 29808

**AIME Presentation on Helium Weld Cracking**

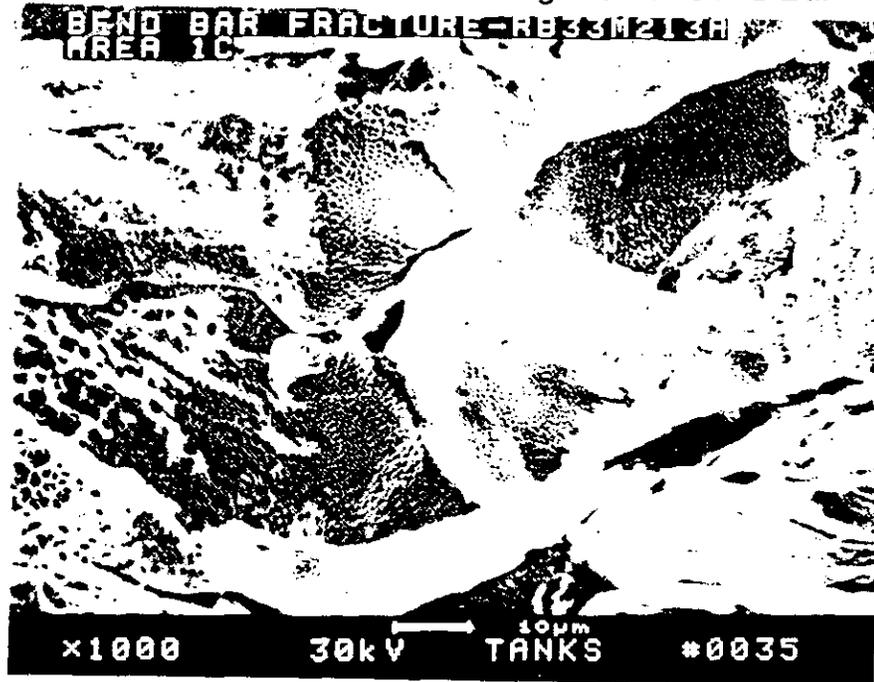
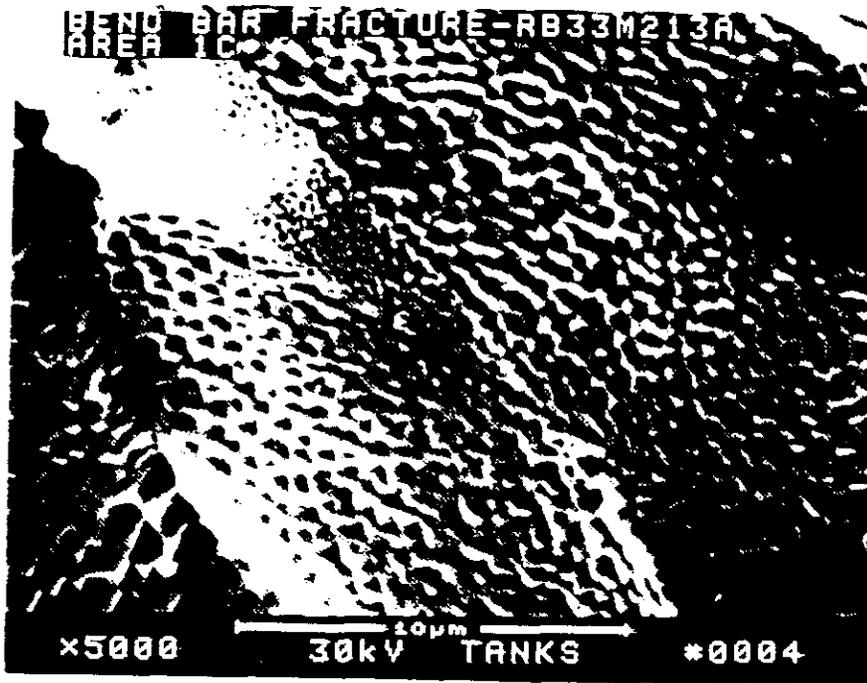
Slide 9 - Fracture Surface From Longitudinal Bend Bar

The faces of the exposed grain boundaries were decorated with fine dimples spaced about 1 micron apart. Since no nucleating particles could be observed at 5000x in the dimples, it is likely they are nucleated by helium bubbles which disperse upon fracture. However the spacing of the dimples is much coarser than that of the grain boundary helium bubbles observed in transmission electron microscopy of annealed but unstrained samples. This indicates that helium redistribution has occurred during the weld thermal and the straining of the cracked grain boundary. This redistribution is probably stress driven and thus offers the key to avoiding cracking; through stress reduction via weld technique modification.

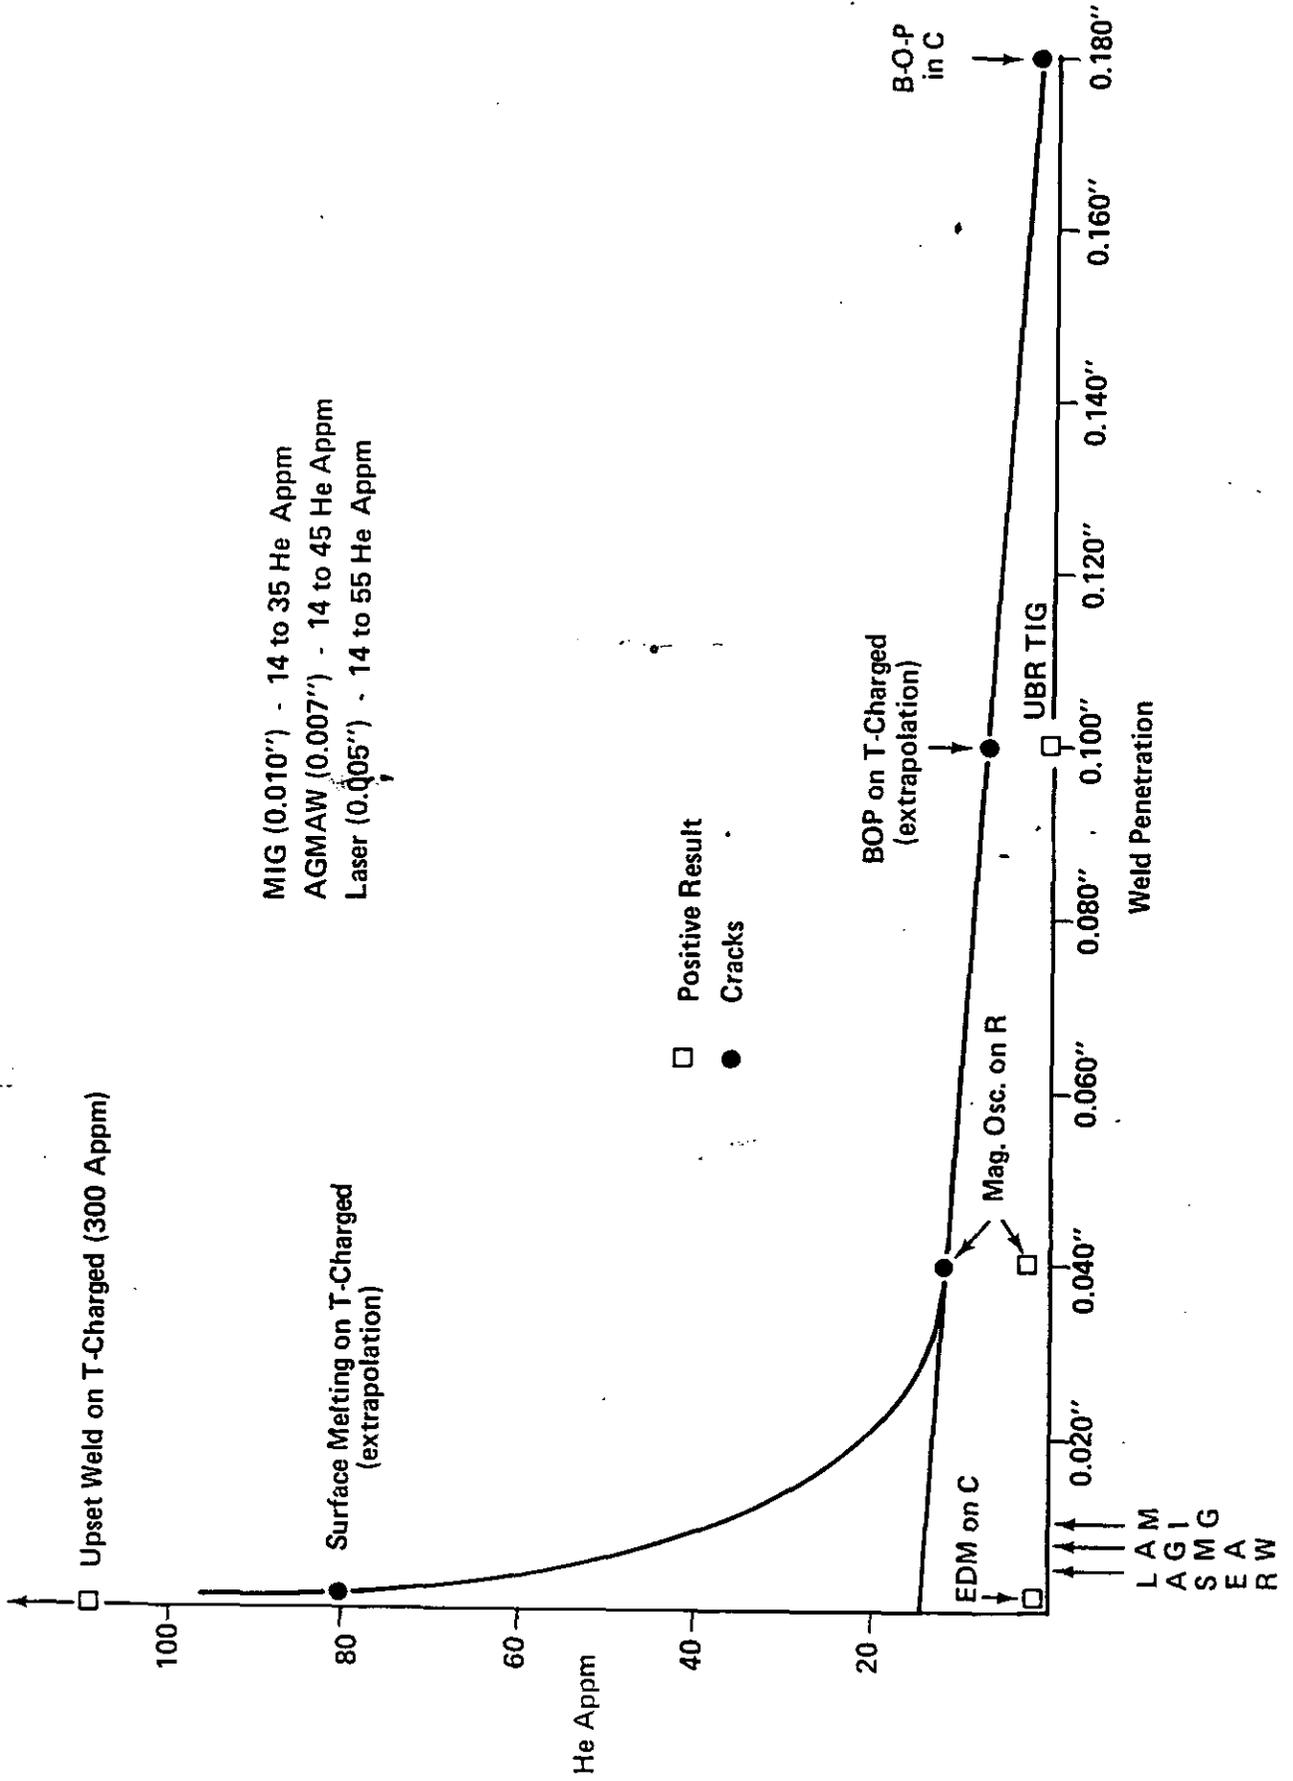
# Projected Helium Concentration Limits for Welding

If the cracking is controlled by the stress at elevated temperature, if the

solidification stress is controlled by the size of the weld and if the weldability (from the shear/peel test results) is affected by the helium content, then a plot of weld penetration versus base material helium content should delineate regions where sound welds can be made. The data obtained from R-reactor material, 304 irradiated at the University of Buffalo, and from the work of Kanne on tritium charged and aged material is plotted. Although the data is limited, it supports the premise that shallower welds on lower helium content material. This data was obtained using autogeneous GTA welding. Estimates of applicable range of helium content may be obtained from estimates of the minimum penetration depth achievable by various other welding technologies (particularly those which use addition of filler metal to the weld) and assumptions about the shape of the function controlling cracking. Additional experiments are needed to define the relationship between solidification stress, weld penetration, base metal helium content, and helium-induced cracking.
