HYDROGEN EFFECTS ON LASER ENGINEERED NET SHAPE (LENS) REPAIRED WELDMENTS

Paul S. Korinko and Thad M. Adams

Savannah River National Laboratory, Aiken, SC 29808 USA

Presented at the 8th Global Innovations Symposium: Trends in
Materials and Manufacturing Technologies for Energy Production
TMS (The Minerals, Metals & Materials Society), 2007

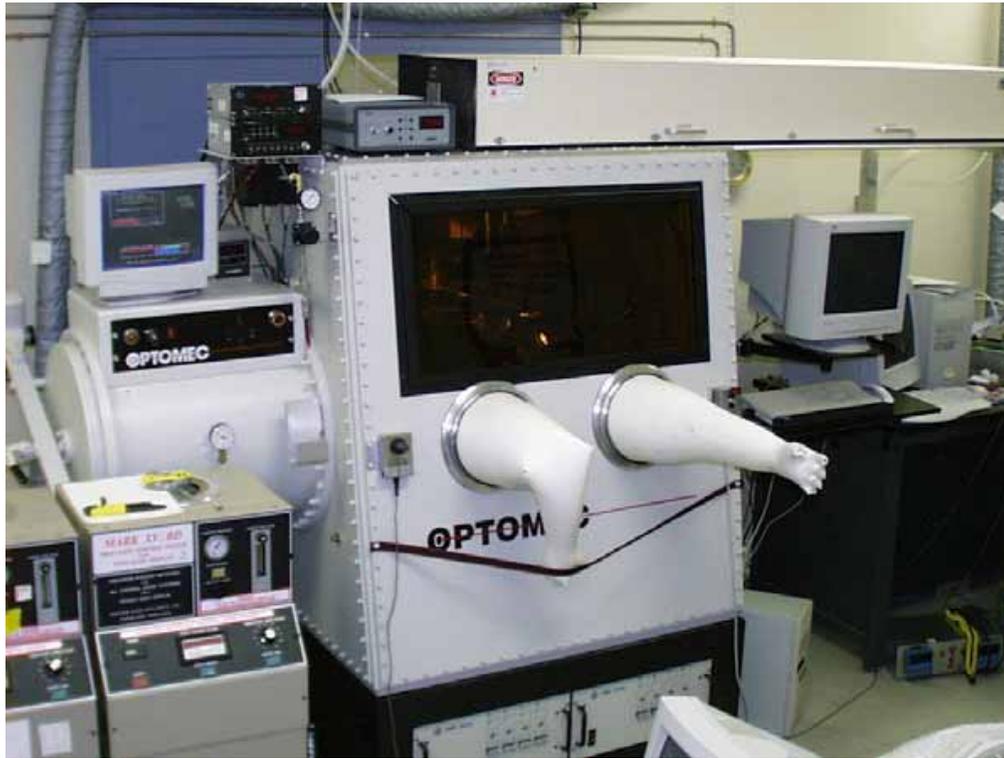
The LENS processing was performed at Sandia National Laboratory-NM, whose LENS machine is shown in Figure 2. The system is composed of 5 major subsystems. 1) The laser subsystem is of sufficient size to melt metal and the wavelength determines the laser's compatibility with specific materials. SNL's system utilizes a 1200W, continuous wave, Nd-YAG laser. 2) A closed loop melt pool control system that works closely with the laser to create consistent, repeatable process conditions. 3) A motion control system that uses coordinated movements of a set of axes. The motion must be controlled to create the component in the desired geometry. 4) A powder delivery system that typically consists of a stream of pressurized process gas, one or more powder feeders to meter powder into the gas stream, and a powder distribution system. And 5) a purified environment (typically argon with <5 ppm oxygen) is needed to assure the material deposited is as similar as possible to the composition of the metal powder used in the process.

Figure 2. Sandia National Laboratory LENS® Processing Machine

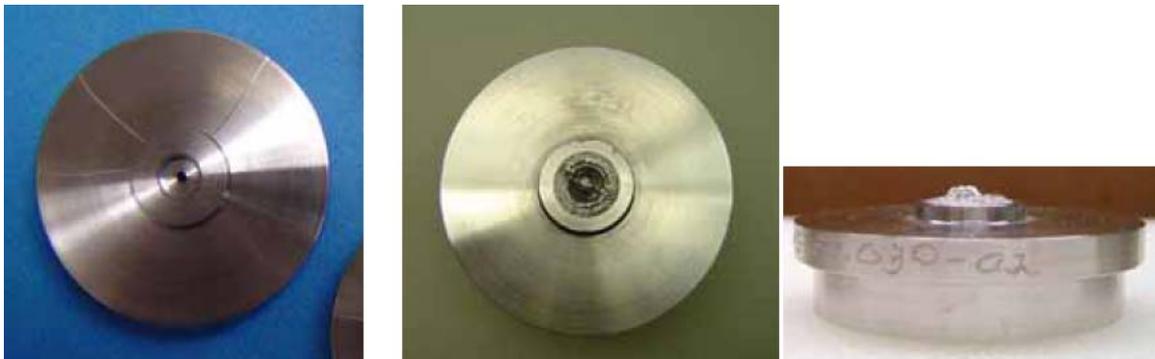
Type 304L stainless steel pieces were machined using conventional machining practices to a standard test geometry as shown in Figure 4a. To simulate both over diameter and eccentric boring, test bases were machined with bore diameters of 0.38 mm, 0.76 mm, and 1.14 mm. In addition, the nominal depth of the hole was excessive by 0.38 mm. These parts were repaired using the LENS process to the condition shown in Figure 4b. The cone shape of the additive metal is due to repairing these samples by canting the test base at an angle, approximately 45°, and rotating the part as the powder was fused. The decreasing radius of the repair area resulted in excessive build up at the center. This excess material did not cause any issues since it was removed during weld preparation.

Figure 4. Photographs showing the as machined and LENS repaired condition of the test bases.

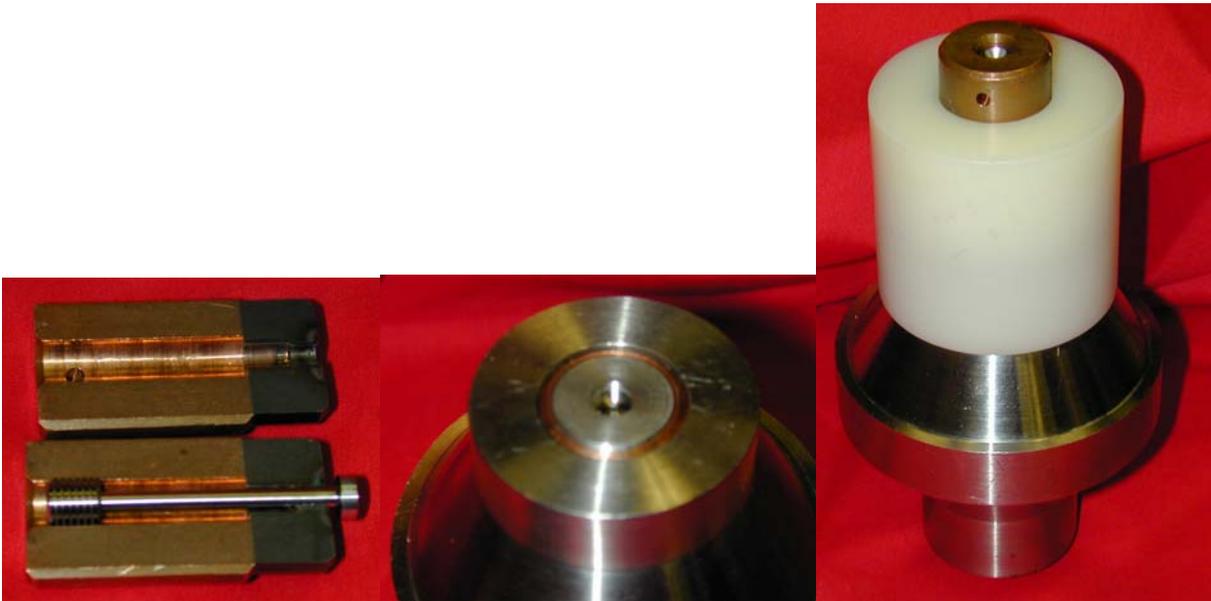
The test base was welded using a series of components shown in Figure 5. A fill stem with a known “foot” diameter and depth is forced into the smaller diameter hole at a load of approximately 2250 lbs. A current of approximately 11,400 amperes is applied for 25 cycles of 60 Hz AC electricity. During this time the foot and test base heat to near the melting point of the metal and are deformed. Recrystallization and solid state diffusion occur during this 0.42 second period and a metallurgical bond is formed.

Figure 5. Typical fixtures needed to resistance forge weld a stainless steel stem into a test base.

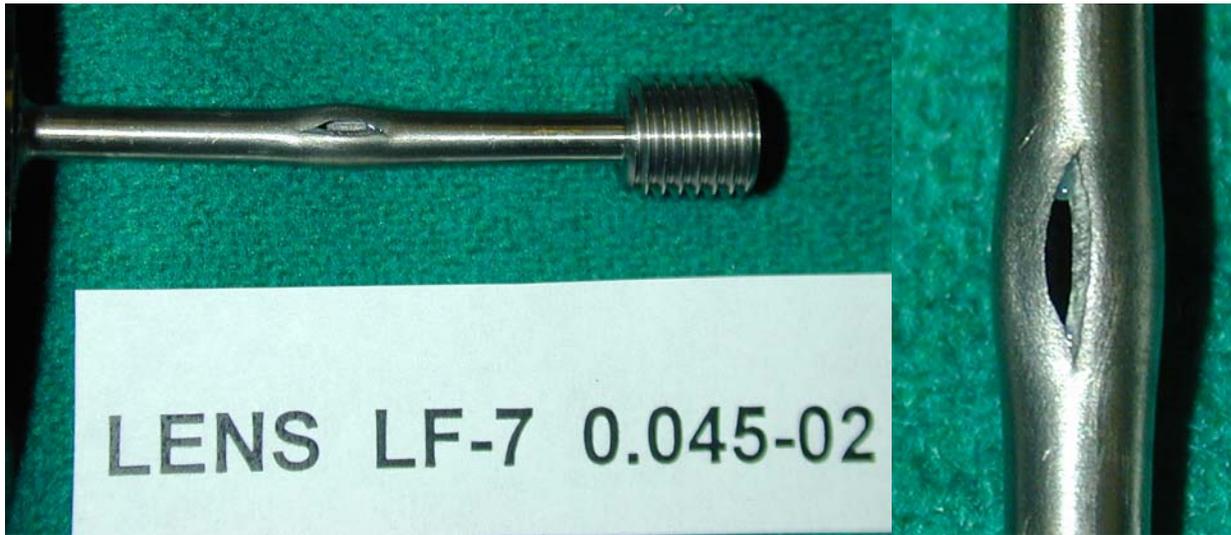
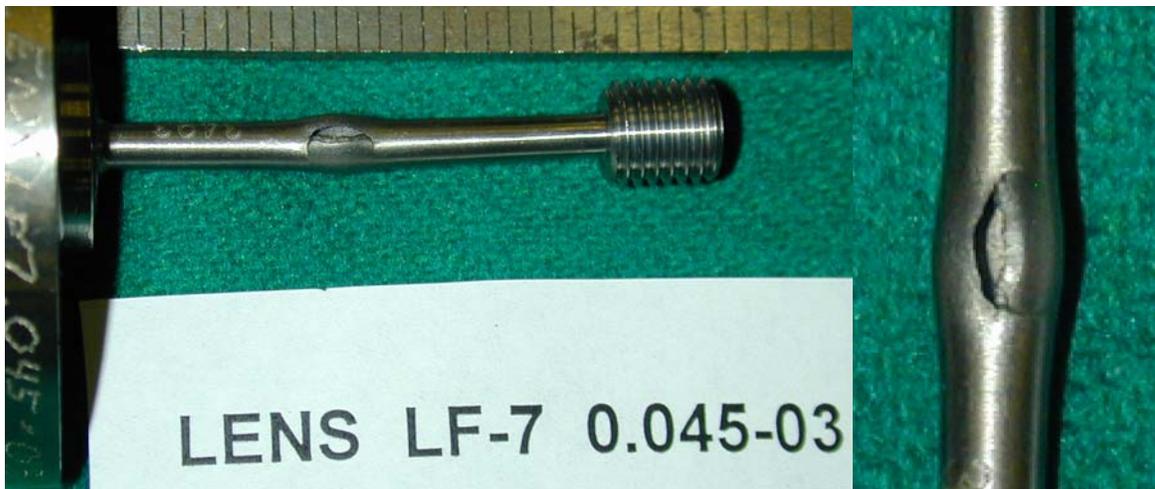
None of the test bases failed near the weld, all failed in the tube wall. Typical tube wall failures for hydrogen charged and baseline samples are shown in Figure 10. These samples exhibit a classic fingernail type failure with evidence of ductile stretching in the tube wall. There may be less deformation for the hydrogen charged samples than for the baseline samples based on the extent of diametral expansion, but the extent of uniform deformation is difficult to characterize for such small diameters.

LENS repaired and hydrogen charged and burst tested sample

Baseline sample burst tested

Figure 10. Typical samples after burst testing.

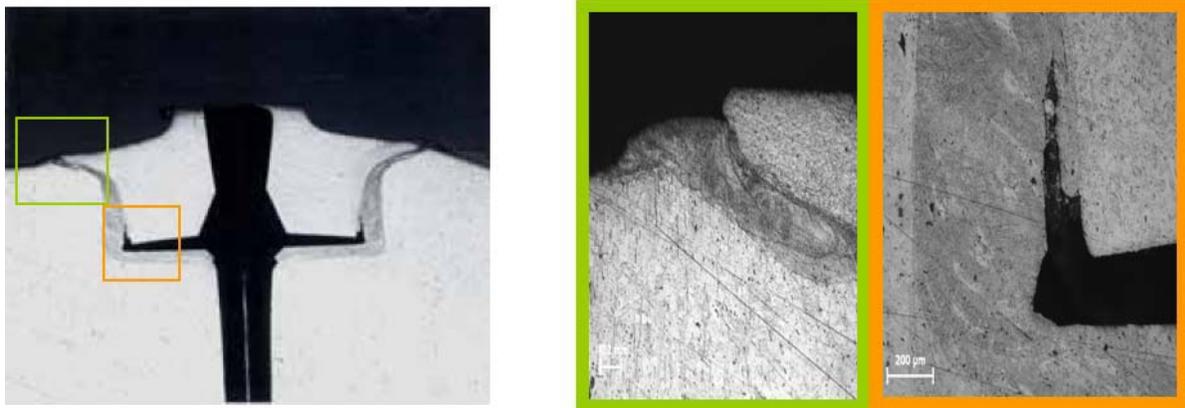
A representative sample from the 1.14 mm overbore and LENS repaired, welded and burst tested sample was examined metallographically. The typical form of the weld and more detailed microstructure can be seen in Figure 11. The low magnification image shows the presence of LENS repair material weld bonded to both the test base as well as the fill stem foot. The separation at the bottom of the foot is due to the pressure testing. Higher magnification images near the root of the weld and near the top of the weld indicate excellent bonding but there may be some tearing at the root of the tested sample.

Figure 11. LENS repaired, welded, and burst tested sample. Original defect was 1.14 mm over bore.
