Investigation of the Presence of Drugstore Beetles within Celotex Assemblies in Radioactive Material Packagings

Bradley M. Loftin¹, James M. Shuler², Robert G. Bellinger³, Glenn Abramczyk¹
¹Savannah River National Laboratory, ²U. S. Department of Energy, Packaging Certification Program, ³Clemson University Department of Entomology, Soils & Plant Sciences

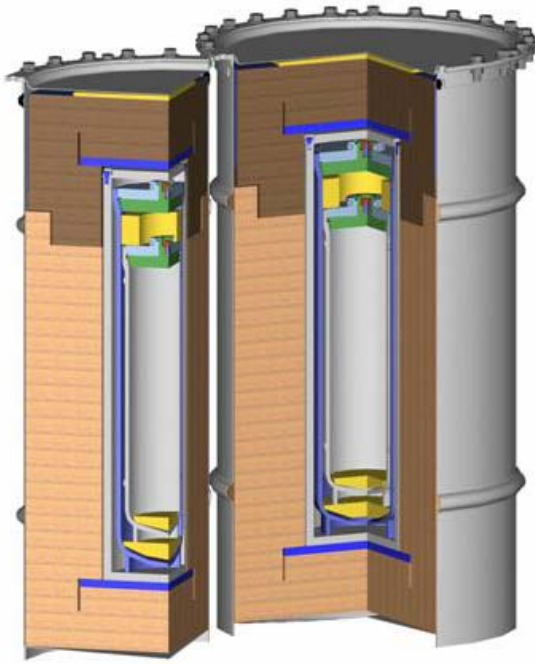
Model 9975 Shipping Package

The Model 9975 is a Type B radioactive material (RAM) shipping package designed and certified to meet the standards and requirements specified in the Code of Federal Regulations, 10 CFR 71 ^[1]. The 9975 design incorporates an outer stainless steel drum, CelotexTM fiberboard, a lead shield, and double containment through nested high-integrity containment vessels. Two 9975 packages were discovered to have beetles subsisting within the CelotexTM fiberboard assemblies. It is postulated that over long periods of time the beetles could consume enough of the fiberboard such that the CelotexTM could not perform its intended safety design function.

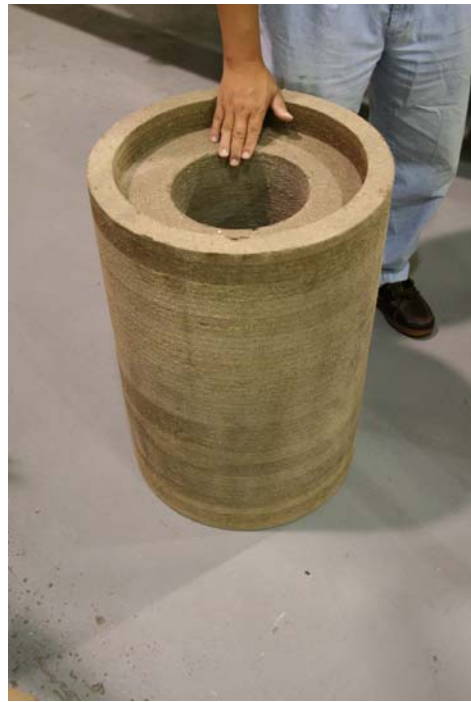
9975 Lower Celotex™ Assembly

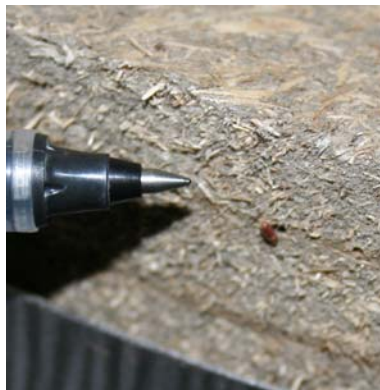
Drugstore Beetle on Celotex™ Assembly
(ink pen at left for reference)

Beetles (Order Coleoptera) are the largest group of animals and are believed to represent one fifth of all known living organisms and one fourth of all animals. Drugstore beetles, as they are known in the U.S., are in the beetle family Anobiidae, which contains about 460 species, many of which are associated with stored products. Drugstore beetles are common, cosmopolitan, and infest on an extremely wide range of plant-based materials, but also a human mummy, and will bore through wood, tin foil and lead sheathing. They earned their name by feeding on dried plant pharmaceuticals and drugs, including strychnine. In much of the world, and especially in the former British Empire, they are known as biscuit beetles, again earning their title. Drugstore beetle tends to reinfest its food source and all metamorphic stages – eggs, larvae (grubs), pupae (non-feeding resting stage), and adults, can be found together in large numbers ^[3,4,5].

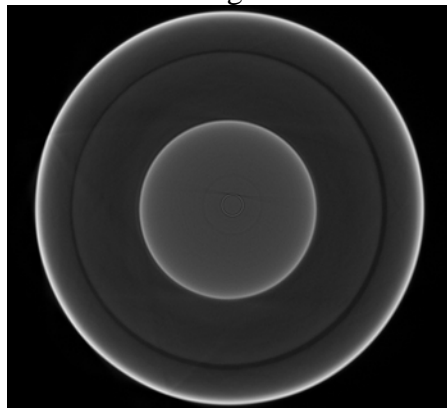
Image Generated from the CT Scan Performed on Package 02662

The CT scan of package 02662 began on October 31, 2007. The package was removed from the unit on November 8, 2007 and the Nondestructive Analysis/Nondestructive Examination (NDA/NDE) organization within SRNL began to compile the data for image reconstruction. The lead shield within the 9975 produces large interferences when taking x-ray images of the package. After examining the image reconstructions and looking in the areas that were known to have beetle bore holes, the NDA/NDE group was unable to definitively identify any beetle bore holes. The CT scan did, however, confirm that the beetles were not consuming Celotex™ within concentrated areas of the 9975 Shipping Package. This was determined by observation of a smooth density gradient within the entire package seen in the CT images.

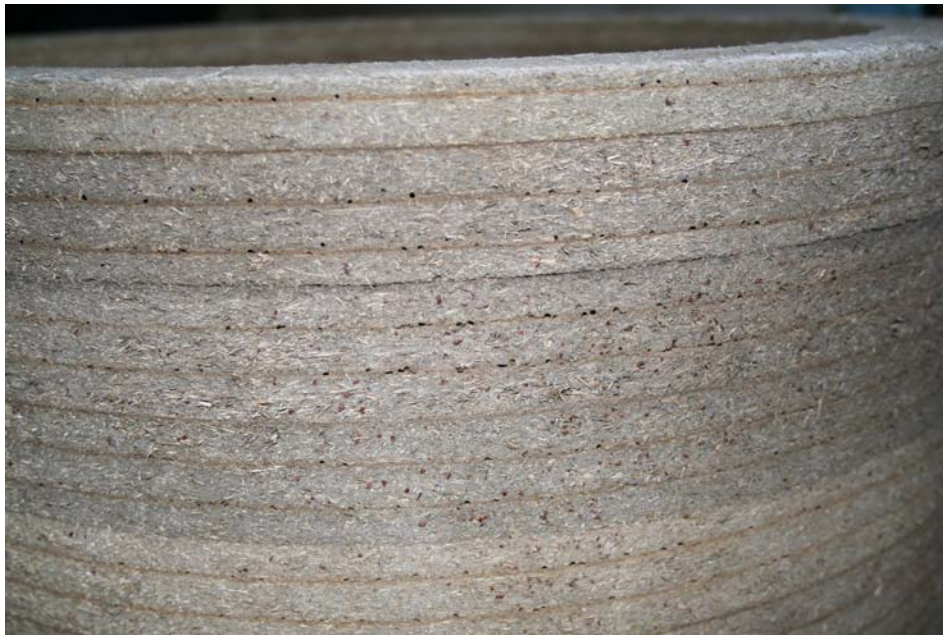
The package was opened and the lid, thermal blanket, and the top of the upper Celotex™ subassembly were examined. Numerous traces of beetle excrement were noticed on the air shield on the upper Celotex™ subassembly and some traces of beetle excrement were noticed on the bottom of the package lid. No traces of excrement were noticed on any exterior surface of the package thus providing evidence to suggest that the beetles have not been crawling out of the package. The upper Celotex™ subassembly was removed and the top of the lower Celotex™ subassembly as well as the entire top surface of the upper Celotex™ subassembly were examined. There were numerous beetle bore holes seen on the sides of the upper Celotex™ subassembly and on the internal face of the lower Celotex™ subassembly. It was discovered that there was a concentration of bore holes at the glue layers bonding the layers of Celotex™. Lead carbonate was observed on the lead shield. A dusting of lead carbonate was observed on the top of the aluminum cover plate that bolts onto the top of the lead shield. The aluminum cover plate was

removed and there was also a dusting of lead carbonate on the top of the secondary containment vessel (SCV). No evidence of beetle activity was seen on any of the surfaces inside the lead shield (SS lead liner, SCV, and the bottom of the aluminum cover plate). The SCV (containing the primary containment vessel (PCV)) was removed from the package and then the lead liner was removed. There was no evidence of beetle activity on the external surface of the lead liner. Finally the lower Celotex™ assembly was removed and examined. The lower Celotex™ assembly contained numerous bore holes on the external of the assembly and there was a large amount of frass (beetle excrement) left inside the package. The frass was collected so that it could be weighed and the volume determined in order to calculate its density. There was no evidence of any live beetles within the package or the Celotex™. It is hypothesized by Dr. Bellinger that the very high radiation field seen during the CT scan is most likely what caused the beetle population to die.

Drugstore Beetle Bore Holes in Celotex™ Lower Subassembly

Dimensions were taken on the Celotex™ from package 02662 and it was weighed in order to determine if the bulk density of the Celotex™ had been affected by the presence of the drugstore beetles. The density of the Celotex™ assemblies was 17.5 lbs/ft³. This density is within the range listed in the 9975 SARP. The density of the frass was calculated to also be 17.5 lbs/ft³.

The Celotex™ from package 02662 was placed into an environmental chamber to be chilled to 20°F. Chilling the Celotex™ assemblies ensures that any drugstore beetles possibly surviving the radiation of the CT scan are killed. The Celotex™ was then sectioned and tested for compression strength, heat capacity, and thermal conductivity. The results of these tests were all within the SARP design parameters for the Celotex™ materials [6,7]. The SCV and PCV were also examined to determine if there are any detrimental effects resulting from the drugstore beetles. This data will be compared to that from other 9975 Shipping Packages that have been destructively examined.

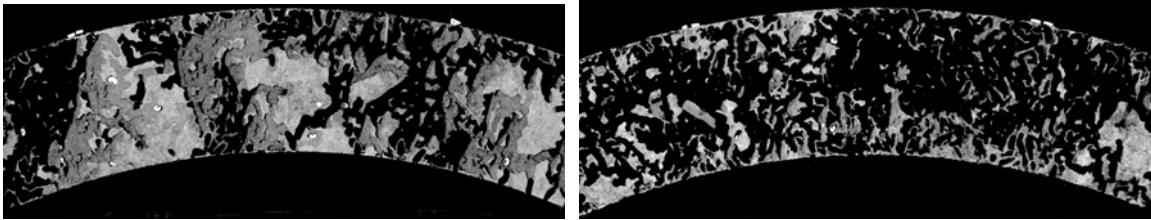
A small slice, approximately 6 inches long, was cut out of the lower Celotex™ subassembly from package 02662 and a CT scan was performed on it. The results of the CT scan showed that the beetles are selectively consuming the glue layers between the Celotex™ layers and are only boring through the Celotex™ to locate the glue layers. Since off-gassing of the glue is hypothesized as one initiator for formation of lead carbonate, investigations are underway to determine if the increased surface area of exposed glue to the atmosphere inside of the package has any effect on the rate of lead carbonate production and what by-products, if any, are being produced by the beetles biologically processing the glue. The images below show damage at two glue boundary layers between the Celotex™ layers.

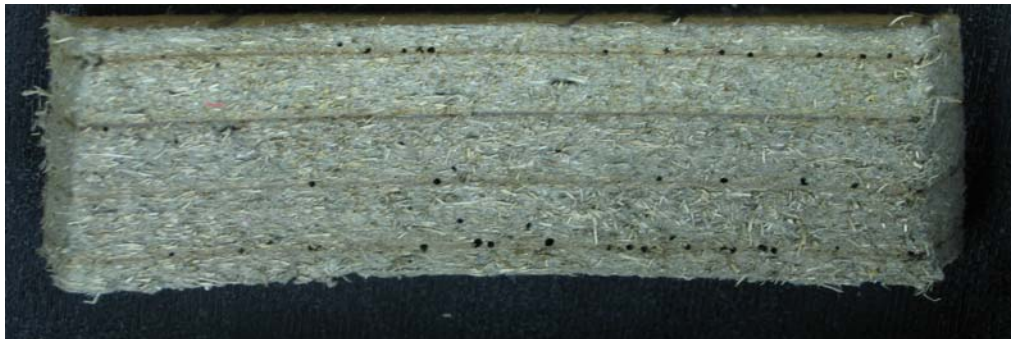
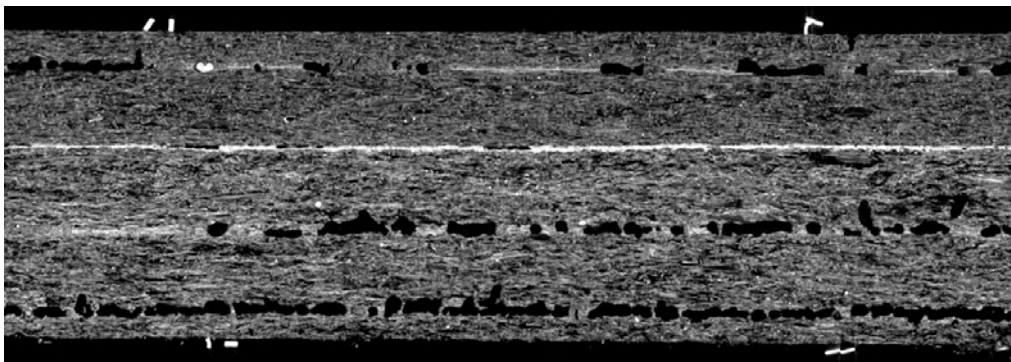
These additional images show a visible light image of the side of the Celotex™ as well as a reconstruction of the same portion using CT.

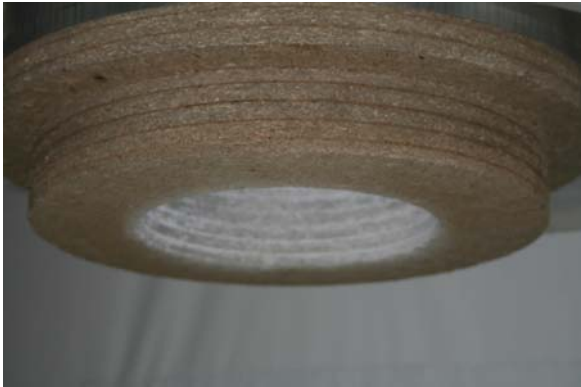
The package was opened and the lid, thermal blanket, and top of the upper Celotex™ subassembly were examined. Small traces of beetle excrement were noticed on the air shield on the upper Celotex™ subassembly. The upper Celotex™ subassembly was removed and the top of the lower Celotex™ subassembly as well as the entire top surface of the upper Celotex™ subassembly were examined. There were quite a few beetle bore holes in the Celotex™ and glue layers bonding the layers of Celotex™ in the region around the interface between the two Celotex™ subassemblies. Lead carbonate was observed on the lead shield. A dusting of lead carbonate was observed on the top of the aluminum cover plate that bolts onto the top of the lead shield. Pictures of the package disassembly were taken to document the damage to the Celotex™, and the package was then reassembled and closed. Three or four live beetles were seen crawling inside of the package.

02711 Upper Celotex™ Assembly 12/07

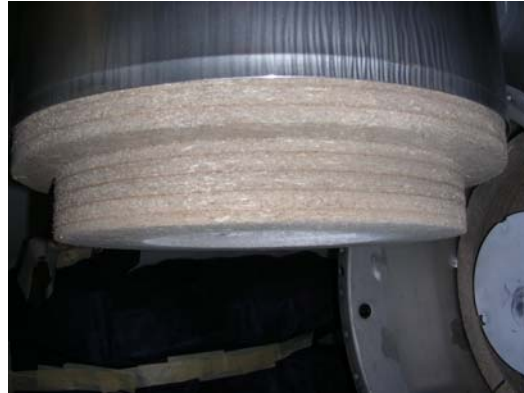
Package 02711 was opened again on May 21, 2008 for a second examination. Differences in the amount of damage to the Celotex™ within the package were minimal, however there was a significant growth of the beetle population as approximately two

dozen live beetles were seen crawling inside of the package and many dead beetles were found on top of the upper and lower Celotex™ subassemblies. There was a slight increase in the amount of lead carbonate formed on the lead shield.

02711 Upper Celotex™ Assembly 05/08

The investigation shows that the Celotex™ has not been damaged to an extent such that it could not perform its intended safety function. Future examination and testing of 9975 02711 will provide additional insight into the effects, over time, of the drugstore beetle on fiberboard assemblies. Clemson University entomologists will obtain live specimens of the beetles and, through experimentation, will determine the by-products the beetles create from the consumption of the Celotex™ as well as the glue.
