ProTec™ TEAR-OFFS: RESULTS OF LONG TERM TESTING

D.K. Peeler

July 2008

Process Science and Engineering Section
Savannah River National Laboratory
Aiken, SC 29808

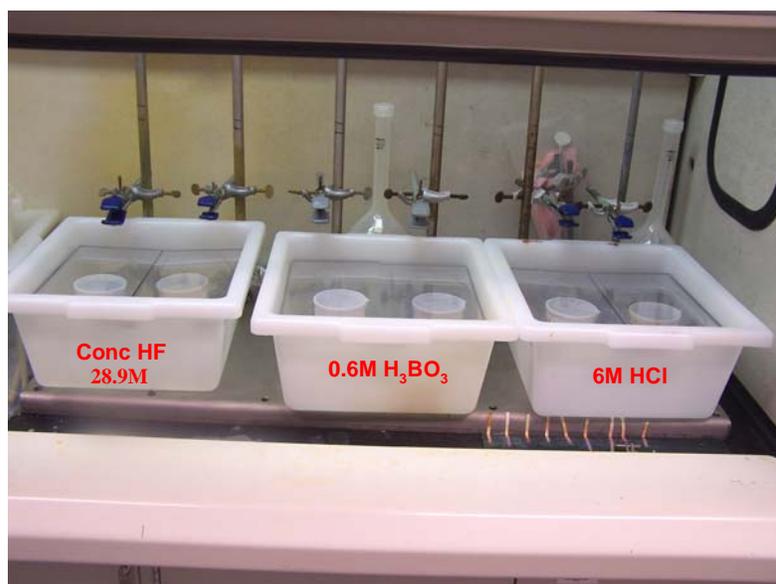
Figure 1. Experimental Set-Up for Acid Resistance Testing (0" height).

To support this assessment, four sets of 4 mil (3 layer) ProTec™ tear-offs^e were mounted onto separate Lexan® plates and placed on vessels containing four different acids; concentrated (28.9M) HF, concentrated (15.9M) HNO₃, 6M HCl, and 0.6M H₃BO₃.^f In addition to the tear-off system, a blank (Lexan® plate without a tear-off system) was also placed on each acid bath as a reference. The Lexan® blanks provide a baseline or measure of how aggressive the specific test conditions (acid type and/or acid molarity) were with respect to historical observations in the SRNL Shielded Cells.

The initial outer layer tear-offs were successfully removed on August 8, 2005 after 39 days of exposure at varying heights. This was the termination point for the Phase 1 testing program (see George et al. (2005) for more details). Upon removal, the Lexan® blanks and tear-off systems were placed directly on top of the acid bath, referred to as a 0" height set-up,^g which was the initiation point of Phase 2 testing that covered 456 days of exposure. Figure 1 shows the experimental set-up for three of the Phase 2 acid resistance tests. In general, the tear-offs and blanks were inspected on a routine basis for physical degradation and/or visual distortion and photographed periodically for documentation/comparison purposes.^h

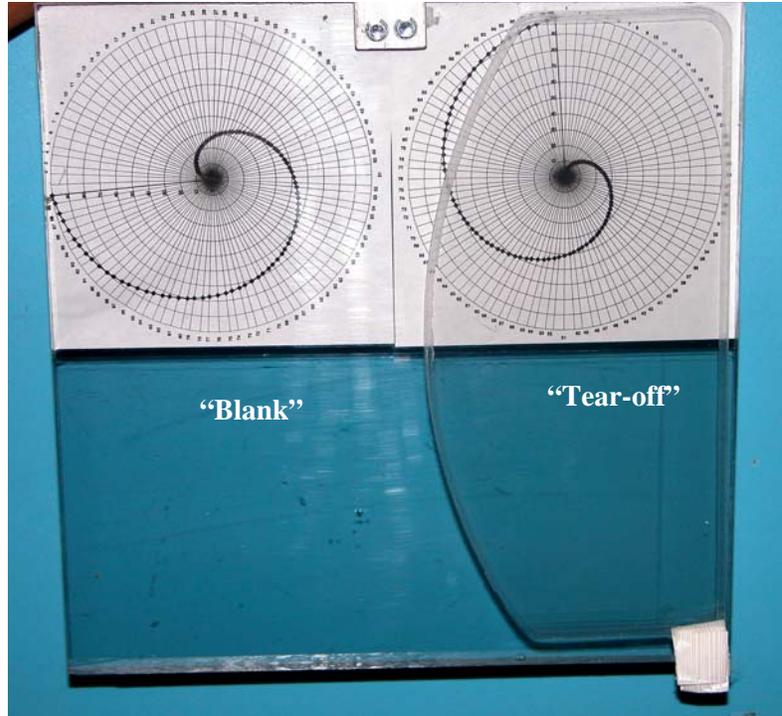
Figure 2. Lexan Blank (left) and ProTec™ Tear-Off System (right) Prior to Cell #15 Entry.

Figure 2 is the initial condition of the Lexan® sheet prior to Cell #15 entry. Note the use of modified tabs (application of tape in lower right hand corner) on the pre-existing smaller tabs of the tear-off system being used.^j

^j To provide a frame of reference, the Lexan plate is roughly 10” x 10”. The tear-offs (mounted on the right hand side) are roughly 9.5” long and ~4.5” wide at the maximum width (center or mid-point).

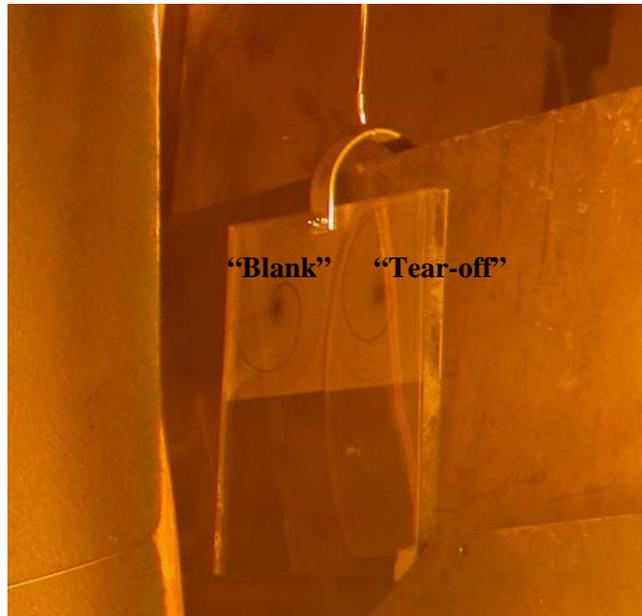
Figure 3. Lexan Blank and ProTec™ Tear-Off System in the SRNL Shielded Cells (Day 1).

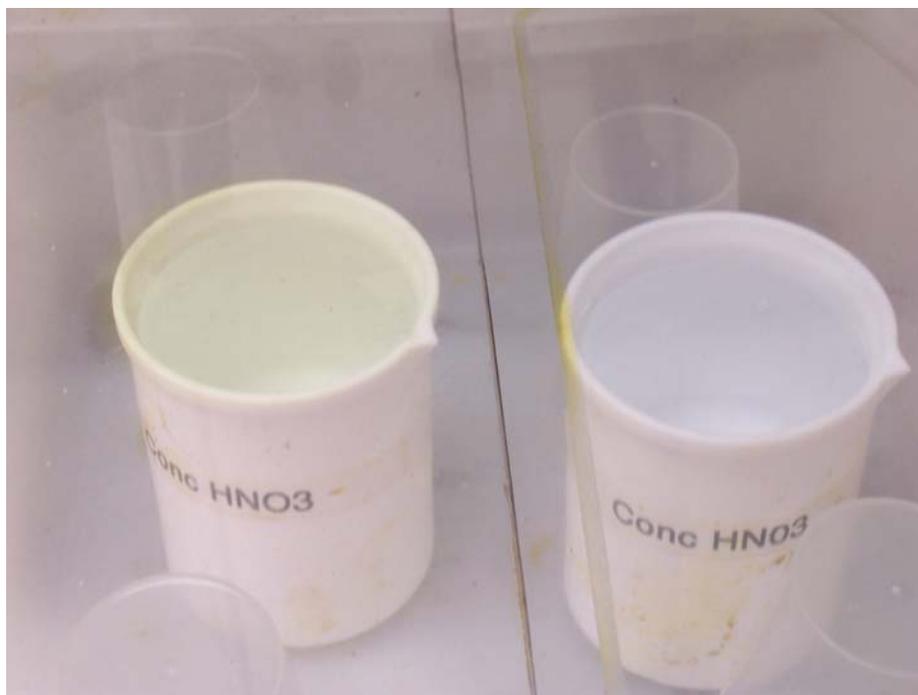
Figure 4. Visual clarity of Blank (left) and Lexan[®] + Tear-Off (right) after 35 days at the 0" mark (concentrated HNO₃). Note: Yellow stain on Blank and vapor attack on glue holding the tear-off to Lexan Plate.

The 0" height tests were initiated on August 8, 2005 just after the successful removal of the initial tear-off layer (1st of three). After 35 days of Phase 2 testing, the only signs of visual degradation were observed on the Lexan® blank for concentrated HNO₃ (Figure 4). No optical distortion was observed on any of the tear-offs after 35 days at the 0" height. These results indicate that the ProTec™ tear-offs would provide more protection (in terms of time exposure) as compared to the Lexan® blank (or plate) under this specific test condition. It should be noted that the HNO₃ fumes or vapors appear to have caused some reaction with the glue holding the ProTec™ sheet to the Lexan® plate (right hand side of Figure 4). Although some reaction (or staining) of the glue is noted, the ProTec™ sheets remained adhered to the Lexan® plate throughout the Phase 2 testing (456 days of exposure).

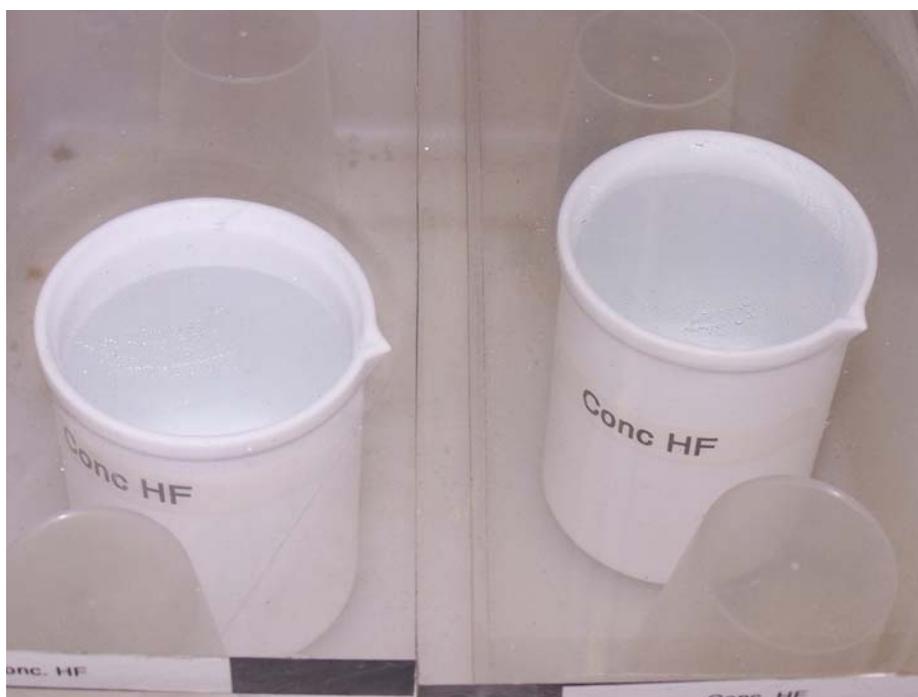
Figure 5. Visual clarity of Blank (left) and Lexan[®] + Tear-Off (right) after 414 days (September 28, 2006) at the 0" mark (concentrated HF).

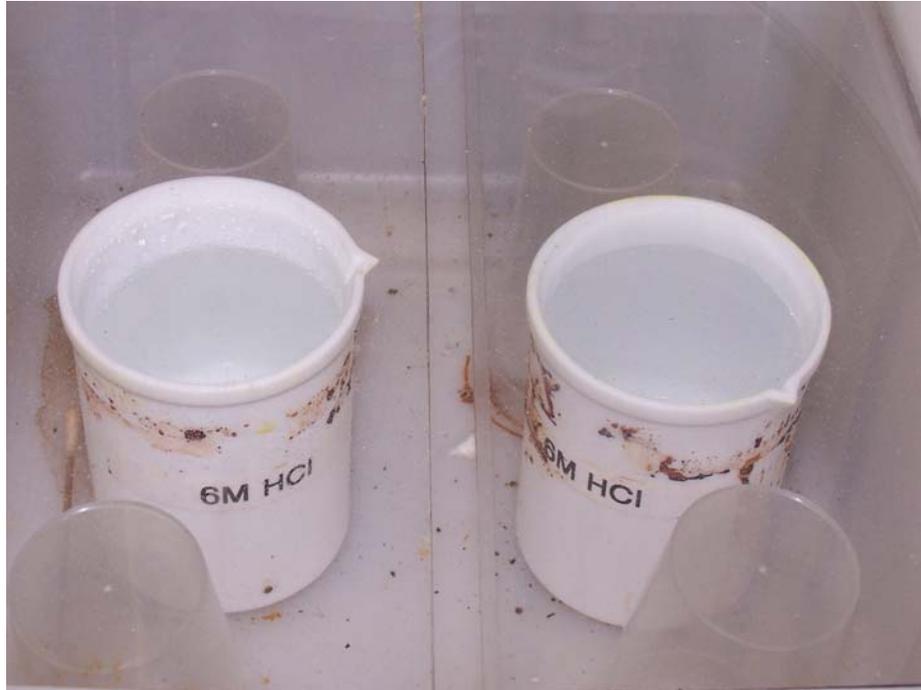
Figure 6. Visual clarity of Blank (left) and Lexan[®] + Tear-Off (right) after 414 days (September 28, 2006) at the 0'' mark (6M HCl). Note: the outer layer is the third and final layer on this system.

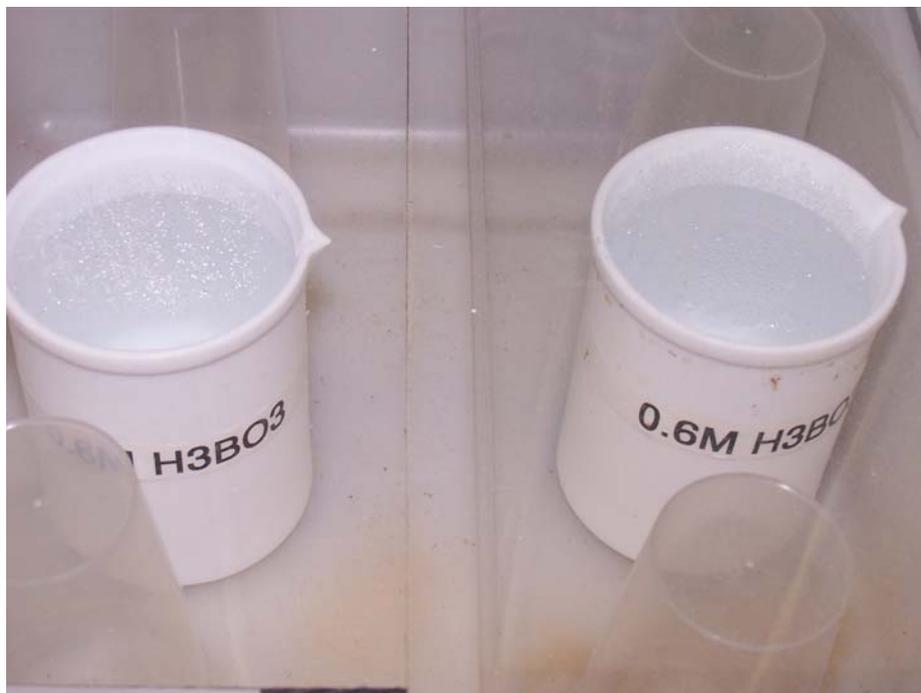
Figure 7. Visual clarity of Blank (left) and Lexan[®] + Tear-Off (right) after 414 days (September 28, 2006) at the 0'' mark (0.6M H₃BO₃).

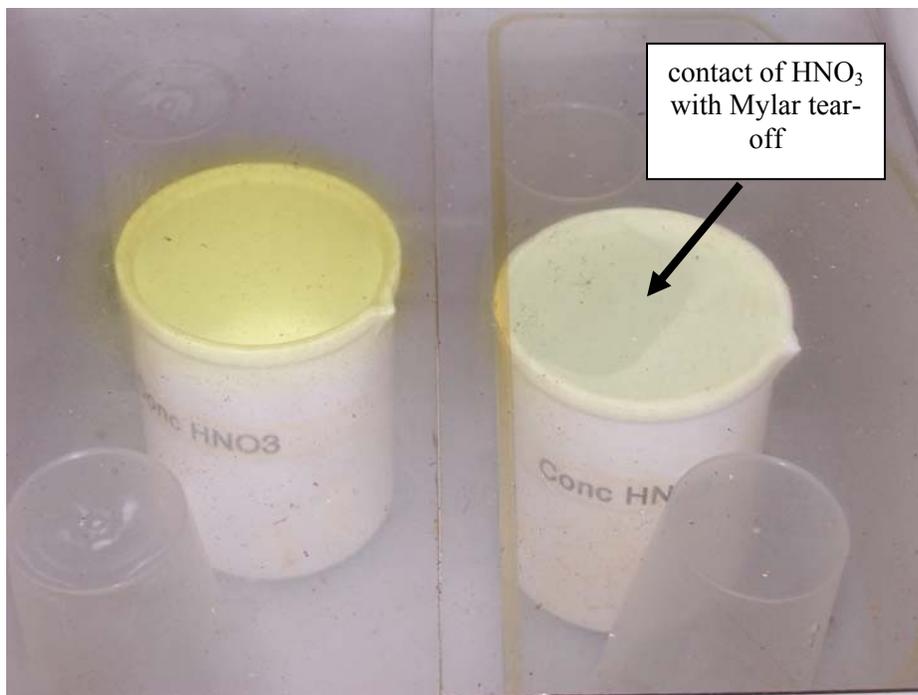
Figure 8. Yellow stains on both the Blank (left) and Lexan[®] + Tear-Off (right) after 414 days (September 28, 2006) at the 0" mark (concentrated HNO₃).

Figure 8 shows the yellow stains or reactions on both the Lexan[®] plate and tear-off exposed to the HNO₃ bath after 414 days. It was noted that during the filling of the HNO₃ bath after 314 days of exposure (but prior to the 414 days of exposure), the vessel was apparently overfilled leading to physical contact of the HNO₃ with the ProTec[™] tear-off which increased the rate of attack on the tear-off. Physical property data of Mylar[®] suggests that immersion in HNO₃ leads to a significant reduction in mechanical strength.^m

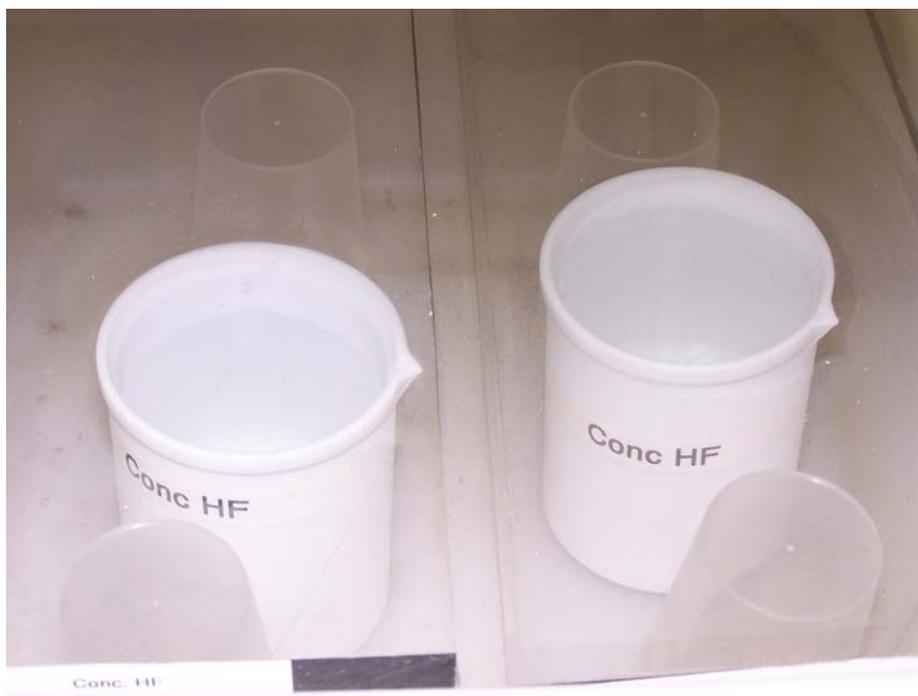
Figure 9. Visual clarity of Blank (left) and Lexan[®] + Tear-Off (right) after 456 days (November 9, 2006) at the 0" mark (concentrated HF).

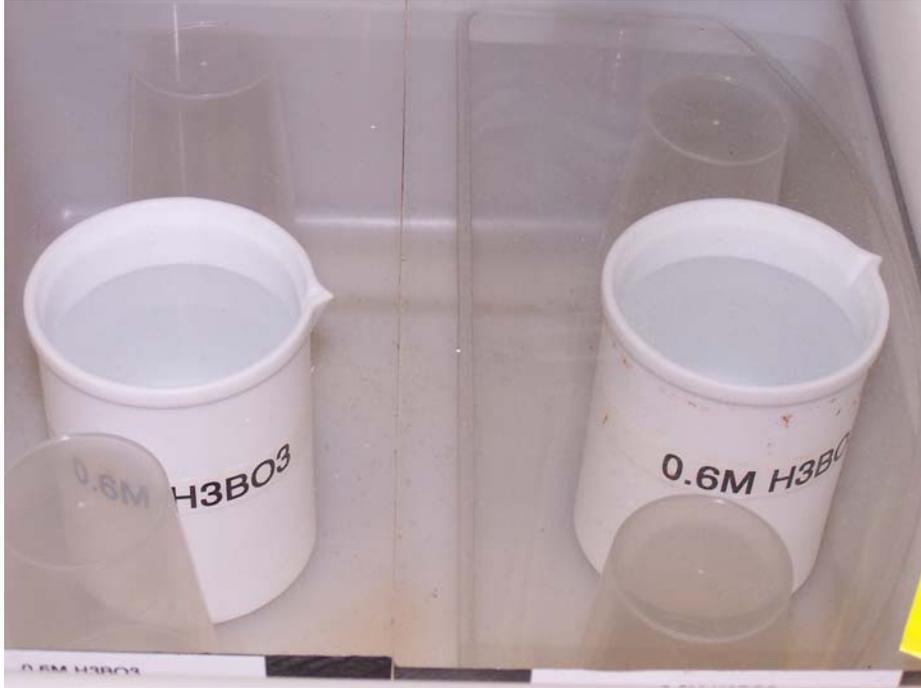
Figure 10. Visual clarity of Blank (left) and Lexan[®] + Tear-Off (right) after 456 days (November 9, 2006) at the 0" mark (0.6M H₃BO₃).

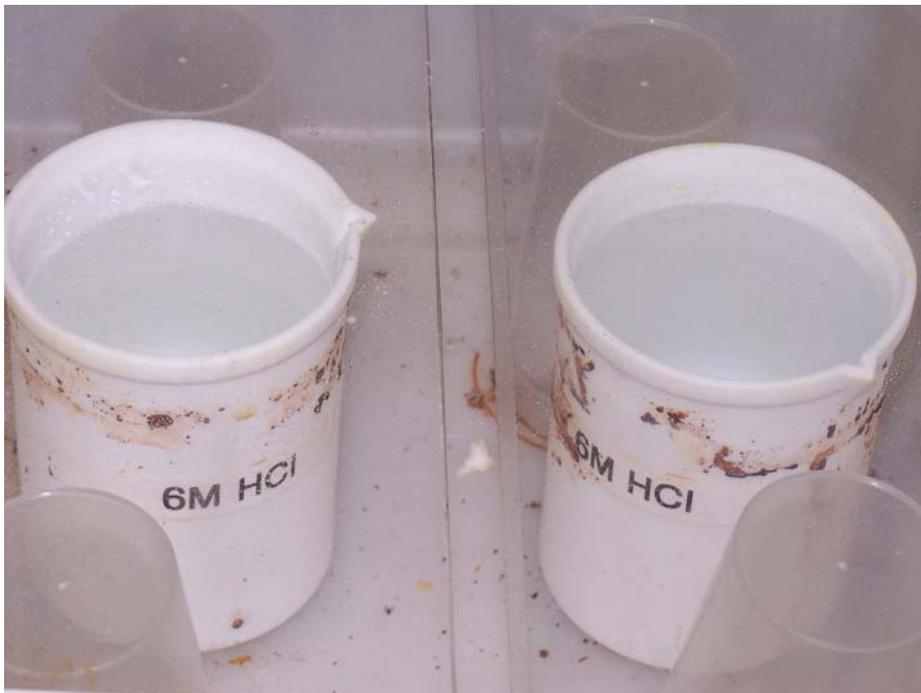
Figure 11. Visual clarity of Blank and Lexan[®] + Tear-Off (right) after 456 days (November 9, 2006) at the 0" mark (6M HCl). Note: the outer layer is the third and final layer on this system.

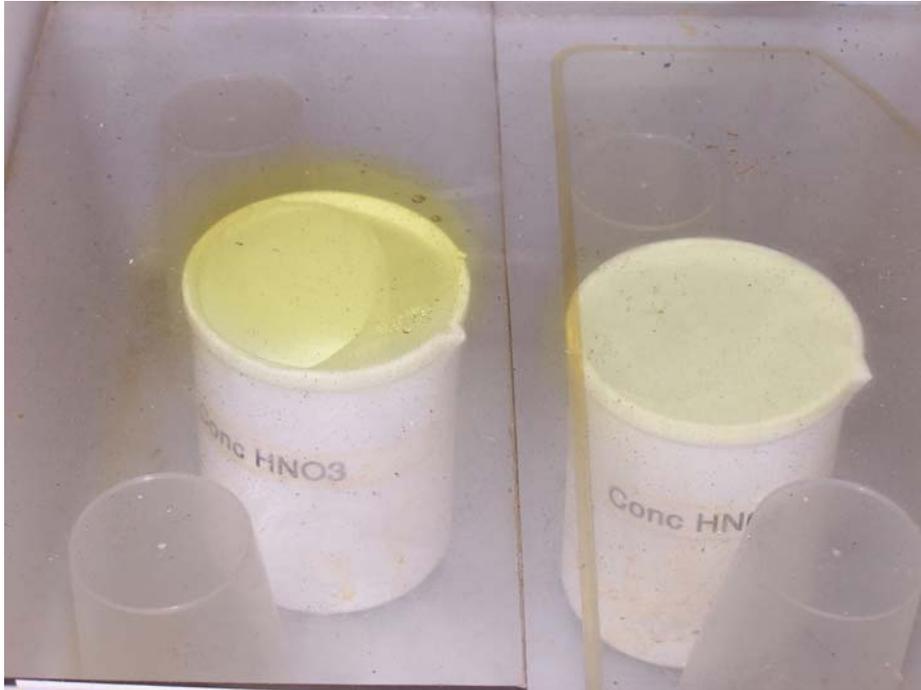
Figure 12. Yellow stains on both the Blank (left) and Lexan[®] + Tear-Off (right) after 456 days (November 9, 2006) at the 0" mark (concentrated HNO₃).

On November 9, 2006, after 456 days of exposure, the Phase 2 testing was terminated. Visual observations were recorded and the 2nd tear-off was removed to assess mechanical integrity. As with previous visual observations, no visual distortion was noted on the concentrated (28.9M) HF, 6M HCl, and 0.6M H₃BO₃ systems (either Lexan[®] blanks or tear-offs) as shown in Figures 9-11. However, the yellow stains as a result of the HNO₃ exposure or contact were still apparent on both the Lexan[®] plate and tear-off as shown in Figure 12.

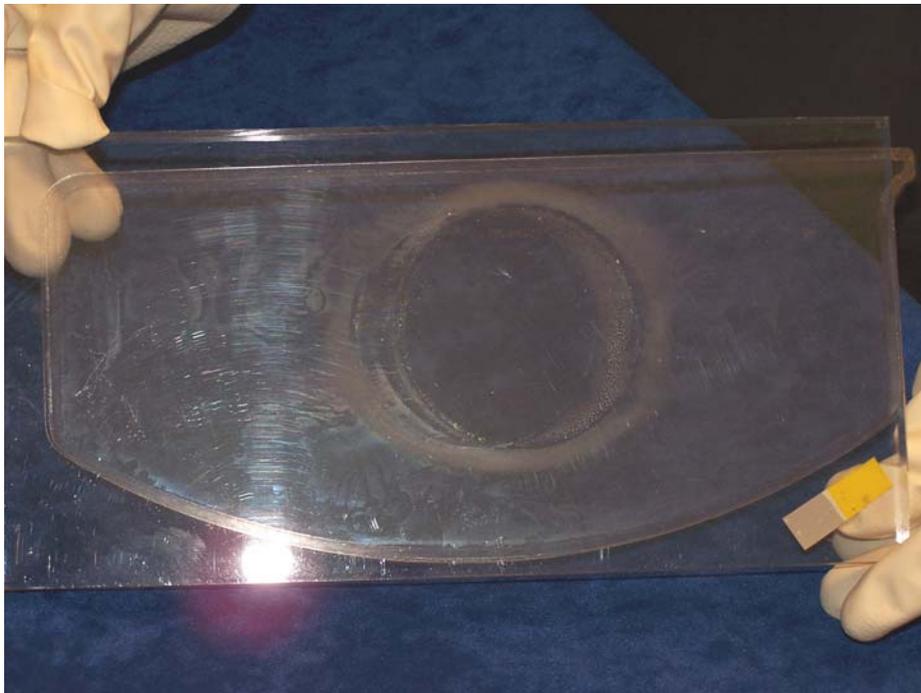
Figure 13. Pre-removal condition of the 6M HCl ProTec[™] Tear-Off system (456 days at 0").

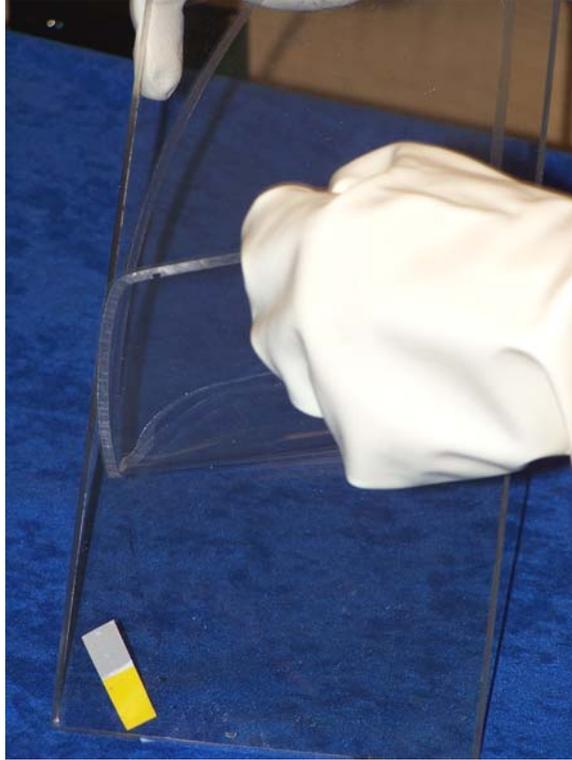
**Figure 14. Final ProTec™ Tear-Off being removed from the 6M HCl system (456 days at 0”).
Note: no residual “glue” left on the Lexan® plate.**

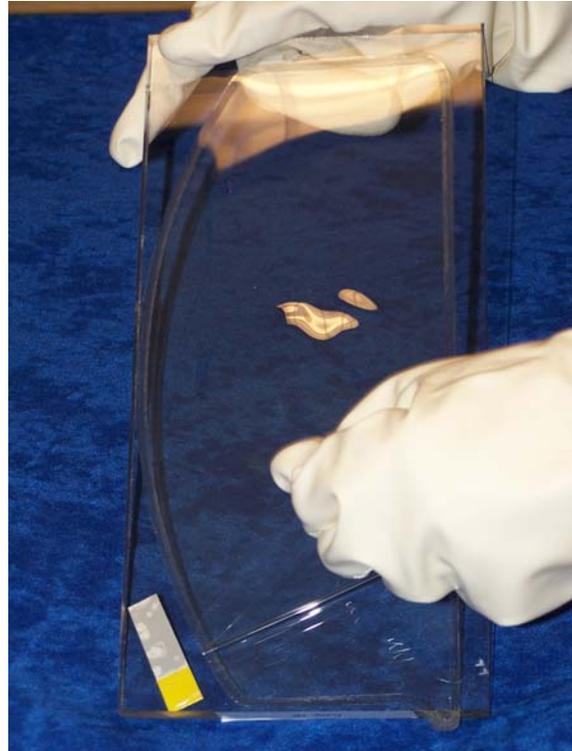
**Figure 15. Final ProTec™ Tear-Off being removed from the concentrated HF system
(456 days at 0”).**

Figure 15 and Figure 16 capture the removal of the 2nd tear-off and post-removal condition for the concentrated HF system. As with the 6M HCl and 0.6M H₃BO₃ systems^o, complete removal of the outer-layer tear-offs was achieved. These results suggest that the ProTec[™] tear-offs are a viable system capable of withstanding relatively aggressive vapor attack from these specific acids, while still offering the opportunity to restore visual clarity when needed. The fact that the 2nd layer tear-offs were exposed for 456 days suggests that (at a minimum) the Lexan[®] sheets currently used by the

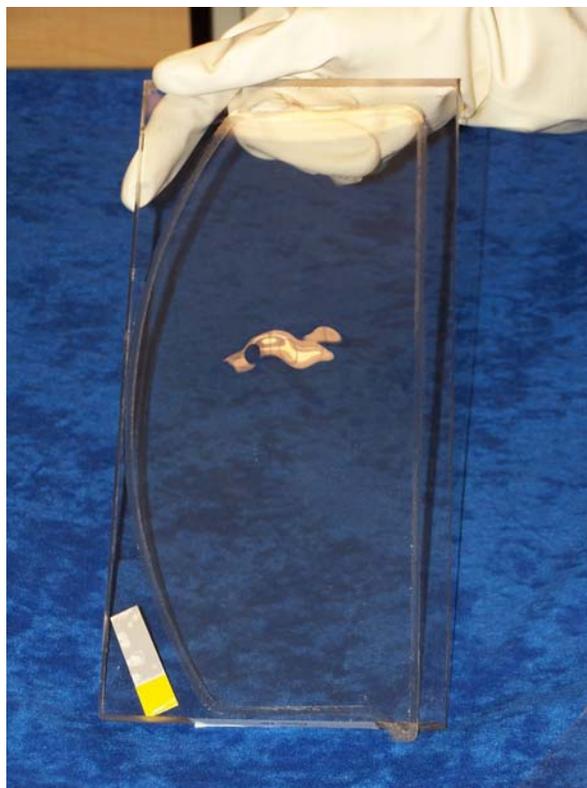
Figure 16. Post-removal of the outer ProTec™ Tear-Off from the concentrated HF system (456 days at 0”).

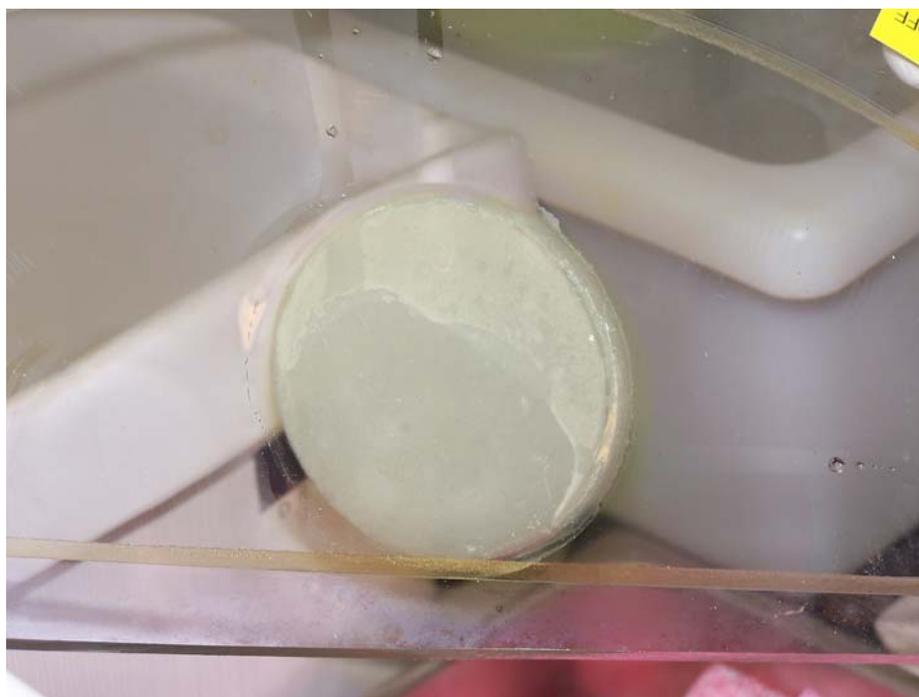
Figure 17. Pre-removal condition of the concentrated HNO₃ Tear-Off system (456 at 0”).

With respect to the HNO₃ test, an attempt was made to remove the outer layer tear-off from this system to determine if the “yellow stain” could be removed leaving a fresh (and final) tear-off on the Lexan® plate after 456 days of exposure. Figure 17 shows the tear-off system exposed to HNO₃ prior to removal. Removal of the outer layer tear-off resulted in fracture or tearing (i.e., incomplete removal of the tear-off). In fact, when attempts to remove the outer layer were initiated, it was determined that the two remaining layers had “fused” together. These results were discouraging from the standpoint of not having a long term data point in which complete removal was successful. In hindsight, once the yellow stain had been observed (at the 314 day mark) or shortly after, the outer (2nd) layer should have been removed to gain insight into mechanical integrity issues and to evaluate the potential to remove the stain. If not, then the decision to remove the outer layer (2nd tear-off) should have been made once physical contact between the HNO₃ and the tear-off was noticed (at the 414 day mark). The tear-offs were potentially in direct contact with HNO₃ for 30-40 days, which may be considered a condition under which this system would (and should) not be utilized.

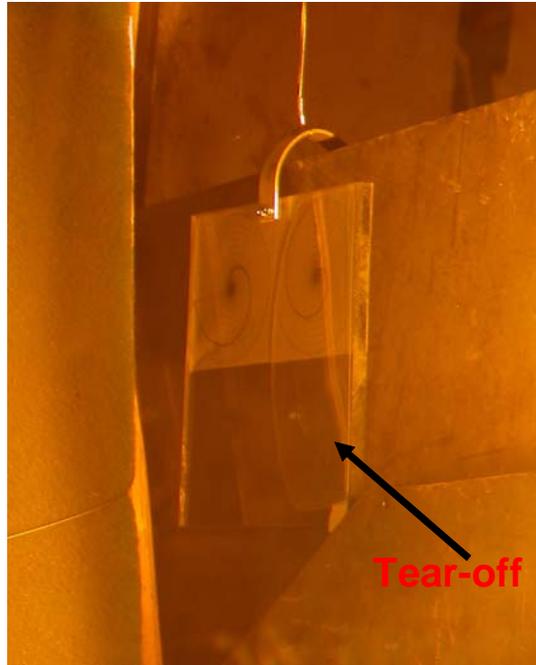
Figure 18. Lexan® plate with Tear-Off system (right) introduced into Cell #15 on July 28, 2005 (day 1).

Figure 18 shows the “blank” and “tear-off” systems hanging from an intermediate wall in Cell #15 just after cell entry (July 28, 2005). The “tear-off” is visible on the right hand side of the Lexan[®] plate, which is aligned vertically. As previously mentioned, the average radiation dose in Cell #15 is 17.3 rad/hr (Bibler (2005)). The SRNL Shielded Cells personnel monitored the system on a daily basis for any signs of visual distortion or mechanical degradation.

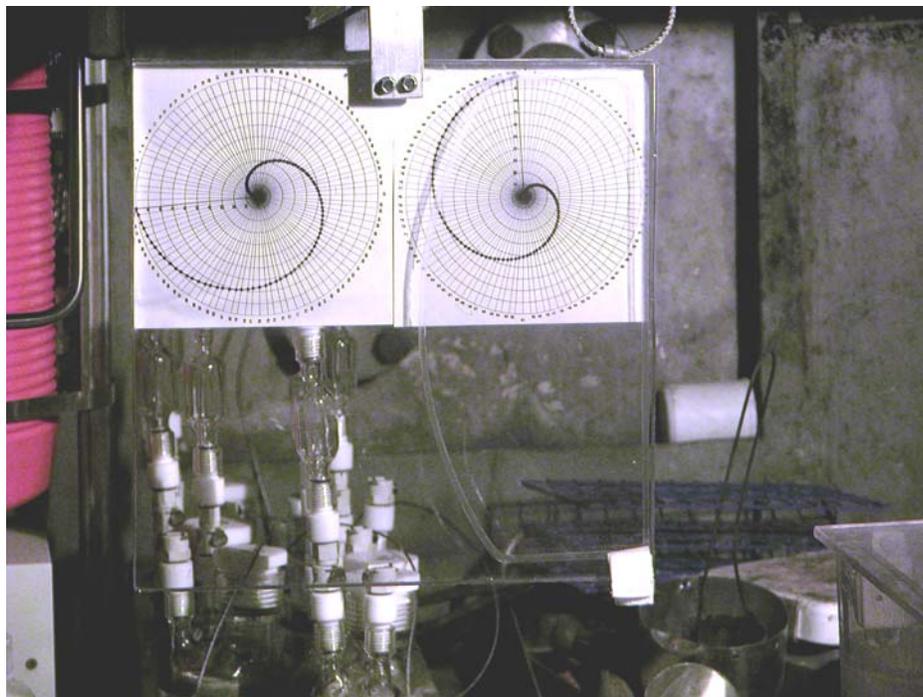
Figure 19. Lexan® plate with Tear-Off system in the SRNL Shielded Cells prior to removing the outer Tear-Off layer (day 46 – termination point of Phase 1 testing).

As documented in WSRC-TR-2005-00386, after 46 days of exposure (estimated cumulative gamma dose of ~20,000 rad), there were no signs of visual distortion as shown in Figure 19 (photo taken prior to the removal of the outer layer tear-off on September 12, 2005). After documenting the visual clarity of the system, the SRNL Shielded Cell technician used the manipulators to remove the outer layer tear-off. The outer layer tear-off was completely removed (i.e., no ripping which demonstrated some degree of mechanical integrity after a cumulative dose of ~ 20,000 rad of gamma exposure) and left the two remaining tear-offs intact and undamaged.

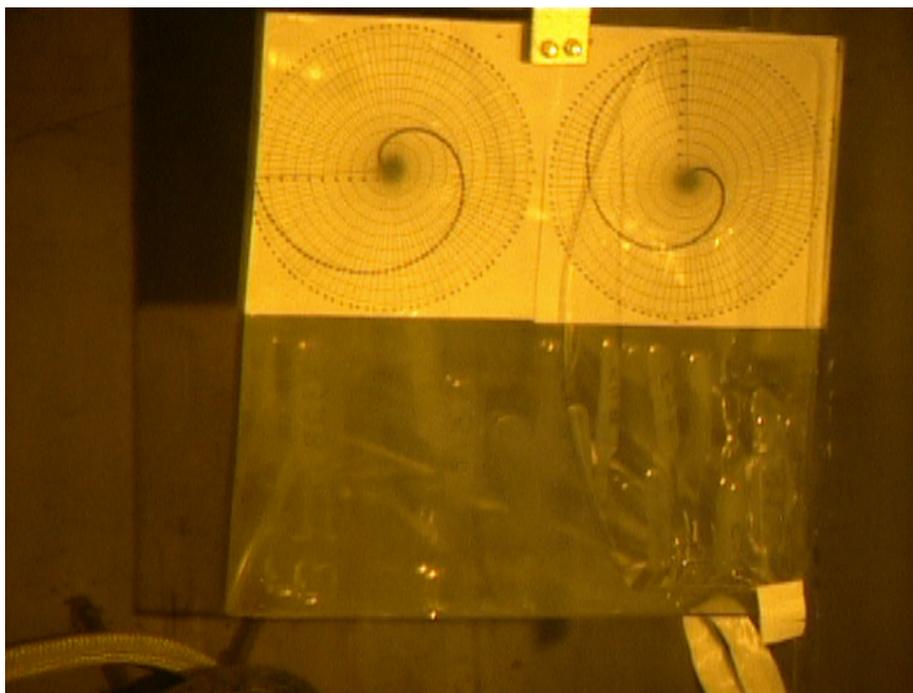
Figure 20. Post-removal of the outer ProTec™ Tear-Off layer after 328 days of exposure (~155,000 rad).

On June 20, 2006, the second tear-off was removed after 328 days of exposure (~155,000 rad). Prior to removal of the outer layer (the 2nd of three layers), no visual degradation was noted. The outer layer was easily and completely removed (i.e. without ripping) with the manipulators, which is consistent with the initial removal on Day #46 (September 12, 2005). The successful removal provided sound technical data to suggest that the tear-off could withstand up to approximately 155,000 rad (gamma) without losing mechanical integrity. After removal of the second layer, there was a noticeable distinction between the “fresh” tear-off and the Lexan[®] blank in terms of visual clarity. Figure 20 shows the system just after removal of the outer layer tear-off. On the right hand side, the reflection of the pipettes or small sample bottles is relatively sharp as compared to the more diffuse Lexan[®] blank side. This result suggests that some type of residue was coating the entire system (not evident prior to removal) and upon removal of the tear-off, the deposited layer was removed.

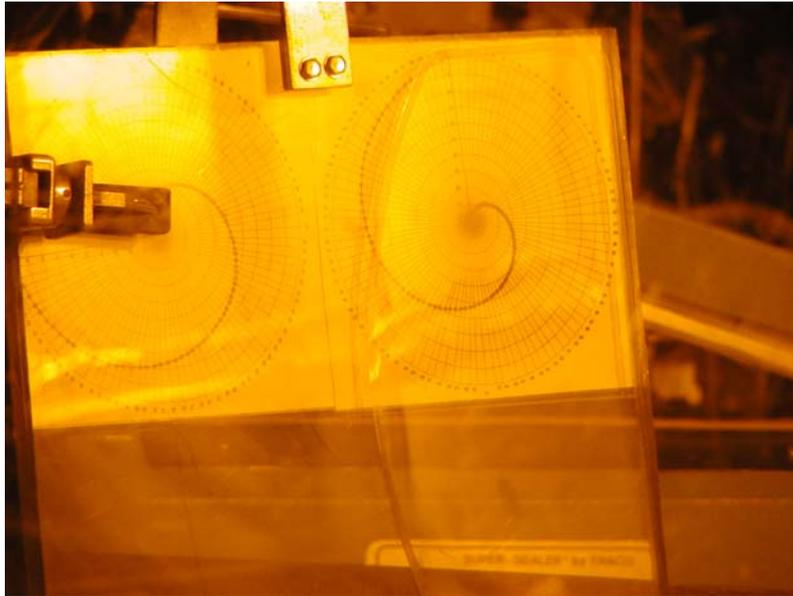
Figure 21. Pre-removal of the outer Tear-Off layer after approximately 700 days of exposure (~330,000 rad) on June 26, 2007.

Visual observations were made on September 26, 2006 and January 1, 2007 with no signs of visual distortions or mechanical degradation. On June 26, 2007, after approximately 700 days of service and an estimated 330,000 rad exposure, the third and final tear-off was removed. Prior to removal, there were no visual signs of degradation (see Figure 21). Although the final tear-off was successfully removed (i.e., one single sheet), there was an increased resistance to removal. In fact, after removal, some residual glue was observed on the Lexan[®] plate in isolated spots (see Figures 22 and 23).^P In terms of possible impacts for certain applications, the presence of residual glue may result in the need for removal prior to applying a second series of tear-offs to the Lexan[®] plate. In other situations (i.e., where replacement of the entire Lexan[®] sheet being used as an alpha shield will be made), the glue may not pose any significant issues as visual clarity in the majority (central

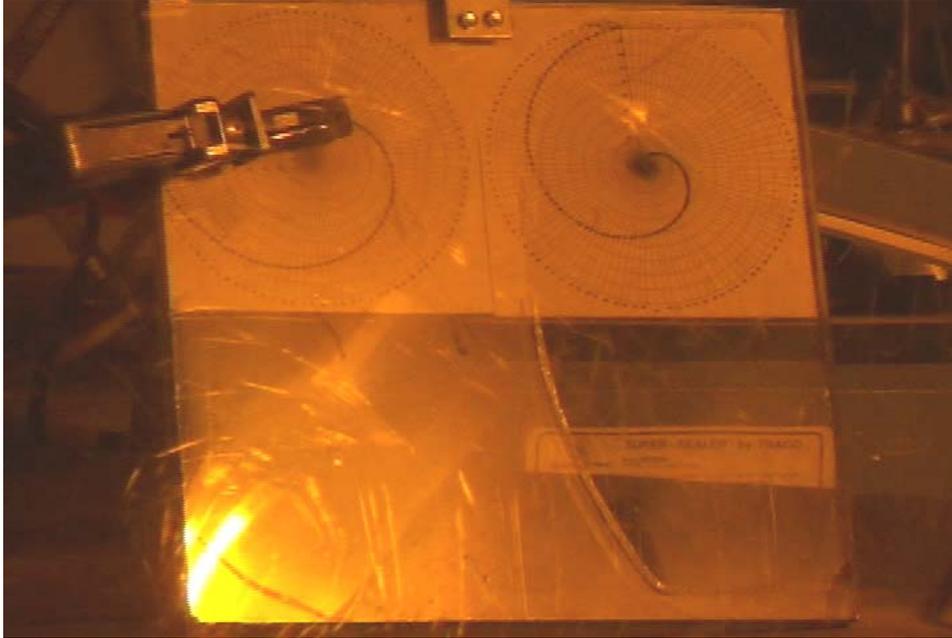
Figure 22. Post-removal of outer Tear-Off layer after approximately 700 days of exposure (~330,000 rad) on June 26, 2007. Note: residual glue is located near the center of the Lexan[®] plate.

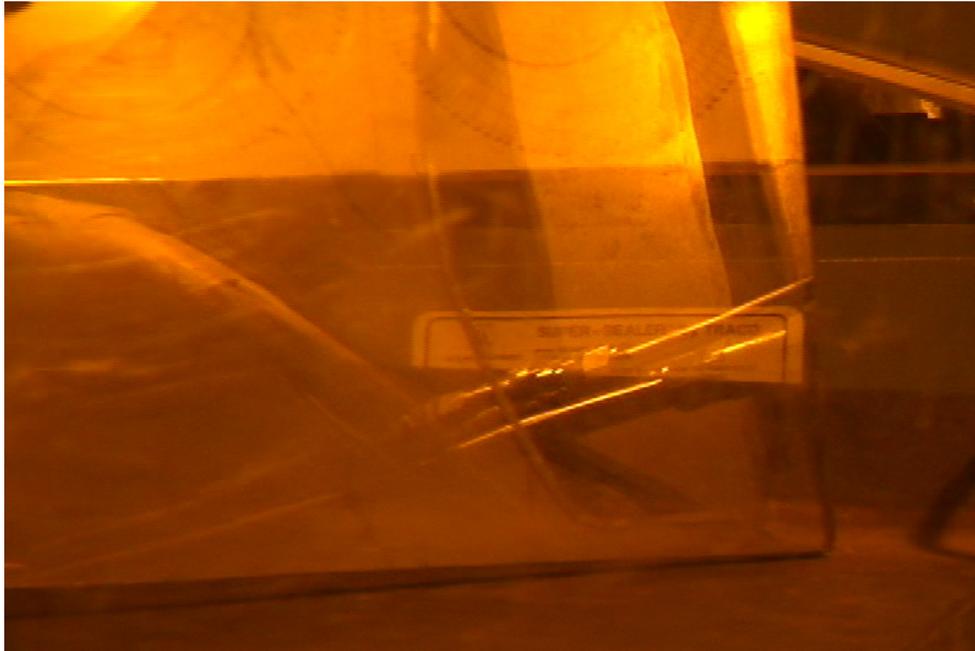
Figure 23. Post-removal of the outer Tear-Off layer after approximately 700 days of exposure (~330,000 rad) on June 26, 2007. Note: residual glue located near the center of the Lexan[®] plate.
