DPSP-83-1030 ✓

March 22, 1983

HIGH STRENGTH STAINLESS STEEL PROPERTIES
THAT AFFECT RESISTANCE WELDING

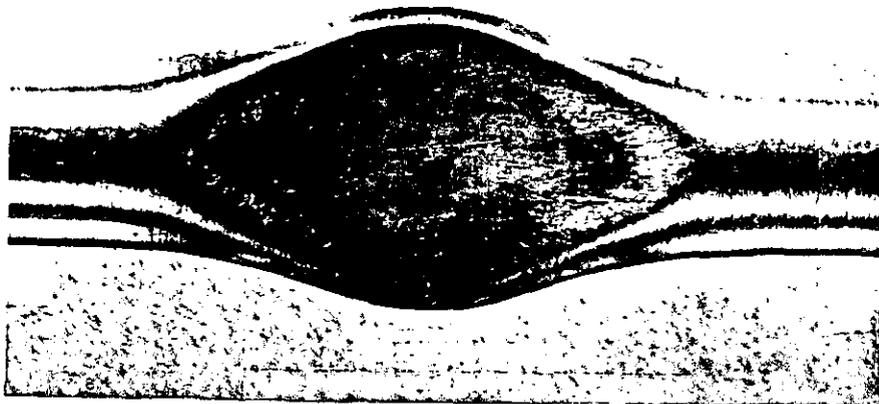
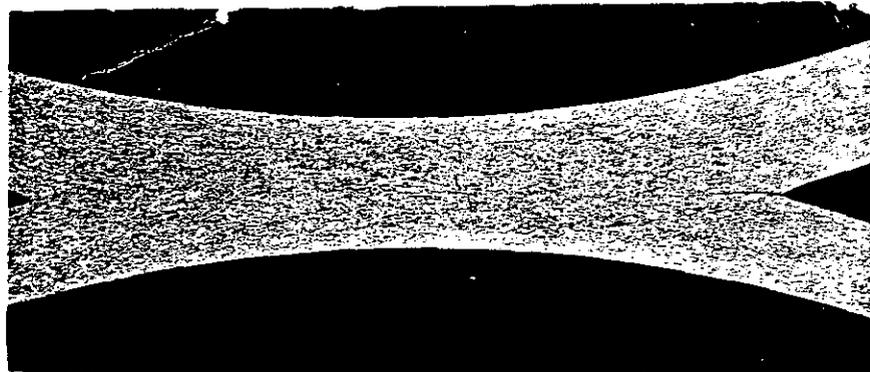
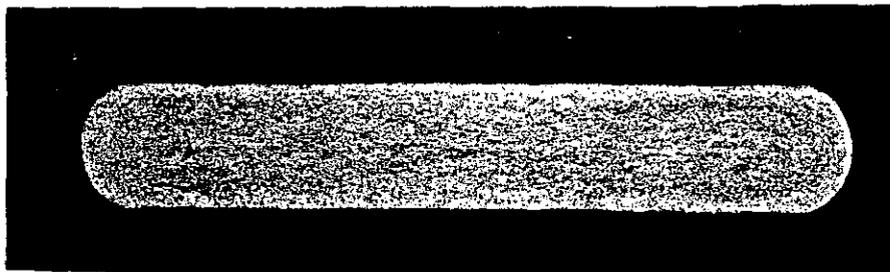
Figure 1. Resistance Weld in 21-6-9 Tube

a) External Appearance

b) Longitudinal (top) and Transverse Cross Sections

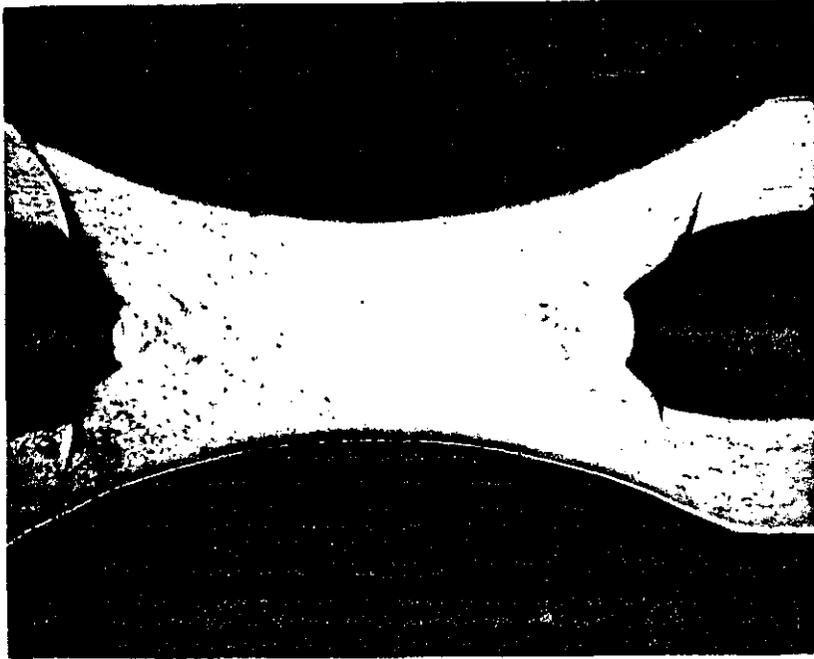
Figure 2. Tearing and Cracking of Resistance Welds in Hard (Over R_c30) Tube

a) Tearing of JBK-75 Tube Wall Adjacent to Weld

b) Cracks in Weld Edge of A-286 Tube Weld

Hardness of the material has been used as one measure of the suitability of these materials for resistance welding. Table III presents several aging treatments and the corresponding hardnesses. The treatments, other than the standard fully hard conditions, were developed to obtain a hardness for which the material retains a high strength yet is sufficiently soft to be resistance welded in the form of a tube. Figure 2 shows the internal tearing and the external cracking which can develop when welding tubes harder than R_c 30.

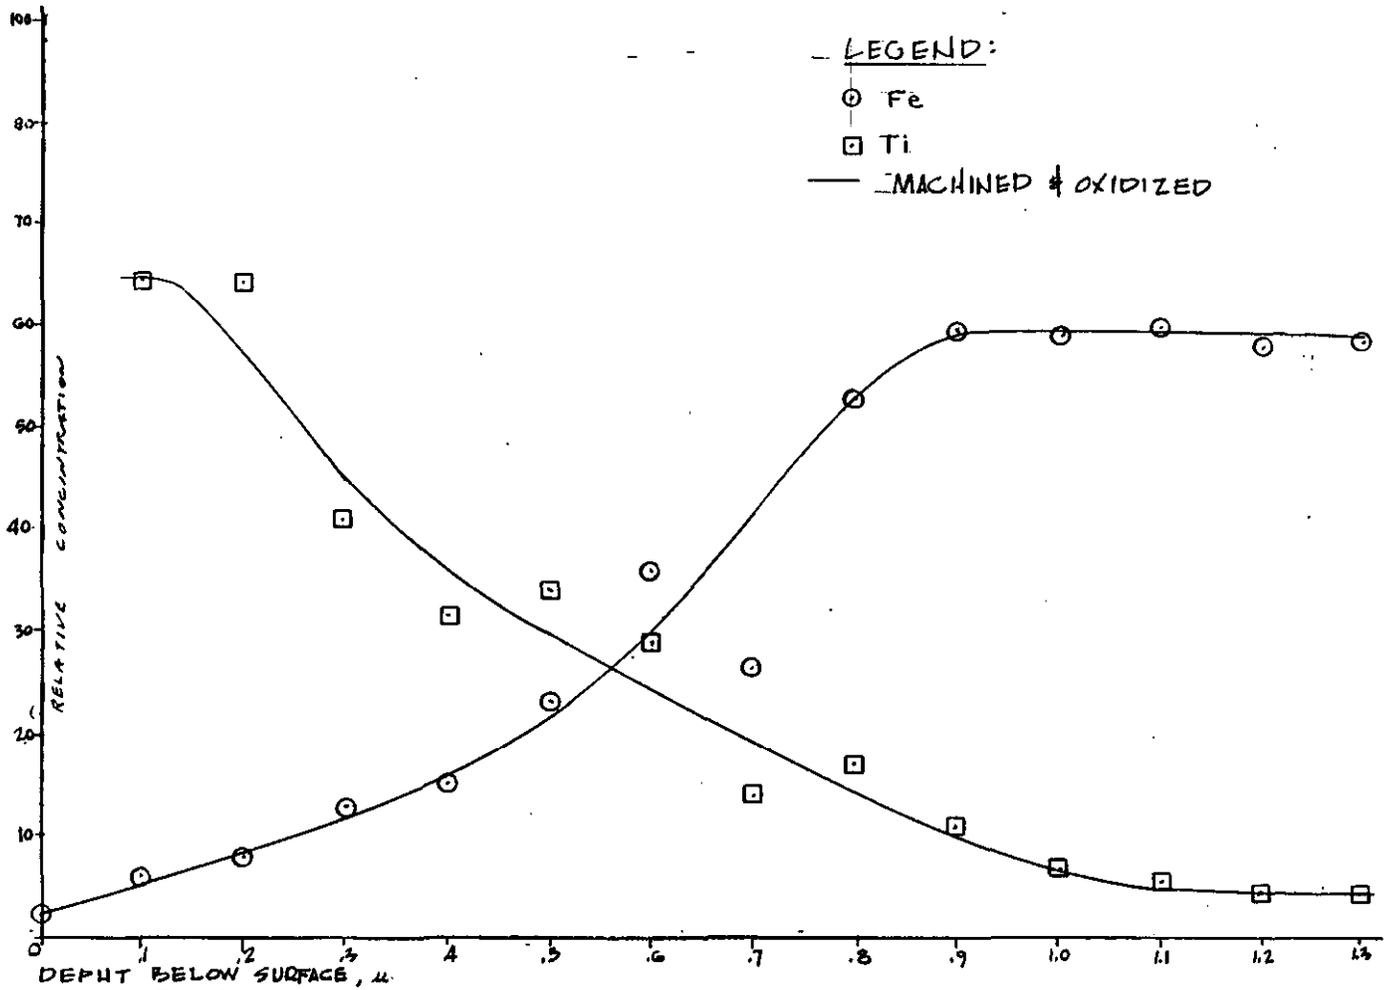
FIGURE 4 JBK-75 SURFACES ESCA DATA

ESCA will determine elements on the surface. Analysis can be made below the surface by removing the surface in small increments by ion bombardment. This was done on the surface of JBK-75 on a piece that had been machined and then oxidized. Results are plotted in Figure 4 for iron and titanium. The results are fairly straightforward in that the titanium concentration is very high in the oxide and then tapers off to the alloy concentration at a depth of 1.0 microns (4×10^{-5} in.). The oxide is therefore titanium oxide with almost no iron oxide present.

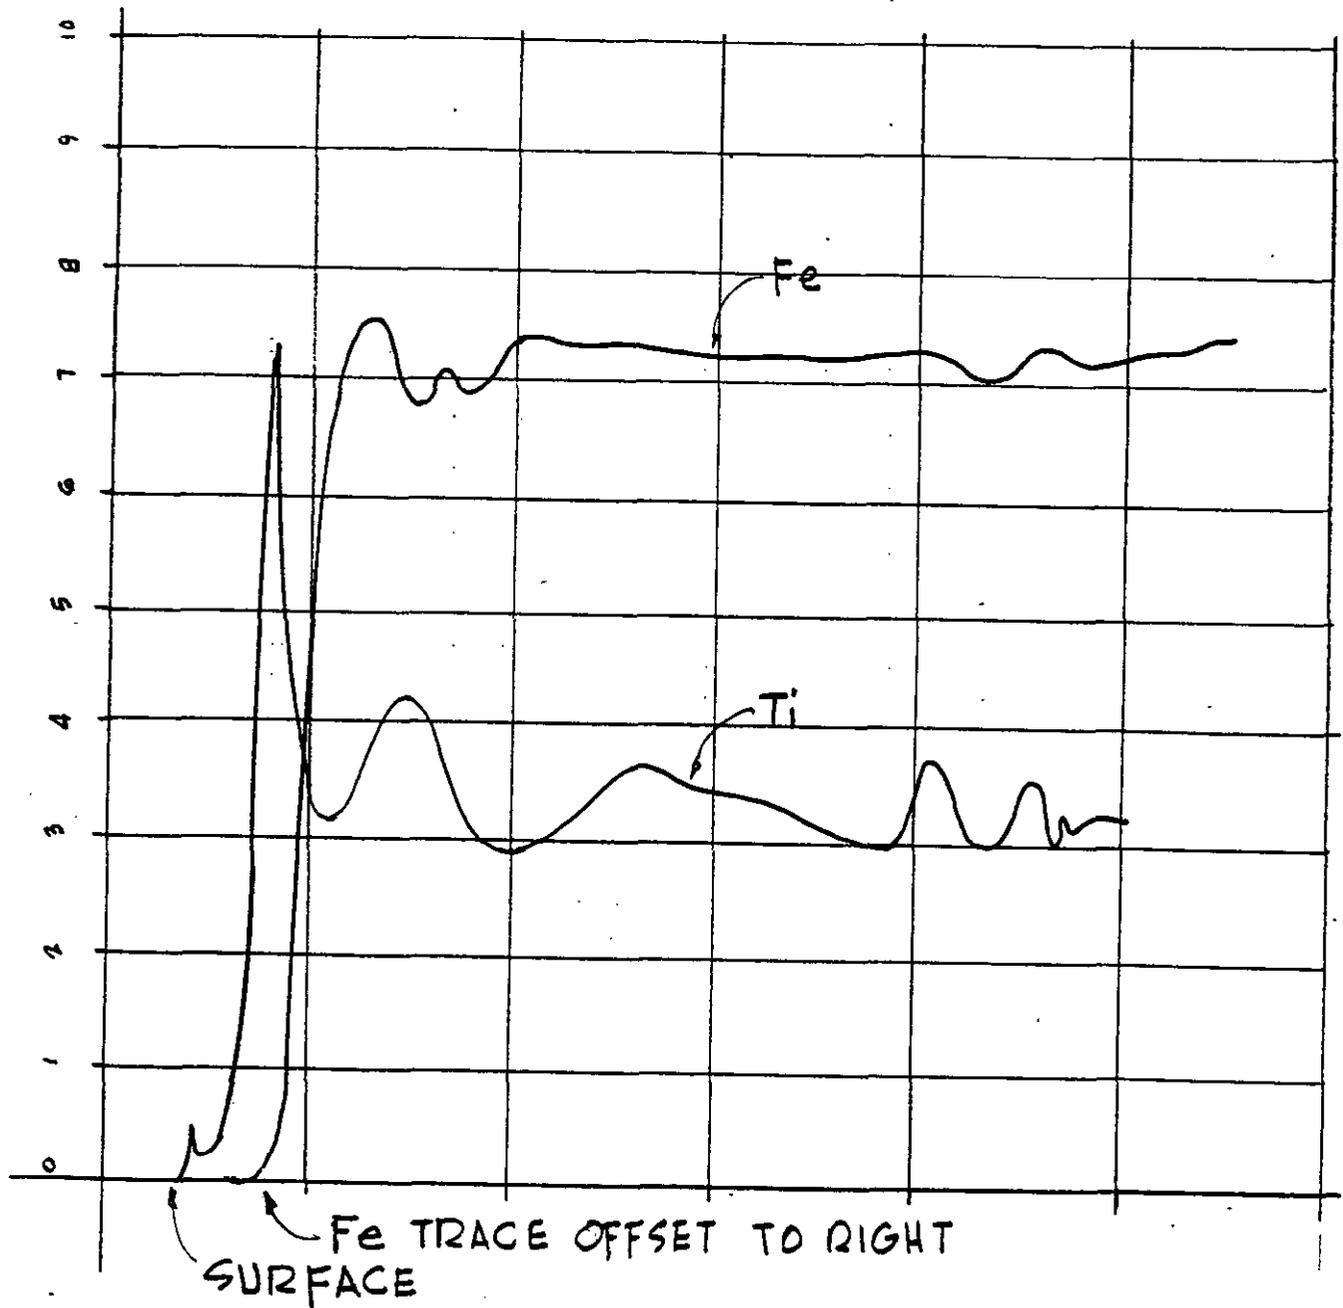
FIGURE 5. ELECTRON PROBE MICRO ANALYSIS (EPMA) SHOWING CONCENTRATION PROFILE FOR IRON AND TITANIUM STARTING AT THE SURFACE OF A J3K-75 FORGING.

EPMA was used to look at a cross section of forged JBK-75 with oxide on the surface. The titanium rich oxide layer is clearly visible in the concentration profile of Figure 5 but again no depleted layer can be identified. A scan into the material identified inclusions which are rich in titanium and low in iron and nickel, Figure 6. These inclusions can be identified metallographically and exist randomly rather than just at grain boundaries. The titanium concentration within the alloy is not very homogeneous.

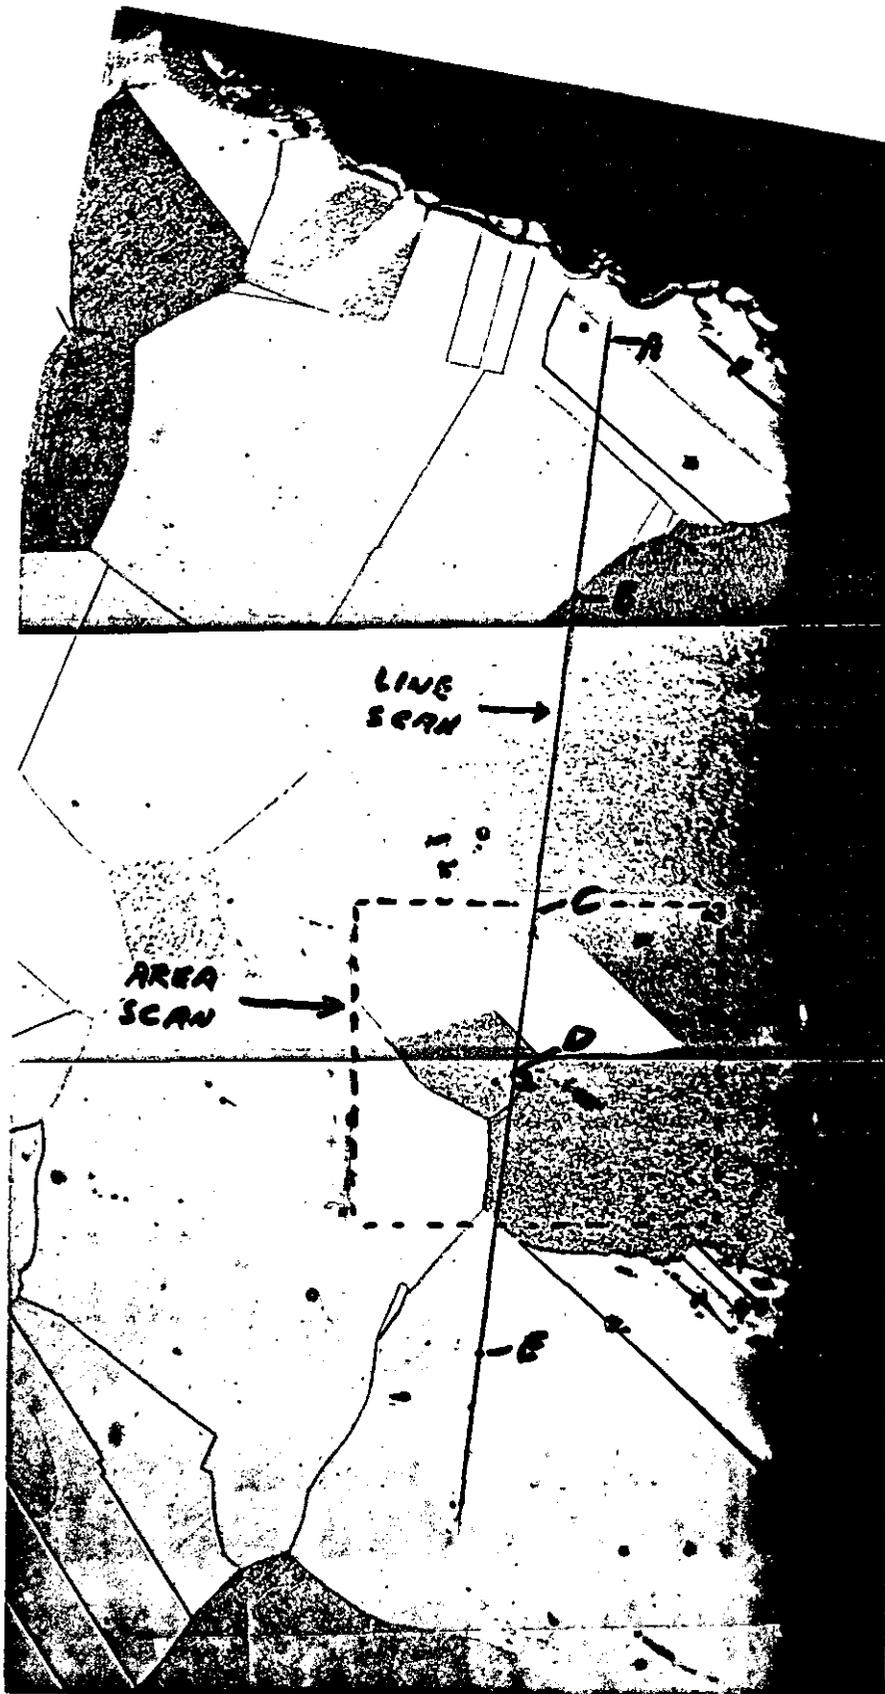
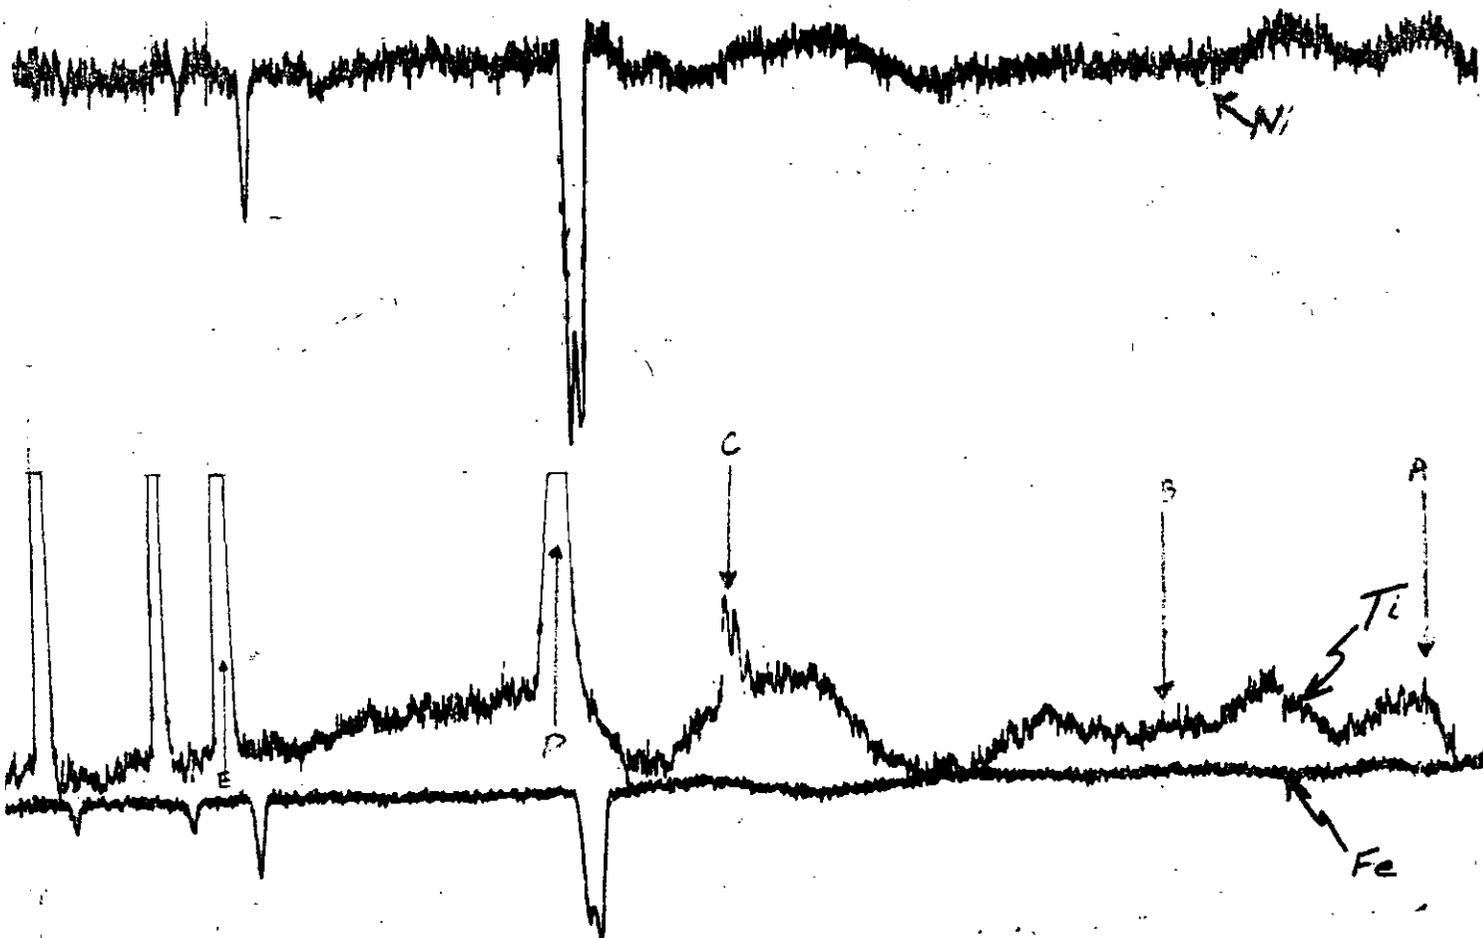
Figure 6. EPMA of Annealed JBK-75 Sample

a) Photomicrograph showing inclusions (dark spots) and x-ray scan locations.

b) Line scan showing high titanium and low iron and nickel content of inclusions.

c) Area scan with inclusions in center.

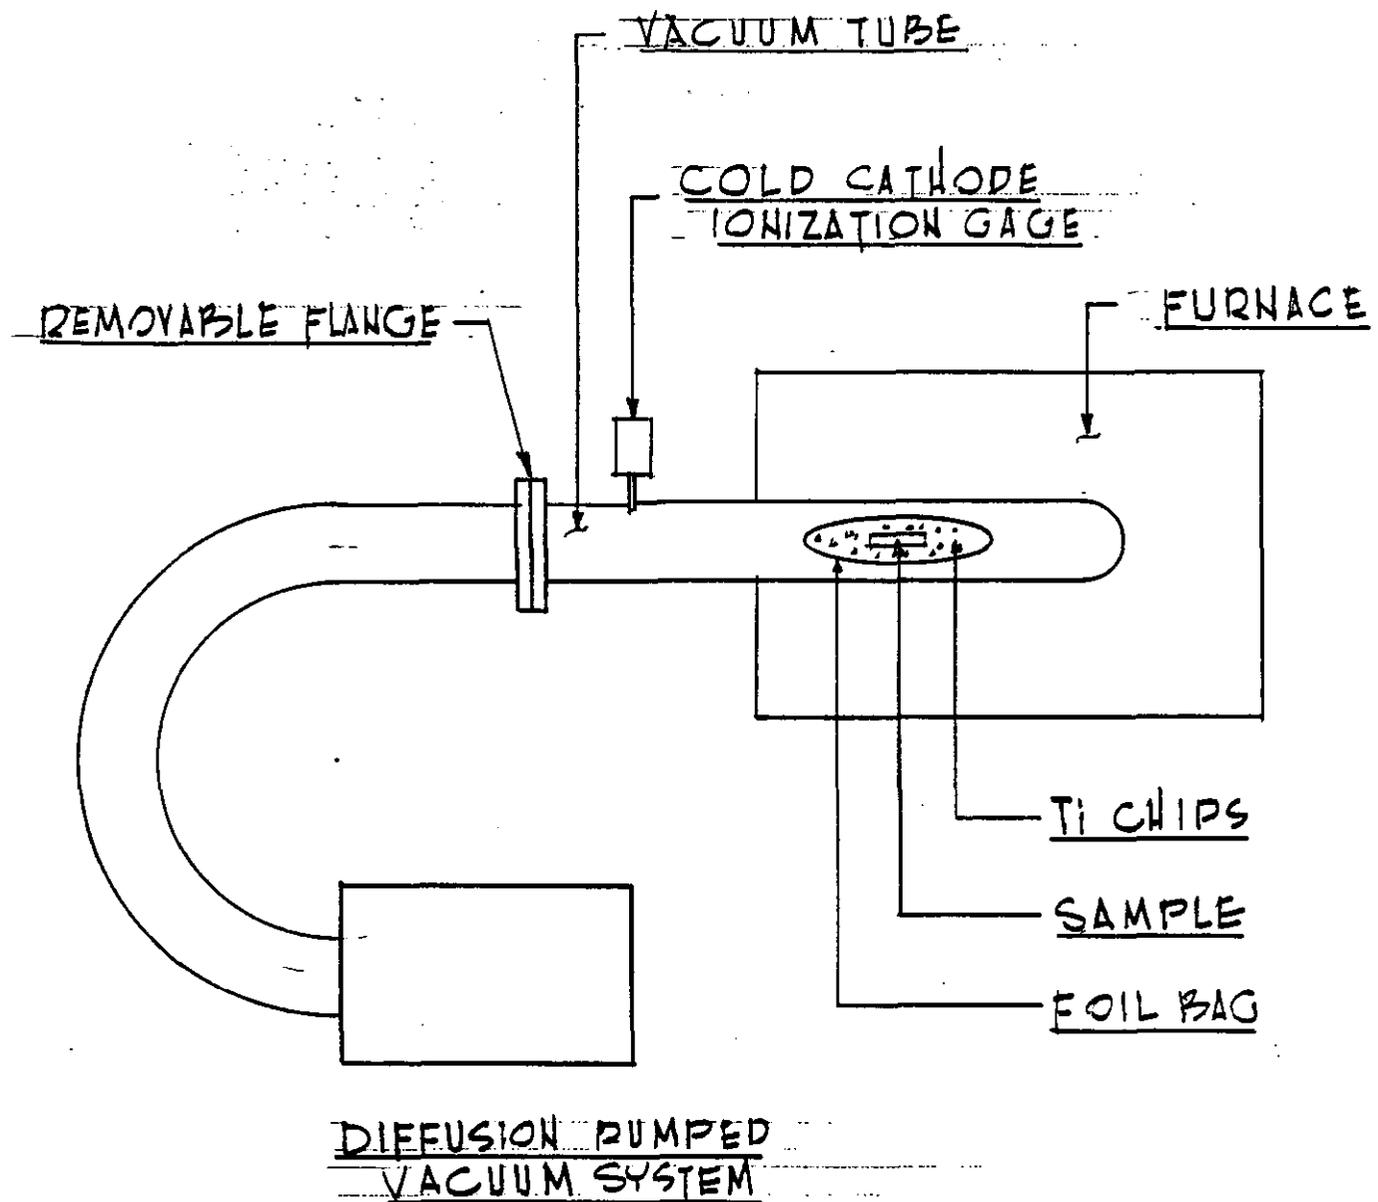
FIGURE 7

VACUUM HEAT TREATMENT STATION
USING TITANIUM GETTERING

A more successful method for keeping samples clean during heat treatment used a titanium getter. This work was done in a stainless steel vacuum tube placed in a Glo-Bar furnace. A portable diffusion pumped vacuum system pulled a vacuum on the tube. Samples were surrounded by titanium turnings and placed in a stainless steel foil bag in the vacuum tube, Figure 7. Satisfactory cleanliness was obtained at both the annealing and aging temperatures.

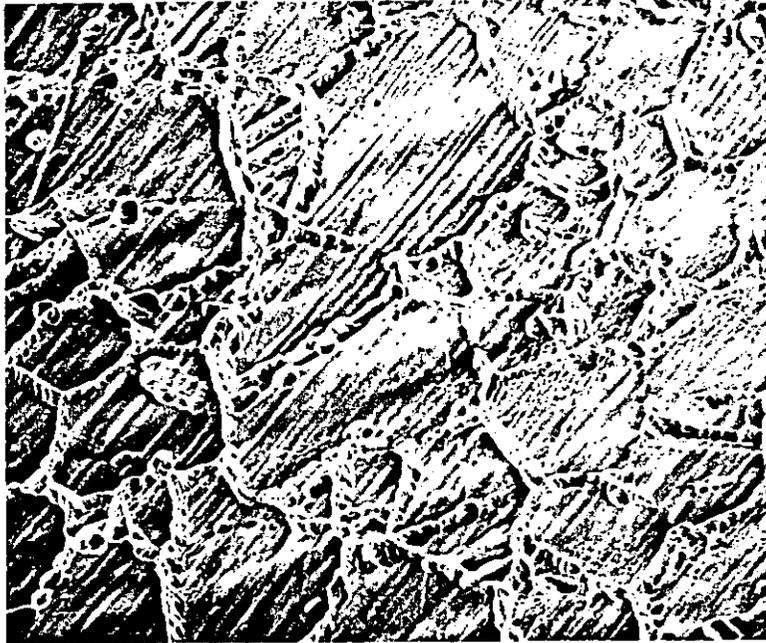
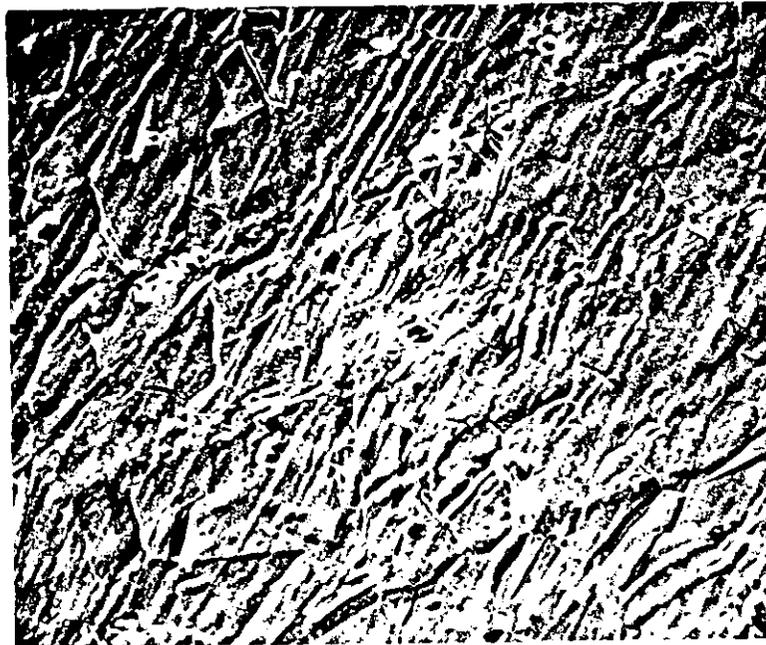
a) Aged material. Note grain boundary attack.

b) Forged material. No grain boundary attack.

Figure 8. SEM Photomicrographs of JBK-75 Surfaces Cleaned in Inhibited Nitric Acid Solution

Appearance of cleaned surfaces may not directly effect weldability of parts but it does effect inspection that is a final check on part cleanliness. Dull gray surfaces are generally suspect for cleanliness. In the case of aged JBK-75, the dull appearance coupled with the high corrosion rate led to a concern about the cleanliness of the surface and the nature of the attack. Samples were examined by Electron Spectroscopy for Chemical Analysis (ESCA) for any foreign material. Only the usual trace of chlorine typical of clean stainless steel was found as an impurity on the surface. Scanning Electron Microscopy (SEM) of the cleaned surface also showed no impurities in x-ray scans. SEM metallography indicated the dull appearance to be a surface texture phenomenon. Considerable grain boundary attack takes place on aged material as compared with unaged material, Figure 8. Aged A-286 behaves in a similar manner. The temperature for cleaning aged JBK-75 and A-286 was reduced to 125°F to minimize the attack. Samples resistance welded subsequent to cleaning by this procedure welded satisfactorily, Figure 9.

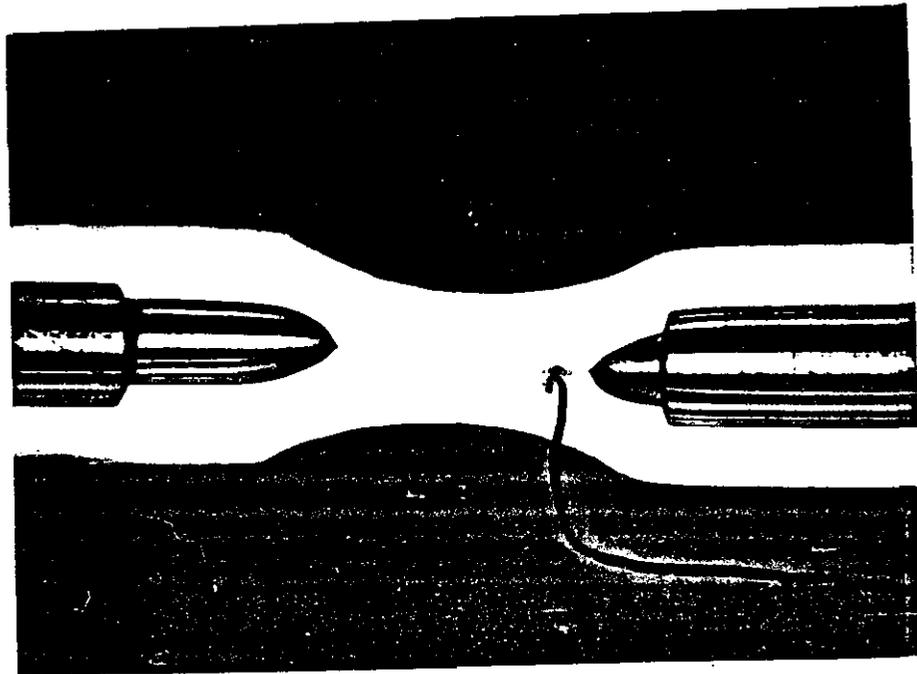
PINCH WELD INTERFACE

Figure 9. Resistance Weld in Tube Made From JBK-75

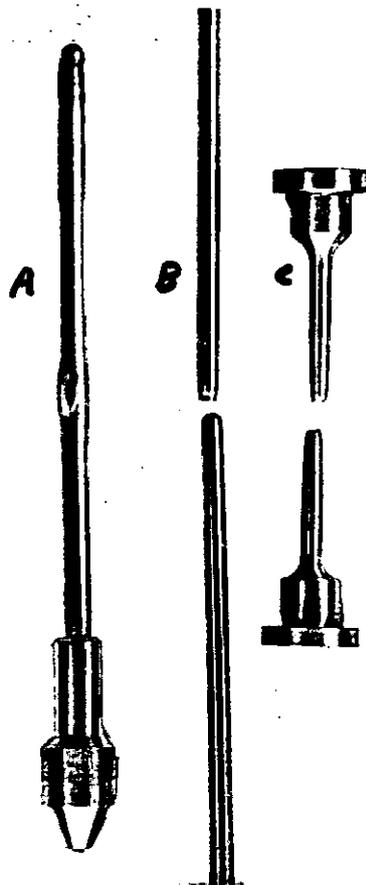
- a) Hydrotest sample with TIG weld at upper end and high pressure fitting at lower end.
- b) Tensile test tubing sample that is clamped directly in grips.
- c) Tensile test sample machined to 1/8" OD X 1/16" ID in gage length.

Figure 10. 1/8" OD X 1/16" ID Tubes After Mechanical Testing Showing Failure Modes

Data for all materials falls together with some degree of scatter. Two types of samples were used depending upon the available material, Figure 10.

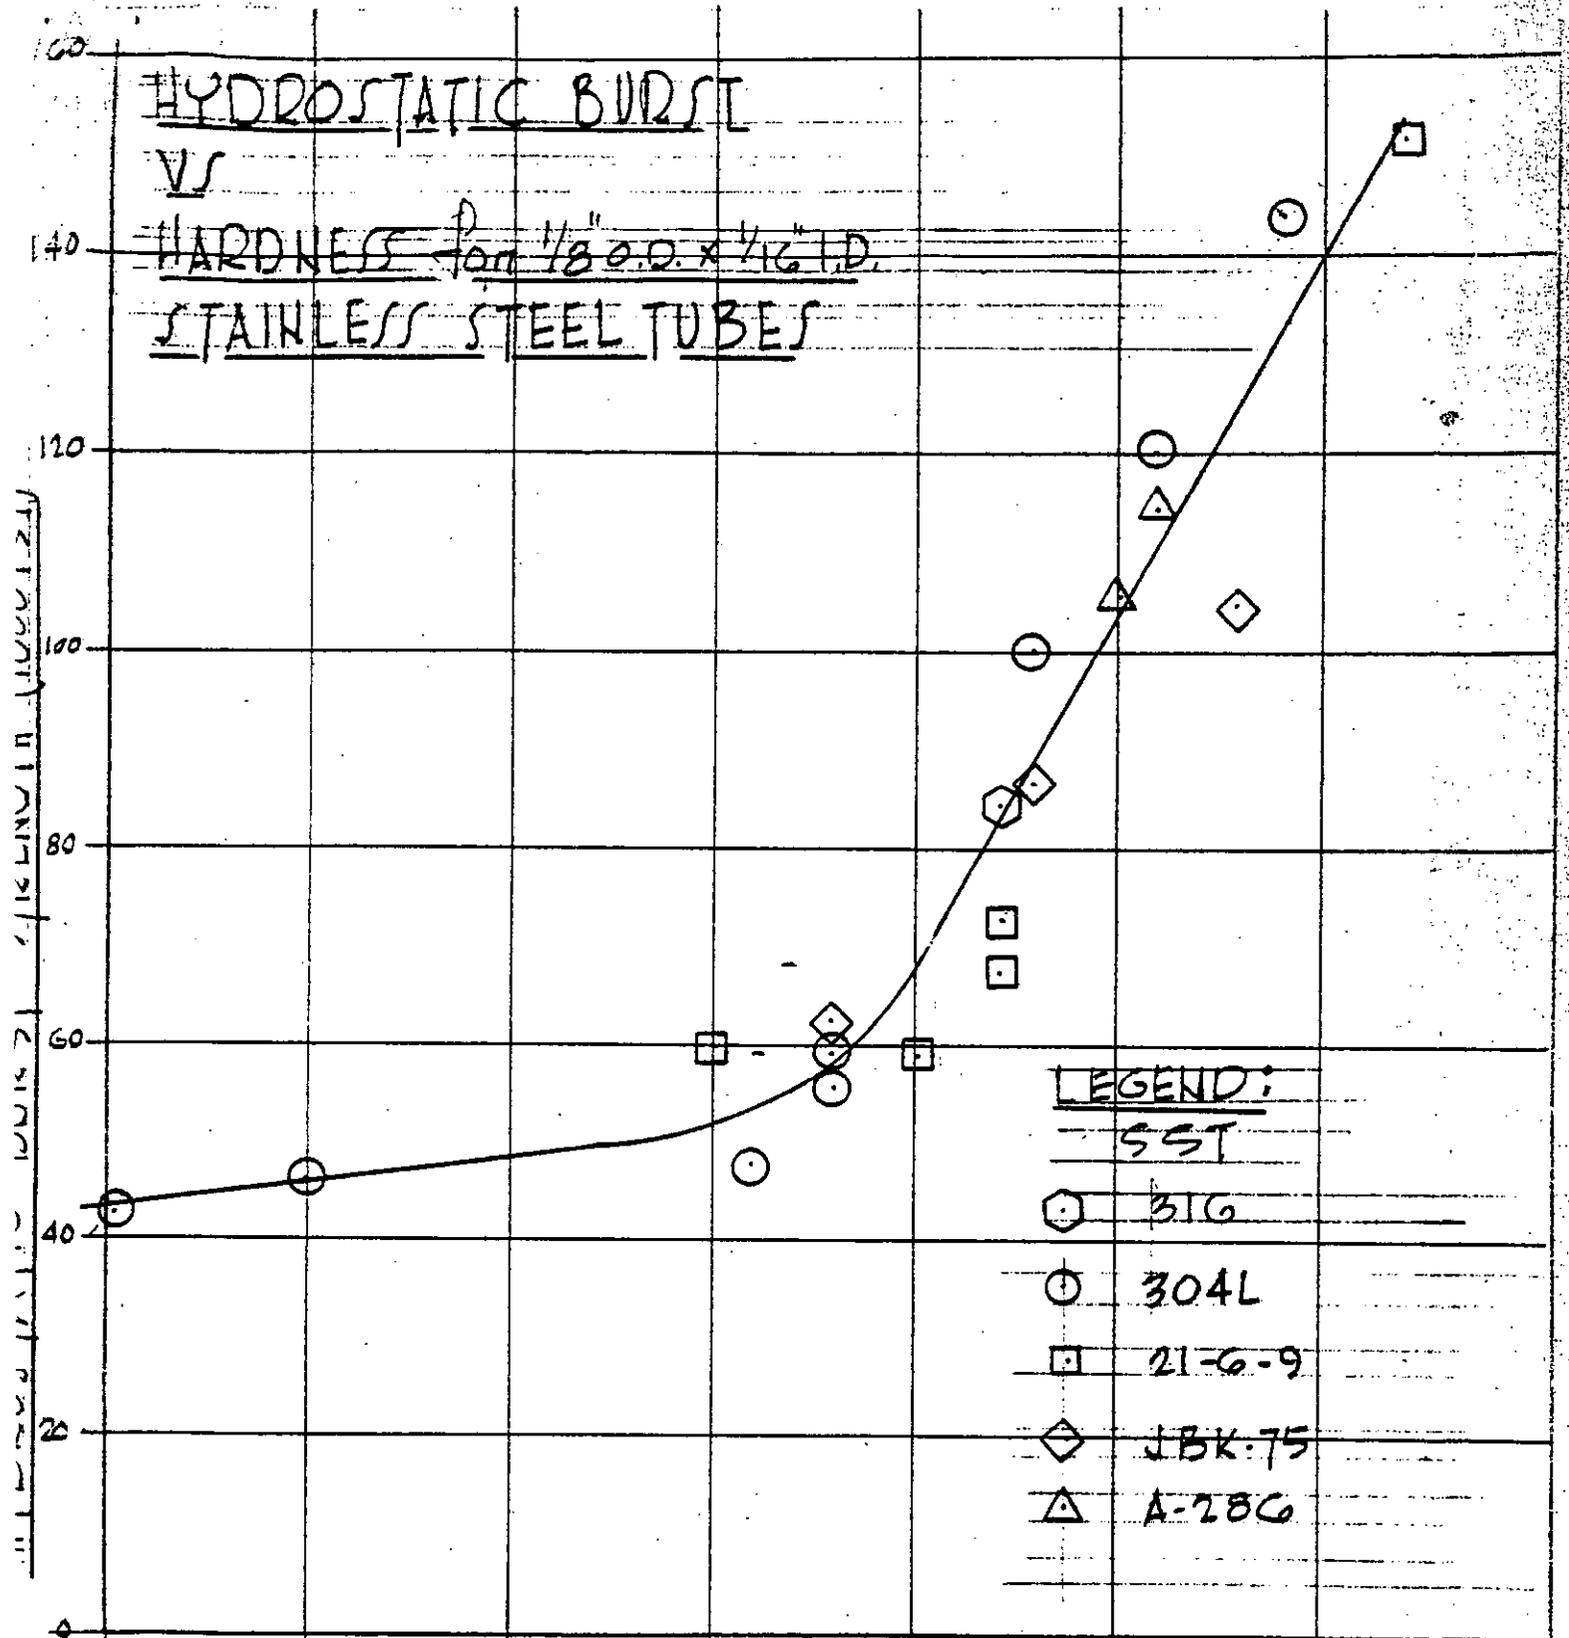
FIGURE 11

HYDROSTATIC BURST
VS
HARDNESS for 1/8" O.D. x 1/16" I.D.
STAINLESS STEEL TUBES

Hydrostatic strengths were measured for 20 different lots of tubing. The data is tabulated in Table IX and plotted in Figure 11. Fairly accurate predictions of tube hydrostatic strength can be made for 1/8 inch OD by 1/16 inch ID tubing using the curve in Figure 11.

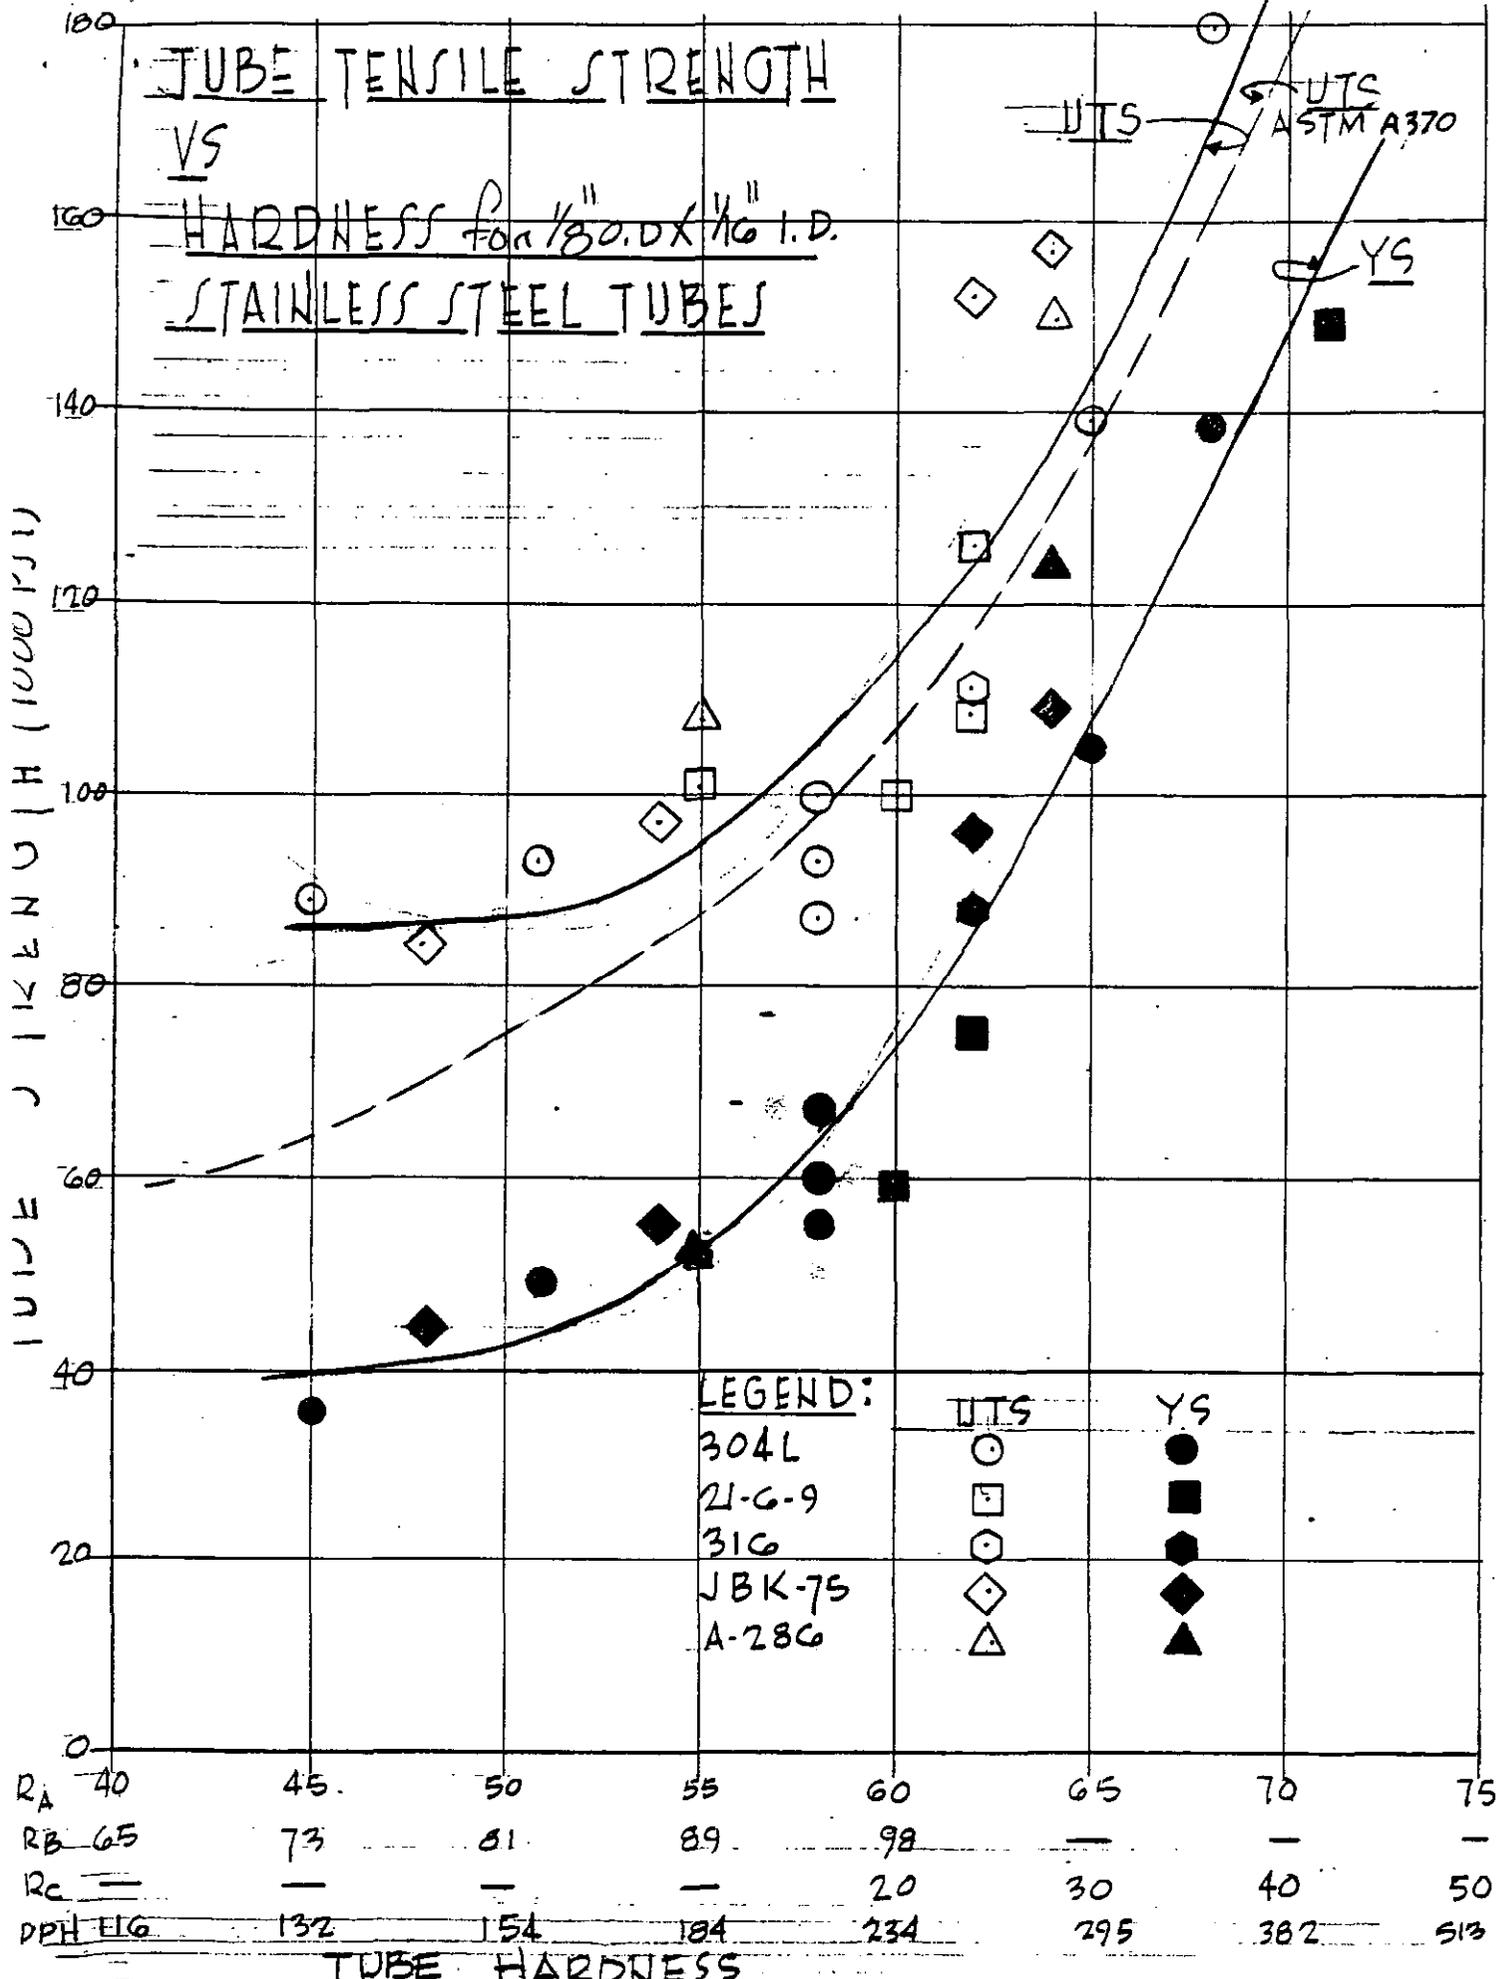
FIGURE 12

TUBE TENSILE STRENGTH
VS
HARDNESS for 1/8" O.D X 1/16" I.D.
STAINLESS STEEL TUBES

Tensile strength of tubes 1/8 inch OD by 1/16 inch ID was measured and correlated with hardness. Data are tabulated in Table X and plotted in Figure 12 using a parabolic least-squares representation. Curves follow the same pattern as the hydrostatic strength vs. hardness. The curves for yield strength and hydrostatic strength are, it turns out, nearly identical.

Correlations of tensile strength with hardness are available in the literature (9, 12). Drawn on the plot of Figure 12 is the data from ASTM A370 for steels. The fit is fairly close at higher hardness down to where the curve breaks. The difference could be due to the material or to the nature of the test (tubes vs. bar).

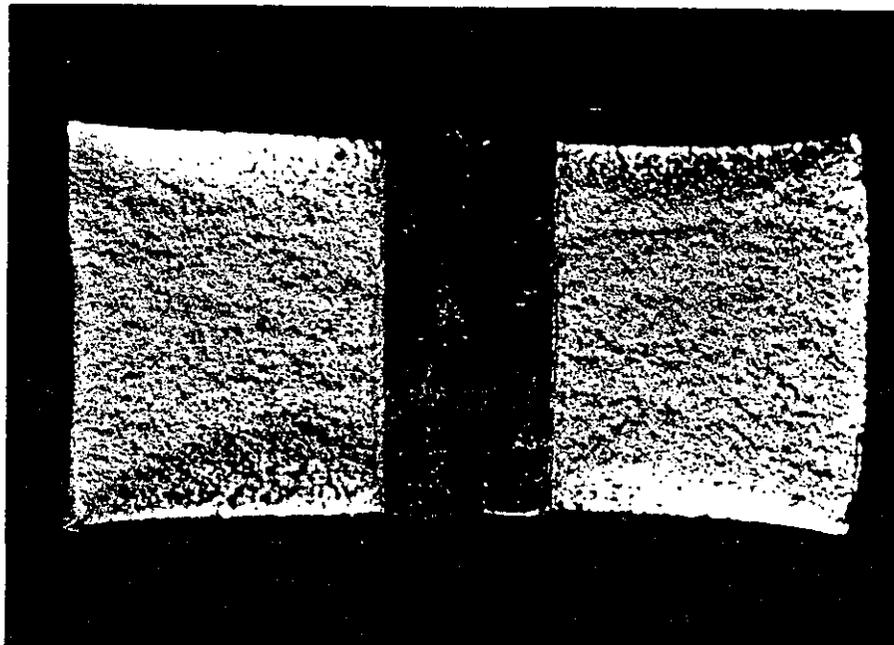
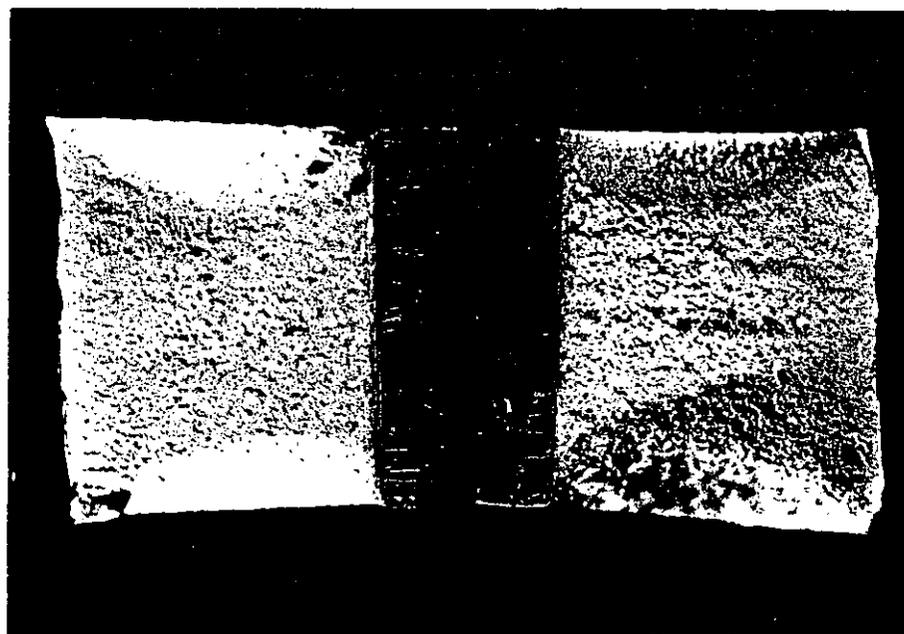
Figure 13. Fracture Surfaces of Impact Samples Tested at -41.5°F .

Impact strength of materials is important as it relates to the likelihood of failure of tubes in impact. Charpy V-notch impact tests were made per ASTM designation E23 (9). A test of JBK-75 and A-286 at -41.5°F showed good impact strengths of 46.5 and 42 ft-lbs respectively. Comparison samples of A-286 at room temperature resulted in slightly lower impact energy. Additional data on fracture toughness, dynamic yield strength and critical crack dimensions were obtained from the Dynatup - instrumented output of the impact tester, Table XI. Fracture toughness, which measures the resistance of a material to rapid crack propagation, resulted in relatively high numbers indicating a crack resistant material. Dynamic yield strength, critical crack depth and length are also good. Calculating fracture toughness data by impact tests may result in high (nonconservative) numbers because of higher strain rates than standard fracture toughness tests. Dynamic yield strength and critical crack length and depth are also high for the same reason. The critical crack length and depth are measurements of the critical size of a hypothetical flaw subjected to a nominal stress. The nominal stress is based on the dynamic yield strength that would cause rapid crack propagation in the material at the test temperature (13). The fracture surface, shown in Figure 13, had a typical ductile appearance.
