INVESTIGATION OF THE CORROSIVITY OF THE VAPOR PHASE OVER HIGH-LEVEL RADIOACTIVE WASTE

K. H. Subramanian and P. E. Zapp
Westinghouse Savannah River Company
Savannah River Site
Aiken SC 29808

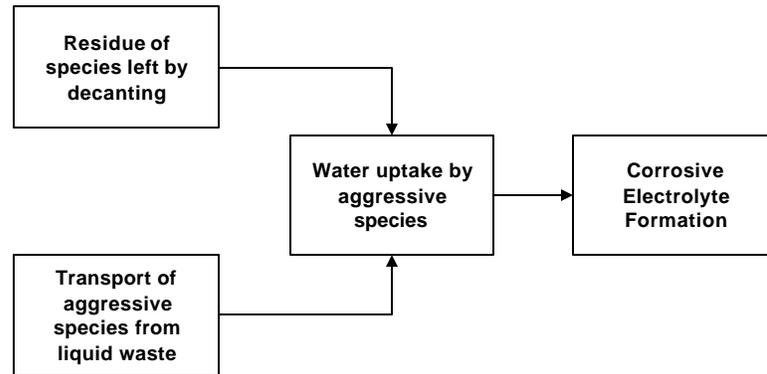
supernate, transport as an aerosol, condensation, and deposition on the tank wall. In sufficiently humid conditions the nitrate residue can adsorb atmospheric moisture and dissolve, forming a corrosive electrolyte. A schematic of these mechanisms is shown in Figure 1.

FIGURE 1. Hypothesized VSC Mechanisms

In the first mechanism, it is hypothesized that a corrosive, nitrate-rich liquid electrolyte exists on the tank wall, due to evaporation. These deposits would deplete in hydroxide over time due to reaction with atmospheric carbon dioxide. Under wet conditions the deposits could re-dissolve to create a nitrate-rich electrolyte that could induce degradation.

The alternate hypothesis is that an aqueous solution can lead to the deposition of the salts on the tank wall in the vapor space through an aerosol transport process. The mutual deliquescence relative humidity (MDRH) determines the precipitation sequence of the aerosolized salts as a function of relative humidity. The deliquescence point (relative humidity) of sodium nitrate at room temperature has been reported to be 74%.² However, the MDRH of a mixture of salts is generally lower than the deliquescence point of the single salts indicating the transition to a completely liquid system and the sequential dissolving of the electrolytes. It is known that the eutectic composition of the liquid phase and the MDRH are constant for all ratios of salt. The eutectic point is defined to be the point at which the solution has become saturated with all salts, and the relative humidity is termed the MDRH. As the relative humidity is reduced, the precipitation sequence of the salts may be different depending upon the mixture and thermodynamic properties. In terms of the Gibbs' Phase Rule, at a specific temperature and pressure, there are no degrees of freedom, and the eutectic point is fixed and invariant irrespective of the total amounts of salt present. The relative humidity within the vapor space of a tank is dependent upon ventilation system operation. Since the ventilation air is unconditioned, the natural variation of the humidity may be great enough to cycle the relative humidity around the deliquescence and efflorescence point of the salt mixture. This cycling would lead to a preferential deposition of salts, expected to be nitrate due to its relatively high deliquescence point.

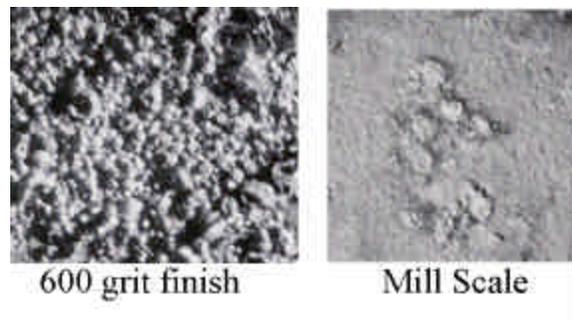
ASTM A537 Steel. The A537-13 coupon exhibited extensive tubercle growth typical of low carbon steel corrosion on the polished surface and spotty growth on the mill scale surface, as seen in Figure 2. The A537-21 coupon exhibited no corrosion on the polished surface, but spotty tubercle growth on the mill scale surface, as seen in Figure 3.

Figure 2. Coupon A537-13 (W1, 95% RH, Vapor Space) Tubercle Growth

The corrosion product was removed layer by layer by scraping and characterized using x-ray diffraction (XRD) analysis. The primary constituents found in A537-13 were oxyhydroxides [FeO(OH)], while the primary constituent found in A537-21 was magnetite (Fe₃O₄).

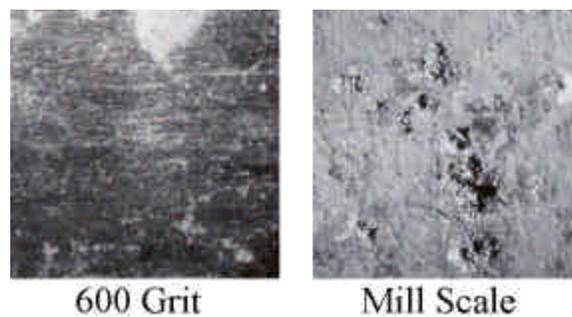
Figure 3. Coupon A537-21 (W2, 95% RH, Vapor Space) Tubercle Growth

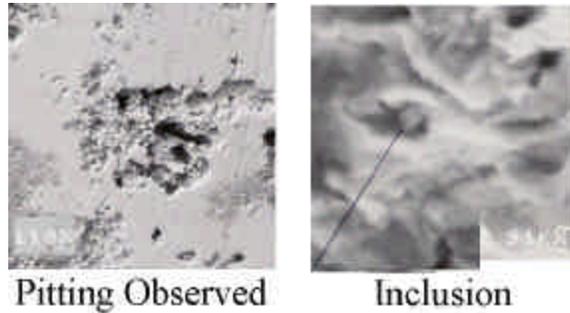
could promote more aggressive pitting. The inhibited solution W2 did not induce pitting on the polished surface of the coupon exposed to the vapor space. The pitting on coupon A537-13 is shown in Figure 4. Inclusions determined to be iron copper sulfides were observed in the bottom of some pits. The underlying pitting found in A537-21 on the mill scale surface is shown in Figure 5. The average pit depth was 2.5 mils as determined with optical microscopy at 200X.

Figure 4. Coupon A537-13 (polished surface) SEM Analysis

Underlying pitting was observed on the mill-scale surface of both the coupons, and on the polished surface of coupon A537-13. It is postulated that inhomogeneities in the mill-scale layer allow for the creation of crevices that

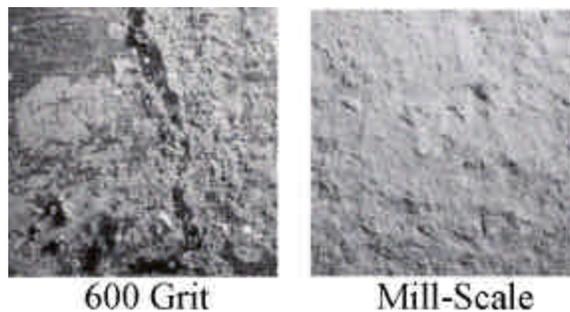
ASTM A285 Steel. The A285-23 coupon (exposed to W1 solution) also exhibited extensive tubercle growth on the polished surface and no growth on the mill scale surface, as seen in Figure 6. The corrosion products are primarily oxyhydroxides with minor amounts of magnetite. The A285-31 coupon (exposed to W2 inhibited solution) exhibited no corrosion on either surface.

Figure 6. Coupon A285-23 (W1, 95% RH, Vapor Space) Tubercle Growth

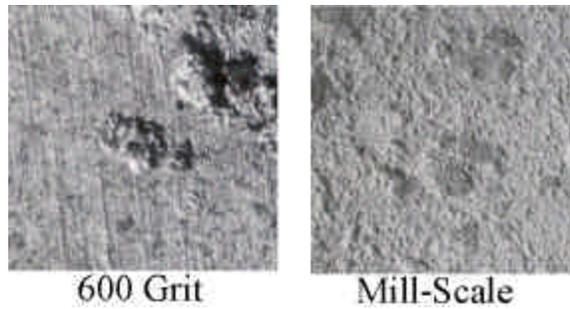
Underlying pitting, shown in Figure 7 was observed only on the polished surface of the A285-23 coupons exposed to the uninhibited solution. The average pit depth was 2.5 mils.

Figure 7: A285-23 SEM Analysis

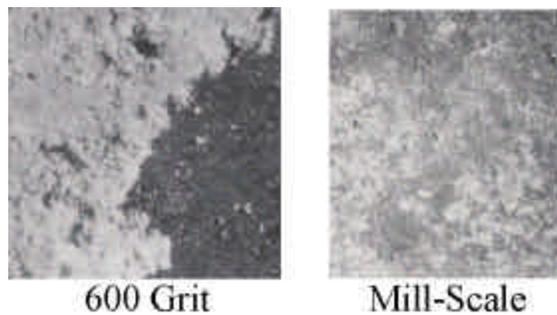
ASTM A537 Steel. The A537-23 coupon exhibited extensive tubercle growth in the liquid space typical of low carbon steel corrosion on the polished surface and spotty growth on the mill scale surface, as seen in Figure 8. The A537-27 coupon exhibited no corrosion on the mill scale surface, and shallow pitting on the polished surface. However, there was no distinct tubercle growth.

Figure 8: A537-23 Corrosion Product (W1 Solution, Interface)

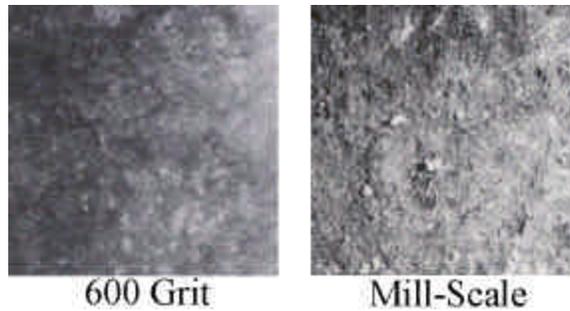
Figure 9: A537-27 Corrosion Products (Inhibited, Interface)

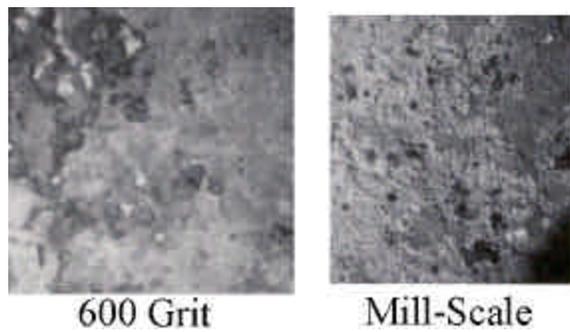
A shallow line of pits was seen along the interface on the A537-23 coupon. The general corrosion occurred throughout the polished surface of the sample, including the vapor space just above the liquid level.

Figure 10: A537-23 SEM Analysis

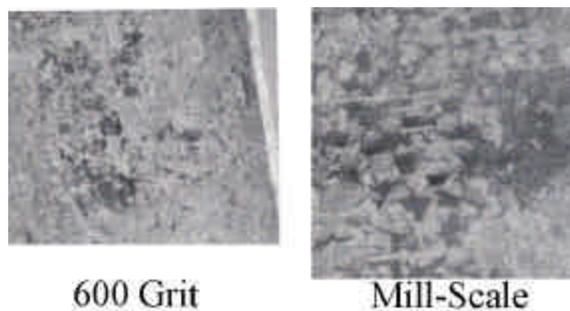
A shallow line of pitting was evident just above the liquid/air interface of the inhibited solution, particularly on the polished surface. The mill scale surface had minor corrosion product, but underlying pitting was not found. Inclusions were not found at the bottom of the pits in either sample.

Figure 11: A537-27 SEM Analysis

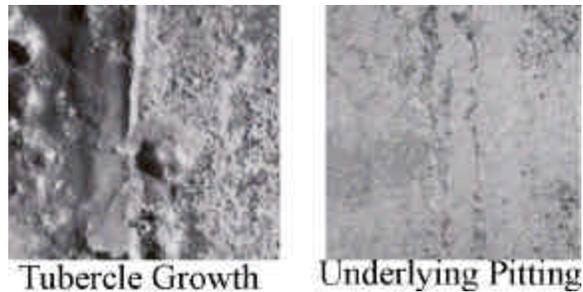
ASTM A285 Steel. The A285-35 (uninhibited) coupon exhibited extensive tubercle growth in the liquid space typical of low carbon steel corrosion on the polished surface and no growth on the mill scale surface, as seen in Figure 12. The corrosion products are primarily oxyhydroxides with minor amounts of magnetite. The A285-37 (inhibited) coupon exhibited no tubercle growth on the mill scale surface or polished surface. In addition, there was no pitting found on either surface. The micrographs of only the polished surfaces are presented here for comparison purposes.

Figure 12. A285-35 (Uninhibited W1, Interface) Polished Surface
