Drop Tests of 325 Pound 6M Specification Packages

ABSTRACT

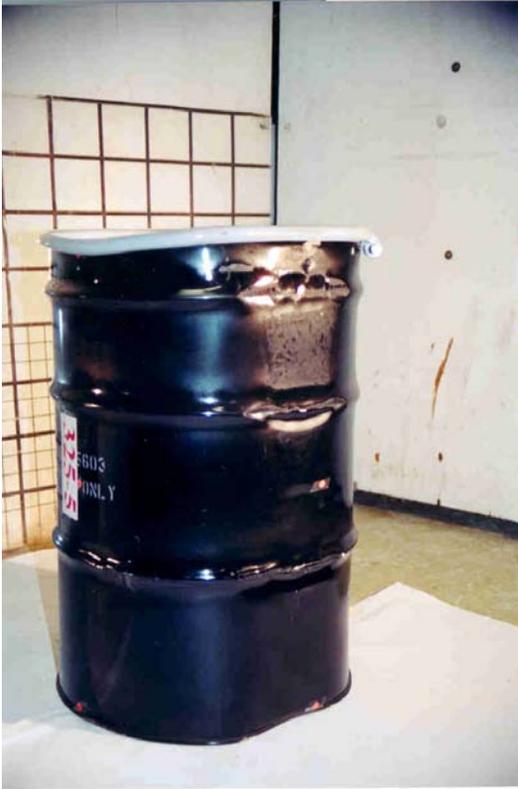
Figure 1. Flattened side of 325-5 following 10°, shallow angle drop test. Damage is typical of results for shallow angle impact.

The 9 m 10° drop resulted in nearly uniform flattening of the side of the package, the flat region having a width of approximately 28 cm (11 in.). The inverted “J” rim of the top was bent inward, forming a reverse curvature. The curl of the drum was flattened, with the clamp-ring remaining engaged with the curl. The vertical dimensions of the package were essentially unchanged. The damage was typical of very shallow angle drops, with the deformation of the chime being comparable to that of the curl. The clamp-ring remained engaged with the drum and top and the top was securely retained. The results of this drop are shown in Figure 1.

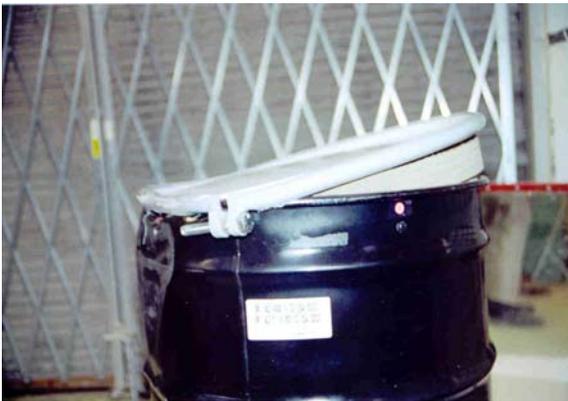
Figure 2. The 20° impact resulted in an opening of about 8.9 cm (3 ½ in.).

The 9 m 20° drop resulted in separation of the top and flattening of the rim and closure ring of the package at the point of contact, and associated flattening (about 28 cm) along the length of the drum. The height of the package was not changed. The damage was typical of low angle drops, with a distinct triangular, flattened region surrounding the point of contact, and local buckling of the drum and top in the damage

region. The rim of the top was bent downward resulting in the top pulling out from under the closure ring on both ends of the flattened region. These openings then propagated around the lid, so that it became disengaged from the clamp-ring and the drum over its most of its circumference (approximately 230°). The maximum opening between the top and the curl of the drum, measured after the test, was approximately 8.9 cm (3.5 in.). The raised and curved (inverted “J”) rim of the top was buckled inward and folded downward, almost touching the horizontal, disk section of the top, at the point of impact. The top was barely retained on the package. The results of this drop are shown in Figure 2.

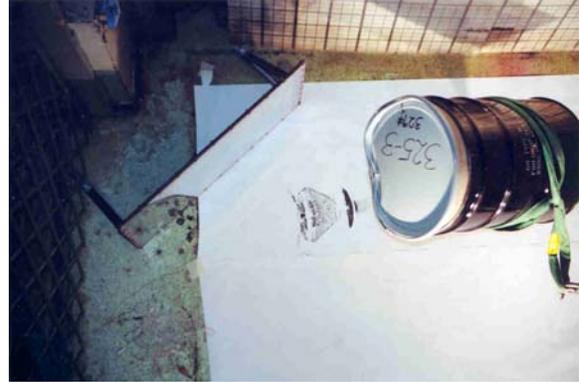
Figure 3. Package 325-3 in mid rebound following impact for 9 m (30 ft), 20° drop test. The opening of the package top is visible at this time.

The 9 m 20° impact angle drop yielded results were almost identical with those of 325-4, which was also dropped at 20°. As in the case of 325-4, the drop resulted in separation of the top and flattening of the rim and closure ring of the package at the point of contact, and associated flattening along the length of the drum. As in the case of 325-4, the damage was typical of low angle drops, with a distinct triangular, flattened region surrounding the point of contact, and local buckling of the drum and top in the damage region. The rim of the top was bent downward along a line parallel to the flattened side, resulting in the top pulling out from under the closure ring on both ends of the flattened region. These openings then propagated around the lid, so that it became disengaged from the clamp-ring and the drum over approximately 190° of its circumference. The maximum opening between the top and the curl of the drum, measured after the test, was approximately 6.35 cm (2.5 in.). The raised and curved (inverted “J”) rim of the top was buckled inward and folded downward, on to the horizontal, disk section of the top, at the point of impact. As in the case of 325-4, the top was barely retained on the package. The results of this drop are shown in Figures 3 and 4.

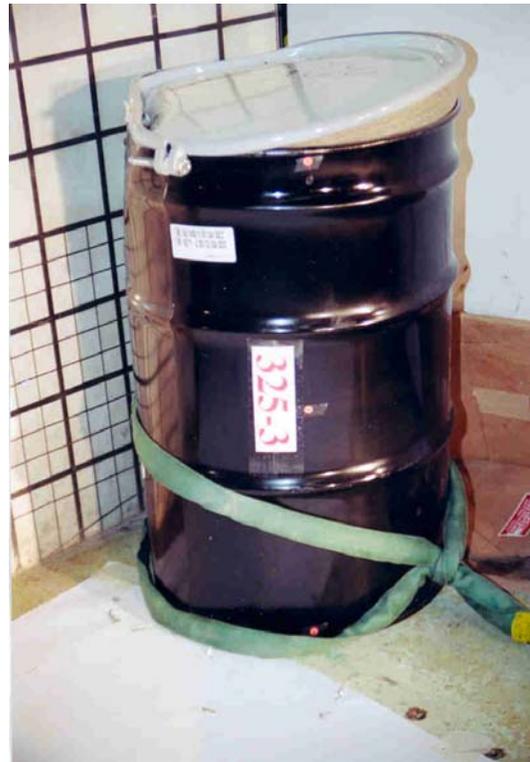
Figure 4. Impact region deformation and top opening of 325-3 following repeat of 9 m (30 ft), 20° drop test.

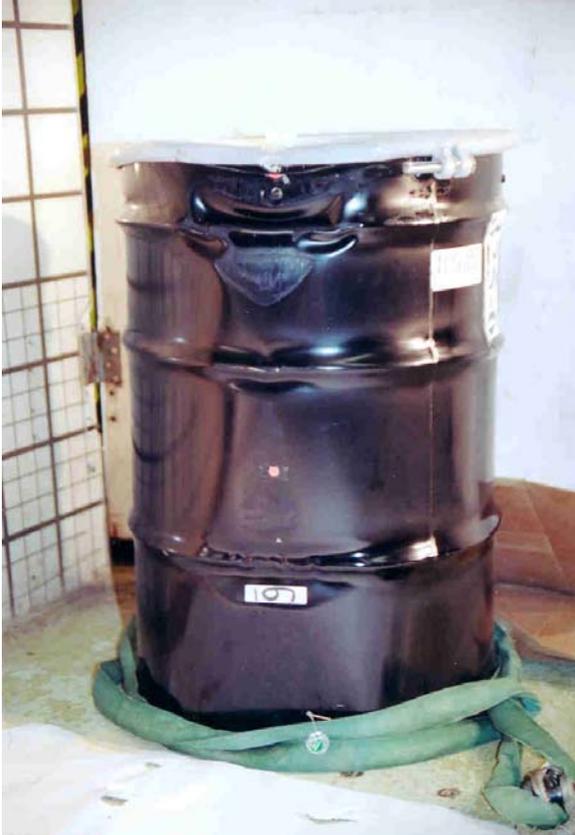
Figure 5. Package 325-6 with plywood disk enhanced closure struck the test surface at 6.5°. The damage was typical of that for other shallow angle tests. As discussed in the text, the intended impact angle was 20°.

The test procedure specified that a test with the Plywood Disk Enhanced Closure be performed following any event where a repeat test resulted in a second failure. Accordingly, following the second failure in the 20° drop (package 325-3), a duplicate (20° drop) test of a package with a Plywood Disk Enhanced Closure was performed using package 325-6. This enhancement consisted of replacing the top 2.54 cm (1 in.) of Celotex with a 2.54 cm thick plywood disk. The results of the drop testing of package 325-6, are shown in Figures 5 and 6.

The 9 m 20° drop was performed with the package oriented so that its axis was 20°, top down, at release. Examination of the high speed video revealed that the orientation drifted following release, so that the angle of the drum at impact was 6.5°. The response of the package was sufficiently energetic that it rotated upright and came to rest standing on its bottom. The top remained securely attached following the test. The drop resulted in flattening of the rim and closure ring of the package at the point of contact, and associated flattening along the length of the drum. The height of the package on the impact side was reduced by 1.3 cm (½ in.). The damage was typical of low angle drops such 325-5 (which struck at 7°), with a distinct triangular, flattened region surrounding the point of contact, and local buckling of the drum and top in the damage region. The inverted “J” rim buckled inward to a greater extent on 325-6, and the adjacent region of the top buckled outward to a much greater extent than the corresponding deformations of 325-5. The clamp-ring remained engaged with the top and the curl of the drum around the full circumference except for the region of reverse curvature of the rim at the point of impact. At this location, the raised and curved (inverted “J”) rim of the top was buckled inward against an upward bulge of the top. Unlike the previous cases, the curl of the drum also assumed a reverse curvature, so that a gap (of approximately 1.3 cm or ½ in.) was formed between the clamp ring and the curl and top of the drum at the impact point, Figure 19. The top was securely retained, with no opening into the interior (Celotex region) present. The results of this drop are shown in Figures 5 and 6.

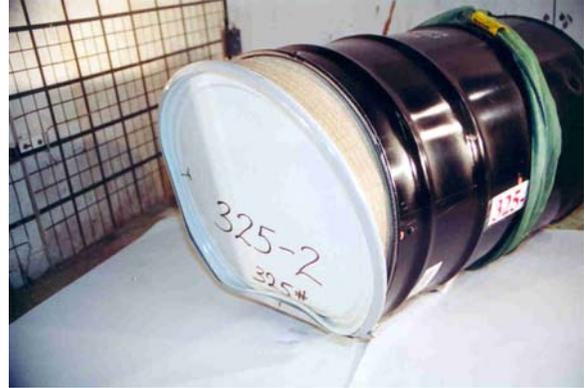
Figure 7. Package 325-2 following 9 m (30 ft) drop with 30° impact angle. This test resulted in the largest opening of the top.

Package 325-2 (30° case) struck at 25° and resulted in separation of the top and flattening (about 28 cm wide) of the rim and closure ring of the package at the point of contact, and associated flattening along the length of the drum. The height of the drum on the impact side was reduced by 6 mm (¼ in.). The damage was typical of intermediate angle drops, with a distinct triangular, flattened region surrounding the point of contact, and local buckling of the drum and top in the damage region. The flattening of the side was less pronounced than in the shallow angle cases. As in the 20° test cases, the rim of the top was bent downward along a line parallel to the flattened side. This bending was more pronounced than in the 20° cases, and resulted in the top pulling out from under the closure ring on both ends of the flattened region produced by the 9 m drop. These openings then propagated around the lid, so that it became disengaged from the clamp-ring and the drum over its most of its circumference (approximately 250°). The maximum opening between the top and the curl of the drum, measured after the test, was approximately 11.4

cm (4.5 in.). The raised and curved (inverted “J”) rim of the top was buckled inward and folded downward, on to the horizontal, disk section of the top, at the point of impact. As in the 20° cases, the top was barely retained on the package. The results of this drop are shown in Figure 7.

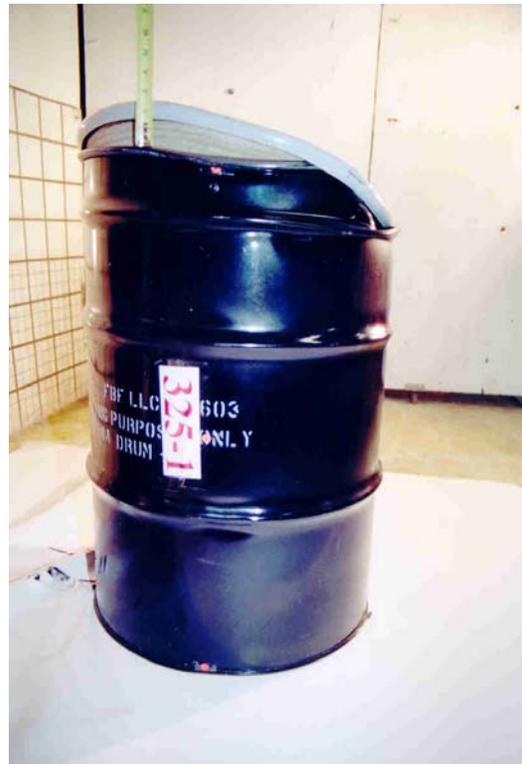
Figure 8. The 55°, CGOC test resulted in an opening of approximately 3.8 cm (1.5 in.).

Because of the additional 20° tests, the planned 45° test case was omitted. The 9 m 55° CGOC drop resulted in separation of the top and crushing of the “corner” of the package in the region of the point of contact. The height of the package, through the point of impact was reduced by approximately 8.3 cm (3 ¼ in.). The damage was typical of CG over corner drops with extensive local buckling and folding of the drum and top in the damage region. The crushing of the corner resulted in the top pulling out from under the closure ring in the NCT damage region. The opening then propagated around the lid, so that it became disengaged from the clamp-ring and the drum over approximately 120°. A discharge of dust occurred when the top began to separate from the drum, indicating that pressure caused by deformation of the drum was released by the opening of the top. The maximum opening between the top and the curl of the drum, measured after the test, was approximately 3.8 cm (1.5 in.) The results of this drop are shown in Figure 8.

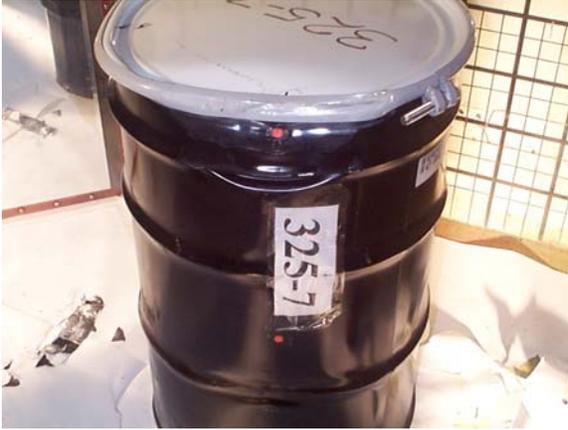
Figure 9. Package 325-7, with plywood disk enhanced closure, successfully retained its lid in the 30 °, 9 m drop test.

The lid remained attached with no opening, following the impact, for the 9m 30° drop. The drop resulted in flattening of the rim and closure ring of the package at the point of contact, with associated flattening (about 30.5 cm wide) along the length of the drum. The height of the package on the impact side was reduced by 2 cm (3/4 in.). The damage was typical of intermediate angle drops, with a distinct triangular, flattened region surrounding the point of contact, and local buckling of the drum and top in the damage region. At impact, the drum rebounded and rotated, so that the second impact was on the chime flattening it and the lower rolling ring. As in the 20° test cases, the rim of the top was bent downward along a line parallel to the flattened side. This bending was more pronounced than in the 20° cases. The lower edge of the clamp ring was displaced about 1 cm (3/8 in.) in the vicinity of the NCT point of impact, exposing much of the bottom surface of the curl in this region. Although the engagement of the clamp ring with the curl of the drum was challenged, the drum lid was

securely retained all around its circumference.. The raised and curved (inverted “J”) rim of the top was buckled inward and folded downward, against the buckled section of the top at the point of impact, producing a reversed curvature. The closure ring was flattened in this region, and formed a chord across the reverse curvature section, resulting in disengagement of the ring from the top over a length of about 15 cm (6 in.) with a maximum gap width of about 1.6 cm (5/8 in.) The results of this drop are shown in Figure 9.

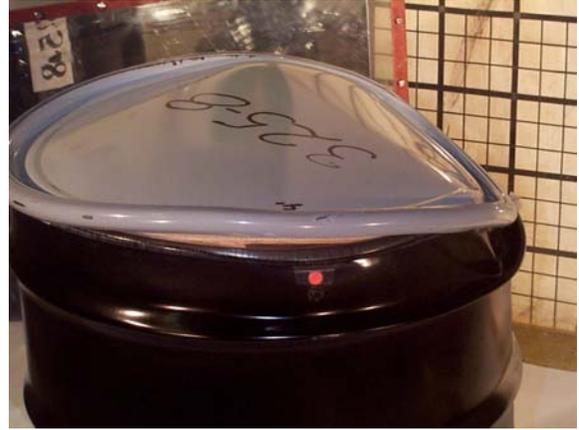
Figure 10. The CGOC, 9 m drop test of package 325-8, with plywood disk enhanced closure, resulted in the opening shown here.

On the rebound, from the 9m CGOC drop, the package rotated to the vertical position and came to rest standing on its bottom. As a result, there was no flattening of the side of the package away from the crushed corner. The drop resulted in separation of the top and crushing of the “corner” of the package in the region of the point of contact. The height of the package, through the point of impact, was reduced by approximately 7.3 cm (2 7/8 in.) The damage was typical of CG over corner drops with extensive local buckling and folding of the drum and top in the damage region. The crushing of the corner resulted in the top closure ring being pulled over the drum curl in the NCT damage region, exposing the plywood. The resulting opening was approximately 1.3 cm (½ in.) wide and 30.5 cm (12 in.) long, corresponding to an angular width of about 60°. The results of this drop are shown in Figure 10.
