WSRC-MS-99-00493

## **Examination Of 304L Stainless Steel To 6061-T6 Aluminum Inertia Welded Transition Joints After Irradiation In A Spallation Neutron Spectrum**

**Abstract:** The Savannah River Technology Center (SRTC) designed and fabricated tritium target/blanket assemblies which were irradiated for six months at the Los Alamos Neutron Science Center (LANSCE). Cooling water was supplied to the assemblies through 1 inch diameter 304L Stainless Steel (SS) tubing. To attach the 304L SS tubing to the modules a 304L SS to 6061-T6 Aluminum (Al) inertia welded transition joint was used. These SS/Al inertia weld transition joints simulate expected transition joints in the Accelerator Production of Tritium (APT) Target/Blanket where as many as a thousand SS/Al weld transition joints will be used. Materials compatibility between the 304L SS and the 6061-T6 Al in the spallation neutron environment is a major concern as well as the corrosion associated with the cooling water flowing through the piping. The irradiated inertia weld examination will be discussed.

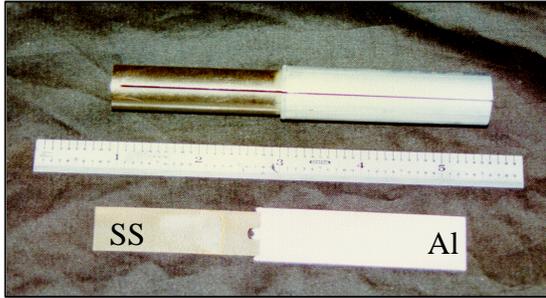
Figure 2. Solid Inertia Welded Piece Prior to Machining.

details are shown in Figure 1 and the solid inertia welded piece prior to machining is shown in Figure 2.

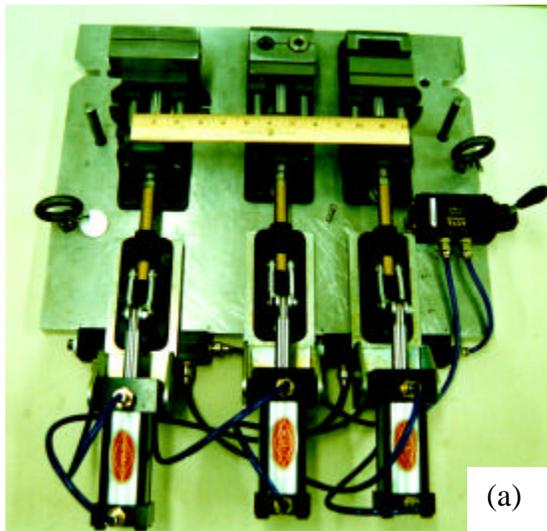
Figure 3. (a) Fixture used to section pieces in the hot cell. (b) Sectioned pieces.

A fixture and cutting apparatus was designed, fabricated and mocked up at SRS to support the sectioning of the irradiated inertia welded samples in the Chemical and Metallurgical Research (CMR) facility at LANL, Figure 3. The cutting apparatus was designed to provide ease of operation in the hot cells because of the difficulty working with manipulators. Clean inertia welded transition joints were used in the mock-up operation at SRS to ensure the cutting apparatus would operate smoothly in the hot cells. Once the mock-up operation at SRS was complete the cutting apparatus was transferred to the LANL CMR hot cells.

The fixture and cutting apparatus was used to separate the sleeve from the transition joints prior to sectioning the samples for further examination. Once the sleeve was removed the inertia welded transition joints were placed in the fixtures and sectioned in half and then one of the cut pieces was sectioned in half again, creating two  $\frac{1}{4}$  sections and one  $\frac{1}{2}$  section. After visual examination, a  $\frac{1}{4}$  section of each transition joint was mounted for metallographic preparation. The remaining two pieces were available for additional testing such as SEM/EDS or x-ray analysis.

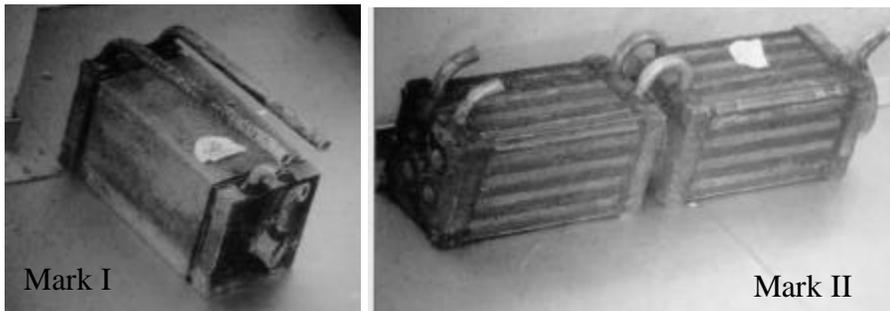
Figure 5. Mark I and Mark II following irradiation showing corrosion product.

Over the course of the irradiation, some leaks developed, from other components in Area A, which produced a spray of the cooling water to the exterior of the target/blanket assemblies. Radiolysis of this water in the air environment created a nitric acid spray on the components in Area A. Corrosion on the outside of the assemblies was clearly evident following irradiation and has been attributed, primarily, to the presence of the nitric acid, Figure 5.

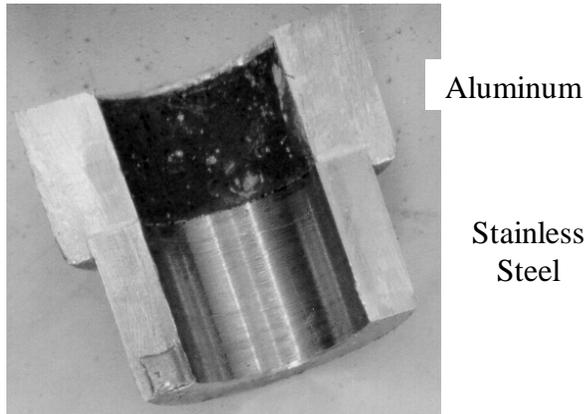
Figure 6. Inside wall of cooling line from Mark II assembly. Note black corrosion product on aluminum.

Visual examination of the sectioned inertia welded transition joints showed the presence of corrosion on not only the exterior of the cooling water tubing but also on the interior of the tubing. The corrosion was evident both on the aluminum section of the cooling water tubing and at the inertia welded interface, Figures 6-7. The stainless steel was relatively unaffected. Differences in the appearance of the corrosion on the aluminum metal and at the inertia welded interface was clearly evident between the different samples.

and the observation made visually and with metallography, Figures 6, 7 and 10.

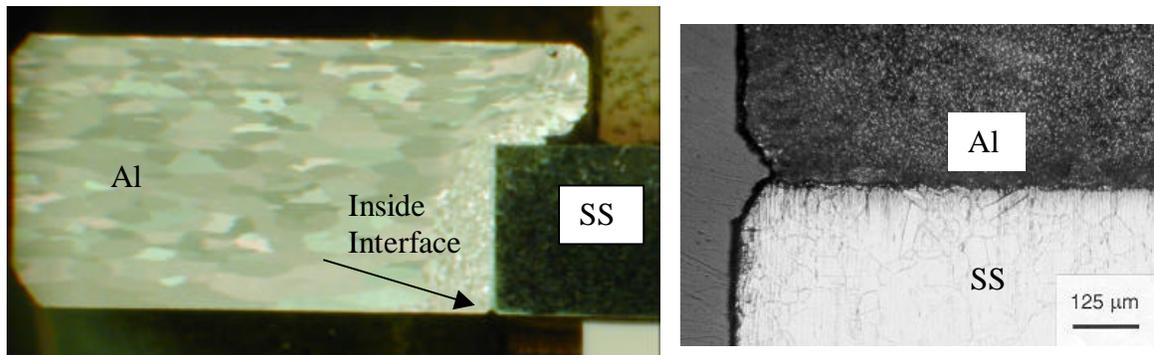
Figure 8. Slight degradation at inertia welded interface on the cooling water side of the High Flux inlet piece (a) macrograph and (b) higher magnification of inside at interface.

Samples from each assembly (Mark I, Mark II and High Flux Assemblies) were sectioned, prepared metallographically and examined in CMR hot cells. Because Al and SS are dissimilar metals, the inertia welded interface is susceptible to galvanic corrosion. Metallographic examination of the irradiated inertia welds indicates that some of the samples did exhibit degradation at the interface, which is characteristic of galvanic corrosion, Figure 8. However, general corrosion along the length of the aluminum piping

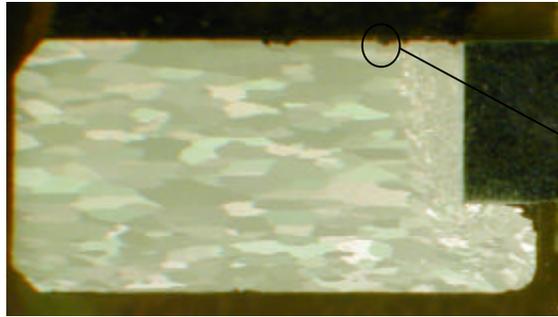
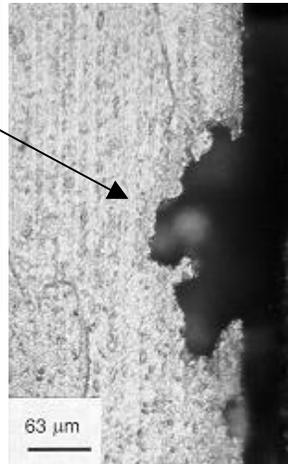
Figure 9. Pitting corrosion along the length of the aluminum on the cooling water side of the Mark I outlet piece (a) macrograph and (b) higher magnification of inside aluminum wall showing representative pitting.

and pitting corrosion were more prevalent, Figure 9. The pitting corrosion appeared to present the most severe effects of corrosion. This pitting corrosion, which is located along the piping away from the interface, indicates that the effect of the cooling water chemistry, flow rate and irradiation all need to be scrutinized more than the effect of corrosion due to the galvanic couple at the stainless steel to aluminum weld interface.

However, the  $Al_2O_3 \cdot 3H_2O$  oxide layer was fairly thick and masked the presence of the copper deposits. Copper deposits on aluminum are known to cause pitting, which would explain

the pitting corrosion observed in the metallographic specimens, Figure 9. The copper deposits were present as a result of the corrosion of the copper beam stop, which was also cooled by the XO2 cooling water system.

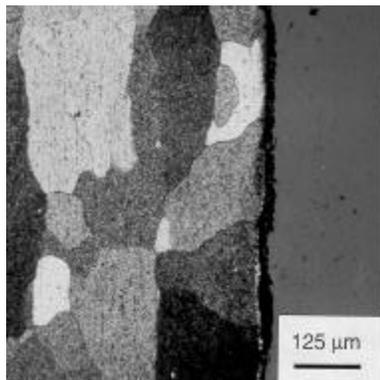
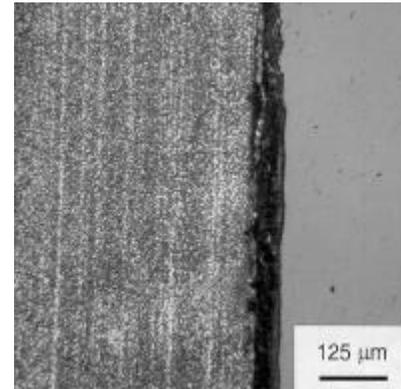
Figure 10. Oxide buildup on inside wall of aluminum cooling water piping near the inertia weld (a) high flux section (25.86 gpm) (b) Mark I section (7.0gpm).

Flow of the XO2 cooling water through the 9A and 9C inserts (Mark II and Mark I) was 7.5 and 7.0 gpm, respectively, while the flow through the 18B insert (high flux assemblies) was 25.86 gpm. As a result of these different cooling water flow rates, oxide thickness on the inside wall of the cooling water piping from the 9A and 9C inserts was approximately 50 μm while the oxide layer on the cooling water piping from the 18B

insert was approximately 15 μm, Figure 10.

Because the temperature of the cooling water was maintained at approximately 30°C the predominant oxide layer was Bayerite, ( $\beta$ - $\text{Al}_2\text{O}_3 \cdot 3\text{H}_2\text{O}$ ).

Initially, Gibbsite ( $\alpha$ - $\text{Al}_2\text{O}_3 \cdot 3\text{H}_2\text{O}$ ) is formed before a phase change to

Bayerite [5]. Fifty μm is the maximum oxide thickness expected for the Area-A test conditions [6].

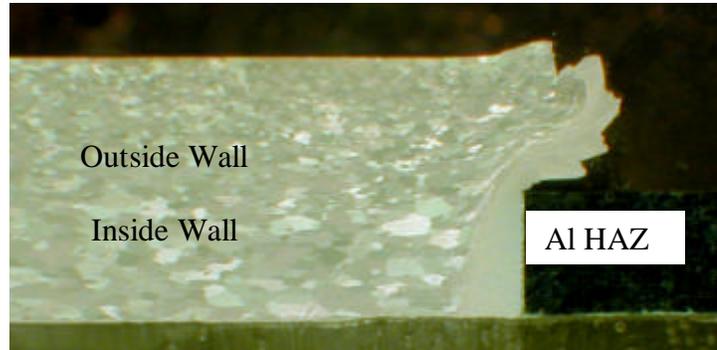
Figure 11. Control sample metallographically prepared in CMR hot cells. Solid inertia welded piece machined to simulate irradiated sections.

Another observation made during the metallographic examination is the effect of recrystallization of the Heat Affected Zone (HAZ) in the aluminum at the inertia welded interface and grain growth in the aluminum parent material. In each of the unirradiated inertia welded samples prepared for the baseline study, as well as the control sample that was prepared in the CMR hot cells, the HAZ does not show the presence of individual grains in the structure, Figure 11. In addition, the grain structure in the Al parent material of the unirradiated samples shows small equiaxed grains along the outside of the samples

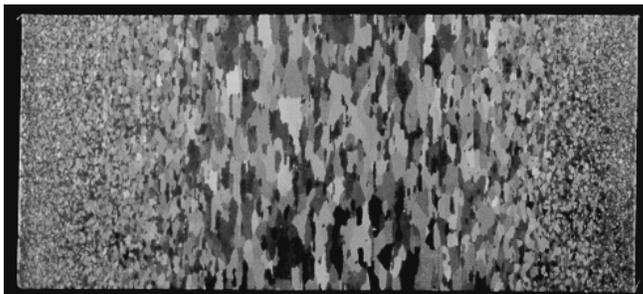
Figure 12. Grain size variation across solid aluminum parent metal from inertia welded specimens.

with an elongated grain structure near the inside of the samples, Figure 12. However, all of the irradiated inertia welded samples show grain definition in the heat affected zone of the aluminum, indicating recrystallization, and grain growth in the Al parent material, Figure 9(a), 10(a) and 13. The grain growth in the parent material resulted in a fairly consistent grain size throughout the microstructure. Because of the low dose these samples received and the low temperatures measured during irradiation, 30°C, the only

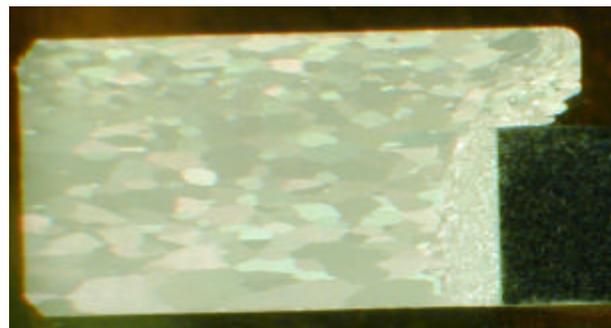
Figure 13. Irradiated piping from High Flux outlet section showing evidence of recrystallization at inertia welded interface (HAZ) and grain growth across the Al parent metal.

explanation for the recrystallization and grain growth is that these specimens were heated during welding before irradiation. Hardness measurements were performed on the inertia welded non-irradiated as well as the irradiated samples to evaluate differences as a result of the recrystallization and grain growth. Hardness values in the non-irradiated samples were higher than those in the irradiated samples, as shown in Figure 14. These hardness results indicate an aged structure in the irradiated samples and, hence, a reduction in strength. This reduction in strength did not present any deleterious effects during the six month irradiation. However, it is a consideration in the APT design and proper cooling techniques must be employed when joining the 6061-T6 aluminum tubing associated with the inertia weld to the aluminum tubing in the target/blanket region of the APT facility. The mechanical properties of inertia welded tensile specimens did not degrade during the irradiation [7].

period of time [8]. An inertia welded sample was sectioned into quarters for evaluating the effect of temperature on the recrystallization and grain growth of the HAZ and Al material. One quarter section was heated at 200°C and a second quarter section was heated at 300°C, each for a 24 hour period. No recrystallization or grain growth was observed in these test samples.

Welding of these inertia welded sections to the aluminum cooling water piping caused recrystallization at the aluminum HAZ and grain growth in the parent material. This recrystallization and grain growth in the Al material resulted in a reduction in hardness of the aluminum material. Quality control of the welding procedures for the design and construction of the APT facility will have to be controlled via procedures that outline appropriate cooling mechanisms for the inertia welds.

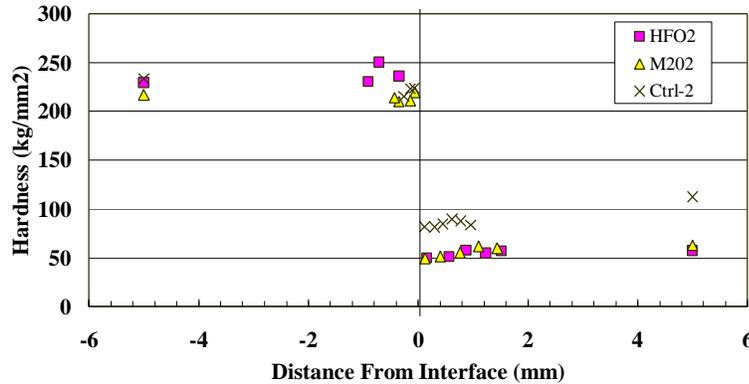
**Figure 14. Hardness vs. Position for Stainless Steel/Aluminum Inertia Welds**

explanation for the recrystallization and grain growth is that these specimens were heated during welding before irradiation. Hardness measurements were performed on the inertia welded non-irradiated as well as the irradiated samples to evaluate differences as a result of the recrystallization and grain growth. Hardness values in the non-irradiated samples were higher than those in the irradiated samples, as shown in Figure 14. These hardness results indicate an aged structure in the irradiated

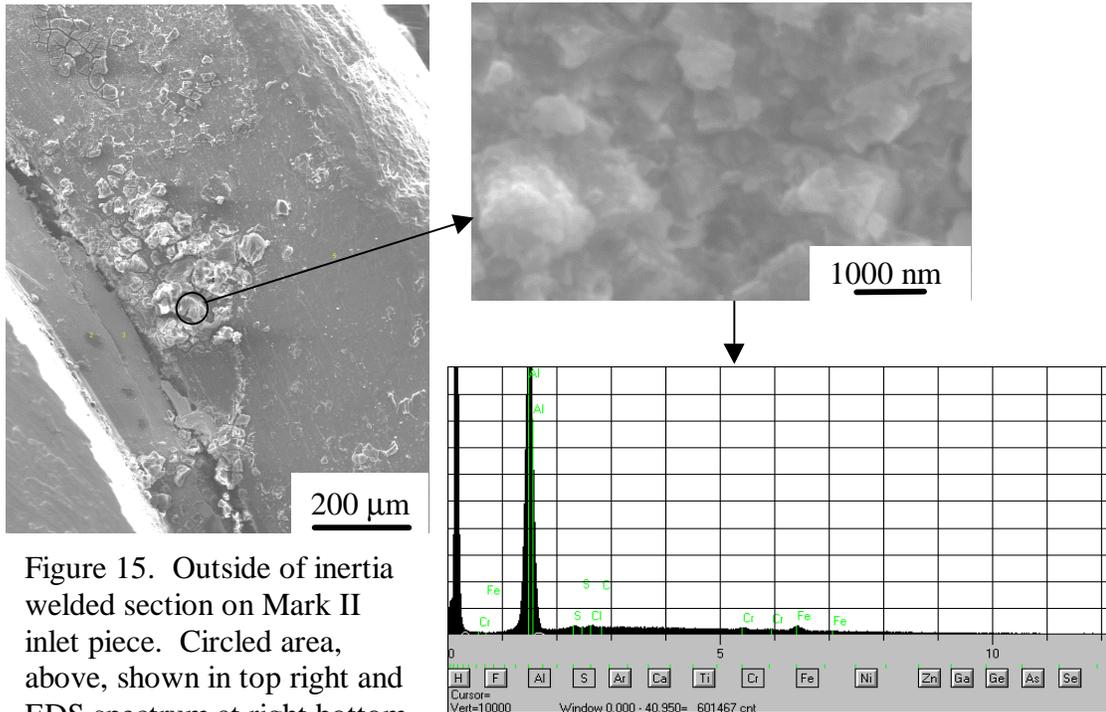
Figure 15. Outside of inertia welded section on Mark II inlet piece. Circled area, above, shown in top right and EDS spectrum at right bottom indicates aluminum oxide.

The primary focus of the SEM and EDS study was to investigate the interior of the inertia welded specimens. The exterior of the piping of the samples generally indicated corrosion product consistent with an aluminum oxide, Figure 15. The interior of the

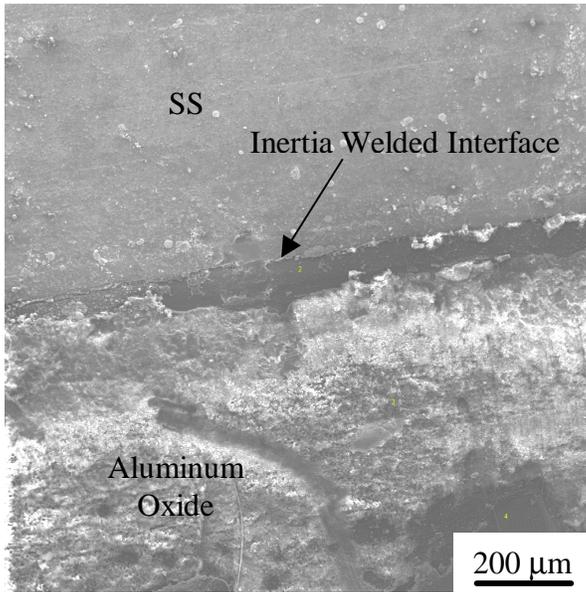
Figure 16. SEM of inside weld taken from High Flux Assembly on inertia welded interface. Note the region of “flaked-off” corrosion product adjacent to the interface.

inertia welded specimens showed a high degree of oxidation on the aluminum portion of the specimens, Figure 16, consistent with the previous visual examinations.

Several areas observed had portions of the aluminum oxide that had flaked off of the surface, exposing another layer below the outer layer, Figure 16, which is consistent with earlier findings. The presence of a “mud-flat cracking” appearance was evident on several samples, Figure 17. This flaking of the oxide layer and “mud-flat cracking” is consistent with the presence of  $Al_2O_3 \cdot 3H_2O$ , which does not adhere well to the surface of the aluminum substrate.

the weld interface shown in Figure 16 and 17 (High Flux) has flaked off while the oxide layer shown in Figure 18 (Mark II) does not indicate flaking. This observation is consistent with the increased agitation from the flow rate with the High Flux assemblies

Water chemistry and flow rate are important considerations for the APT design. The reduction or elimination of impurities in the cooling water aids in corrosion control of the aluminum piping and the inertia welded interface. Static or low flow rate of cooling water provides an avenue for oxide buildup on the aluminum portion of the inertia weld while a higher flow rate induces flaking of the aluminum oxide layer.

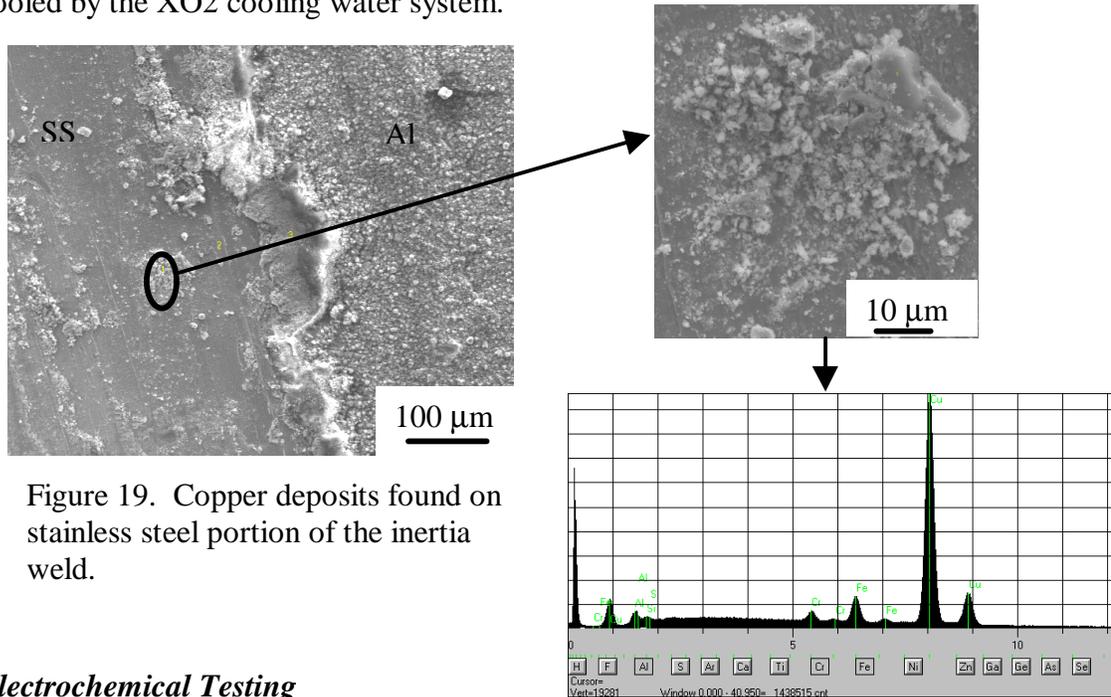
Figure 19. Copper deposits found on stainless steel portion of the inertia weld.

Another observation with the SEM was the presence of copper (Cu) rich deposits on the surface of the stainless steel, Figure 19. No evidence of the copper deposits was seen on the aluminum material.
