**WSRC-TR-2000-00434**  
**SRT-RPP-2000-00040**

# **Material Corrosion and Plate-Out Test of Types 304L and 316L Stainless Steel**

*SAVANNAH RIVER TECHNOLOGY CENTER*

Publication Date: January 2001

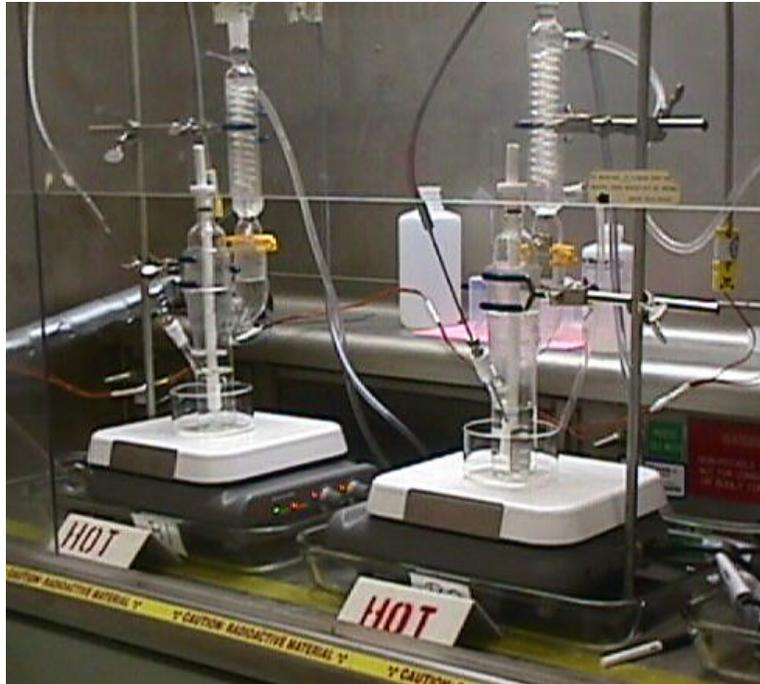
Figure 1. Apparatus for the corrosion and plate-out tests, before addition of solution and placement of coupons.

In accordance with the program test plan, coupon immersion tests were conducted in small volumes of pretreated Envelope B and C solutions [3]. Separate tests were conducted for each stainless steel in each pretreated solution. Only 250 mL of Envelope B solution were available for testing, so special glass flasks were fabricated for testing both envelopes. These flasks permitted full immersion of the standard 1-in. by 2-in. flat specimens prescribed in the test plan. The flasks were equipped with reflux condensers and with polyethylene and polytetrafluoroethylene rods on which to suspend the coupons (Figure 1). (Fluorinated plastic liners were not used in the flasks because the solutions were lower in hydroxide concentration than originally planned.) Coupons were also suspended for partial immersion in liquid and for exposure to vapor immediately above the liquid (termed the vapor position) and to vapor at the entrance to the condenser (termed the condenser position).

Duplicate coupons were exposed in the full-liquid, partial-liquid, and vapor positions. The flasks were heated on hot plates to bring the solution temperature to  $100 \pm 3^\circ\text{C}$ . The temperature of the vapor immediately above the liquid was  $88 \pm 3^\circ\text{C}$ , and the temperature at the inlet to the condenser was  $74 \pm 3^\circ\text{C}$ . Chilled water was recirculated through the condensers, which were linked in series. Thermocouples were used to measure the liquid temperature. The hot plates were adjusted manually to maintain temperature. Distilled water was added weekly to restore evaporative losses.

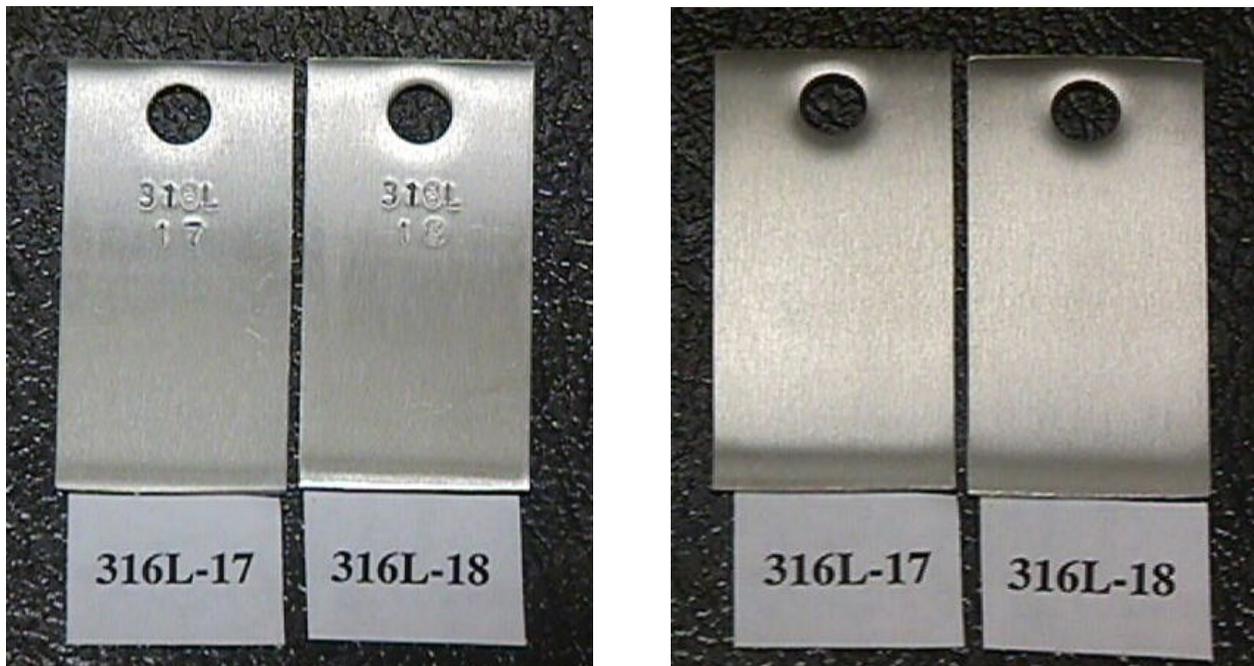
Figure 2. Front and rear views of 1 in. by 2 in. by 1/16 in. flat type 316L stainless steel coupons before test.

The flat test coupons were of types 304L and 316L stainless steel obtained from Metal Samples Inc., Munford, AL. The 304L coupons were 1/8 in. thick and the 316L coupons were 1/16 in. thick, and were used in their as-received, 600-grit-finish condition. The coupons were degreased in acetone, photographed, and weighed prior to emplacement in the test flasks. Figure 2 shows photographs of a typical pair of coupons before insertion into the test flask.

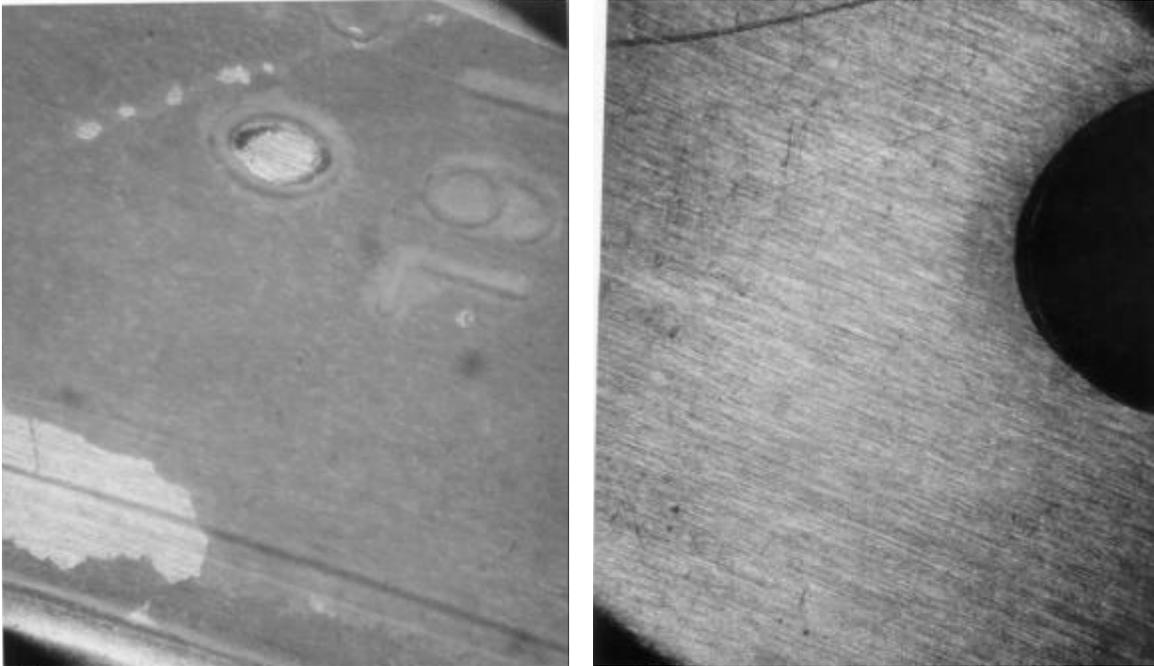
Figure 3. Front (left, mostly covered with plated-out solids) and rear (right, ) views of coupon 316L-20 after acid and mechanical cleaning, original magnification 7.8X. The thickness of the plated-out solids is about 0.003 in.

The high decontamination factors and the overall low level of contamination of the cleaned Envelope C coupons were revealed visually in the absence of the substantial deposits of the type seen on Envelope B coupon 316L-20. Envelope C coupons were generally shiny with some areas of staining and few slight plated-out solids.

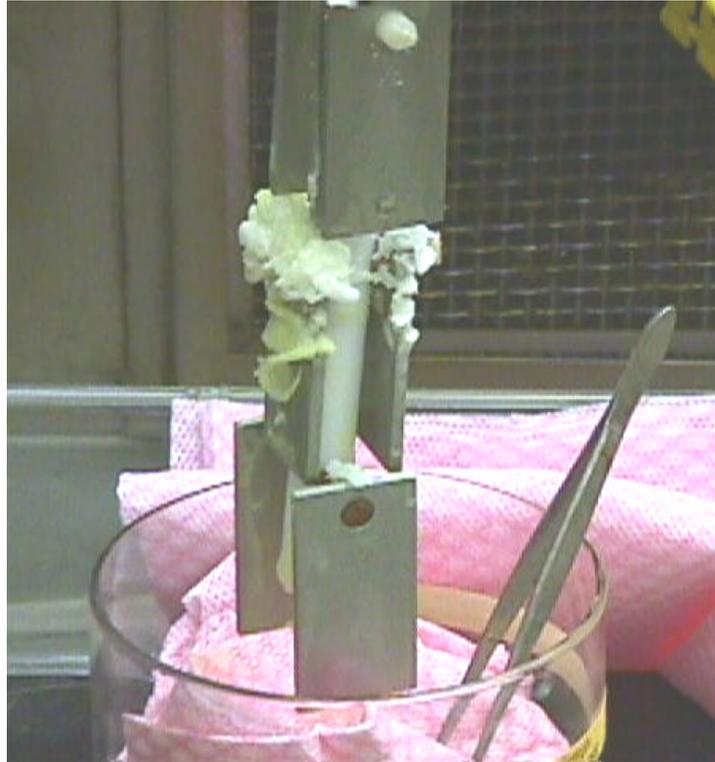
Figure 4 shows 304L stainless steel coupons upon removal from Envelope B solution after 61 days' immersion. This appearance was typical of both envelopes and both stainless steels. The solids attached to the middle pair of coupons (partial liquid position) were especially prominent, although not tightly adherent.

There was considerable plate-out of solids in hard, thin films on coupons that were in contact with liquid. Thin films of solids also deposited on the vapor position coupons. Substantial precipitation of solids was seen at the liquid-vapor interface, where solution was continually evaporating. Figure 4 shows a photograph of these especially prominent deposits on coupons in the partial liquid position. These deposits were not adherent and were easily dislodged mechanically. The materials deposited on the test coupons were not chemically analyzed.

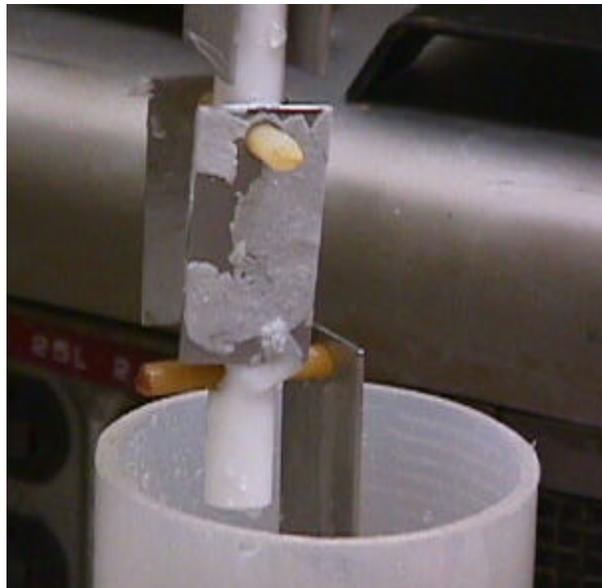
Figure 5. Type 316L coupons after acid immersion for 24 hours, with deposits especially retained on the partial-liquid position coupon.

The coupons were soaked in 1 N nitric acid at room temperature for 24 hours for decontamination and dissolution of plated-out solids. As Figure 5 and 6 show, deposits were still quite evident following the acid soak. The whitish, plated-out solids remaining after the mechanical cleaning and wiping consisted of thin films less than 0.001 in. thick to a maximum of about 0.003 in. thick. The thickness was determined with an optical microscope whose stage is equipped with a digital micrometer. The heights of an object or material normal to the plane of the specimen can be measured through the micrometer readout of the distance between in-focus images of the top and bottom of the object. Radioactively contaminated specimens were contained in transparent polyethylene bags during measurement.

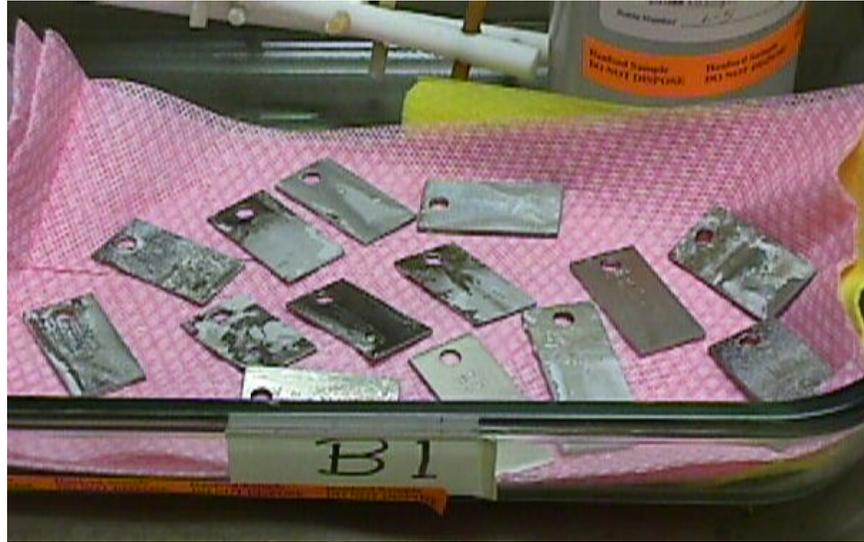
Figure 6. Type 304L and 316L coupons from Envelope B after acid immersion, rinsing, and drying.
