DWPF Melter #2 Prototype Bus Bar Test Report (U)

Westinghouse Savannah River Company
Aiken, South Carolina 29808

Engineered Equipment & Systems Section
Savannah River Technology Center

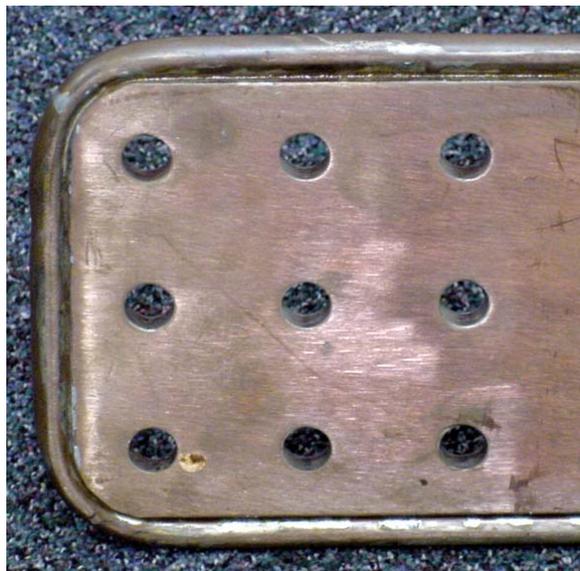
Figure 2-1

Close-up of Existing Bus Bar Heater End

Some of the copper tubing attached to the Defense Waste Processing Facility (DWPF) Melter #1, Dome Heater Bus Bars has developed leaks. Thermal modeling of the existing Dome Heater Bus Bars (see Figure 2-1) indicates that there is significant heat generation in the Inconel terminals of the heaters.[1] Thermal stress/cycling created by this heating may have contributed to the leaks in the tubing on Melter #1. The DWPF Melter #2 has been constructed and is currently being readied for installation in DWPF when Melter #1 reaches the end of its life. A modification necessary to prevent recurrence of the cooling water leaks is desired prior to installation of Melter #2 in DWPF. A timely, yet proven, solution is required due to Melter #1 having exceeded its original design life, and the importance of reliable operation of this critical and remotely-accessed system that precludes repair of the bus bar once installed.

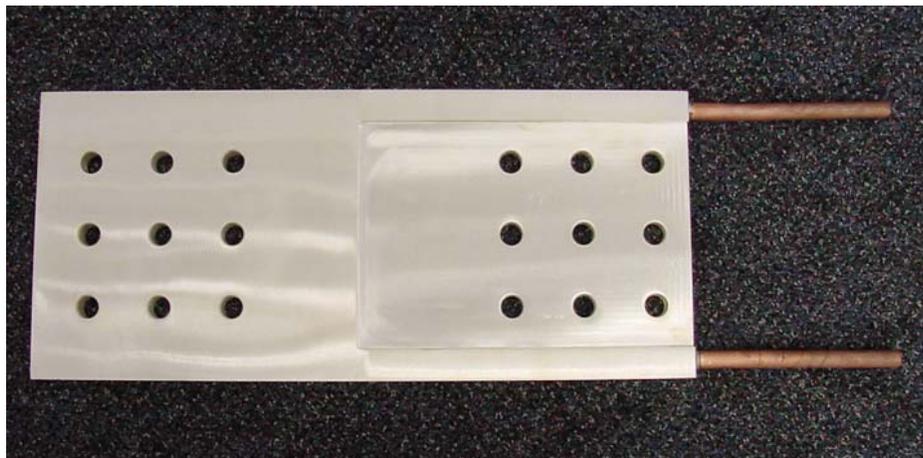
Figure 2-2
Prototype Bus Bar

The prototype bus bar is a 3/4" x 8" C110 copper bar approximately 18 inches in length with an internal cooling water passage (see Figure 2-2). The bus bar was manufactured by Watteredge-Uniflex of Avon Lake, Ohio (a national manufacturer specializing in bus bars and other high-current-carrying components) per their standard practice for the fabrication of internally cooled bus bars, and EES drawing number EES-22787-R3-001.[2] The prototype bus bar was purchased under Purchase Order number AC14343A, placed on August 23, 2000. Included as part of the bus bar design is the connection detail for the bus-to-transformer and the bus-to-heater connection points. This detail was altered from the existing design to provide a more reliable connection, given the cyclic loading of the system as current to the Dome Heaters is varied to control vapor space temperature.

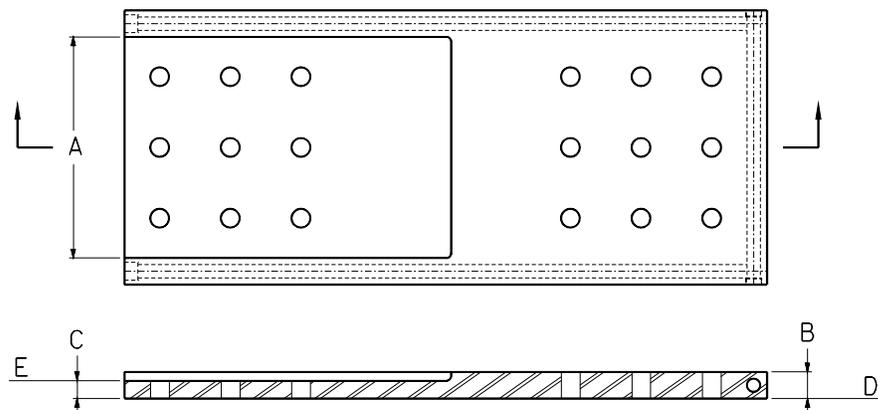
Figure 3-1
Dimensional Measurement Locations

Dimensional measurements were conducted in the 717-A Dimensional Inspection Facility to quantify the as-built characteristics of the bus bar and compare this condition to the design drawing. The following attributes were measured: slot width (dimension A, Figure 3-1), bar thickness at each end (dimensions B and C, Figure 3-1), flatness of the bottom and top surface of the bar (areas D and E, Figure 3-1). In addition the position of slot A was also determined.

The dimensional inspection results were compiled in inspection report number 2000-IR-06-7066. All attributes were found to be within the tolerances specified on drawing EES-22787-R3-001. During testing it was discovered that the tolerance for dimension C (see Figure 3-1) on drawing EES-22787-R3-001 did not match the required tolerance listed in the Task Acceptance Criteria section of the TTQAP (EES-22787-TTQAP) for this test program, nor did it match the tolerance for dimension B. To address this conflict, drawing EES-22787-R3-001 was revised to match the TTQAP and reissued as Revision B.

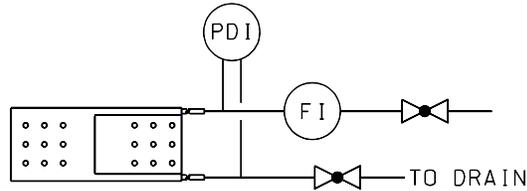
Figure 3-2
 Coolant Loop Test Configuration

two sets of data allowed comparison of the two designs. The test configuration is shown in Figure 3-2, and the following M&TE were used: flow meter (TR-20270) and pressure gage (TR-03604) with 4-20 mA output to remote indicator (3-2745). Differential pressure data was collected for a range of flows from 0.5 to 2 gpm.

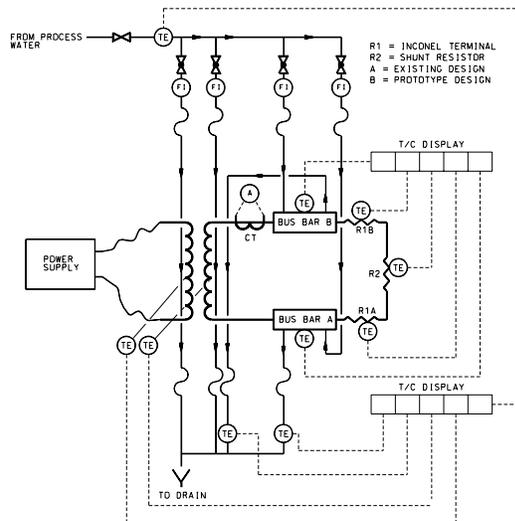
Figure 3-3
 Load Test Schematic

The two bus bars were operated in parallel at three current levels so that bus bar temperature, temperature distribution, and cooling water temperature differential could be compared. The test configuration is shown schematically in Figure 3-3, and Figure 3-4. The M&TE used in the test are listed in Table 3-A. In the test configuration three separate resistor sections were employed to close the secondary circuit. There were two Inconel sections (designated R1 A and B) to simulate the Dome Heater Stabs and an aluminum shunt resistor to close the circuit. The Inconel “heaters” were sized based on previous thermal analysis[1] to produce the same I^2R heating effect as the heater stabs in the actual melter assembly. The shunt resistor was designed to provide the proper resistance in the secondary for the power supply while providing sufficient surface area to convectively shed its own I^2R heating.

The most marked difference between the two bus bars occurred at the 5000 amp nominal secondary current test and these results are depicted below in Figures 4-3 through 4-5. As previously depicted in Figure 3-3, A is used to identify the existing design bus while B identifies the prototype. The resistors, R1 and R2, are also as shown in Figure 3-3 and represent the Inconel Terminal and the aluminum shunt resistor respectively.

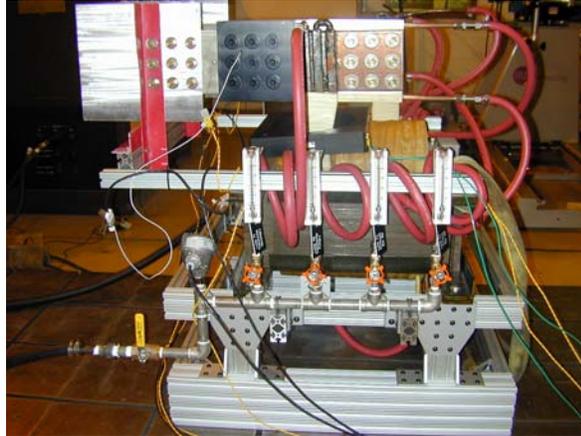
Figure 3-4
 Load Test Apparatus

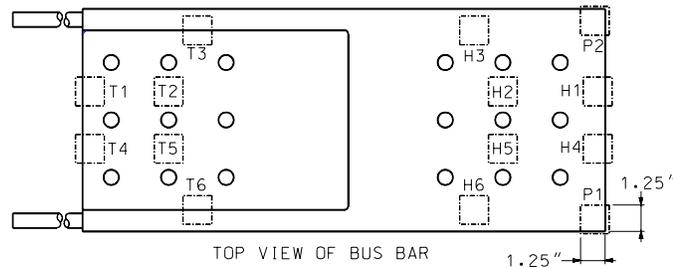
Figure 3-5
Bus Bar Sample Location Plan

Samples were removed from the bus bar according to the sampling plan shown in Figure 3-5. These samples were prepared and micrographs were recorded of the silver soldered or welded areas while the plating thickness was measured on half of the remaining samples in accordance with the test procedure FP-870.

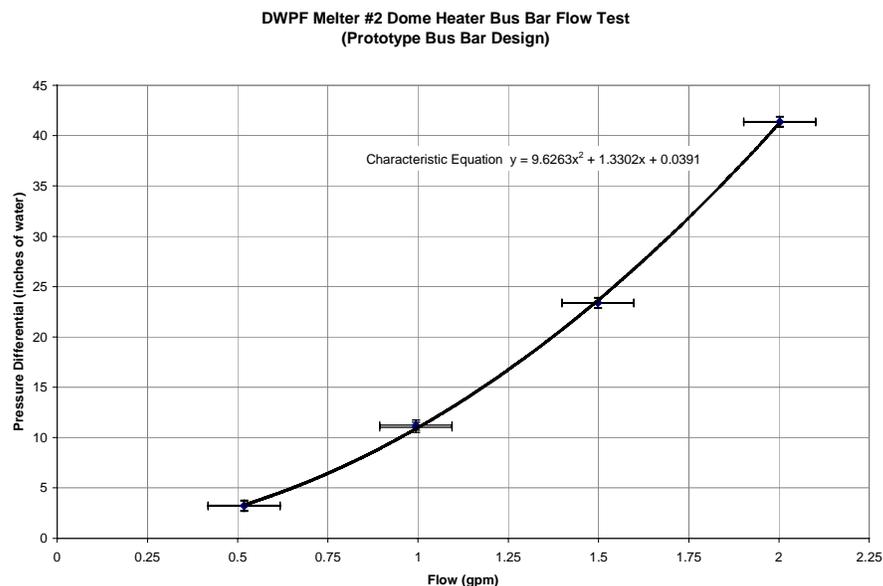
Figure 4-1
Prototype Bus Bar Flow Test Results

The differential pressure data gathered were plotted versus flow and a second order polynomial equation was generated for each of the bus bars. These graphs are shown below in Figures 4-1 and 4-2. The differential pressure in the two bus bars can be compared at a flow rate of 1.5 gpm using these characteristic equations. The results of this comparison show that pressure drop through the prototype bus bar is 42.8% greater than that through the existing bar. The total pressure drop in the prototype is 23.7 in-H₂O or 0.86 psi versus 16.6 in-H₂O or 0.60 psi in the existing design. Although the percentage difference appears large, the actual losses are small and amount to less than 5% of the total system pressure loss. The water temperature varied during the tests from 70.7 °F during the tests with the existing bar to 63.3 °F during the prototype tests. This variation would cause a 14% difference in Reynolds number; therefore, a difference in friction factors of about 1.3% between the two tests would reduce the reported percentage difference in pressure differential by the same 1.3%.

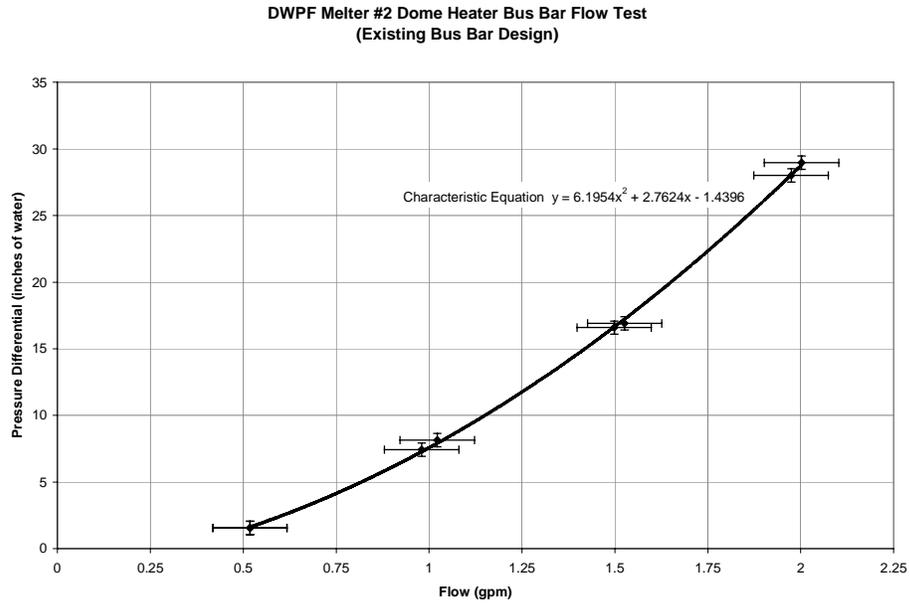
Figure 4-2
 Existing Bus Bar Flow Test Results

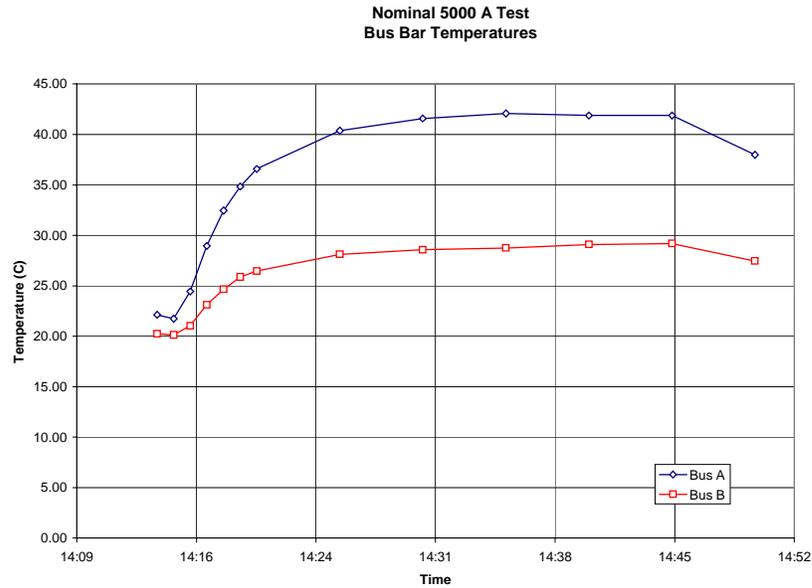
Figure 4-3
 Bus Surface Temperature vs Time for 5000 A Nominal Current

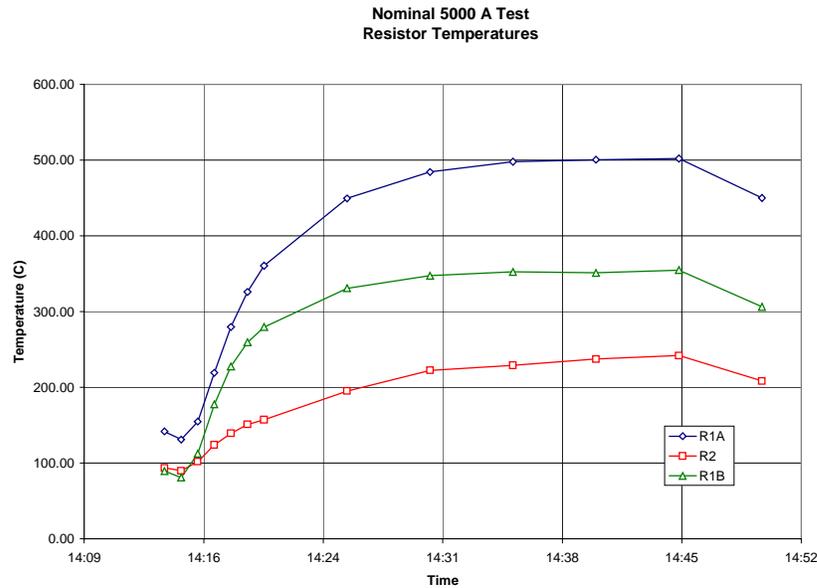
Figure 4-4
 Resistor Surface Temperature vs Time for 5000 A Nominal Current

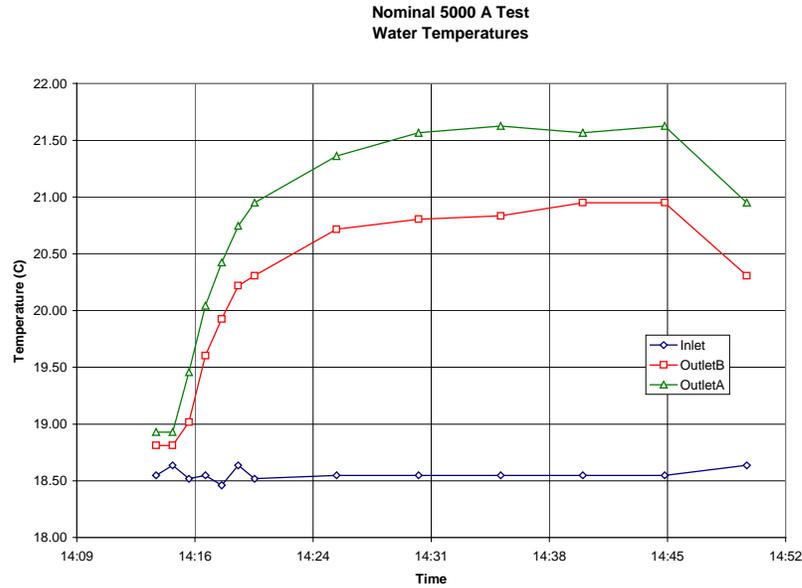
Figure 4-5
 Cooling Water Temperature vs Time for 5000 A Nominal Current

In all four tests cases the thermal energy carried from the system by the cooling water was greater in the case of the existing design bus bar. The familiar relation $q = \dot{m}c_p\Delta t$ was used to make this comparison and at first the result seemed incongruous since the existing design bus bar was operating at a higher temperature. However, when the electrical resistance of the two bars is compared it can be shown that the resistance of the existing bus bar is 40% greater than the prototype and therefore produces 40% more I^2R heating. The greater resistance in the existing bus bar design is due to its smaller cross sectional area. Because of the increased resistance more energy is required to be dissipated by the cooling water in the existing bus compared to the prototype bus to maintain the energy balance of the two systems.

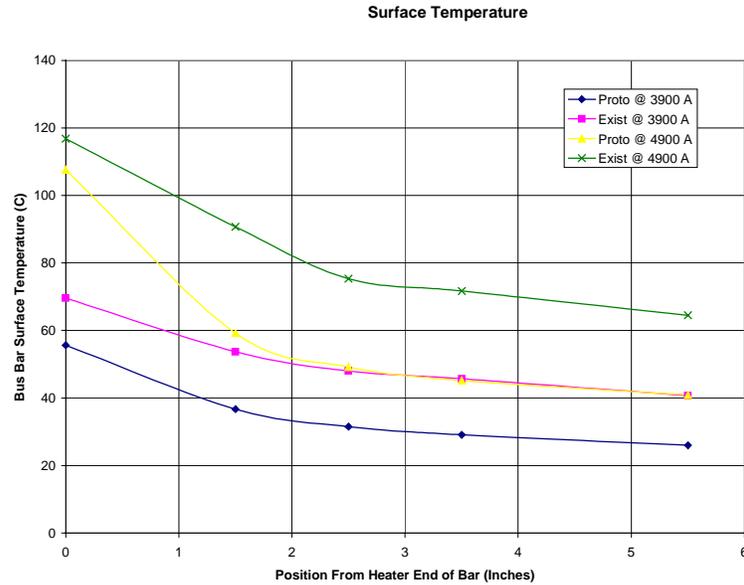
Figure 4-6
 Bus Bar Surface Temperature vs Position

Thermal profiles of the bus bars generated with the infrared camera produced fair images depicting the thermal gradient in the bus bars at each of the test points. However, the extreme heat from the Inconel resistor in the view of the camera appears to have biased the recorded temperatures. Using these thermal images a plot of the bus bar surface temperature along the length of the bar under four test conditions was generated. This plot is shown in Figure 4-6. Note that the close proximity of the Inconel resistor to the leading edge of the bus bar makes the determination of the maximum bus bar temperature difficult and for this reason the maximum temperatures are somewhat suspect. This is especially true of the maximum temperature presented for the prototype bar at the 4900 amp test point as this point does not follow the trends of the other curves. These curves suggest that the temperature delta between the two bus designs remains fairly constant along the length of the bar, at least over the first 5.5 inches measured.

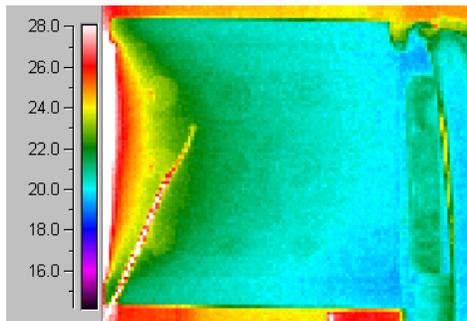
Figure 4-7
 Prototype at 2600 A

The temperature profiles for the 2600 and 4900 amp test conditions are shown in Figures 4-7 through 4-10. The profiles are consistent between the two current levels with only a change in scale. There are only slight “hot” indications of the bolt locations and this is at least partly due to the fact that the bolts protrude above the bus surface and are thus able to reflect the radiant energy of the Inconel resistor.

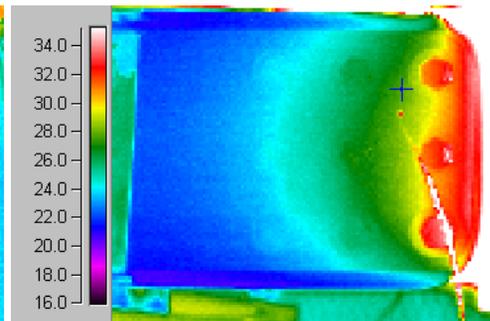
Figure 4-8
 Existing at 2600 A

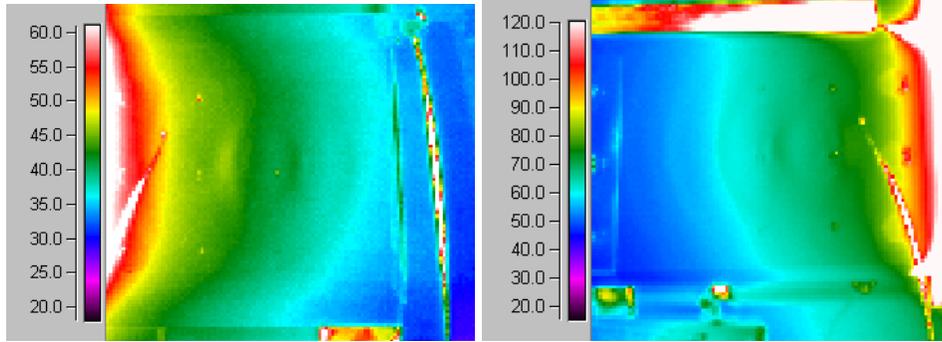
Figure 4-9
Prototype at 4900 A

Figure 4-10
Existing at 4900 A

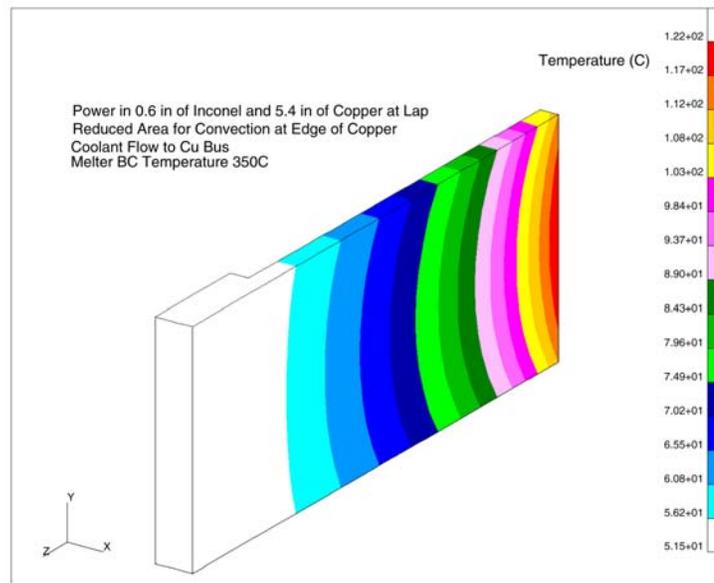
Figure 4-11
Temperature Profile Produced by Thermal Model[1]

The profiles produced are in good agreement with the profiles generated from a previous finite element analysis of the system[1]. One difference apparent when the images of the existing bus are compared with the corresponding profile generated by modeling is the inflection of the thermal profile at the rounded corners on the leading edge of the bar. The profile generated through modeling of the existing design at a 5000 amp load is shown in Figure 4-11.

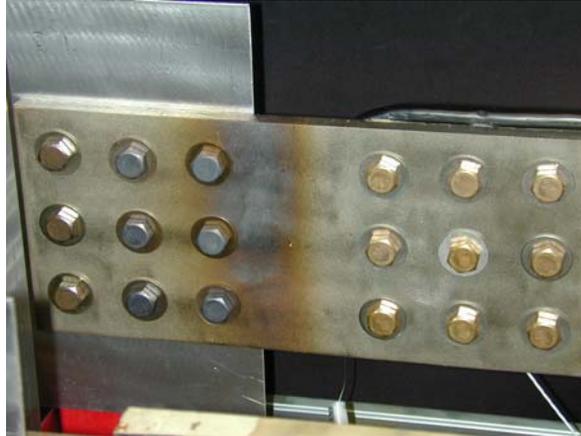
Figure 4-12
Heat-effected Zone in Inconel Resistor

The intense heat generated in the Inconel resistor is evident in the discoloration that can be seen in the post-test picture (see Figure 4-12). This heat-affected zone extends for approximately 2.5 inches along the resistor, and provides some indication of the current path through the Inconel with respect to the copper and aluminum attachments.

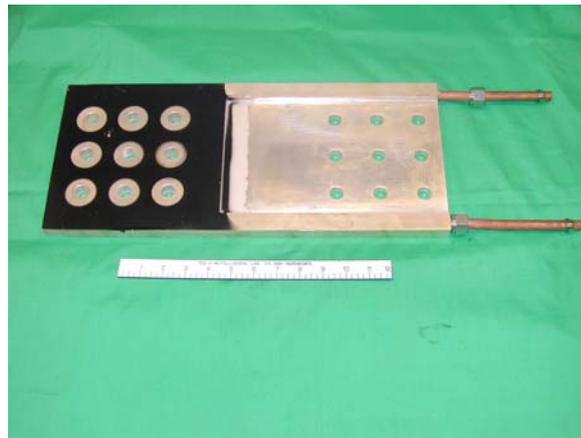
Figure 4-13
 Prototype Bus Bar Condition Previous to Destructive Testing

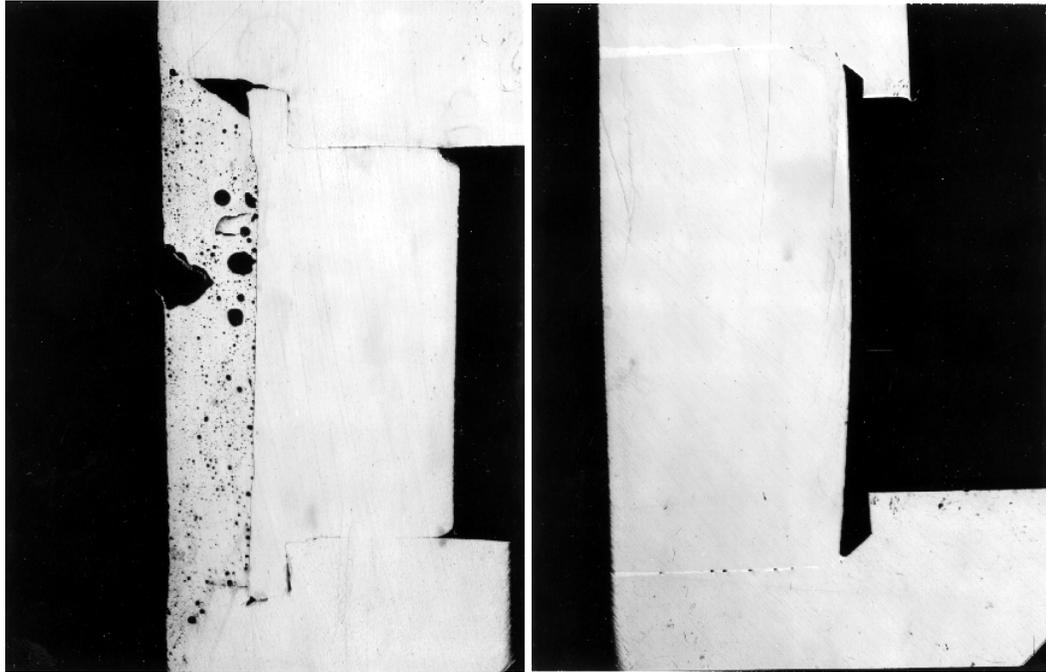
Figure 4-14
Welded Bus Bar Plug Section

Figure 4-15
Silver Soldered Bus Bar Plug Section

Sectioning of the plugged regions of the bus bar revealed a number of findings. The most important of these was that the plug installed by the manufacturer was silver soldered in place as opposed to welded, as called for on the design drawing. The two plugged regions are shown in Figures 4-14 and 4-15. Both joints were leak tight under pressure and at full design current. Review of the plugged areas also revealed that the manufacturer installed the plug opposite the location called for on the design drawing. (This was also noted when the bus bar was examined by video probe.) Also, the source of the flow restriction in the bus bar that was observed during the flow tests can be seen in the sample from the repaired corner of the bar. This sample is shown in Figure 4-16. It is clear from observing the

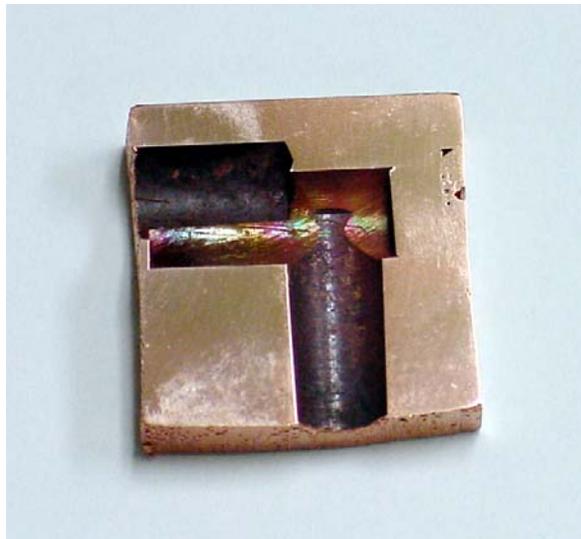
Figure 4-16
Repaired Corner of Bus Bar
(Shown in section)

original holes in the bar (the holes which pass across the edge of the sample) that the end of one bore (the cross bore) barely penetrated the side of the other.

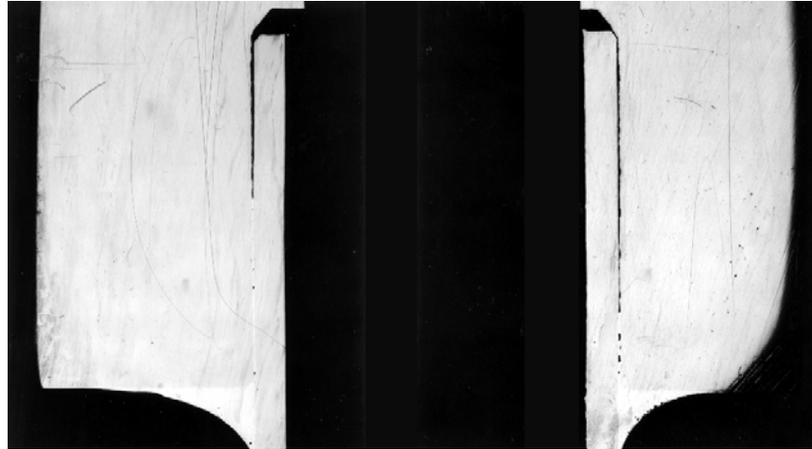
Figure 4-17
Bus Bar Tubing Connection Section

The tubing connections to the bus bar were also examined and appeared as expected based on the design drawing for the part. The silver soldered tubing connection is shown in section view in Figure 4-17.
