Residual Stress Testing of Outer 3013 Containers (U)

Savannah River Technology Center
Strategic Materials Technology Department
Materials Technology Section

Publication Date: August, 2003

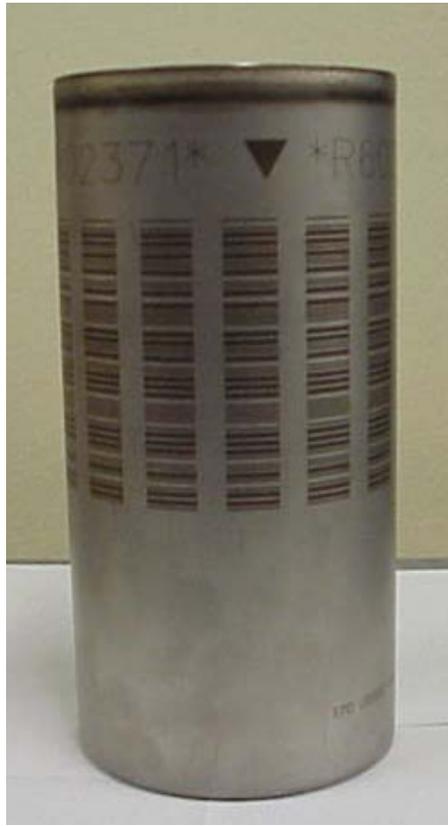
Figure 1. Outer 3013 Container.

The DOE Standard 3013 [2] outlines general requirements relevant to the planned DOE activities to stabilize and package Pu materials in 3013 containers, and place them in long-term storage. The outer 3013 container has been qualified as the primary barrier to the environment during storage of the plutonium materials. The design and fabrication of the outer 3013 containers are consistent across the DOE complex, Figure 1, and they comply with approved engineering drawings [6, 7, 8, 9]. The outer 3013 container, fabricated of “enhanced strength” low carbon grade 316 (i.e., type 316L SS) stainless steel has an inner diameter of 4.68”, outer diameter of 4.91” and a height of 9.84”, without the lid. The placement of the lid with the can sidewall provides an interference fit and therefore creates a crevice due to the chamfer and weld geometry. Two types of closure welds for the outer 3013 container have been approved within the DOE complex, namely the laser beam weld (LBW) and the gas tungsten arc weld (GTAW).

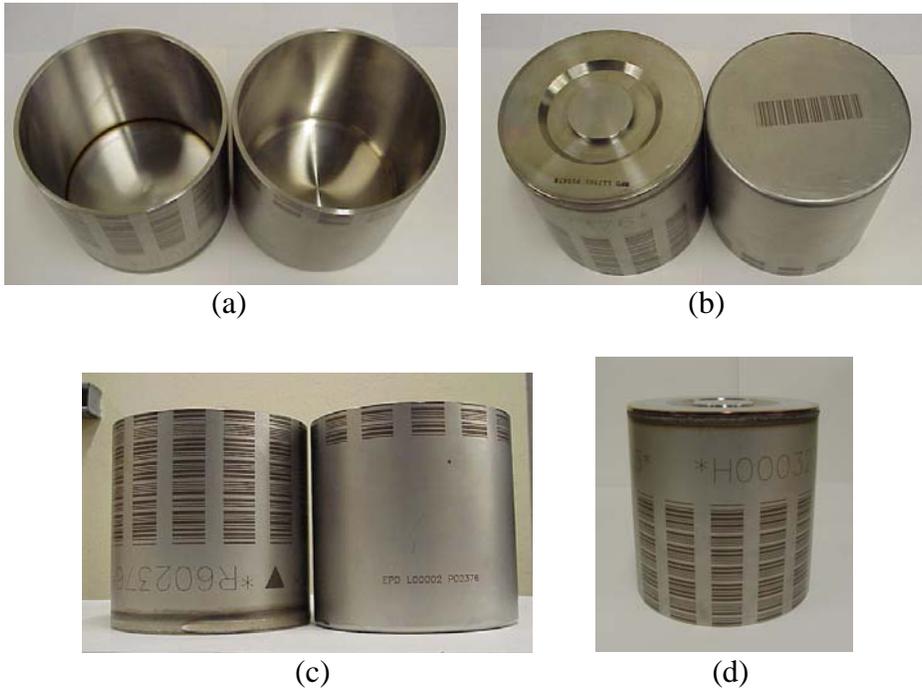
Figure 2. Sectioned Outer 3013 Containers For Testing (a) GTAW (b) GTAW (c) GTAW (d) LBW.

Three outer 3013 containers, two closure welded and one not closure welded, were sectioned axially in half with an electrical discharge machine (EDM) at the center height for the boiling $MgCl_2$ test, Figure 2. The EDM technique was selected because this method minimizes the amount of residual stress introduced to the can as a result of the sectioning process. The two closure welded containers consisted of one LBW and one

GTAW container. The containers were sectioned at the center height so that the residual stress state in the welded regions, both the fabrication weld and the closure weld, would remain as undisturbed as possible. Figure 3 shows the test setup of the MgCl_2 corrosion tests. During the test, each half of the 3013 container, which served as the sample as well as the vessel containing the MgCl_2 solution, was placed in a larger containment vessel to collect any MgCl_2 solution that may leak through the 3013 container specimen. The nested containers were then placed on a hot plate. A water-cooled condenser and lid, made to fit snugly into the 3013 container specimen, were designed with a liquid trap and an insert for a thermometer. A solution of 25 weight percent solution of magnesium chloride was placed in the liquid trap per the ASTM standard. The approximately 45% MgCl_2 test solution that boils at $155.0 \pm 1^\circ\text{C}$, prepared according to the ASTM Standard, consisted of 600 g of $\text{MgCl}_2 \cdot 6\text{H}_2\text{O}$ mixed with 15 mL water. Sufficient solution was prepared to ensure the tip of the thermometer was immersed into the solution during the test. Once the boiling temperature of the test solution was established at $155.0 \pm 1^\circ\text{C}$, it was then maintained during the test by either adding additional MgCl_2 crystals to the condenser, to raise the boiling temperature, or by adding water to the condenser, to lower the boiling temperature.

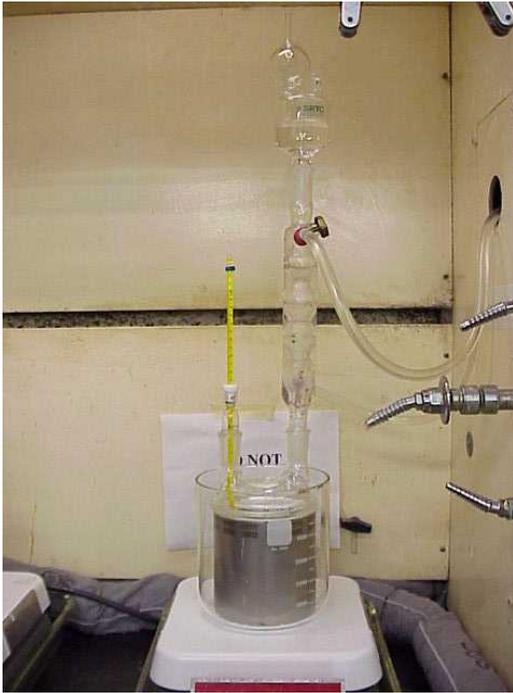
Figure 3. Test Setup For Boiling MgCl₂ Test.

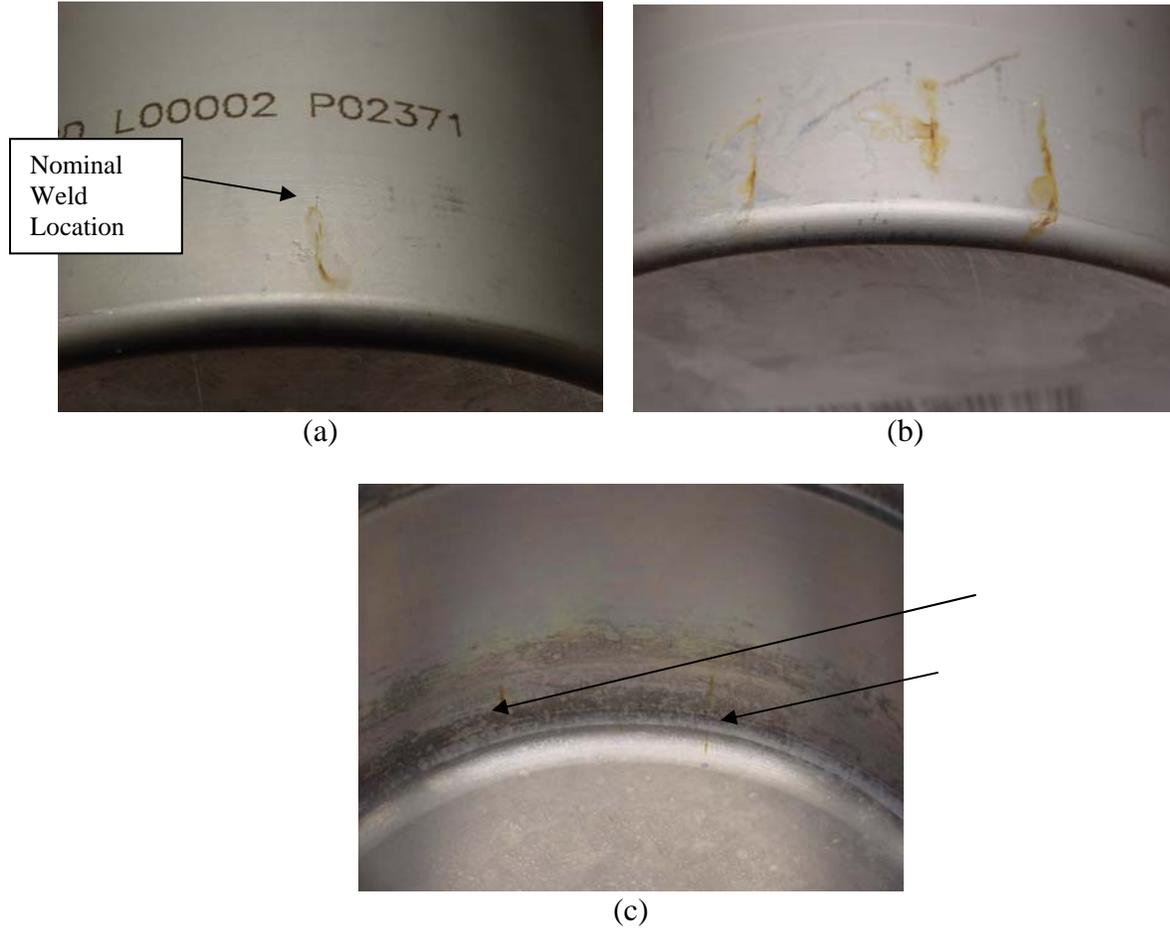
Figure 4. Bottom Half Of as-fabricated 3013 Container After Boiling $MgCl_2$ Test. (a) Exterior of container through wall crack (b) Exterior of container through wall cracks (c) Interior of container cracks observed, arrows indicate cracks

Through wall cracks were observed in the bottom half of the as-fabricated container after 48 hours of testing, Figure 4. Other cracks were observed on the interior of the container section that did not appear to propagate through the wall. Approximately five through wall cracks were visible and they ranged in length from 0.15" to 0.81" in. All of the cracks observed visually were perpendicular to the base-to-can fabrication weld. Metallographic examination of one crack showed that they appear to begin in the heat affected zone and grow into the base of the can, Figure 5. The cracks were typical of stress corrosion cracks with regions of branching along their length and some areas of cracking 90° from the main crack. The location and orientation of the cracks are consistent with the residual stresses expected as a result of the base-to-container weld and indicate that the residual stress state is significant in the as-fabricated weld region.

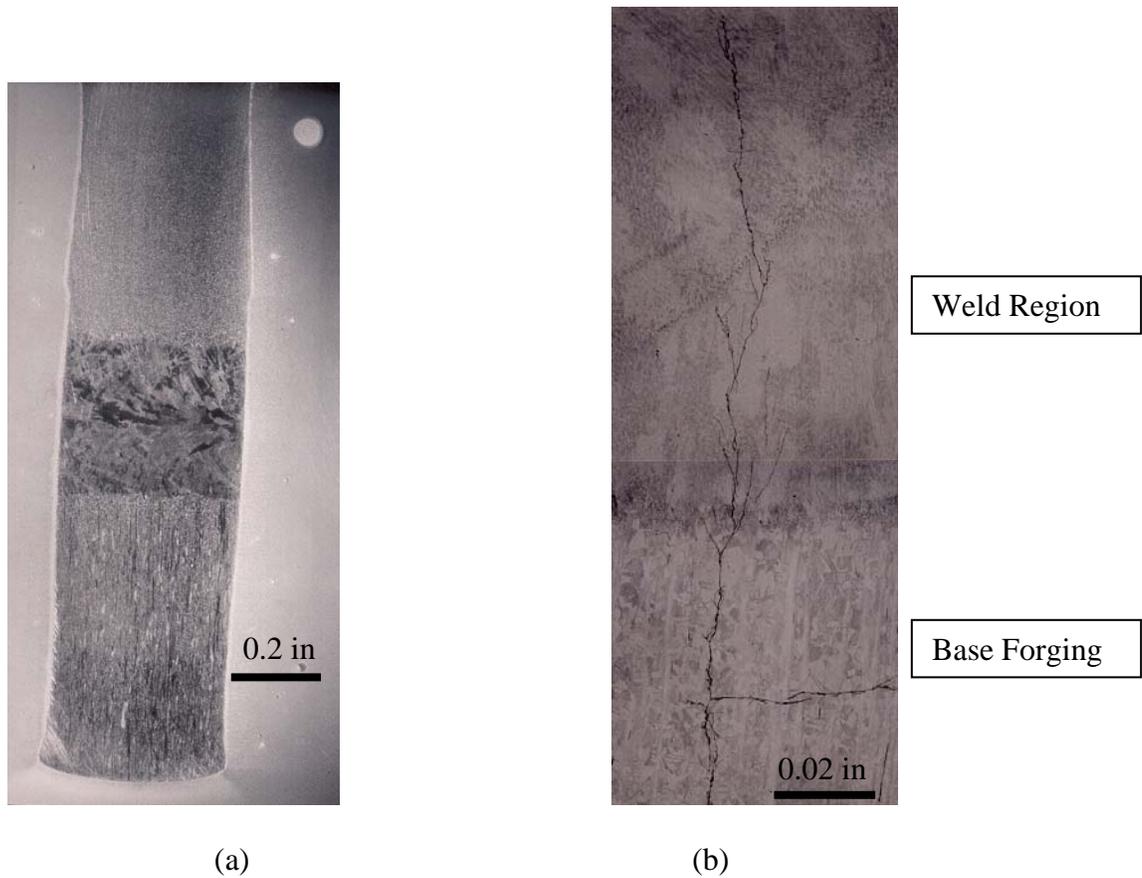
Figure 5. Metallographic cross section of through wall crack showing position of crack in relation to the can to base fabrication weld. (a) Overall macrograph showing base of can through fabrication weld and can body. (b) Stress corrosion crack associated with boiling $MgCl_2$ test from sample shown in (a). Note the position of the crack, beginning in the weld region and propagating into the base of the can. Note also the crack branching.

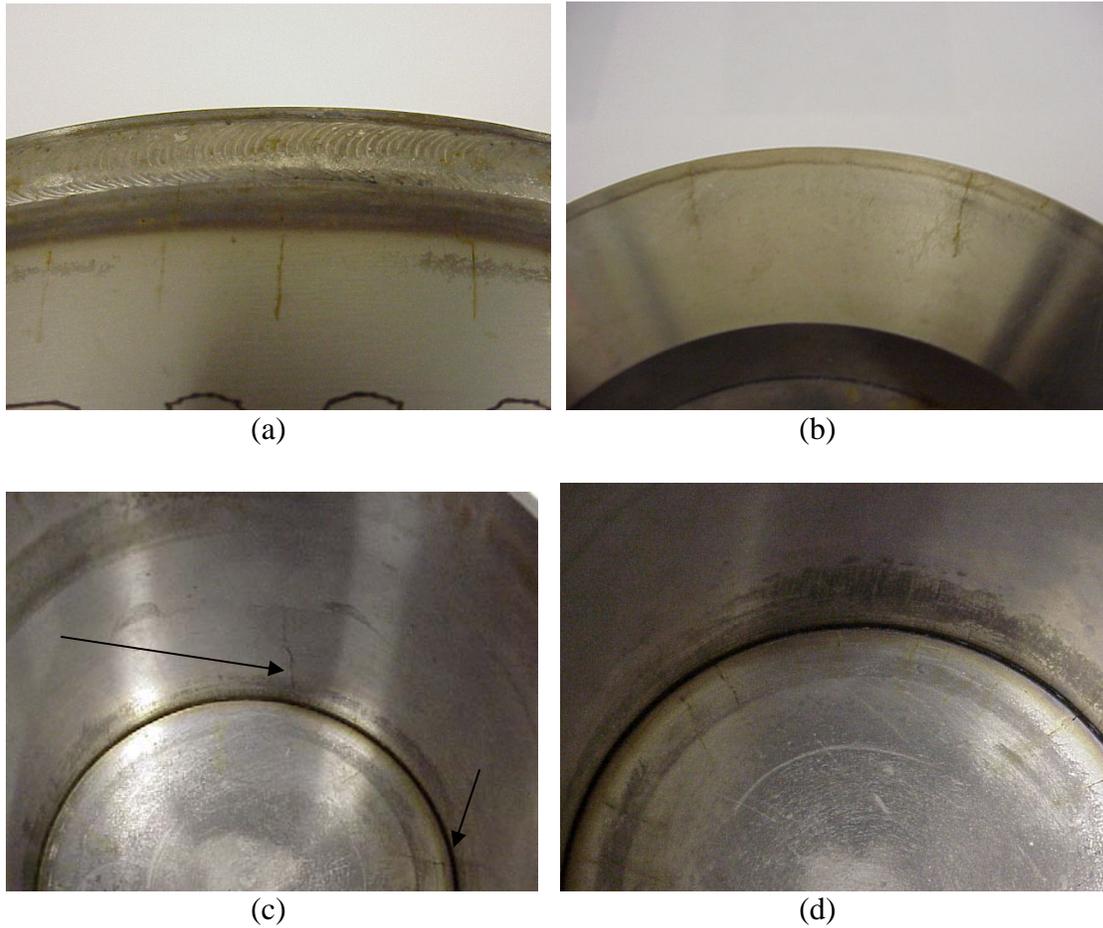
Figure 6. Top Half Of GTAW Closure Welded 3013 Container After Boiling $MgCl_2$ Test. (a) Exterior of container with appearance of through wall cracks perpendicular to GTAW weld into body (b) Exterior of lid showing appearance of through wall cracks perpendicular to GTAW weld in lid (c) Interior of container cracks observed in body of container (d) Interior of container cracks observed in lid.

Through wall cracks perpendicular to the GTAW closure weld and along the length of the container body were observed after 48 hours of testing, Figure 6 (a). Through thickness

radial cracks were also observed on the lid after 48 hours of testing, Figure 6 (b). Cracks on the inside of the container, as tested, are shown in Figure 6 (c) and (d). All of these cracks are consistent with the residual stresses expected as a result of the GTAW closure weld. A crack, perpendicular through the weld and then running parallel to the closure weld, was observed as shown in Figure 7 (a) and is imaged with dye penetrant testing as shown in Figure 7 (b). The external cracks in the lid and along the length of the container through the weld (Figure 6 (a) & (b)) however were not able to be imaged with dye penetrant testing. This observation seems to indicate that, although the cracks penetrated through wall, the resulting crack width was insufficient to allow the dye penetrant to resolve the crack.

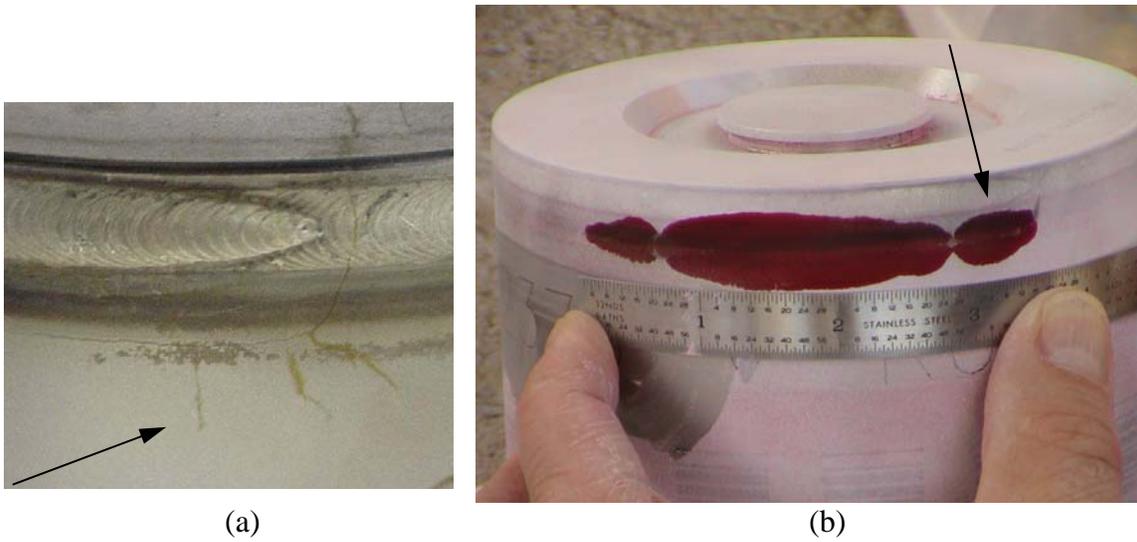
Figure 7. Top Half Of GTAW Closure Welded 3013 Container After Boiling $MgCl_2$ Test. (a) Crack extending vertically through weld and running parallel to weld (b) Dye penetrant test showing crack parallel to closure weld. Note that none of the cracks, as shown in Figure 6 (a) and (b) are visible with dye penetrant testing.

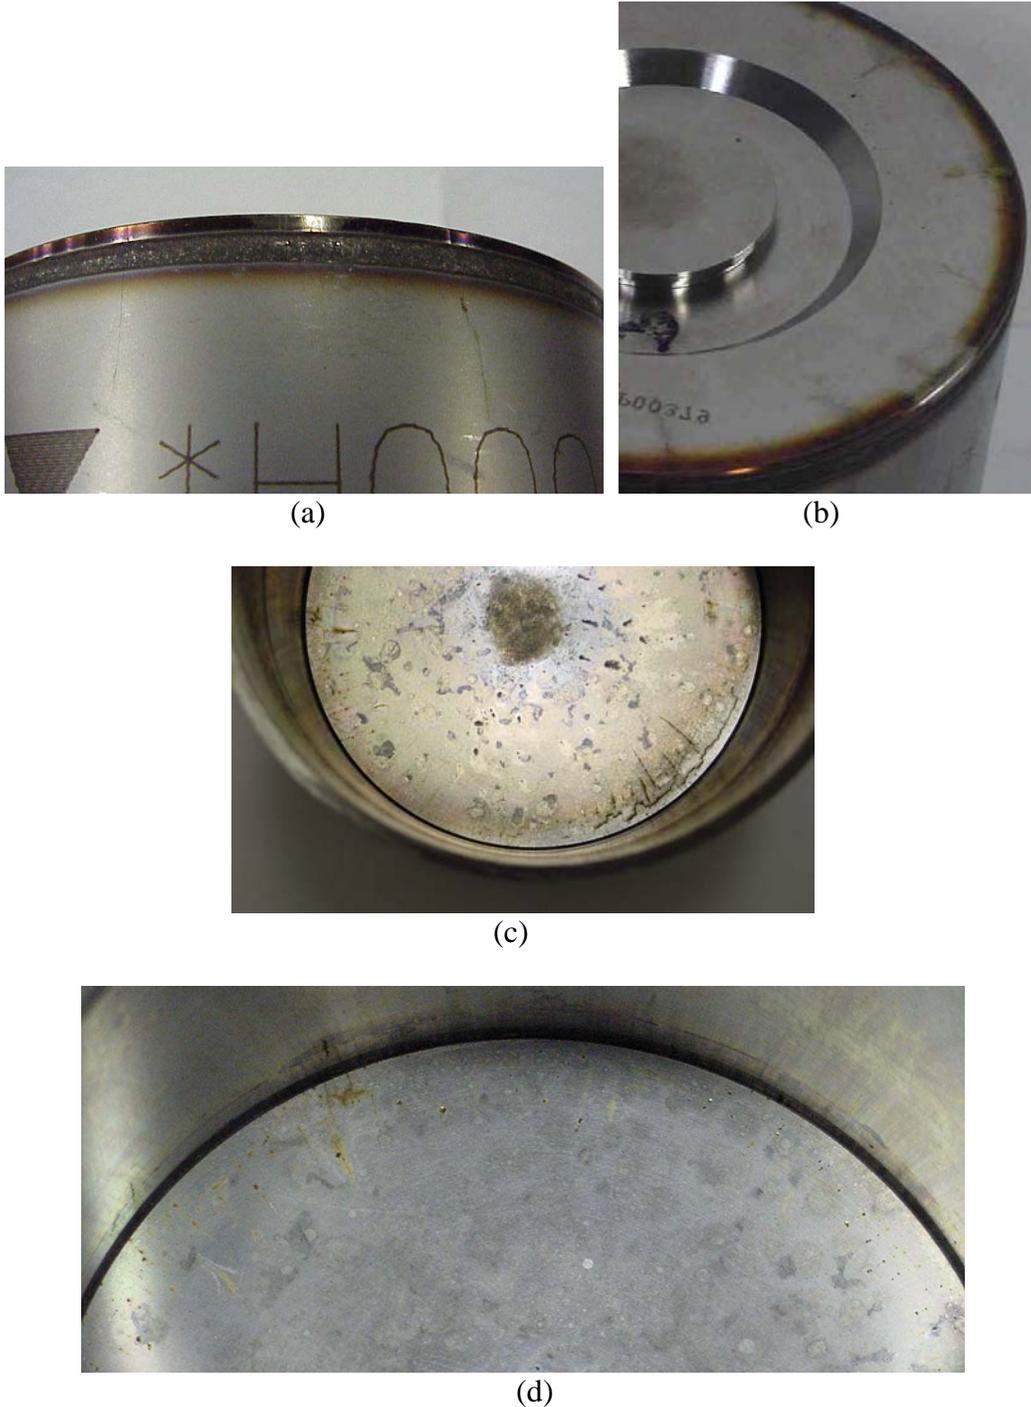
Figure 8. Top Half Of Laser Beam Closure Welded 3013 Container After Boiling $MgCl_2$ Test. (a) Exterior of container through wall cracks perpendicular to laser weld into body (b) Exterior of lid through wall cracks perpendicular to laser weld in lid (c) Interior of container pitting and crack indications observed on lid of container (d) Interior of container pits and cracks observed in lid.

Through wall cracks perpendicular to the laser closure weld and along the length of the container body were observed after 48 hours of testing, Figure 8 (a). Through wall radial cracks were also observed on the lid after 48 hours of testing, Figure 8 (b). All of these cracks are consistent with the residual stresses expected as a result of the laser closure weld. Pits were also observed inside the container, Figure 8 (c). The pits may be chloride induced pits that are exacerbated by the high residual stresses developed during the closure weld. Dye penetrant testing of the exterior of the tested container showed that the cracks observed in both the lid and the body were indeed through wall cracks and ran continuously from the lid into the body, Figure 9.

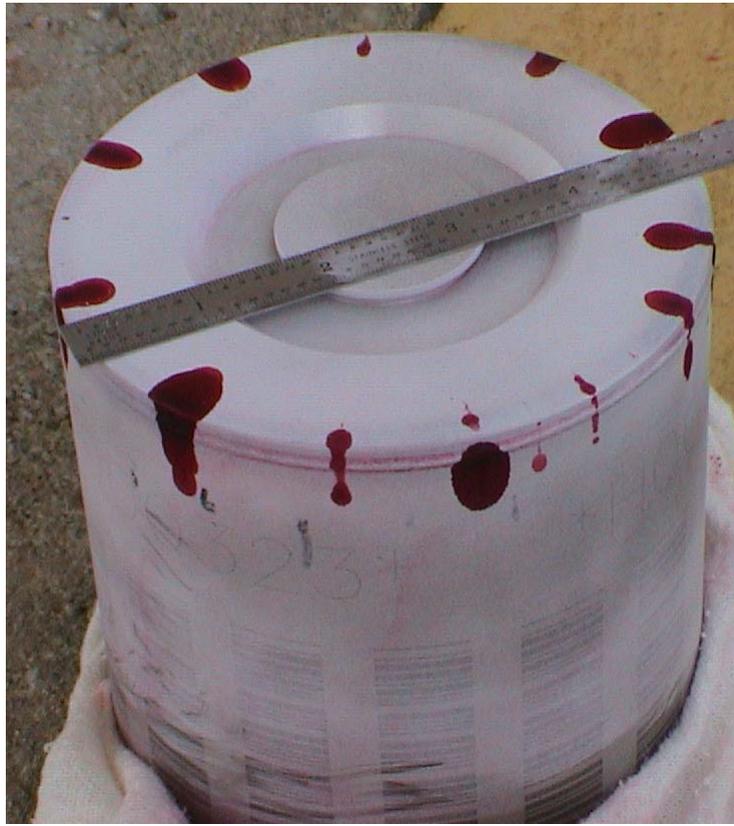
Figure 8. Dye Penetrant Test Of Top Half Of Laser Beam Closure Welded 3013 Container After Boiling $MgCl_2$ Test.
