Bubbler  
Vitrification

## **HIGH-TEMPERATURE CORROSION STUDY FOR THE RPP LOW ACTIVITY WASTE MELTER (U)**

**April 22, 2003**

Westinghouse Savannah River Company  
Savannah River Site  
Aiken, SC 29808

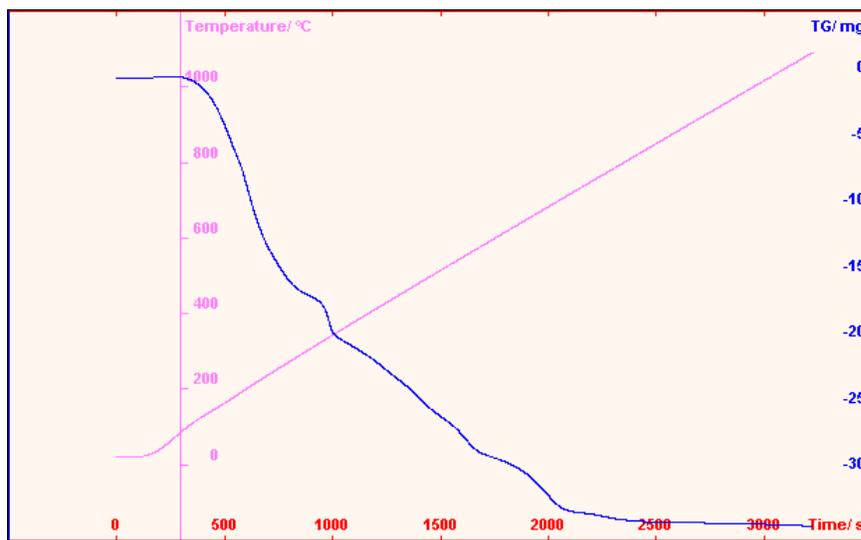
**Figure 3-4 TGA Plot of Weight Loss Vs. Time for LAW Melter Feed Simulant Slurry**

The melter feed was also characterized using a Setaram Model Setsys 16/18 Thermogravimetric Analyzer (TGA) coupled to a Balzers Model Quadrupole QMS200 mass spectrometer (MS). A 50 mg sample of the simulant slurry was heated to 1100°C in the TGA at a rate of 20°C/min. The sample chamber was purged with air at a rate of 35 ml/min. Figure 3-4 is a plot of weight loss versus time. The majority of the mass loss occurred within 30 minutes between 100°C and 700°C. Some additional mass loss may have occurred if the test were run longer. This mass loss would be expected to be small.

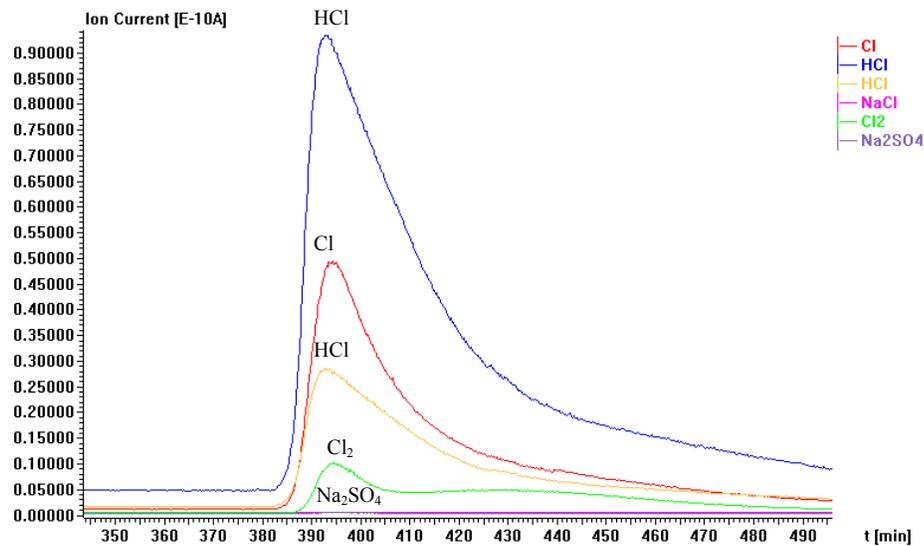
**Figure 3-5 Mass Spec Data Identifying Offgas Components Released from Simulant**

A mass spectrometer inserted in the TGA offgas line gathered compositional data. The MS was later used to characterize the evolved gases from the long-term vapor space experiment. Only a relatively small amount of Na<sub>2</sub>SO<sub>4</sub> salt was detected, most likely because the offgas was cooled to below 200°C prior to entering the mass spec in order to protect the instrument. Consequently salts present in the offgas would have deposited in the heated capillary transfer line prior to MS detection. Figure 3-5 shows the relative amounts of corrosive species detected when a fresh crucible of melter feed simulant was placed in the 1150°C furnace.

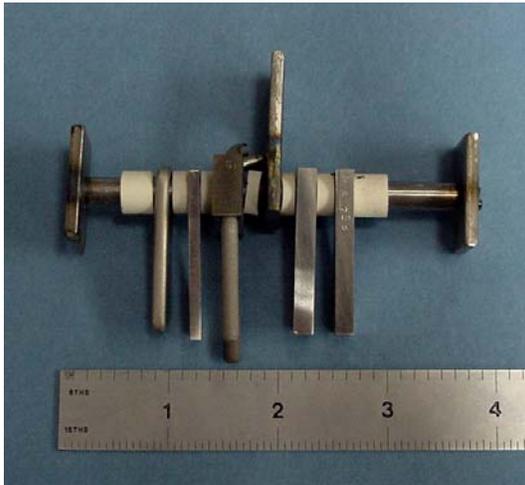
**Figure 3-14 Molten Glass Coupon Rack Prior to Testing,**

The test coupons attached to a rack and placed in a test crucible are shown in Figure 3-14 and Figure 3-15. Table 3-10 contains initial dimensions of each coupon. The glass supplied by VSL was finely ground, weighed into precise charges and placed into mullite crucibles. The glass charges were replaced on a daily basis, except on weekends, in order to maximize exposure to corrosive species, i.e. Cl and SO<sub>4</sub>. To minimize thermal shock to the coupons, the coupon rack remained in the furnace when the crucibles were replaced. This was accomplished by lifting the rack with a rod that was inserted through the top of the furnace and secured with a clamp until the crucible was replaced. After the ground glass melted the coupons were lowered into crucible and maintained at 1150 °C. A lid was not used on top the crucible thus the coupons and glass remained open to the furnace environment at all times.

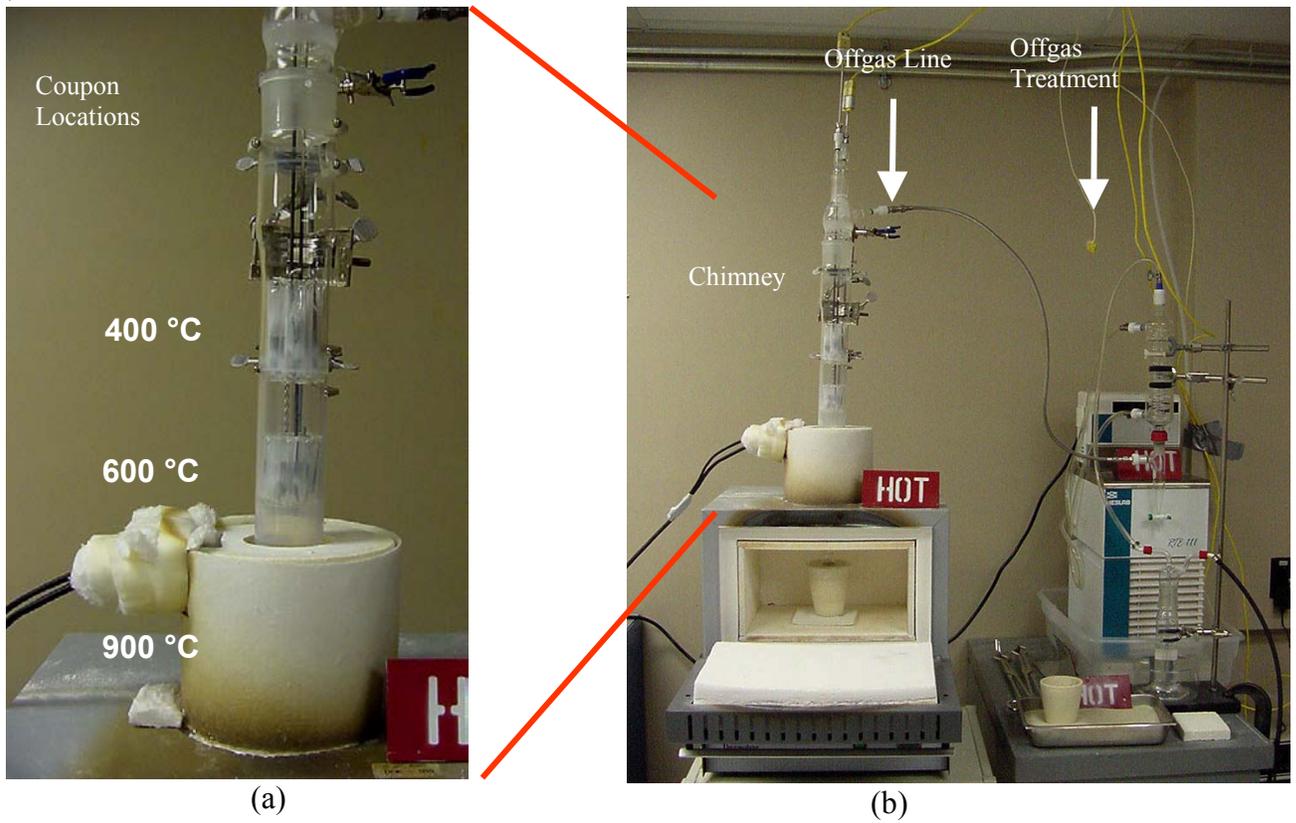
**Figure 3-16 Long-Term Vapor Space Test Apparatus a) Closeup of three coupon positions and b) Overall test setup**

In the vapor space corrosion simulation, a quartz chimney was inserted through the top of a muffle furnace containing a crucible of simulant LAW melter feed. A quartz lid was then placed flush on top of the crucible and was connected to the quartz chimney above with a sliding tube-in-tube joint. Three sets of test material coupons were positioned in the chimney in sections that reached 900°C, 600°C, and 400°C during muffle furnace operation. To maintain the 900°C region, a cylindrical ceramic heater was set directly on top of the muffle furnace, surrounding the first 15 cm of the chimney extending out of the furnace. During operation, thermocouples were used to continuously monitor the temperature zones. See Figure 3-16 and Figure 3-17.

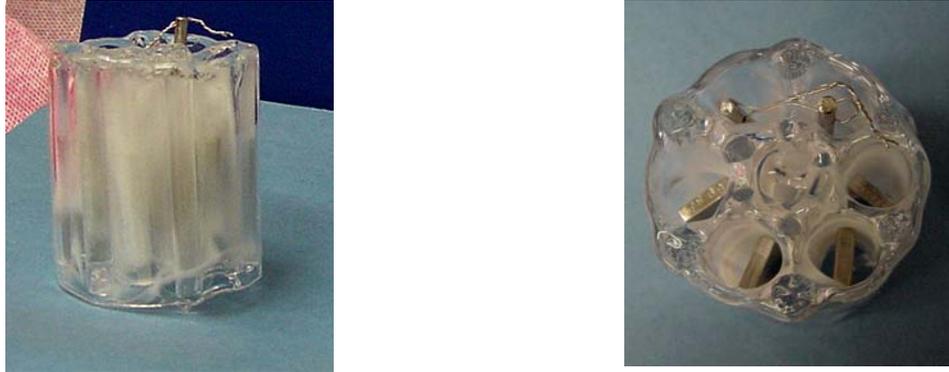
**Figure 3-18 Coupon Holder for the 600°C Zone, Before Testing**

Each set of test coupons was placed in a quartz holder. The six coupons per set were positioned evenly around the vertical axis of the chimney. See Figure 3-18. Air was pulled through the assembly from the crucible-lid interface by a venturi positioned downstream of the chimney. After leaving the chimney, the offgas passed through a condenser, a bubbler of sodium hydroxide solution, and a dry ice cold trap before exiting through the venturi.

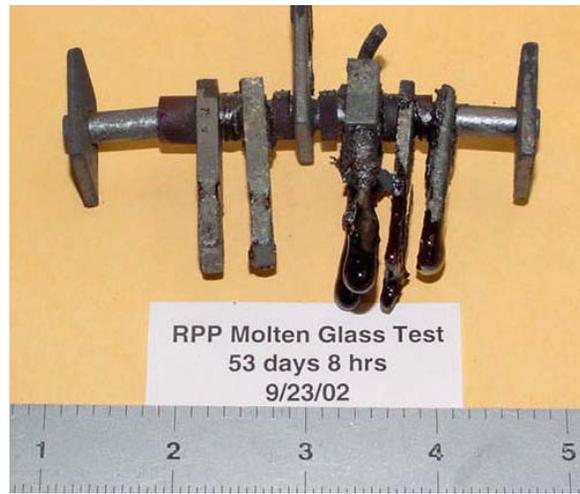
**Figure 3-20 Molten Glass Testing Coupons After Completion of Experiment**

The coupons were removed after 53 days of exposure. Figure 3-20 shows the condition of the coupons after test completion. Initial observations indicated that both the rods coated with Amdry 964 and AE 7855 had spalled and therefore, no further evaluations of these coupons were performed.

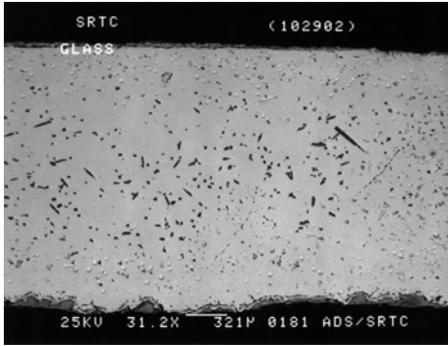
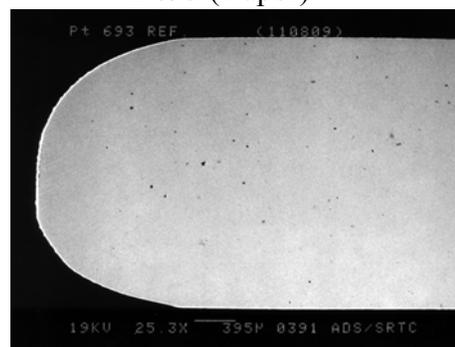
**Figure 3-21 SEM Photographs Showing Condition of Coupons After Molten Glass Exposure.**

SEM photographs were taken in representative areas showing regions of normal attack and areas considered to be worst case. The data are qualitative and are not meant to determine actual corrosion rates for engineering systems. A representative series of SEM photographs are shown in Figure 3-21. Areas deemed to be normal and worst case were then selected for further evaluation at higher magnification. A series of SEM photographs and representative EDS spectra are shown for each alloy in Appendix C.

EDS results indicate that chromium depletion was evident in the near surface region of all the coupons. This is evident in the MA 758 glass contact coupon EDS spectra locations 2, 3, and Center shown in Appendix C. An alumina layer was found beneath the outer Cr<sub>2</sub>O<sub>3</sub> layer in all the coupons and can be seen in the Inconel 693 glass contact coupon locations 9 and 10. This is expected since all the coupons contain aluminum additions. The large particles located in the center of Inconel 693 Pt coated and SRTC glass contact coupons consisted mainly of aluminum. Similar particles have been seen in high temperature oxidation studies performed at SRTC with similar alloys but further investigation of their composition or effect on mechanical properties has not been undertaken. All of the coupons experienced varying degrees of internal attack including internal void formation, intergranular attack (IGA) and chromium depletion. No evidence of chlorine or sulfur was found on the grain boundaries with the limited characterization performed.

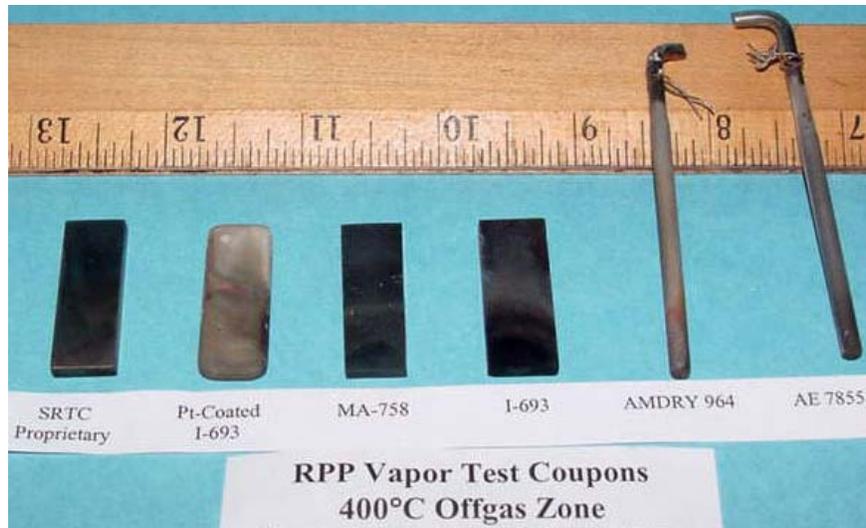
Figure 3-22 Long-Term Vapor Space Coupons from 400°C Region, After Testing

Figures 3-22 through 3-24 are pictures of the coupons after completion of the experiment. The coupons exhibited signs of corrosion in all temperature zones of the offgas line. The AE 7855 coating spalled off from the coupons in the 900°C zone. In general, the greatest amount of corrosion was seen on the coupons from the 600°C zone, followed by the coupons from the 900°C and then the 400°C zones. The corrosion was greatest on the bottom end of all the coupons, which was the end facing the offgas flow and also the orientation of the end grains.

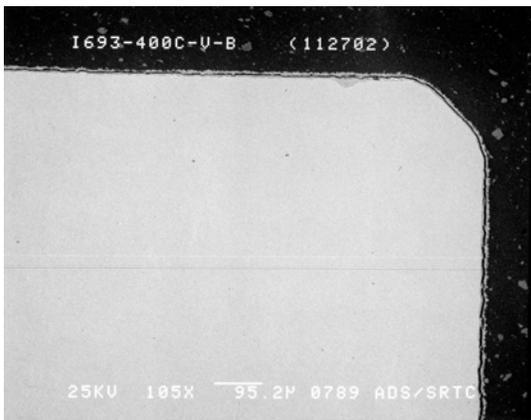
**Figure 3-25 SEM Micrograph; I-693 at 400°C Cross Section**

Among the coupons from the 400°C region, the platinum-coated I-693 coupon showed no discernable degradation when compared to a micrograph of the cross section of an as-received platinum-coated I-693 coupon plated at the same time as the vapor-space coupon. The MA 758 coupon showed the most degradation with metal loss apparent in the 20x SEM micrograph, and the deepest internal corrosion of the four coupons in the 400°C temperature zone. Both the SRTC alloy and the I-693 appeared similar in terms of metal loss. The I-693 coupon appeared to have a more even oxide coating than the SRTC alloy. The SRTC alloy did not, for the most part, have a discernable oxide layer at a 1000X magnification level. Figures 3-25 through 3-28 are SEM micrographs of the four coupons from the 400°C range. A bottom corner of the coupon is shown in cross section. See Appendices D and E for additional SEM micrographs and SEM-EDS scans.

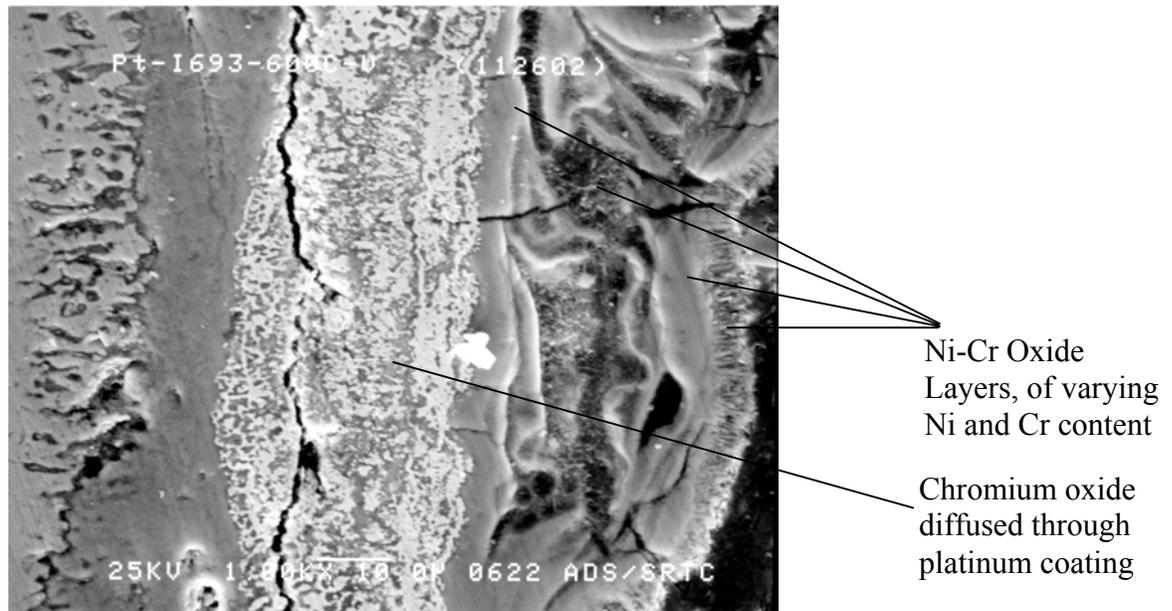
**Figure 3-33 Cross Section of Pt-Coated I-693 Coupon Showing Layers of Ni-Cr Oxide on Surface of Coupon**

Multiple layers of a Ni-Cr oxide were found on the outer surfaces of the four coupons in the 600°C zone, including on top of the platinum layer of the platinum-coated I-693 coupon. The Ni-Cr oxide may have deposited on the coupons from the feed or from material evolved from the coupons in the 900°C zone that were positioned upstream from the 600°C coupons. A second possibility is that the nickel and chromium diffused out to the surface of the 600°C coupons. For the uncoated alloys, regions of chromium depletion and some nickel depletion were found just beneath the surface of the cross sections. See Appendix F. However, on the cross section of the platinum-coated alloy, only chromium oxide was found diffused throughout the platinum layer; no nickel was present. See Figure 3-33. An additional vapor space experiment with only one set of coupons held at 600°C would be necessary to determine from where the Ni-Cr oxide layer originated. Regardless, the 600°C zone coupons were compared in relation to one another, all having seen the same conditions. Additionally, the 600°C coupons did experience the greatest amount of corrosion of the coupons from the three temperature zones, as expected.

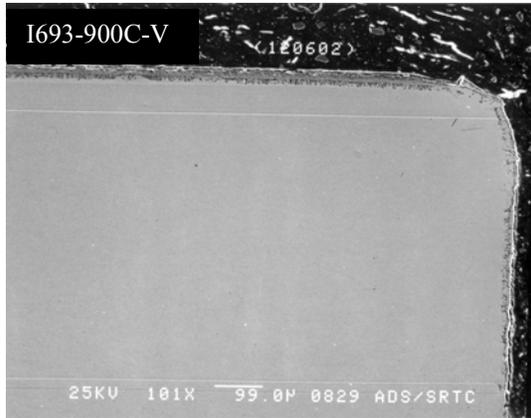
**Figure 3-34 SEM Micrograph; I-693 at 900°C Cross Section**

In the 900°C region, the extent of corrosion for all four samples was similar. Although the MA 758 had relatively low average internal attack, metal loss was noticeable on the 100X SEM micrograph. The SRTC alloy generally had a thicker layer of corrosion than the I-693 coupon or the platinum-coated I-693 coupon. The platinum coating on that coupon was missing in regions, and the maximum depth of internal attack was greater than on the uncoated I-693 coupon. Figures 3-34 through 3-37 are SEM micrographs of the four coupons from the 900°C range. A bottom corner of the coupon is shown in cross section. See Appendices D and E for additional SEM micrographs and SEM-EDS scans.

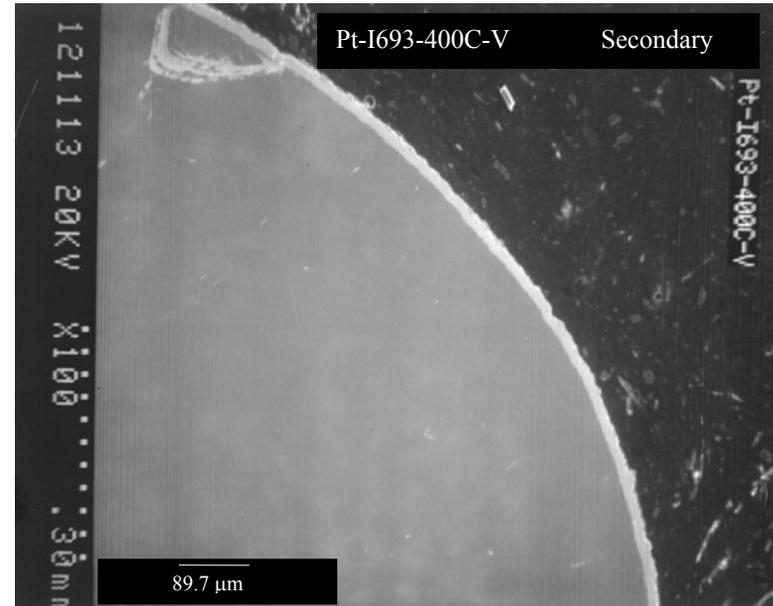
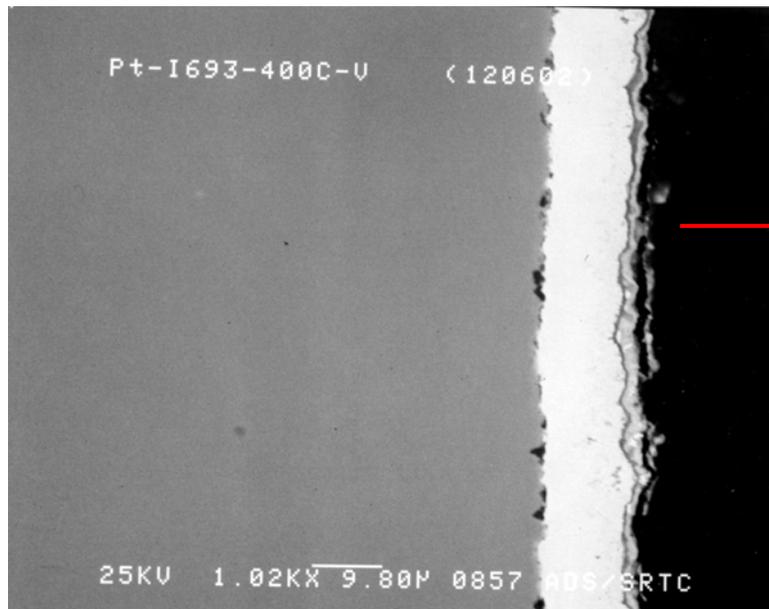
Figure E-3 SEM Photos Showing Depth of Attack, Pt-Coated I-693 at 400°C

Average depth of internal attack less than 1 μm

Maximum depth of internal attack approx. 1.5 μm

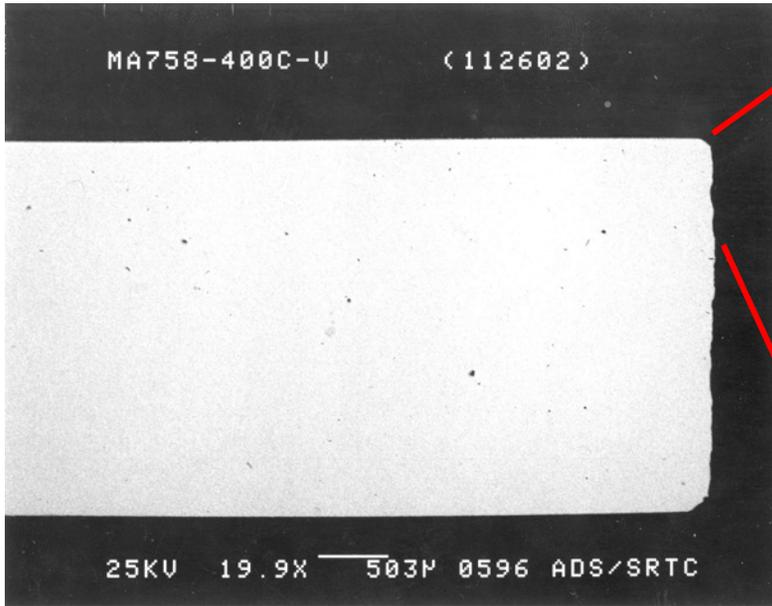
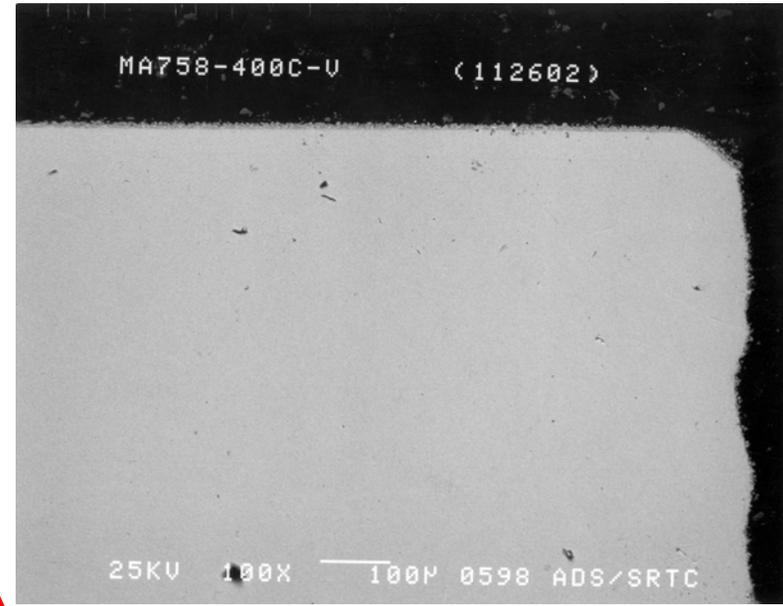
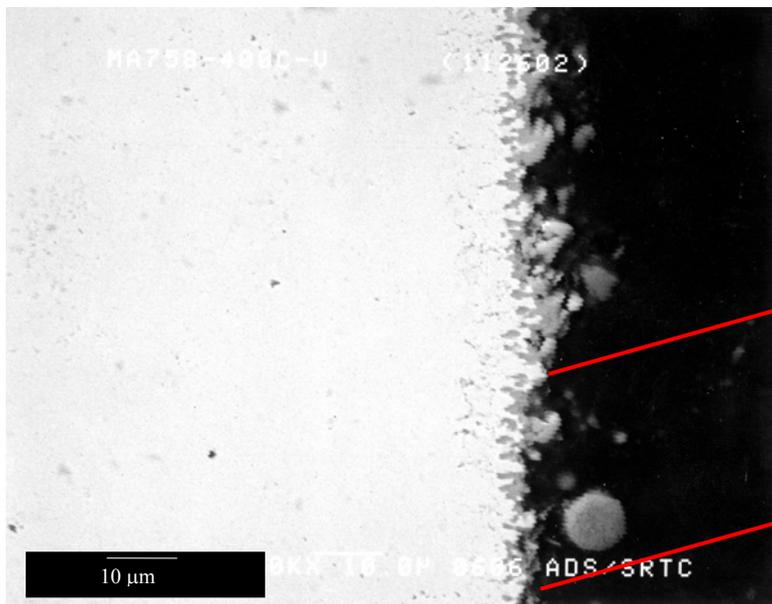
Figure E-5 SEM Photos Showing Depth of Attack , MA 758 at 400°C

Average depth of internal attack approx. 8.5 μm

Maximum depth of internal attack approx. 14.6 μm

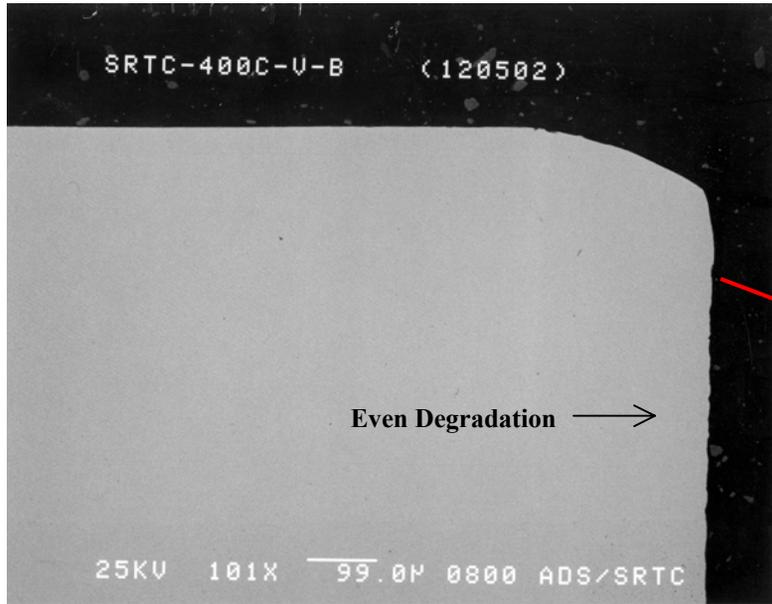
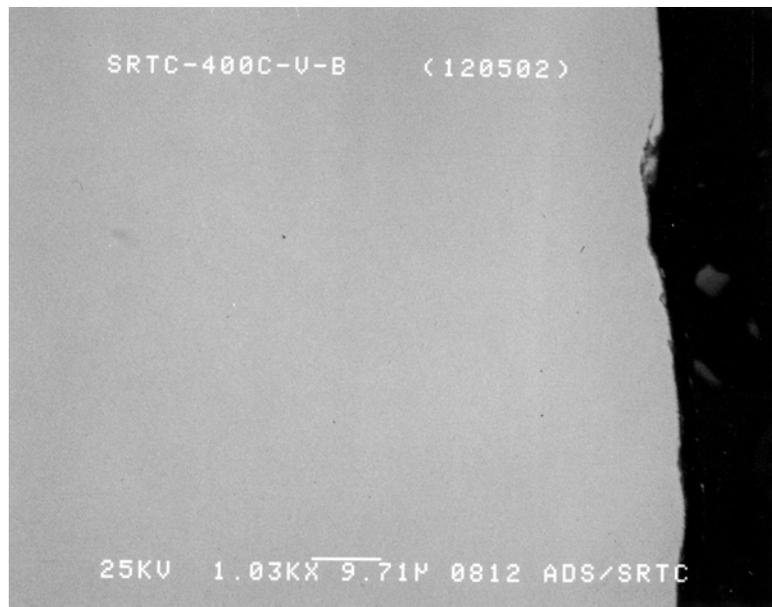
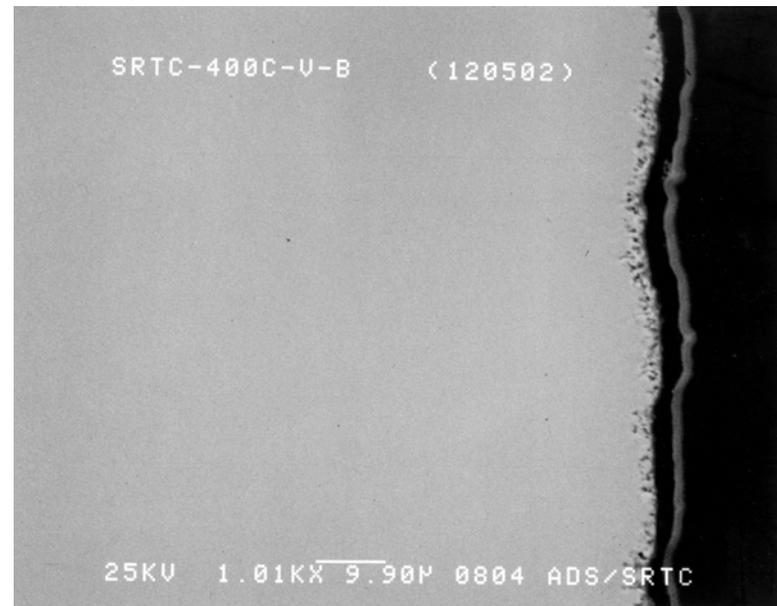
Figure E-7 SEM Photos Showing Depth of Attack, SRTC Alloy at 400°C

Average depth of internal attack;  
no discernable internal attack

Maximum depth of internal attack  
approx. 4.9 µm

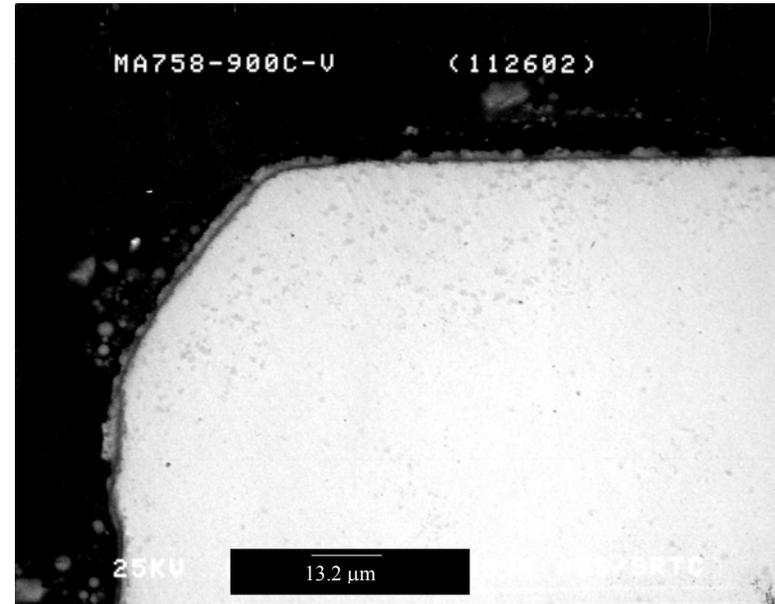
Figure G-5 SEM Photos Showing Depth of Attack, MA 758 at 900°C

Average depth of internal attack approx. 11 μm  
Maximum depth of internal attack approx. 26 μm

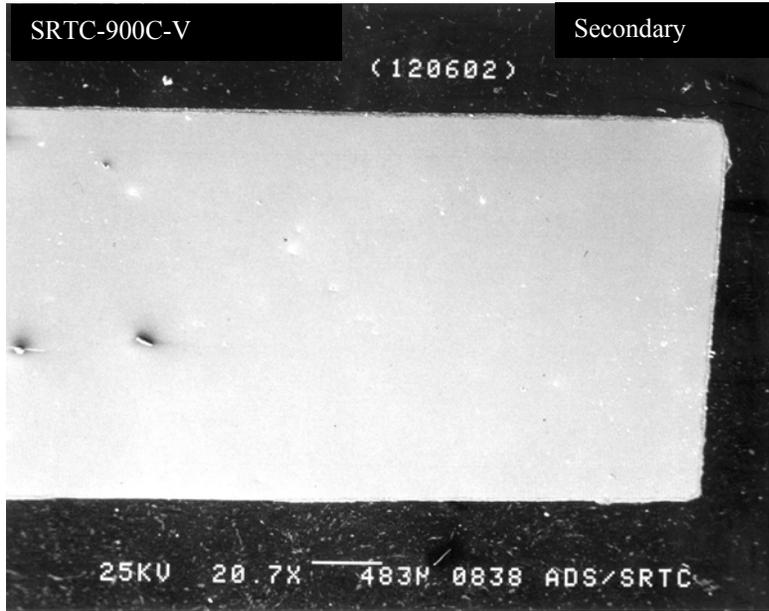
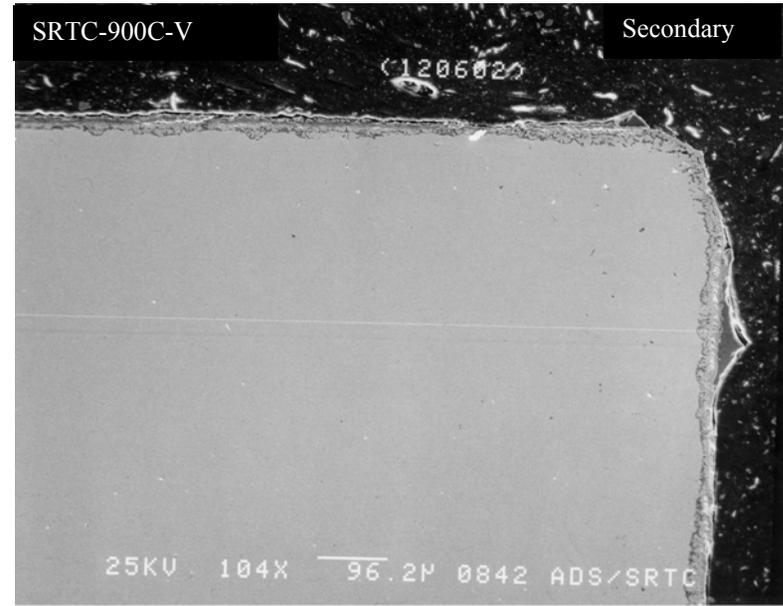
Average depth of internal attack approx. 16  $\mu\text{m}$

Maximum depth of internal attack approx. 33  $\mu\text{m}$
