**ASSESSMENT OF AGING OF CORK AND TISAF MATERIALS  
IN THE SAFKEG 3940A PACKAGE IN KAMS (U)**

Savannah River Technology Center  
Strategic Materials Technology Department  
Materials Technology Section

Publication Date: June 2003

**Westinghouse Savannah River Company  
Savannah River Site  
Aiken, SC 29808**

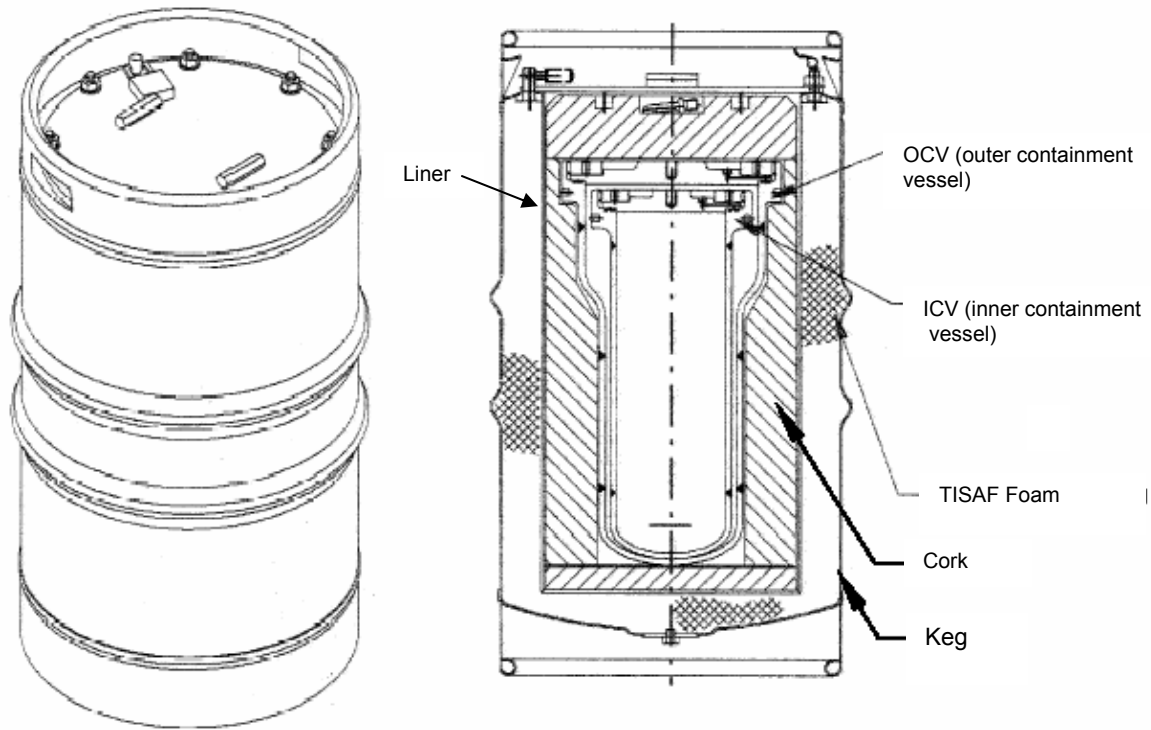
**Figure 1.** SAFKEG 3940A shipping package showing location of the keg, TISAF foam, cork, outer containment vessel (OCV), and the inner containment vessel (ICV). The 3013 vessels will be inserted into the ICV of the SAFKEG. The SAKEG is approximately 40 inches high.

(KAMS), is being readied to safely receive and store these packages for interim storage prior to future disposition. The SAFKEG 3940A shipping package design consists of a double skinned stainless steel keg body (outer keg is 304 stainless steel (SS) with a 304L liner) with a bolted closure lid and O-ring seal (Figure 1). The cavity between the keg and the liner is filled with a layer of phenolic foam, also known as TISAF (Thermal-Insulating, Shock-Absorbing Foam). This cavity is normally sealed but will vent through a bottom vent plug during a fire accident condition. Within the liner is a resin-bonded cork layer; two removable 304L stainless steel containment vessels, each sealed with a bolted lid and double O-rings as shown in Figure 1. The 3013 storage container is placed inside the inner containment vessel (ICV) that is inserted into the outer containment vessel (OCV).

Aging properties of the TISF and cork are not provided in the SARP.<sup>1)</sup> Corrosion Assessment and aging of stainless steel components used in the 3013 storage container are currently under evaluation.<sup>11)</sup> Normal properties of materials that are affected by aging include physical properties such as tensile strength, compressive strength, impact strength, modulus, dimensions and weight changes. The TISAF is entirely contained within the annular space between two stainless steel walls and access to air is expected to be minimal. The only available air is that contained within the closed cell walls of the foam during the insertion process. Moisture should not be a problem as long as the TISAF annular space is sealed. The seal is maintained by the bottom seal plug in the SAFKEG 3940A design, Figure 1.

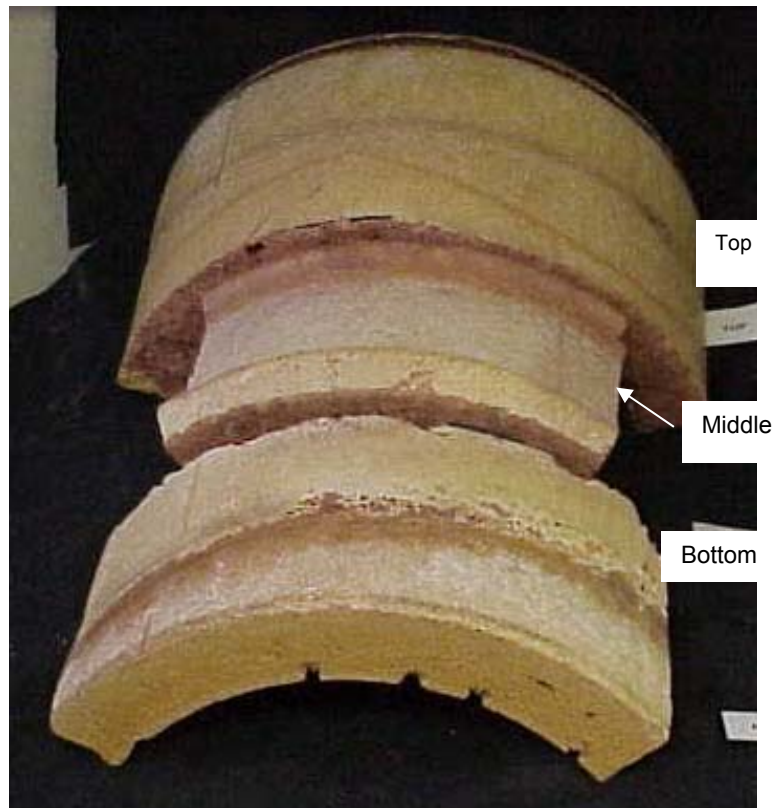
**Figure 2.** Exterior sections (top, middle, and bottom) of TISAF taken from a SAFKEG package. Surface is rough in a few places in the bottom section. The thickness is slightly more than 1  $\frac{3}{4}$  inches. Note there is no surface coating on the TISAF. This is probably not typical of the SAFKEG 3940A package.

Samples of the TISAF from a SAFKEG package are shown in the photographs in Figures 2-8. Open cells (or porosity) are visible on both sides of the TISAF. TISAF has a wide distribution of cell sizes, on the inside surface and the outside, as seen in Figures 4-8. A distribution in cell sizes was also observed from top to bottom and from surface to center thickness. This could indicate anisotropy and properties may be different depending on parallel to or transverse to the pouring direction. The SAFKEG manufacturer states that the TISAF adheres to the stainless steel surfaces after curing.

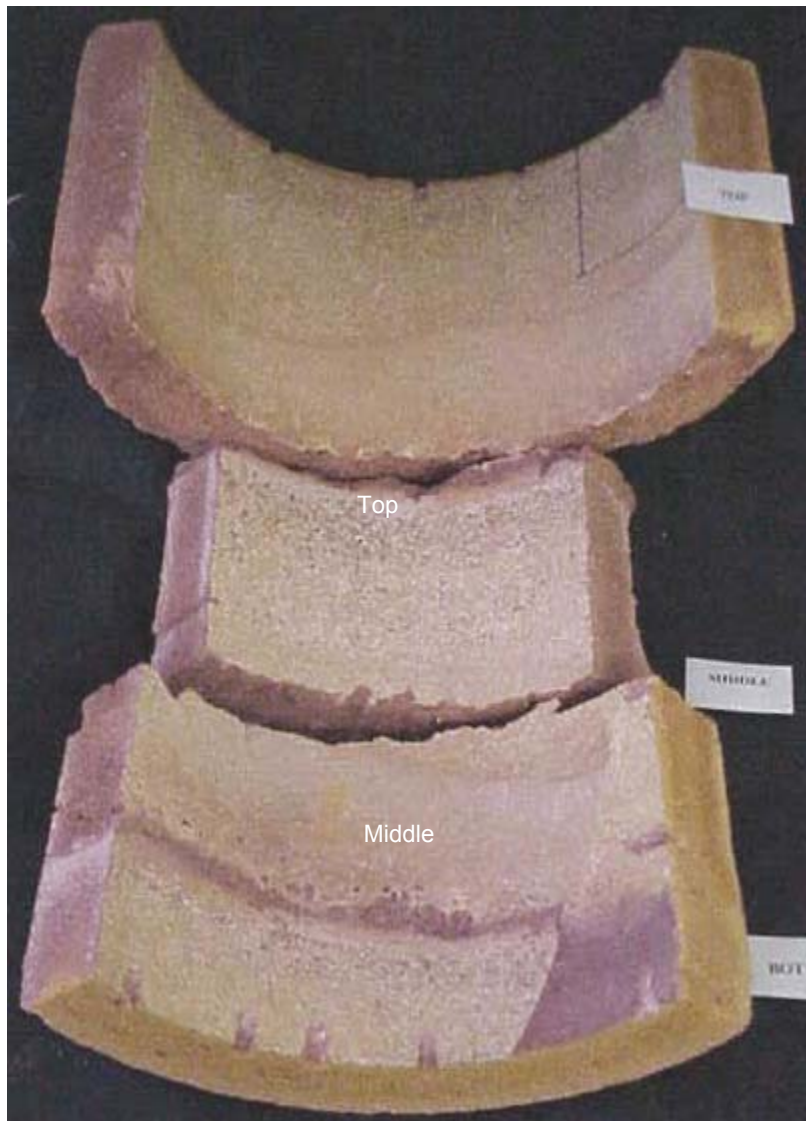
**Figure 3.** Exterior sections (top, middle, and bottom) of TISAF taken from a SAFKEG package. Surface is rough in a few places. Note there is no surface coating on the TISAF. This may not be typical of the SAFKEG 3940A package.

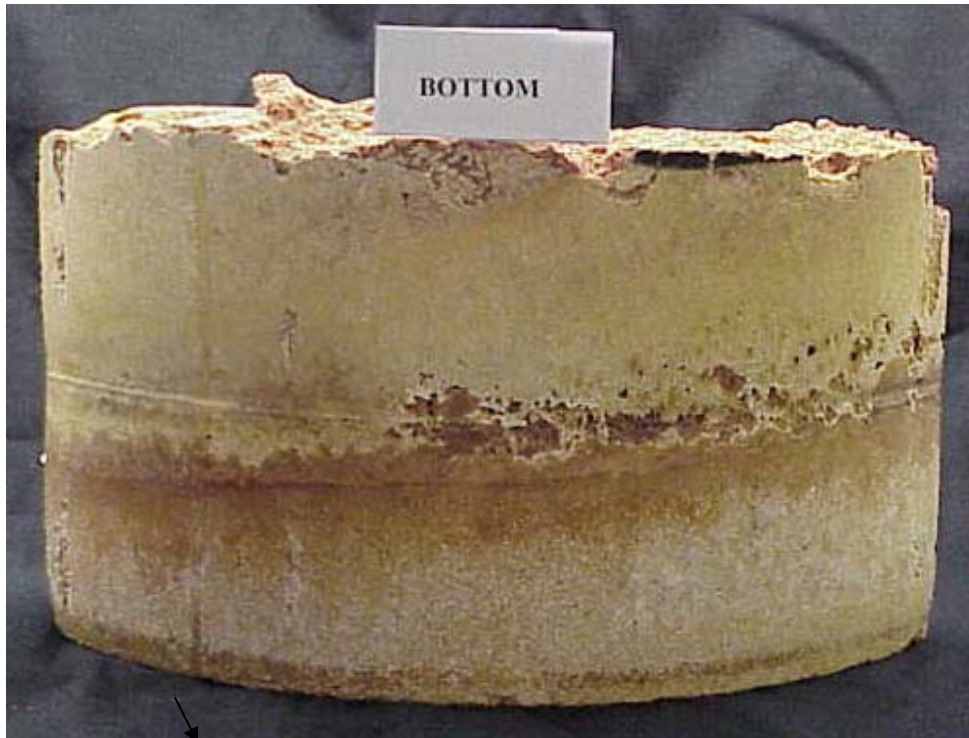
**Figure 4.** Outer surface of middle section of TISAF revealing surface problems in middle. The arrow, to the left, shows the location of the parting line between the two separate pours of the foam during filler of the cavity.

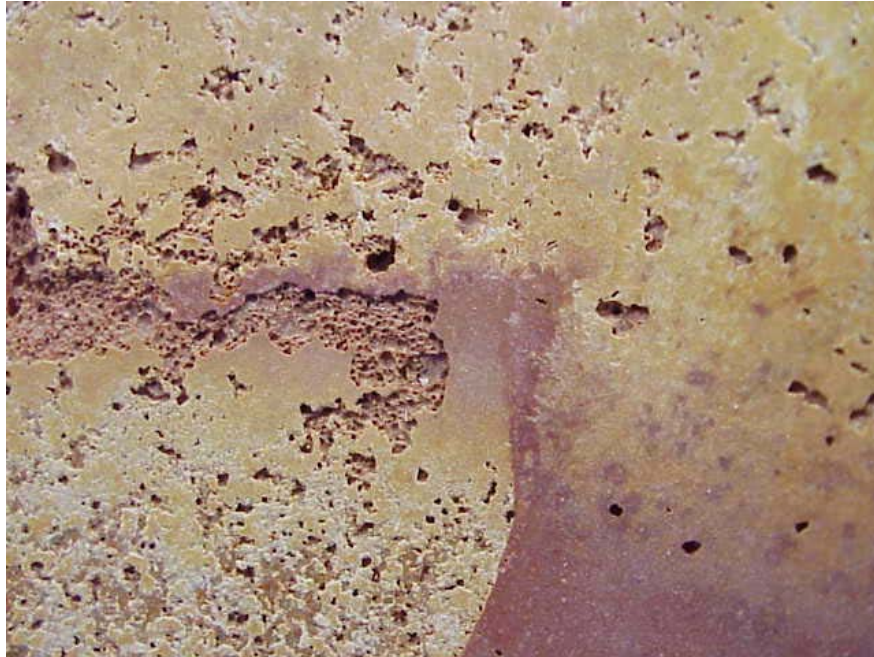
**Figure 5.** Inner surface of bottom section of TISAF from Figure 3 revealing exposed porosity on surface.

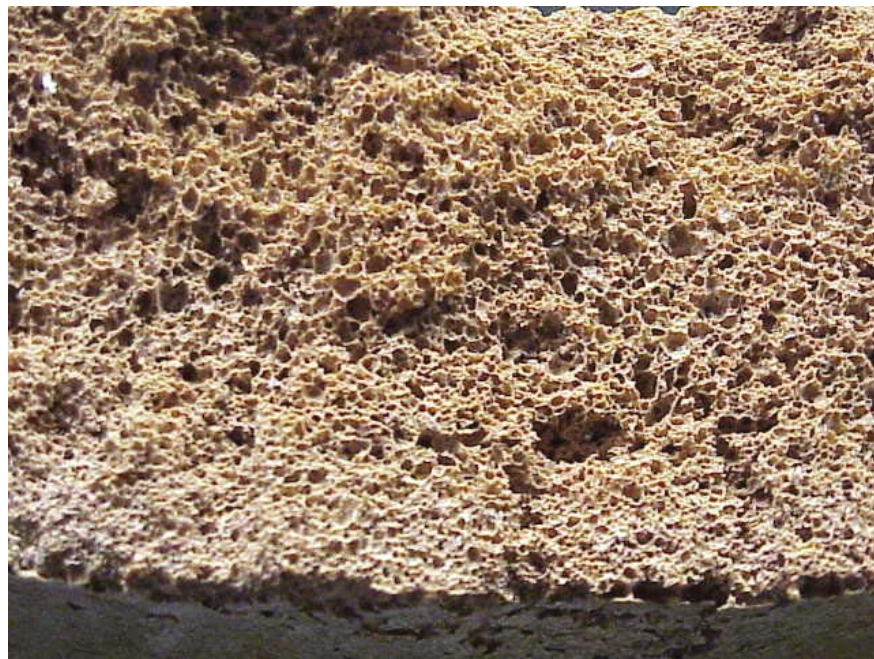
**Figure 6.** Photo of broken section of TISAF revealing wide range of cell sizes.

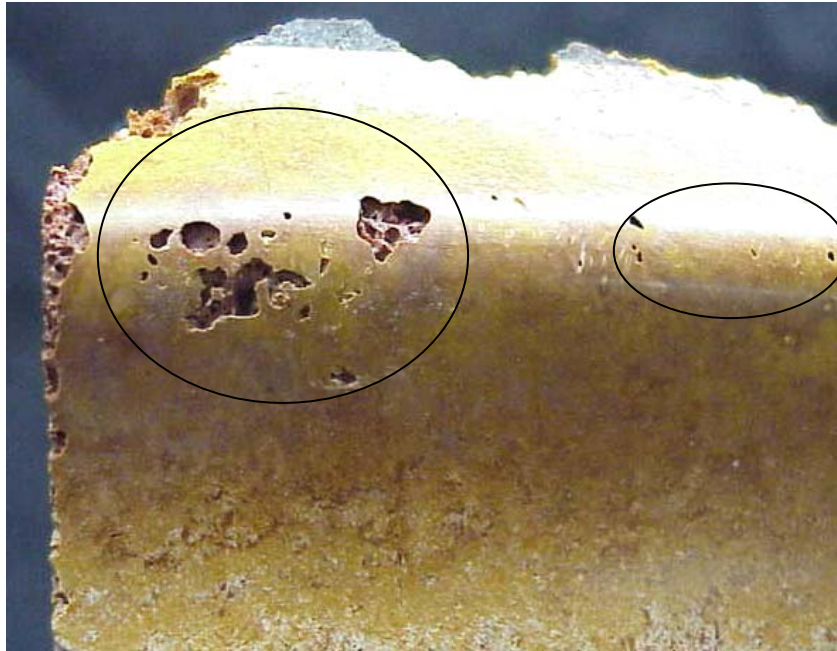
**Figure 7.** Circled areas in Image reveals porosity on the ridge formed by the outer keg.

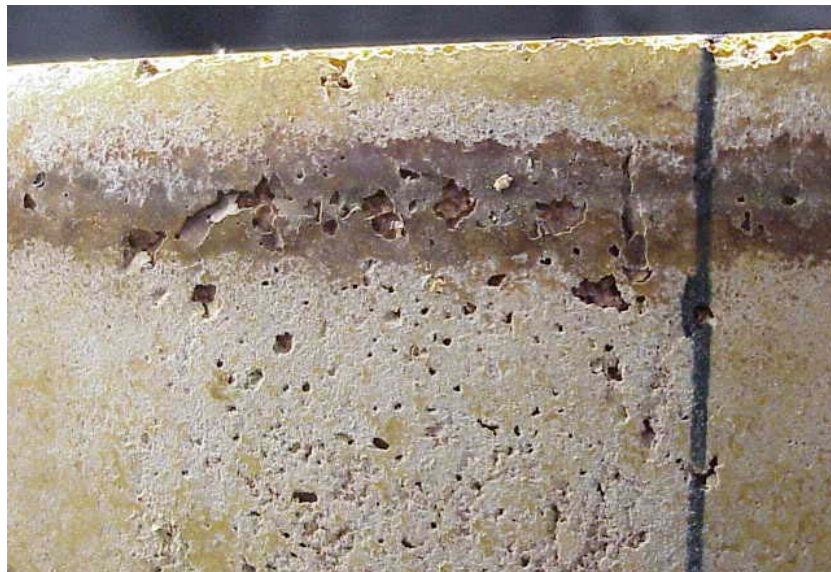
**Figure 8.** In top TISAF section, near the top surface, porosity is visible.

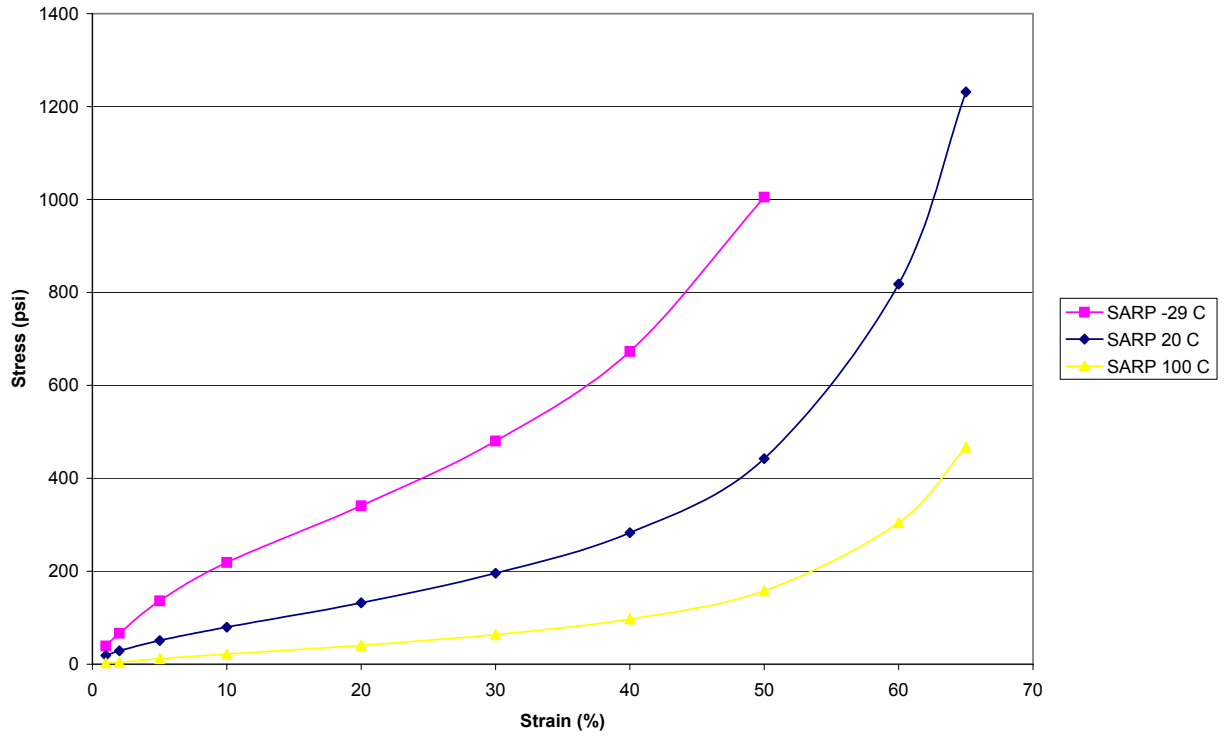
Figure 9. Room Temperature Compression Test Data for Resin Bonded Cork<sup>1)</sup>.

Mechanical testing was performed to establish a set of baseline materials properties for the determination of the impact of aging and to serve as inputs for stress analyses of hypothetical accident scenarios. The tests complemented the data already available in the SARP and provided a starting point by which the effects of aging can be determined. In the SARP the effect of temperature on the relationship between stress and strain is well represented. Figures 9 and 10 show how the stress vs. strain curve changes with temperature for resin bonded cork

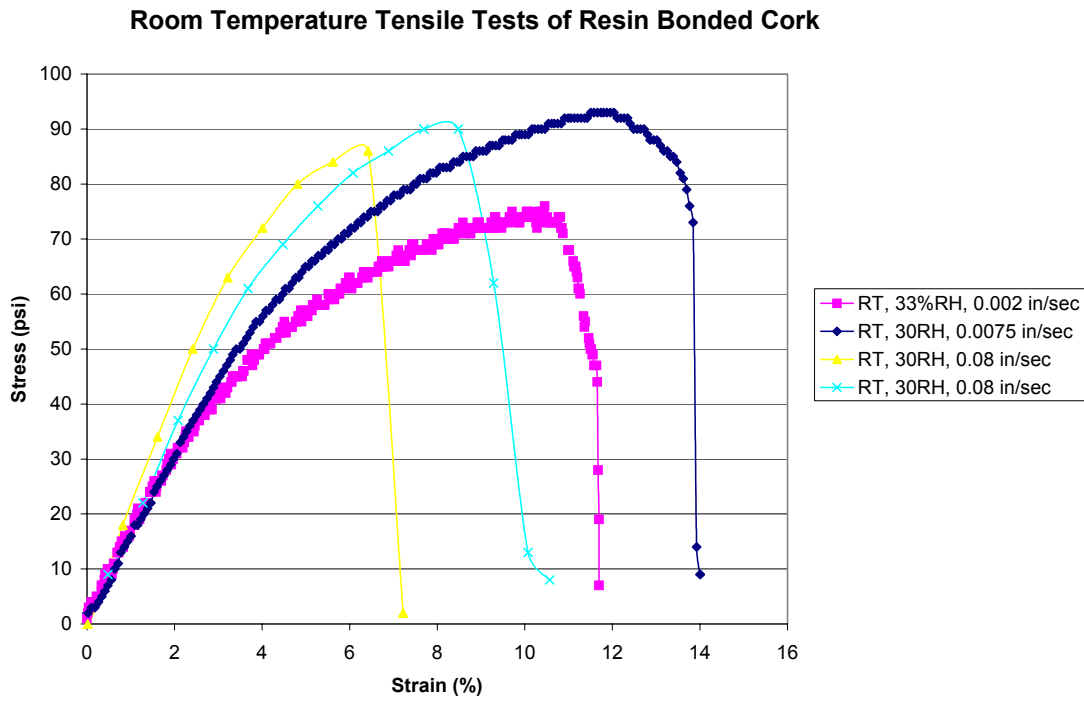
Figure 11. Room Temperature Tensile Test Data of Resin Bonded Cork.

The stress vs. strain curves measured for resin bonded cork in tension, compression and hydrostatic compression are shown in Figures 11 – 13, respectively. The most notable observation of the cork is that it exhibits viscoelastic behavior. Specifically, the deformation of the material has an elastic component and viscous component. When the stress is removed the material will recover to the original shape over a time interval. The SARP stated that this recovery was 98%. Load relation tests were conducted in compression and showed that an average 36% of the stress was relieved during a 30-sec hold before unloading. In addition, the cork also shows a positive strain rate sensitivity at room temperature. This behavior was also observed in the hydrostatic compression tests, shown in Figure 13. Overall, the stress-strain properties measured in this study did not significantly differ from properties listed in the SARP.

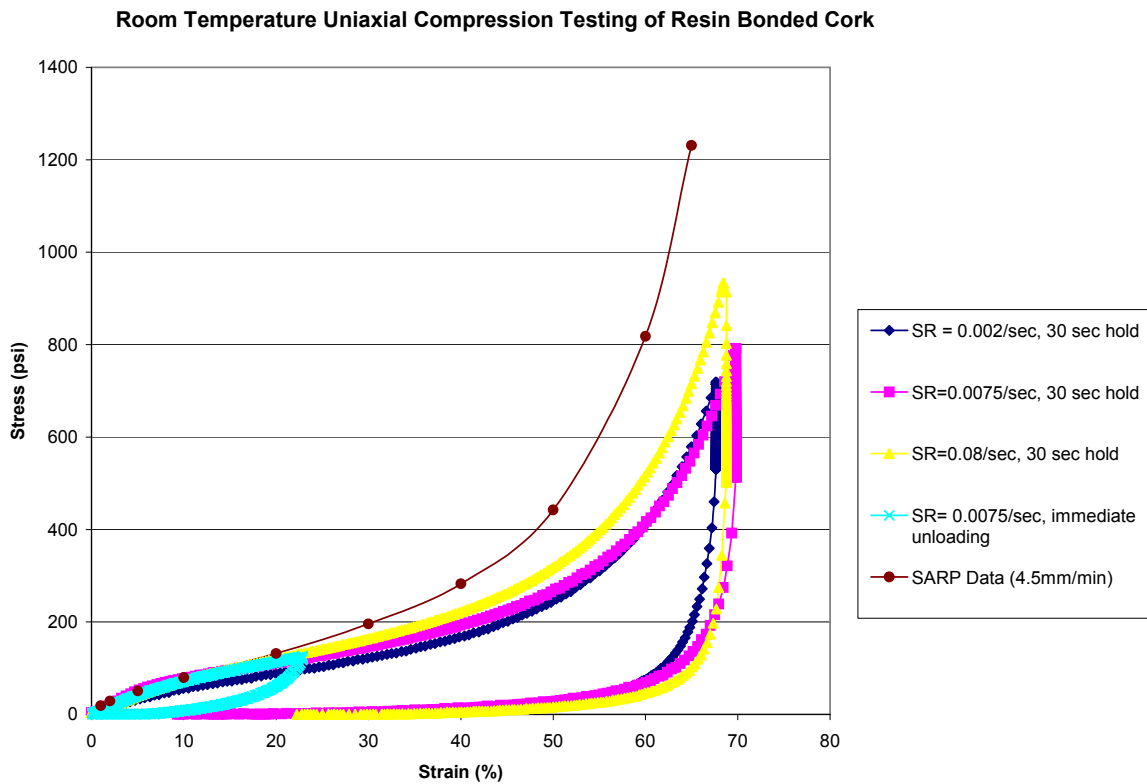
Figure 12. Room Temperature Uni-axial Compression Data of Resin Bonded Cork.

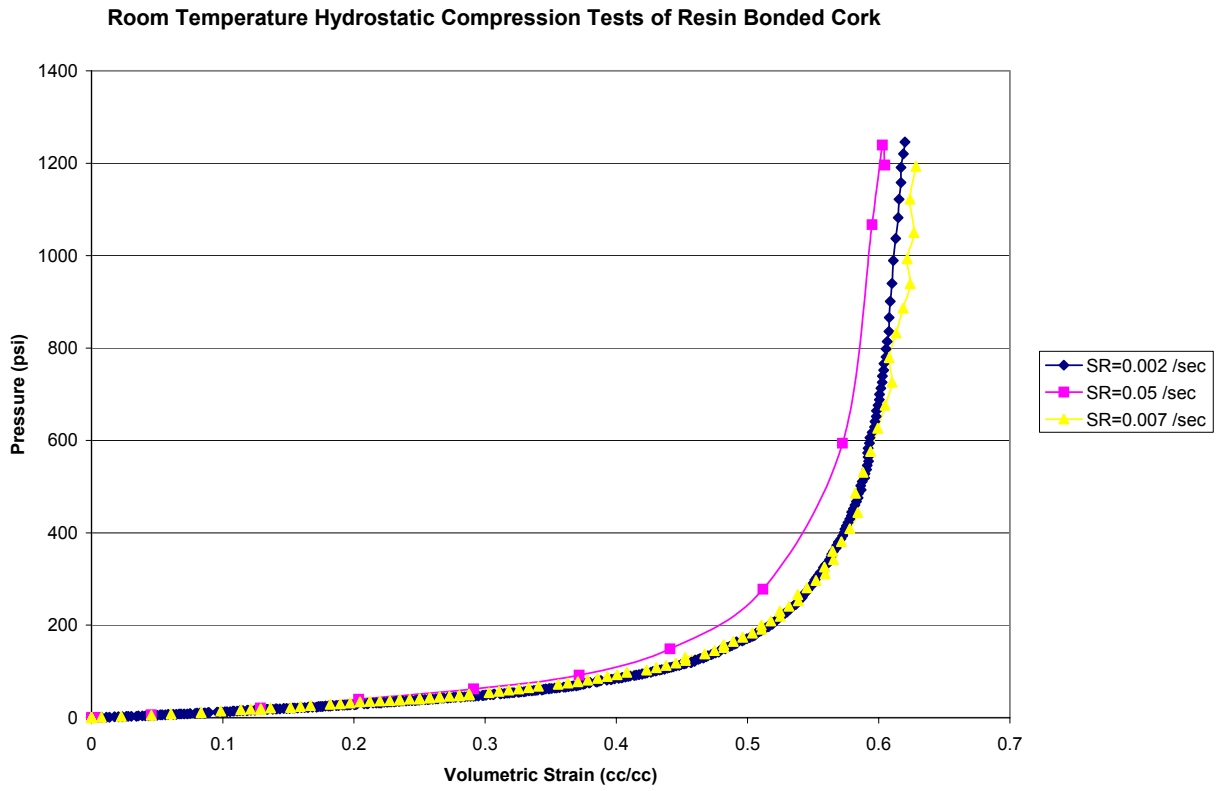
Figure 13. Room Temperature Hydrostatic Compression Data for Resin Bonded Cork

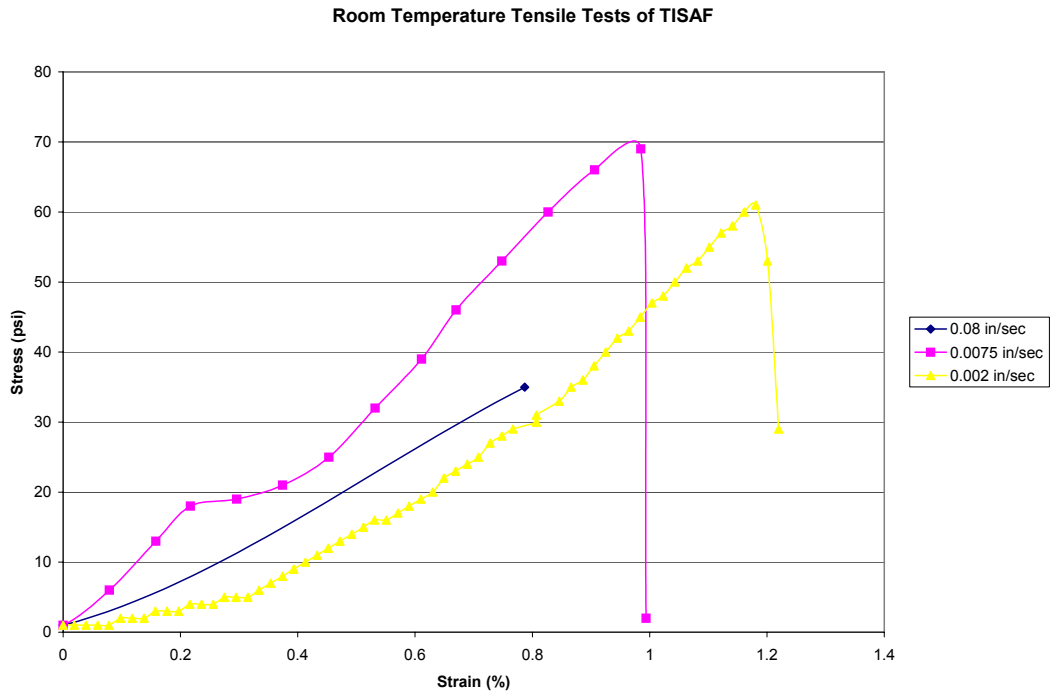
Figure 14. Room Temperature Tensile Test Data of TISAF.

The stress vs. strain curves measured for TISAF in tension and compression are shown in Figures 14 and 15, respectively. The foam is a mixture of gypsum and phenolic resin, which exhibits a very large, and widely varying, cell size. From Figure 14, the brittle nature of this material can be observed. The material exhibited very limited strain rate sensitivity. The tensile specimens failed without any appreciable nonlinear elasticity. In compression, material behaves in a similar fashion. The initial portion of the curve is linear until failure. Subsequent deformation occurs by successive loading and crushing events until complete “powdering” of the material. In Figure 16, a picture of a compression specimen after a compression test illustrates its brittle behavior. The behavior is significantly different to the properties exhibited in the SARP (Figure 10).

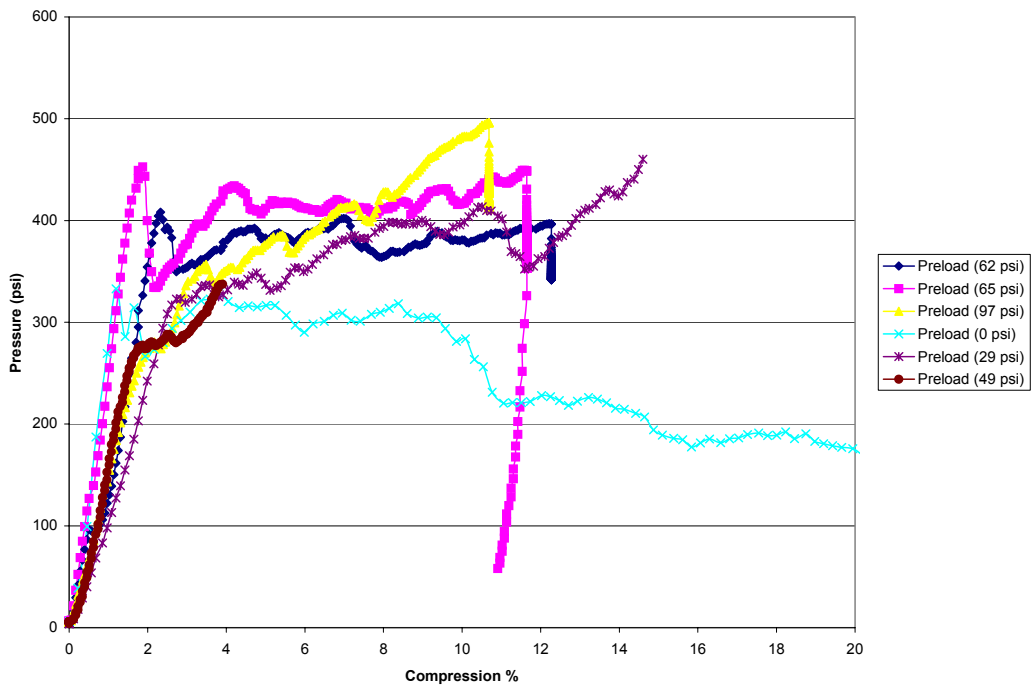
**Figure 15.** Room Temperature Test Data for TISAF in Compression, Tension and Tri-axial Compression.

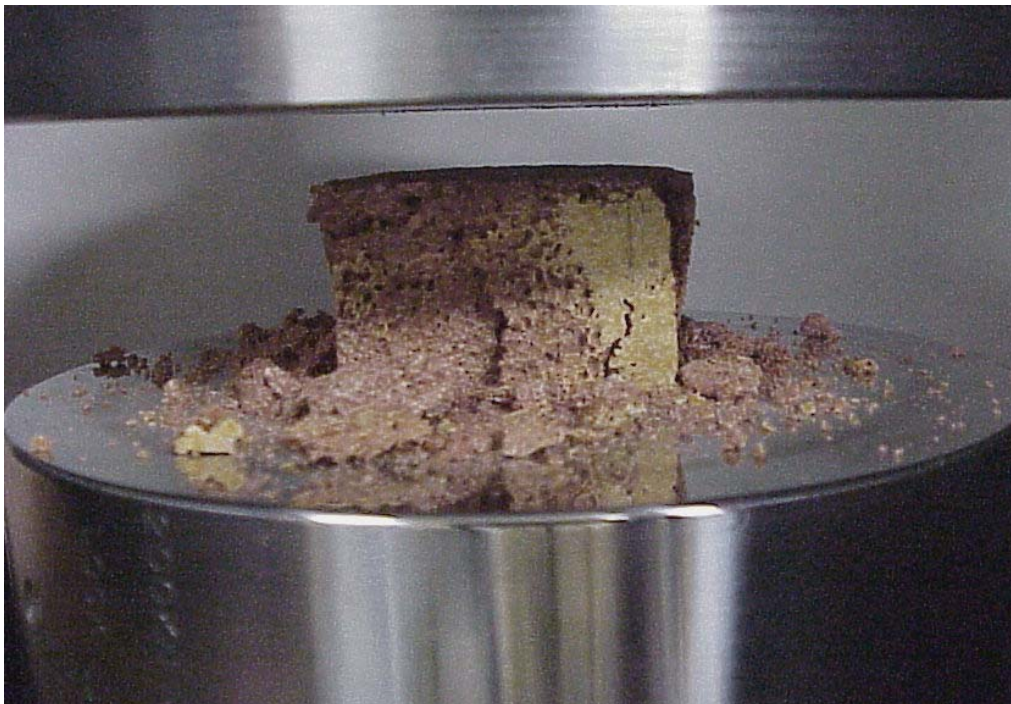
**Figure 16.** Room Temperature Compression Test of TISAF.

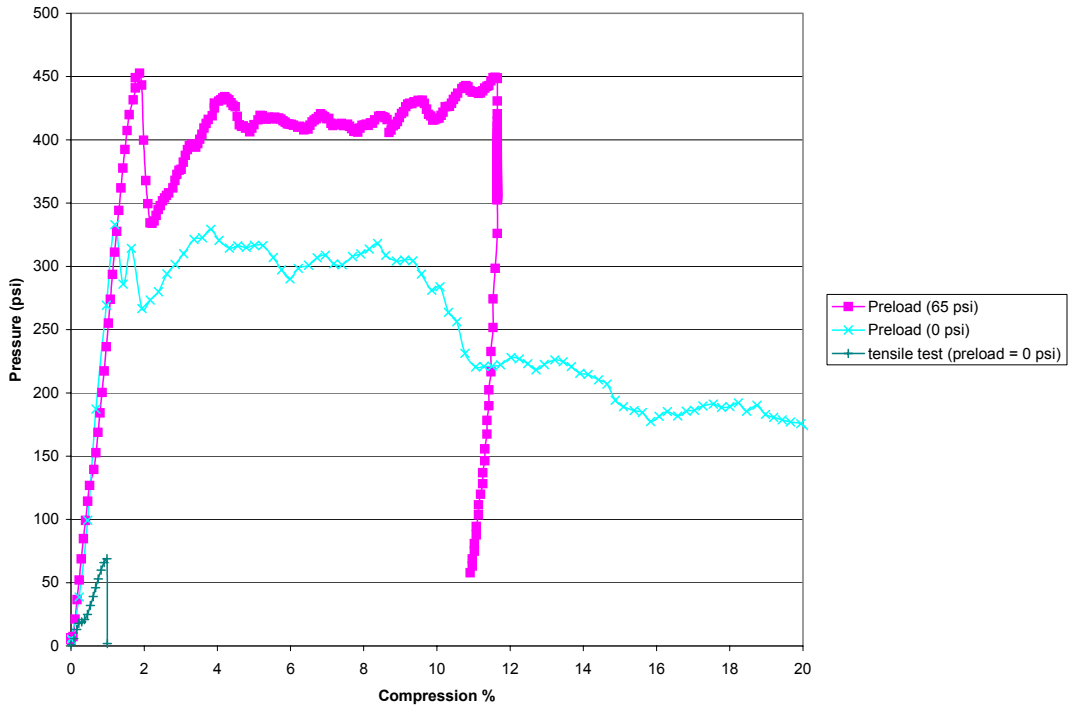
**Figure 17.** Selected Stress Strain Curves used for the Mohr's Circle representation of Fracture Stress vs. Shear Stress for TISAF.

In order to determine the effect of stress state on deformation stress, the sample was compressed in a tri-axial compression fixture which was able to preload samples to constant loads in 2 orthogonal directions ( $\sigma_1$  and  $\sigma_2$ ) and measure breaking strength in the third ( $\sigma_3$ ). Plotting  $\sigma_1$  and  $\sigma_3$  together enables the determination of the yield surface using Mohr's circle. In Figure 17 the three curves that bound all other tensile or compression data are shown. When these curves are plotted using Mohr's circle a tangent line can be used to estimate the breaking strength at different loading conditions. In Figure 18, the  $\sigma_1$  and  $\sigma_3$  values of stress are plotted as intersection points to the X-axis. A circle is used to plot the relationship between X and Y. In this figure, a least squares fit of the tangent points was produced and the equation for the line is shown. Since the material is so brittle and the stress-state is compressive, the tensile curve was neglected and a yield surface was estimated with the two compression tests. This data was used as input to the structural impact analysis of the SAFKEG in KAMS under accident conditions.

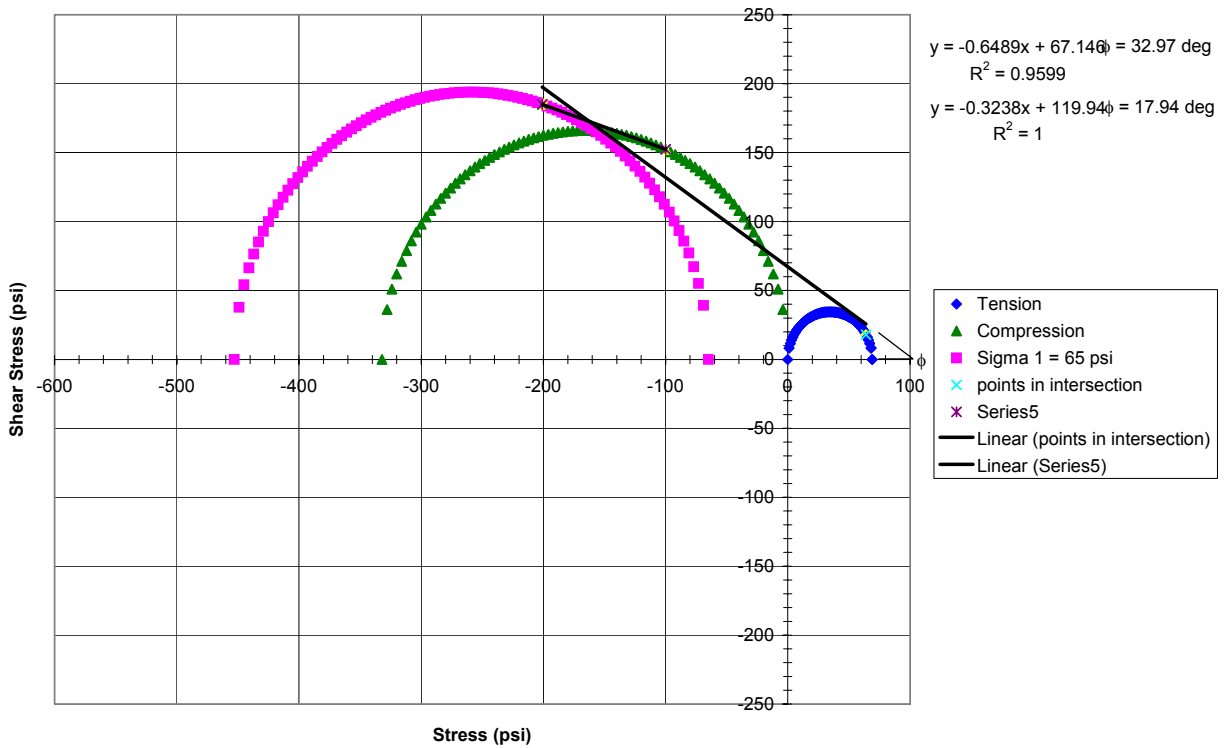
**Figure 18.** Mohr's Circle representation of Fracture Stress vs. Shear Stress for TISAF.

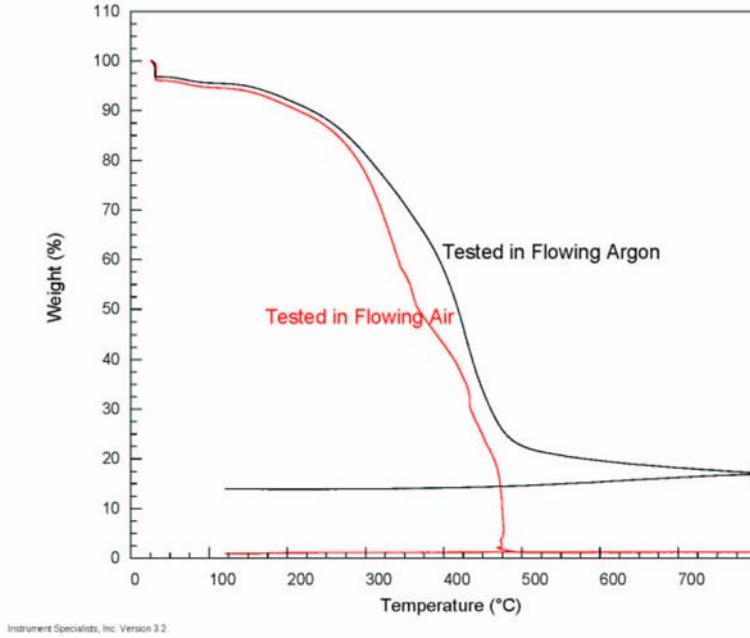
Figure 19. Weight loss from TGA Analysis of Resin Bonded Cork in Flowing Argon and Air.

Thermo-gravimetric analysis was used to measure indicate whether aging at elevated temperatures would lead to a change in properties during interim storage. The SARP states that the cork and TISAF are unaffected during aging at temperature up to 180 C and 140 C, respectively. A weight loss of approximately 7% was noted for both materials (attributed to drying of entrained water). Figures 19 and 20 are weight loss vs. temperature plots of cork and

TISAF, respectively. Initially, a small amount of weight loss (presumably from absorbed water) appears to occur during hold and heating up to 140 C. Samples of cork and foam have been observed to lose up to 6.5 and 3.5 wt. %, respectively, upon heating to 248°F (120°C). So the weight loss, previously reported in the SARP, is representative of the samples tested in the present study. After this initial adjustment, the weight stabilizes until 572°F (300°C) for cork and 752°F (400°C) for TISAF. Above these respective temperatures, the majority of the sample is consumed. In the case of the cork, 100% of the sample (80% flowing argon in air) is consumed before 932°F (500°C) is reached. In the case of TISAF, 55% of the weight is consumed before 1022°F (550°C). Beyond this temperature, the sample weight remains relatively constant up to 1472°F (800°C).

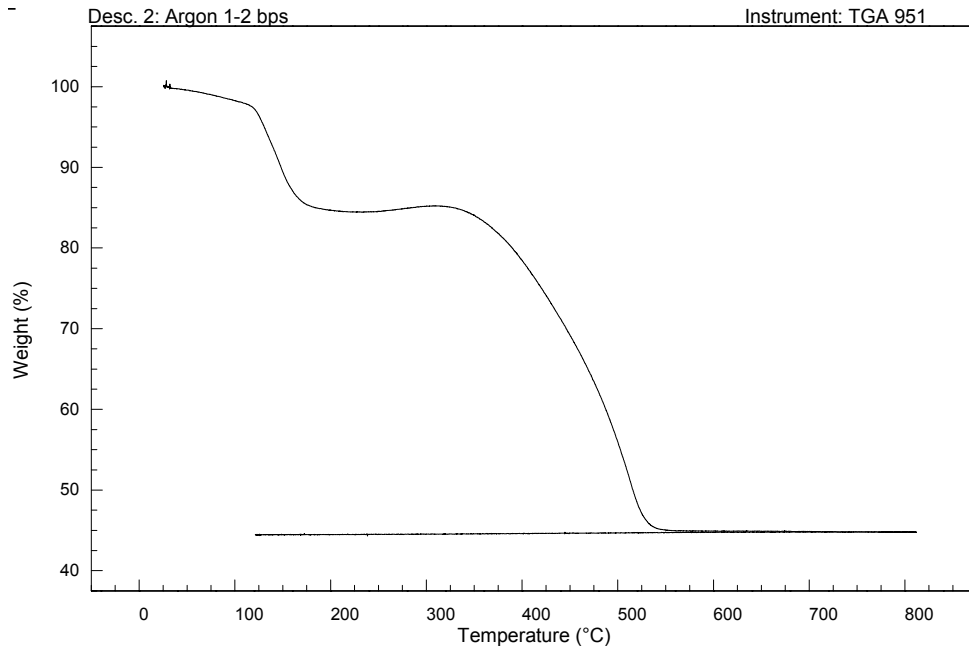
Figure 20. Weight loss from TGA Analysis of TISAF in Flowing Argon.
