Proceedings of ASME PVP 2006 / ICPVT-11 Conference
Pressure Vessel Technologies for the Global Community
July 23 – 27, 2006 Hyatt Regency Vancouver, Vancouver, BC, Canada

PVP2006-ICPVT11-93109

EXTENDING PRESSURE RELIEF VALVE INSPECTION INTERVALS BY USING STATISTICAL ANALYSIS OF PROOF TEST DATA

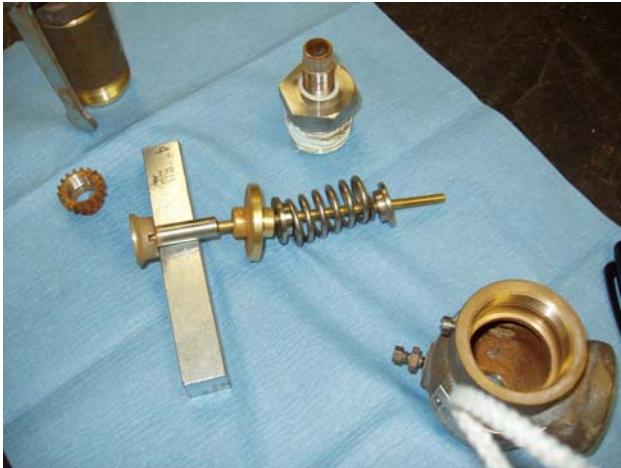
The cooling water valve in Figure 1 was in service at the Savannah River Site. It was a 1" inlet, 1" outlet, valve with a set pressure of 90 psig operating at a temperature of 112 degrees F. The test date was 7/29/04. The lift lever is packed. Its capacity rating is 624 Lb per hour. The first, second, third and fourth pops were 145 psig, 92 psig, 93 psig, and 93 psig, respectively. The valve would not re-seat leak tight after the first pop. The re-seat pressure was 60 psig and blow down was 32/33 psig. The following photograph, Fig 1 was taken in the valve shop prior to cleaning and refurbishment.

Figure 1 Bronze body, stainless disc holder, disc, spring washers and nozzle with bronze guide

The as found condition of this valve is shown in the photograph. No apparent damage or wear marks were visible. There appeared to be no corrosion or buildup on any of the sliding parts. Yet, the cause for high first pop pressure and settling back to set pressure needs to be understood. Disc holder-to-guide and spring washer-to-stem clearance are what we traditionally think of as sticking points. According to our valve shop mechanics, on the test stand this valve was leak tight up to the 1st pop pressure of 145 psig. After the first pop, the valve would not re-seat, but the next three pops were within ASME tolerance for set point of a new valve (90 psig +/- 3 %). Fig 2 is a closer view of the disc, disc holder and deposits from the cooling water system. One theory for the high proof test developed from an MIT paper was that the seat and disc may have micro-welded, diffusion bonded, or galled together.⁵ Further research using scanning electron microscope and X-ray fluorescence spectroscopy (XRF) shown in Fig 3 verified the disc was made of copper-nickel and the nozzle seat made of 302 series stainless steel. No surface distortion was found that would indicate galling or metal-to-metal adhesion. The elemental composition of deposits adhering to the disc surface are listed in Table 2.

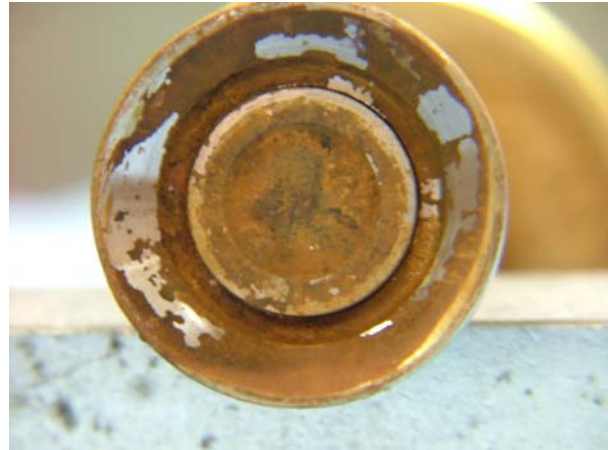
Figure 2 Disc and Disc Holder showing deposits in the seating area

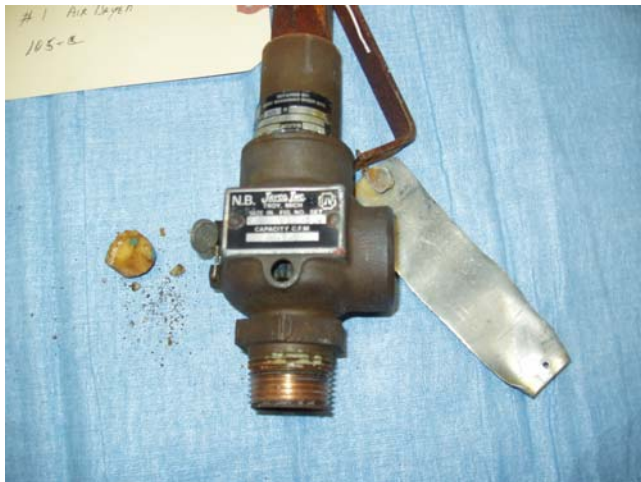
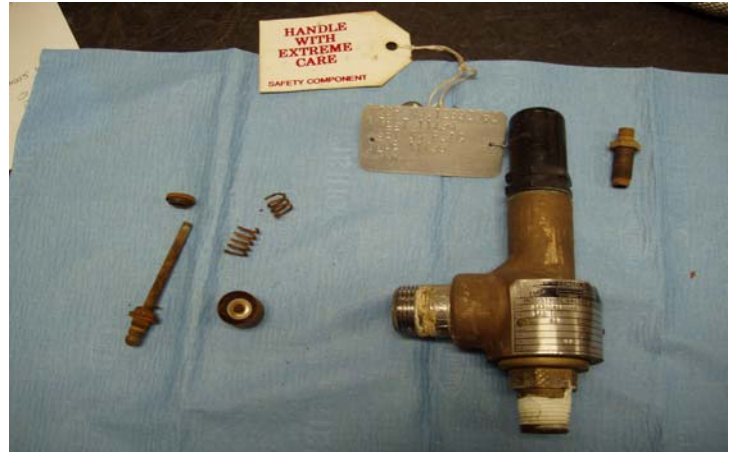
Figure 6. Chill Water Service

This valve was installed in chilled water service for 10 years without retest because the 5-year test was overlooked. Corrosion buildup and broken spring were the result.

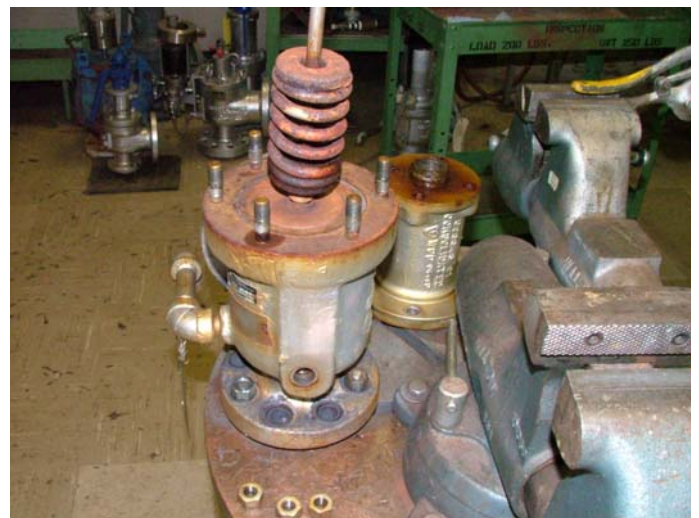
Figure 7. Steam Service

This particular 165 psig set point steam relief valve had been in service for 6 years before needing a rebuild. Every two years it was brought back to the shop and passed proof testing. At the third cycle, it proof tested at 154 psig but the seat leaked and was then repaired.
