Power Over Ethernet Investigation Report

Dillon Tauscher October 19, 2021 B-RPT-A-00001, Revision 0

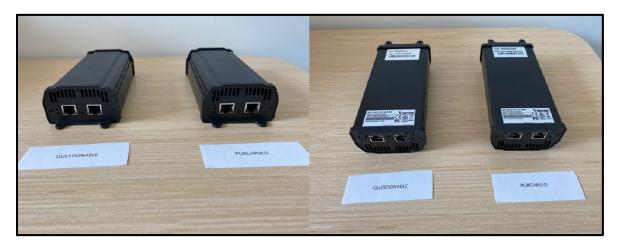
Figure 3-1. Purchased and Questionable Power Over Ethernet Devices

On Thursday April 15, 2021, Glenn Kennedy, the Deputy County Manager for Columbia County, Georgia, contacted the GCC about a potential breach of the Columbia County IT network at an unspecified fire department location. A PoE injector was found on their network, connected to a Cisco 2901 Integrated Service Router. The device was placed by an individual who posed to be working for County Information Technology Services. Columbia County surrendered it to the GCC for further investigation due to lack of evidence and did not want the device returned. The GCC immediately purchased the same device model for comparison and later engaged SRNL to leverage technical capabilities and cybersecurity expertise for non-destructive and potentially destructive analysis.
