November 2019 Initial Deployment of LiDAR in the H-Canyon Exhaust Tunnel

The H-Canyon Exhaust Tunnel (CAEX) structure is periodically inspected under the Structural Integrity Program [1] using camera equipped crawlers or poles to remotely perform visual inspections. To explore the use of enhanced inspection methods a “Proof of Concept” using the Light Detection and Ranging (LiDAR) technology was performed over a 2-day period in November 2019. The purpose of the “Proof of Concept” deployment was to confirm whether a commercially available LiDAR unit could successfully operate and remotely transmit data from the tunnel CAEX environment and whether the data would provide quantitative information to establish baseline measurements. The LiDAR performance requirement was a measurement accuracy of ± 0.25 -inches over a 30-foot distance [2].

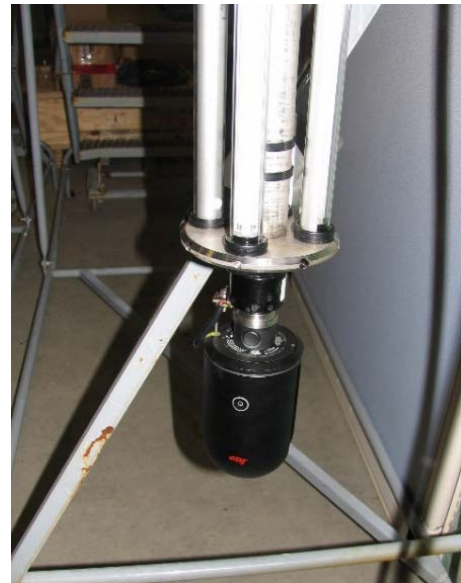
Figure 3.4-1 BLK360 with Slip Ring and Banner LED Lights

Figure 3.4-1 shows the LiDS lower assembly in 781-A. The JFT supplied power cable consists of four sections. All sections of the power cable were connected to confirm differing plug and socket configuration continuity. The power box was powered by an uninterruptable power supply (UPS). A scan was performed successfully while connecting to the BLK360 directly. A scan was initiated using the LiDS network setup and an error message was received. A browser was opened on the JFT supplied desktop and a connection to the BLK360's intranet webpage was made. The firmware page was accessed. The "Search for Scanners" button was pushed in

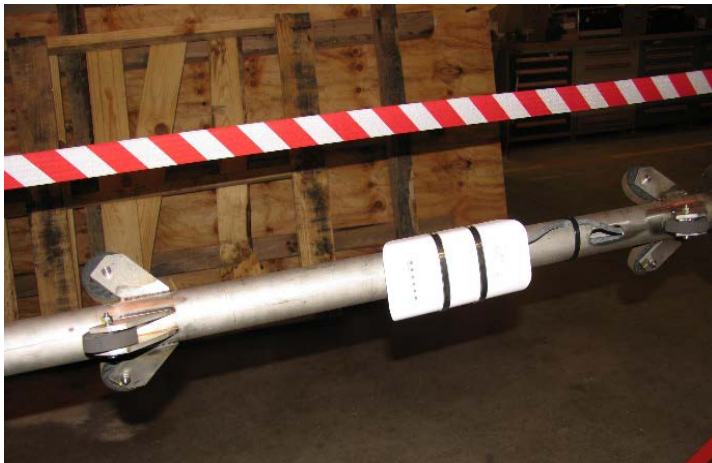
Figure 3.4-4 - NanoStation LocoM2

Figure 3.4-4 is an image of an Ubiquiti NanoStation LocoM2 wireless repeater configured in station mode shown affixed to the deployment pole.

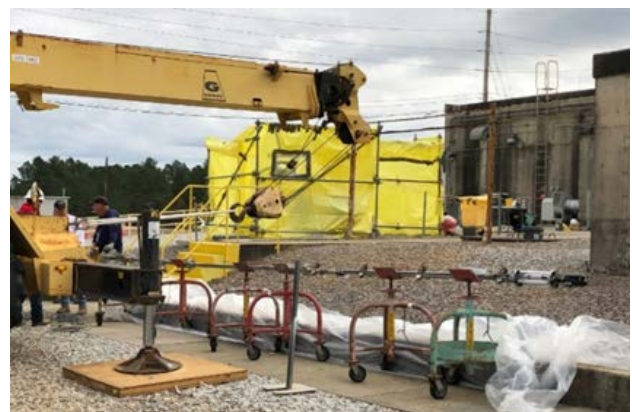
Figure 4.0-1 Staging of LiDS system for crane lift. Pitot tube radiological windbreak shown in background.

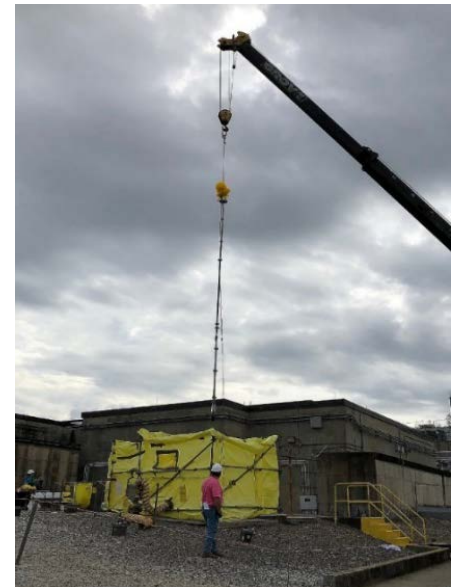
Figure 4.0-3 LiDAR inspection pole being lowered into pitot tube.

Upon returning on Tuesday November 5th morning the generator had shut down unexpectedly during the night. The LiDAR was lifted out of the tunnel and the power button depressed to turn on the unit. The Wi-Fi connection from the iPad to the unit was verified and the LiDAR lowered into the tunnel. Once positioned in the tunnel, a scan was initiated from the iPad. The LiDAR system would begin rotation of its 360-degree panoramic scan, stop after approximately 120 degrees then produce a "Slow Axis Stalled" error followed by a "Scan Aborted" error.

During the troubleshooting session, the LiDAR unit was removed and reinserted into the pitot tube several times along with the battery being installed into and out of the LiDAR device. Each time the LiDAR unit, slipring and cables were checked for visible degradation. The removal of the LiDS from the tunnel and the replacement of the LiDAR scanner battery in the hut proved to be easier than anticipated. After a series of failed troubleshooting efforts including contacting the Leica technical support, the LiDS was relocated to a radiological contaminated storage area and the pitot tube area resealed. The second day planned scans were unable to be obtained.

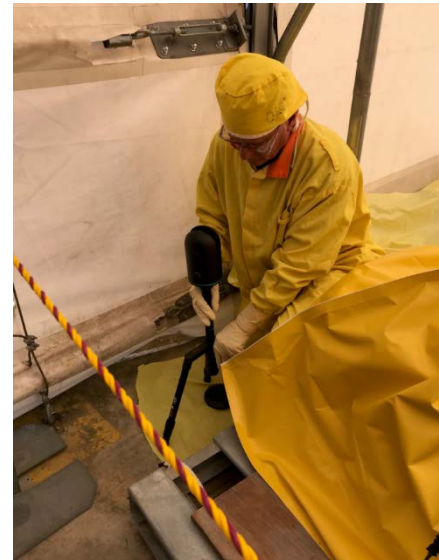
Figure 5.0-1 LiDAR troubleshooting and activity log acquisition

Leica responded after examining the logs that the “Slow Axis Stalled” errors indicate the horizontal rotation axis drives were not working and the factory suspects that the error was caused by too much strain on the scanner’s horizontal axis. They stated that the system “is not very over designed and so any additional strain induced by the installed slip ring or wires could very easily cause this error.” To emphasize this point, they noted that the system could be operated vertically, but even operating the unit horizontally could harm the LiDAR bearings and motors involved with the horizontal axis rotation.

The unrecoverable error was ultimately found to be the Leica BLK360 LiDAR unit. The team reviewed possible issues that affected the horizontal axis drives:

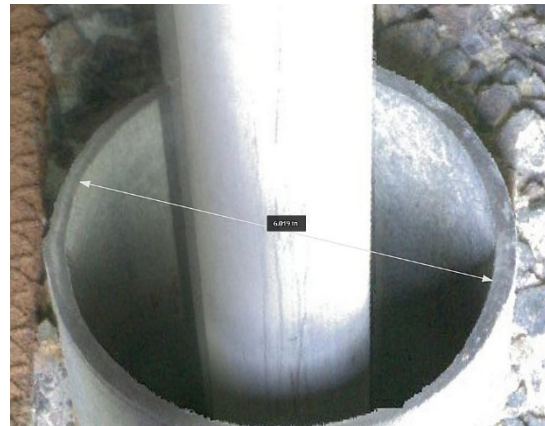
Upon completion of the deployment and the collection of the point cloud data from the scans, the LiDAR calibration and data tolerance were verified by selecting and measuring several physical features in the tunnel with known dimensions, Figure 6.1.3-1. This verification of the BLK360 device accuracy was performed in addition to the initial calibration of the LiDAR unit completed by the manufacturer. The calibration and measurements performed are documented in SRNS-E1122-2019-00020, *Calibration Records of the LIDAR on a Stick Inspection System- November 2019 Inspection* [11]. All measurements were within the ± 0.25 -inch tolerance.

Figure 6.1.3-1 - Interior measurement of a schedule 40 pipe; one of six known measurements taken from the acquired point cloud to verify device and data accuracy

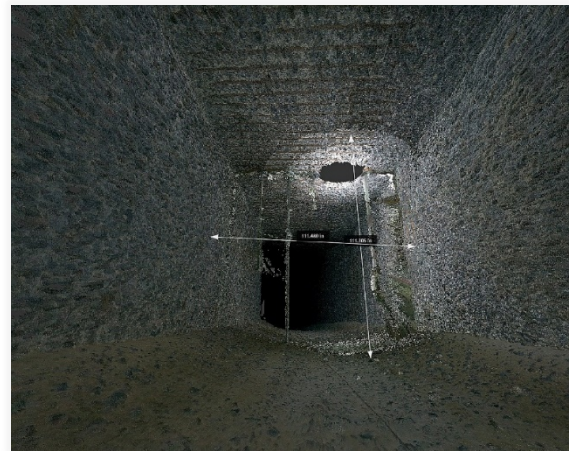
The software allows for two points to be selected on the point cloud and measured, Figure 6.2.1-2. Although it is interesting to perform point to point measurements, because of the uneven surface of the walls and ceilings and the likelihood that surface erosion is uneven throughout the tunnel, they can't be used to determine change of width and height. Instead tunnel segments of equal but opposite walls were defined for comparison, Figure 6.2.1-3. Additionally, ceiling segments were defined for comparison to an artificially defined floor plane. Using colored contour maps that denote differences in surfaces and the accompanying histogram that quantifies these distances an understanding of surface conditions can be evaluated. As the dimensions of the interior tunnel under current field conditions can be quantitatively measured by point cloud data, concrete loss at current conditions can be calculated. Furthermore, the degradation rate of concrete can be calculated with multiple deployments conducted periodically.

Figure 6.2.1-2 Point to point measurements shown on the point cloud with image

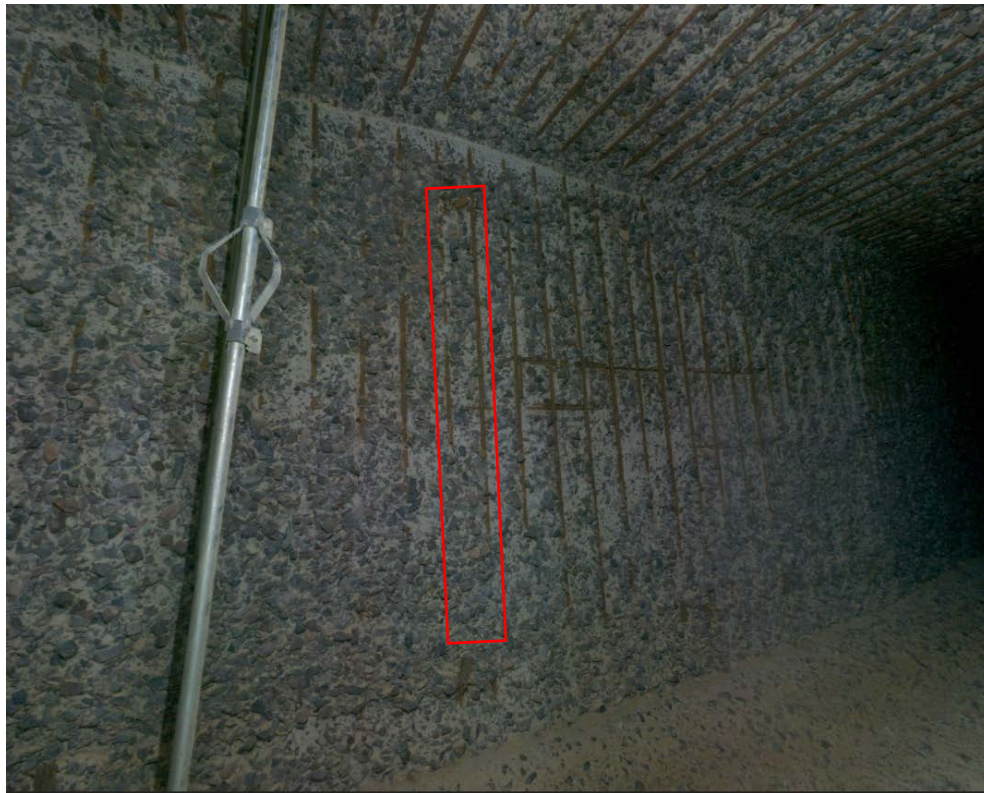
Figure 6.2.1-8 Image of South Wall, Red Boxed area shows location of Figure 6.2.1-7 Segment

Figure 6.2.1-8 is an example of image quality taken of the South wall. The area in the red box is of the West South Wall segment.

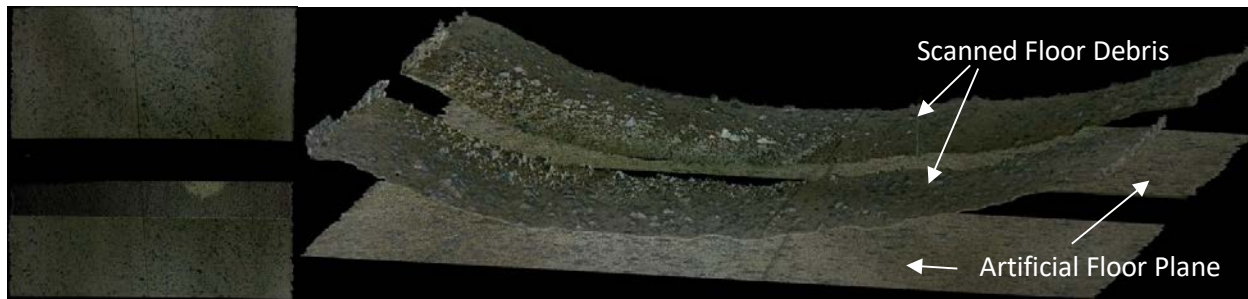
In Figure 6.2.2.2-2, the left image is looking straight down. The right image shows a comparison of the horizontal artificial floor plane to the actual scanned floor.

Figure 6.2.2.2-2 Floor composite segment from West to East W3 to E3 without EW0.

Data for the artificial floor plane was generated by modifying the Z axis (tunnel height) of data points which of the current floor plan to the Z value per original design plane. As the artificial horizontal plane shown in Figure 6.2.2.2-2 is totally smooth on the surface, the deviation of the contour maps shown in Appendix E indicate the surface roughness of the ceiling. The hot spots (red color) next to the rebar indicate where the most concrete loss can be seen in the images. Distance distribution can be quantitatively analyzed with the histogram curve. The artificial horizontal floor plane established from this initial LiDAR deployment becomes the reference from which subsequent deployment data will be measured against.

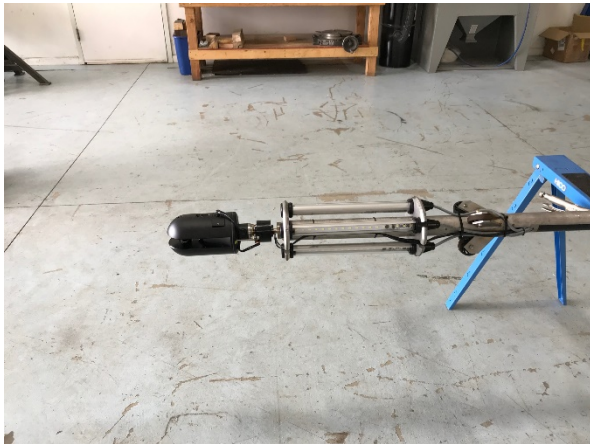
Figure B-1 LiDAR and Lights Attached to Deployment Pole

Figures B-1 through B-3 show components being inspected prior to transport of the assembly to mock-up flange. The tripod connector as well as the Moog AC6438 slip ring are displayed in Figure B-3 with guide pin and power connection wire. The power connection wire was placed between the guide pin and the tripod connection above the LiDAR to protect the wire.

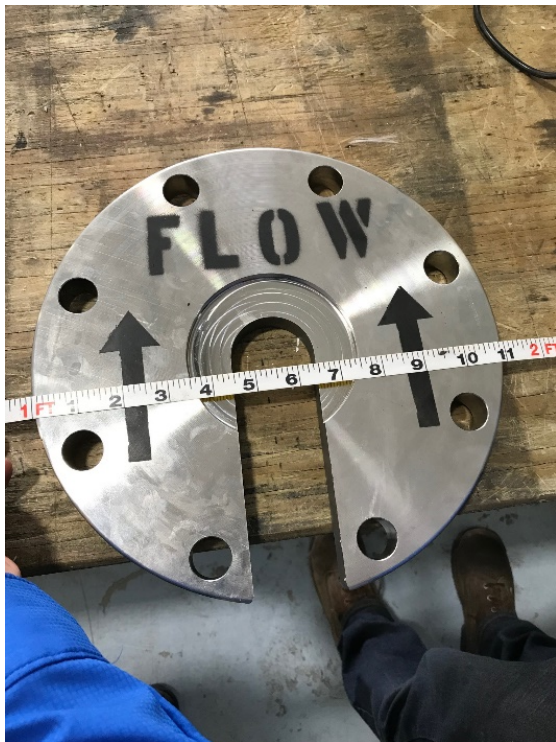
Figure B-2 Pole Height Adjustment Flange

The participants inspected the equipment on the shop floor and the test area setup. The height adjustment flange in Figure B-2 was measured and confirmed to match the SRS pitot tube flange.

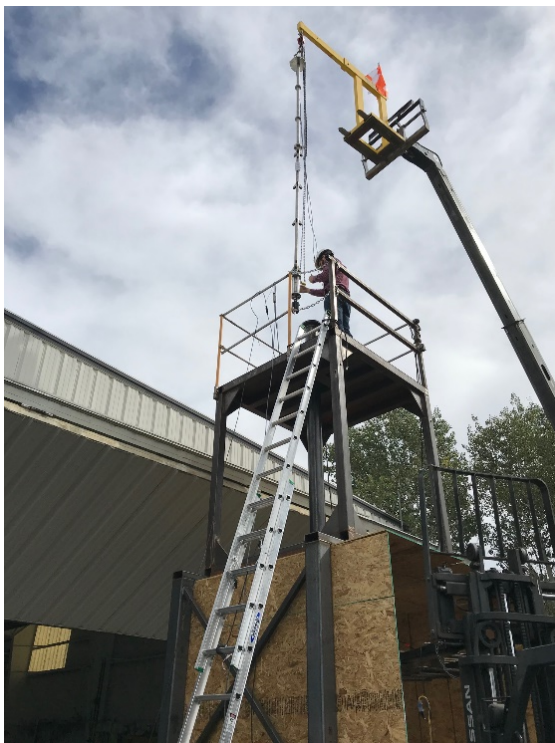
Figure B-4 Deploying Test Pole for FAT (missing middle section)

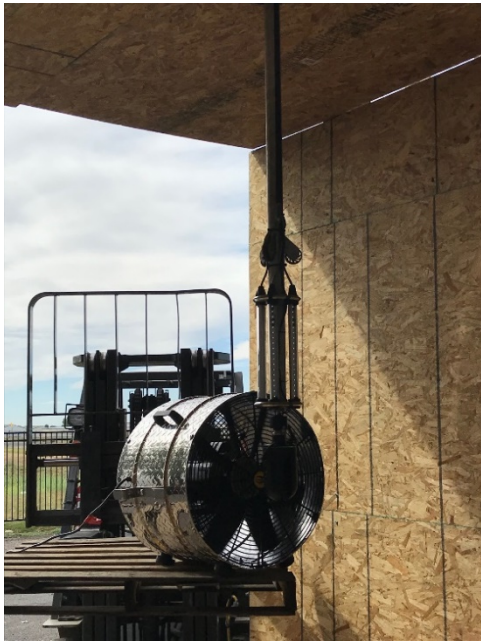
Figure B-6 LiDAR in Mid Position in Test Rig

After lunch, the assembly and the fan were lowered to the 54" position to resume testing. The iPad would not connect to the LiDAR unit. The LiDAR was rebooted. Rebooting did not resolve the issue.
