Effectiveness Evaluation of Vapor Corrosion Inhibitors for Tank Bottom Plate Corrosion Control

Pavan K. Shukla
Savannah River National Laboratory®
Aiken, South Carolina, 29808
USA

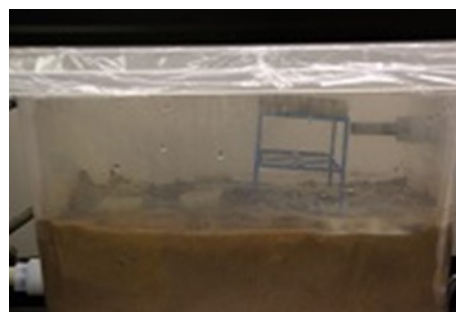
Figure 1. (a) Schematic of container for the control and VCI effect experiments, (b) image of an experimental setup

The control and VCI effect experiments were setup in plastic tubs. A schematic diagram of the experimental system is in Figure 1. Each experimental system consisted of a transparent plastic tub container with an airtight lid. Several tubs were used to setup the experiments. Each tub was approximately half-filled with sand plus water mixture. Twelve coupons were placed inside each tub.

The coupons were fabricated using the A36 grade carbon steel. Each coupon was cut from a one-inch (2.54 cm) diameter A36 rod. Further, each coupon was potted in epoxy, polished, and engraved with unique identification number.

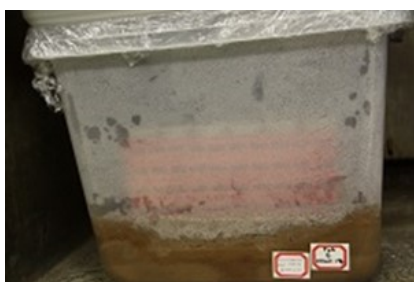
Figure 2. Image of an VCI effect experiment tub (a) three weeks after start, (b) near end of the experiment, showing visible water condensation at the tub walls

It was important to keep the VCI concentration constant through the experiments duration. However, it was not possible to measure the VCI concentration directly. Nonetheless, moisture level in the tubs could be monitored by way of observing water condensation at the tub walls. The water condensation

indicated that the interior environments of the tubes were contained and there were no exchanges between ambient and tubs' environments. Images of a tub immediately after the start and before the end of the experiment are presented in Figure 2. As seen in the figure, condensate water remained on the tub's wall for the entire duration of the experiment. This was used to infer that the VCI concentrations remained constant inside the tubs for the duration of the experiments.

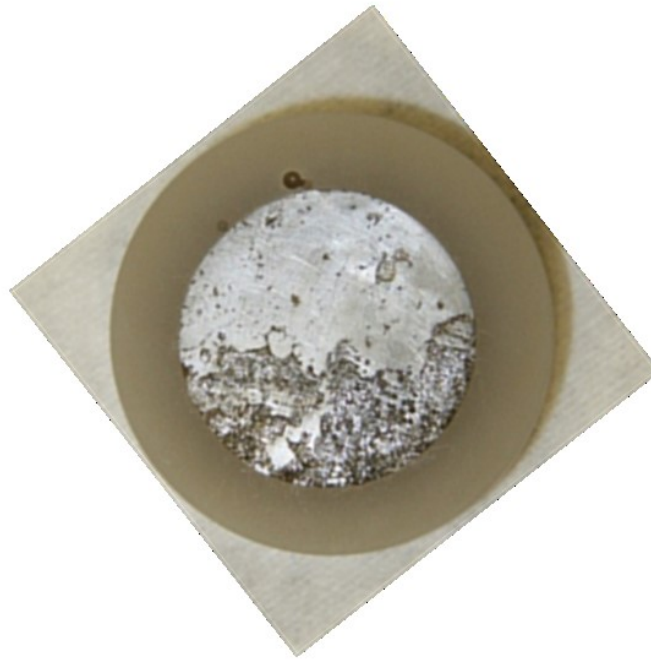
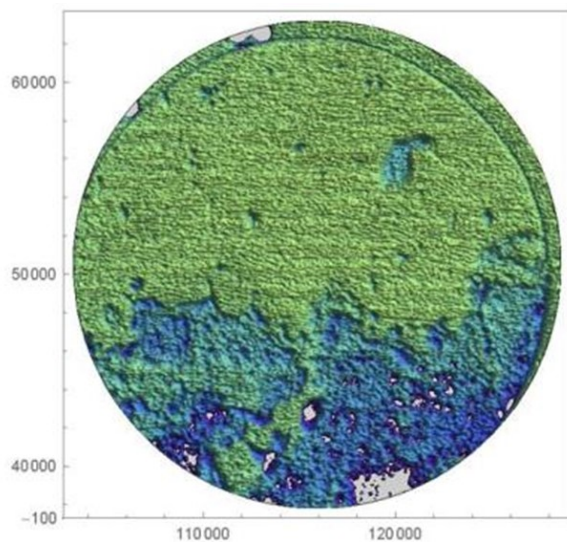
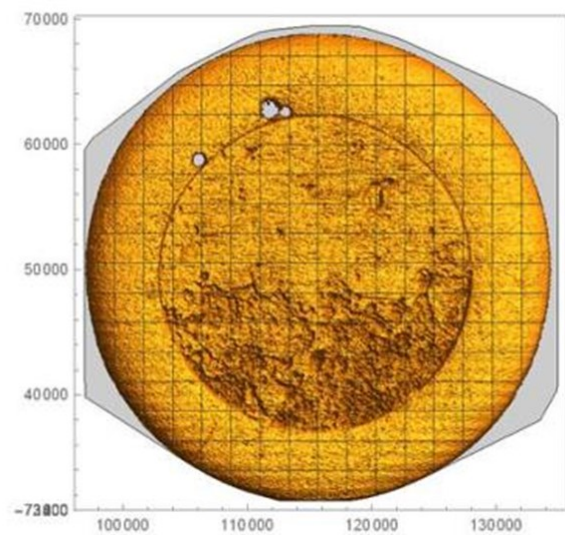
Figure 3. (a) Image of the A36 coupon after 6 months of exposure, and (b) false color map and (c) digital image constructed using the laser-profilometer data.

Vapor corrosion inhibitor (VCI) effectiveness values were calculated after retrieving the coupons, and analyzing them for corrosion rates by estimating surface average and pitting corrosion. A comprehensive surface analysis of the coupons was key to determining both surface average and pitting corrosion rates. Corrosion across the coupons' surfaces was nonuniform and varied from coupon to coupon. A laser profilometry technique was used to measure depths of various pits on the coupons. The techniques involved scanning the coupon surfaces with a laser profilometer, accounting for bulk surface curvature and incline, and statistically analyzing the collected data to estimate pit depths. The technique also enabled to quantitatively characterize pitting corrosion, including pit surface area, pit depths, and surface coverage of the pits. An example output of the laser profilometer-based technique is presented. A coupon was exposed to the sand-only environment for 6 months. The coupons developed several localized corrosion spots. The coupon and the laser-scanned images are presented in Figures 3(a), 3(b), and 3(c). Figure 3(b) shows the digital reconstruction of the coupon as compared to the coupon surface image in Figure 3(a). The technique quantified the pitting corrosion by estimating the following parameters: corroded volume and mass, corroded area, fraction of the corroded surface, average penetration, deepest penetration, penetration standard deviation, and cumulative distribution of the penetration depth. These parameters for the coupon in Figure 3(a) are listed in Table 1.

Table 1. Parameters related to quantifying corrosion for coupon in Figure 3(a)

Parameter	Value
Fraction of corroded surface	0.648
Corroded area	328.4 mm ²
Corroded volume	10.71 mm ³
Average penetration	32.61 μm
99 percent quantile penetration	160.1 μm
Surface average corrosion rate	41.9 μm/yr (1.65 mil/yr)*
Deepest penetration rate	317.5 μm/yr (12.5 mil/yr)* - (based on 99 percent quantile penetration)
* 1 mil/yr = 1 mpy = 25 μm/yr

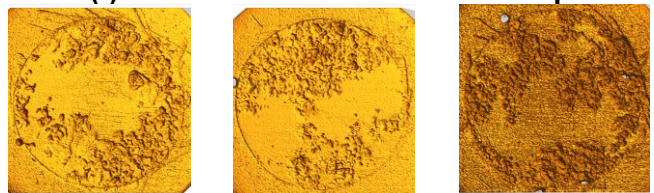
Figure 4. Digitally reconstructed images of the sand-phase coupons after 6 months of exposure

Digitally reconstructed images of the sand-contact coupons are presented in Figures 4 and 5 after 6 and 12 months of exposure, respectively. The corrosion rate data for the sand-contact coupons are listed in Table 2 (sand and sand + 100% VCI), Table 3 (sand and sand + 10% VCI), and Table 4 (sand and sand + 1% VCI). Each table has data for 6- and 12-month coupons for each electrolyte and corrosion type, thus six corrosion rate values for each combination of electrolyte and corrosion type. In addition, a combined average corrosion rate of the 6- and 12-month coupons and corresponding standard deviation was calculated for each electrolyte and corrosion type. These average values and standard deviations of the averages are listed in the respective tables and are graphically presented in Figures 6–8.

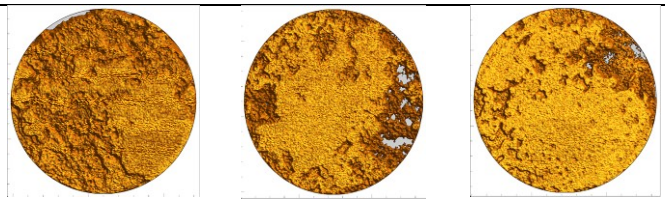
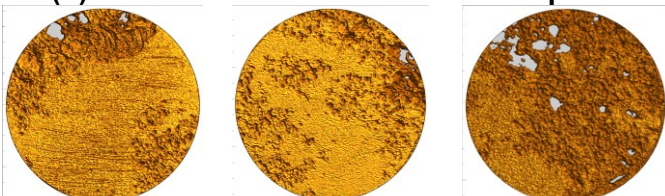
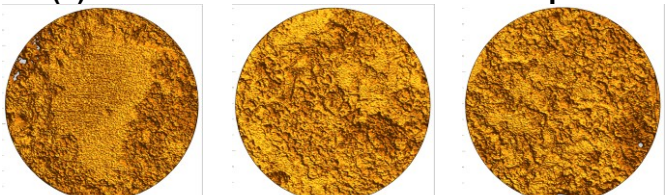
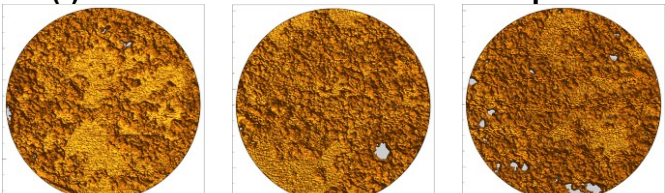
Figure 5. Digitally reconstructed images of the sand-phase coupons after 12 months of exposure

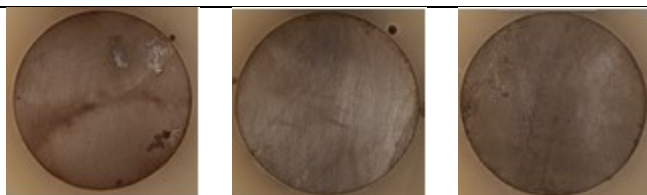
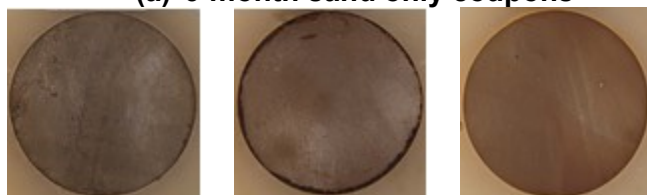
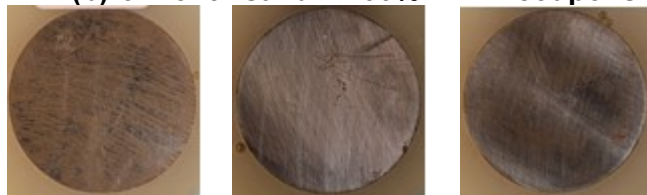
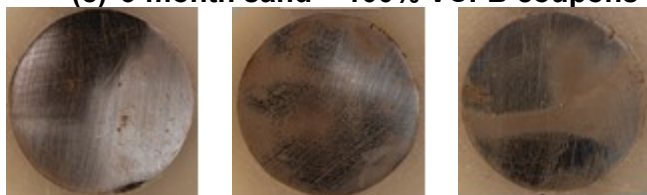
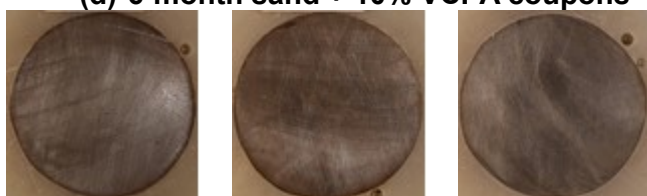
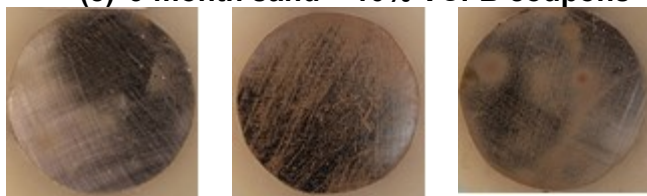
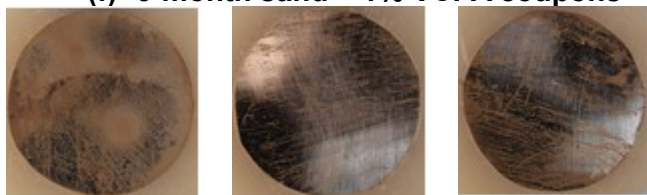
Figure 9. Images of the vapor-phase coupons after 6 months of exposure

The vapor phase coupons were visually analyzed for corrosion prior to laser profiling of the surfaces. It was observed that most vapor phase coupons showed little or no signs of corrosion. Images of the 6- and 12-month coupons exposed to the vapor space of various electrolytes are presented in Figures 9 and 10, respectively. Some coupons showed significant corrosion compared to the others. Corrosion

Visual examination of the coupons that were not analyzed using laser profilometer suggest that vapor phase corrosion of A36 carbon steel is negligible, and the presence of VCI may further reduce pitting corrosion tendencies. The majority of the metal surfaces remained in the pre-test conditions, i.e., as shiny as before commencing the experiments. Some images of the coupons in Figures 9 and 10 may not appear shiny. This was due to contrast ratio selected to photograph the coupons.
