**SCM PASTE SAMPLES EXPOSED TO  
AGGRESSIVE SOLUTIONS**

**Cementitious Barriers Partnership**

**CBP-TR-2015-007, Rev. 0**

## **TASK 12 – EXPERIMENTAL STUDY**

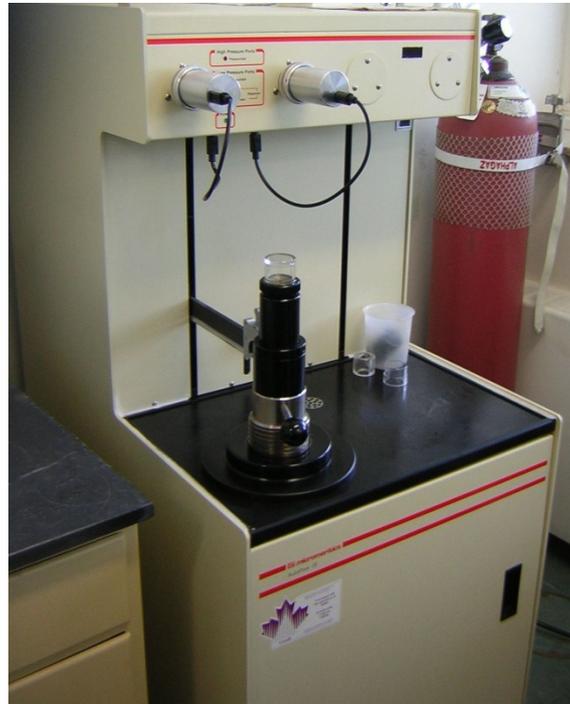
Figure 11 – Mercury Porosimeter Micromeritics Autopore IV,

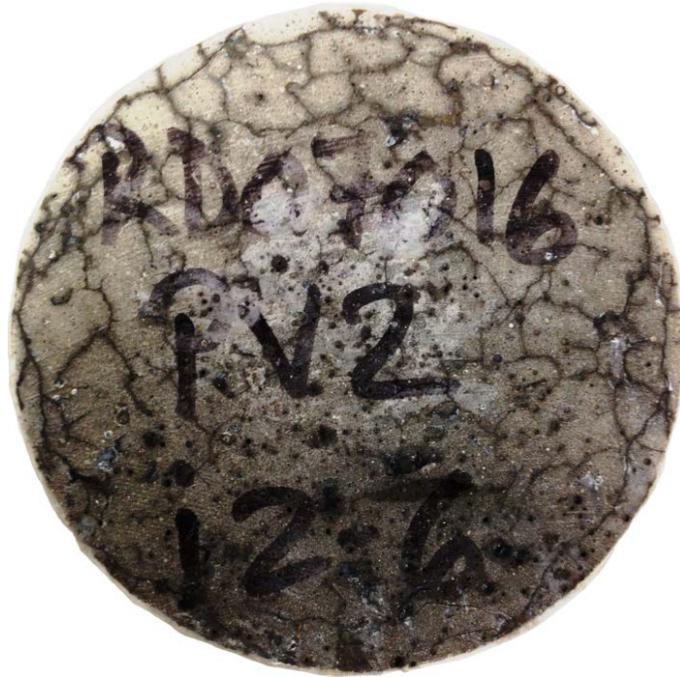
No significant surface alteration was observed on PV1 and PV1b samples exposed to solution 2. However, Figure 13 shows that PV2 sample exhibited an important surface crack network. The cracks are evenly distributed on the material surface. A portion of PV2b's surface was spalled but it is difficult to conclude this can be attributed to chemical damage or sample manipulation in the lab.

**Figure 13 – Surface cracking on PV2 after 8 months of exposure in Sol. 2.**

The damage observed on PV2 samples had an important impact on UPV measurements. After 10 months of exposure, the velocity could no longer be measured.

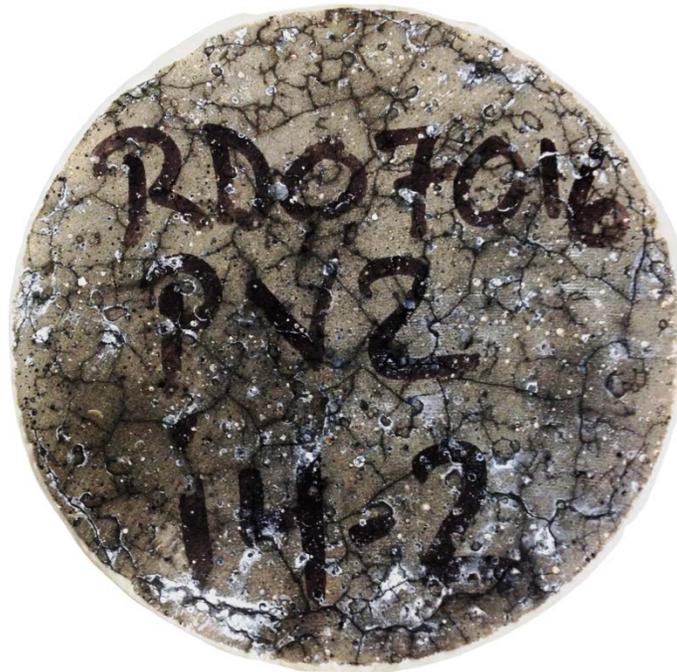
As shown on Figure 16, PV2 mixture was particularly affected by solution 4. It is likely that the same reaction observed in the solution 2 case takes place in solution 4.

**Figure 16 – Apparent damage on PV2 after 8 months of exposure in Sol.4.**

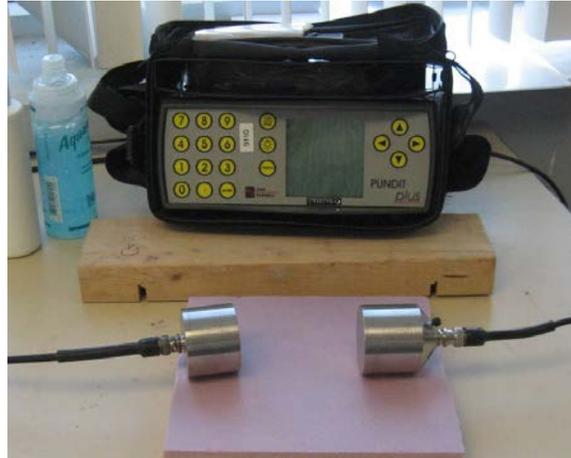
**Figure 17 – Dynamic Testing Apparatus - PUNDIT**
