6603569
DP(NASA)-1130

ROLE OF HYDROGEN CHLORIDE IN HOT-SALT STRESS CORROSION CRACKING OF TITANIUM-ALUMINUM ALLOYS

December 1967

National Aeronautics and Space Administration
Work performed under NASA Purchase Order No. R-124
Issued to the United States Atomic Energy Commission

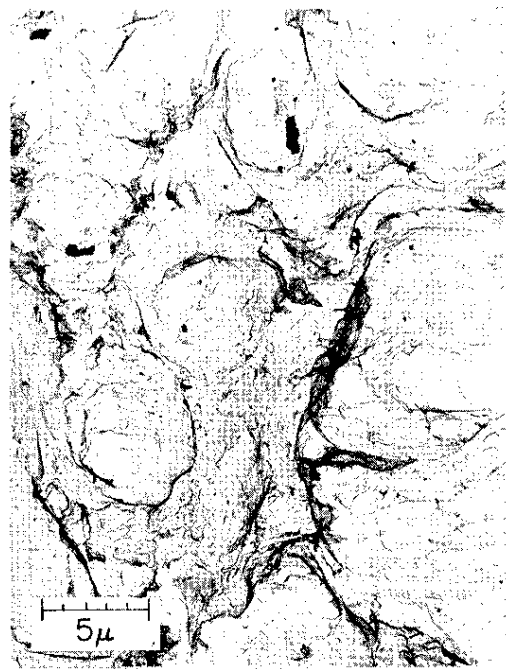
a. Fractograph Showing Ductile Characteristics of Sample Containing 1400 ppm H_2

b. Fractograph Showing Brittle Characteristics of Sample Containing 4000 ppm H_2

c. Microstructure of Surface of Sample containing 4000 ppm H_2

FIG. 9 EFFECT OF HYDROGEN CHARGING ON STRUCTURAL CHARACTERISTICS

Samples containing 1400 and 4000 ppm hydrogen were mechanically ruptured to provide a fractographic comparison with hot-salt and HCl fractures. The sample containing 1400 ppm hydrogen failed by both brittle and ductile mechanisms, but mainly by ductile mechanisms (Figure 9a); the sample with the higher hydrogen content failed almost entirely by brittle mechanisms (Figure 9b). The rough appearance of the fracture surface was due to the twisting path required for the crack to follow the almost continuous network of hydrides lying along the α - α and α - β grain and phase boundaries, shown in the polished microstructure (Figure 9c). These observations show that fracture near a metal-hydride interface was brittle and had a very rough surface due to hydride precipitation. The fractographic appearance of these samples was quite different from that of cracks caused by hot-salt and HCl (compare Figure 5), although isolated regions with

similar features were observed in one crack produced by exposure to SnCl_2 at 343°C (650°F). These studies indicate that hot-salt cracking does not occur by hydride formation and subsequent fracture along or through the hydride platelets.
