# ANALYSIS OF HYDROGEN EXPLOSION HAZARDS

J. B. PORTER

*Savannah River Laboratory*

July 1972

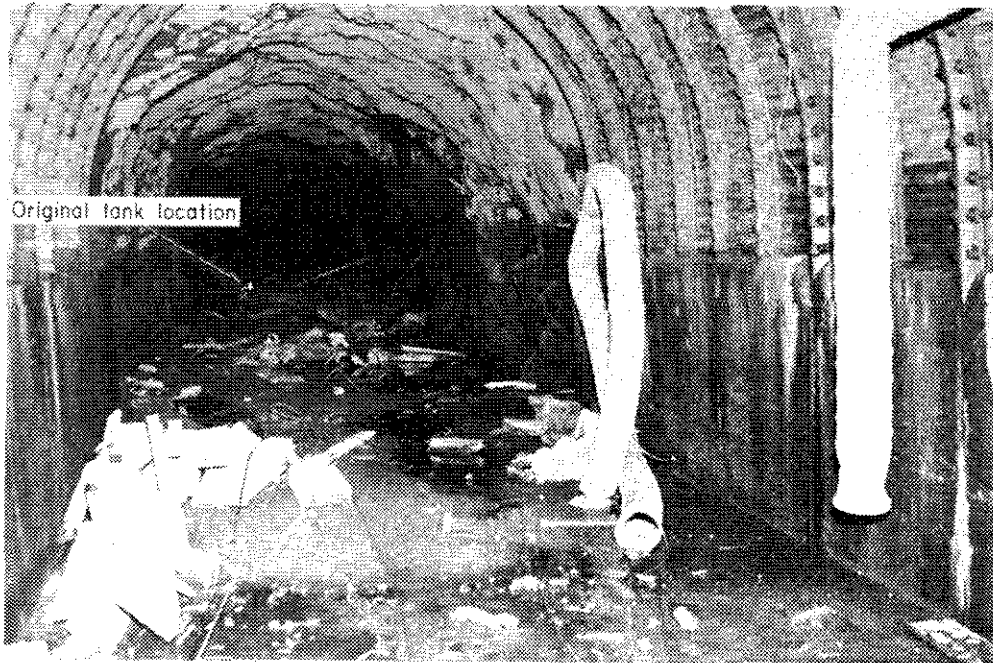
FIGURE 12. General Appearance of Tunnel  
After 10-atm Test

In Test 9, the tank was destroyed at 10 atm abs initial pressure. It failed by rupturing into four approximately equal sized sections. One section came to rest about 5 ft inside the tunnel entrance (the tank had originally been located 125 ft inside the tunnel). A second piece was found 35 ft toward the entrance and the third and fourth pieces were blown 50 and 65 ft to the rear of the original tank location. The general appearance of the tunnel following the explosion is shown in Figure 12, and the concrete base on which the tank was mounted is shown in Figure 13. The condition of the tank remains indicates that the reaction in the tank was a deflagration and not a detonation.

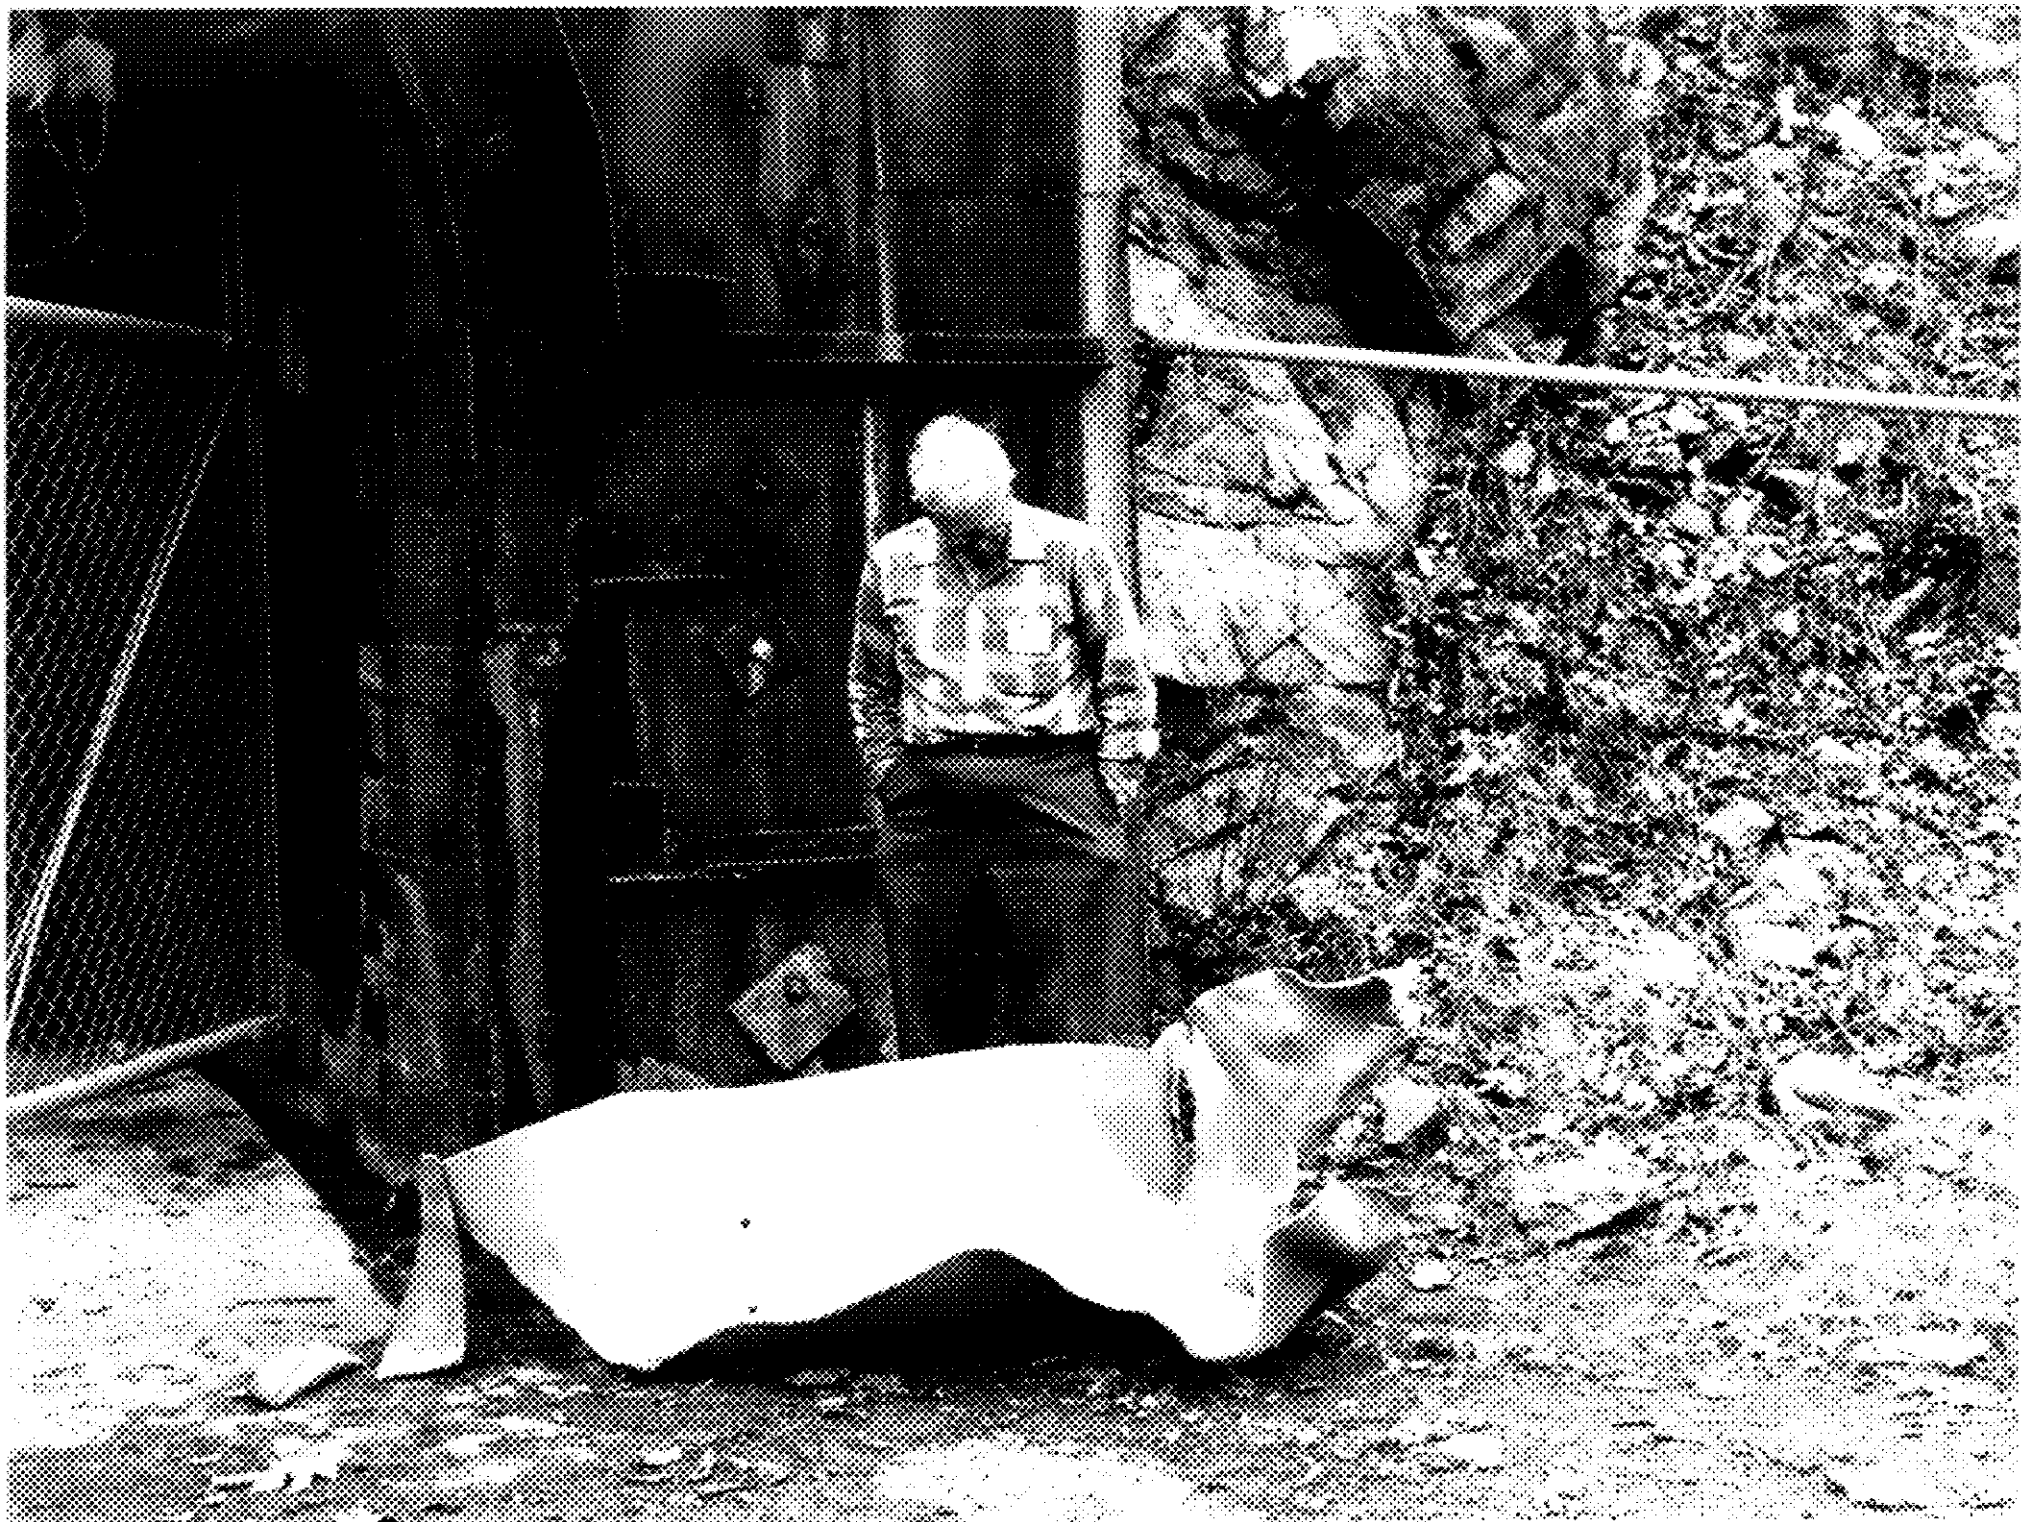
FIGURE 21 : TANK SECTION AFTER 10 ATM. TEST (FOUND  
35 FEET FROM ORIGINAL TANK LOCATION)

A fragment was removed from the ruptured tank and was subjected to a metallurgical examination. Hardness readings on various areas on the fragment varied from Rockwell C-23 to 30. For comparison, the hardness of annealed Type 304 stainless steel is Rockwell B-75 to 90, which is much lower in hardness than the test fragment. These hardness readings indicate that the stainless steel had been severely cold-worked during the repeated explosion testing, resulting in a rise of tensile and yield strengths and in a decrease in the ductility. No tensile tests were made; however, based on the observed hardness, it is estimated that the tensile strength in the most severely deformed areas was raised from 75,000 psi to 110,000-120,000 psi.

A microscopic examination of the stainless steel structure disclosed that the amount the metal was cold-worked varied from area to area, although all areas gave evidence of some cold-work. Grains were found to be distorted and some showed strain lines.

As the tank was tested, the stainless steel was work hardened, which resulted in an increased mechanical strength and reduced ductility. Although the ductility was reduced, it had not been reduced to the point that the stainless steel would be considered brittle.
