HISTORY OF THE SMALL CYLINDRICAL MELTER

**T. L. ALLEN
D. C. IVERSON
M. J. PLODINEC**

DP-1676

Publication Date: August 1985

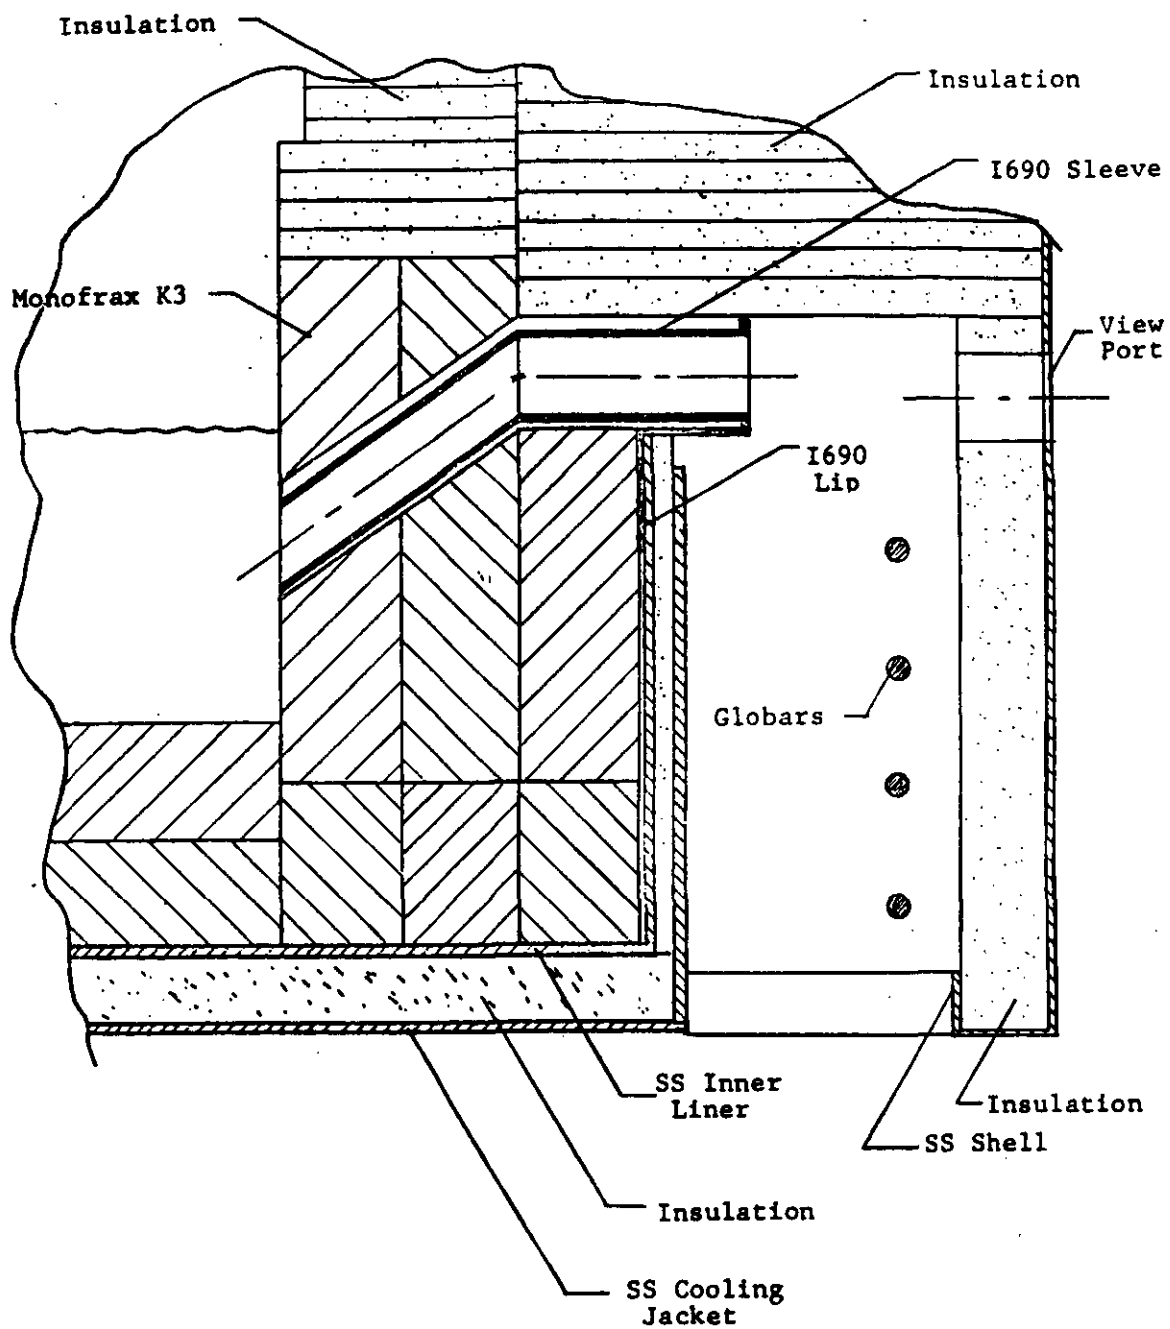
FIGURE 1. Inconel® 690 Sleeve Welded into the Worn Throat Region

During shutdown before the third campaign, a metal sleeve fabricated from 2-inch sch 40 Inconel® 690 pipe was inserted into the worn throat as a temporary replacement. The sleeve was flanged and welded to the Inconel® 690 pour lip to prevent glass from bypassing the sleeve by flowing along its outer surface (Figure 1).

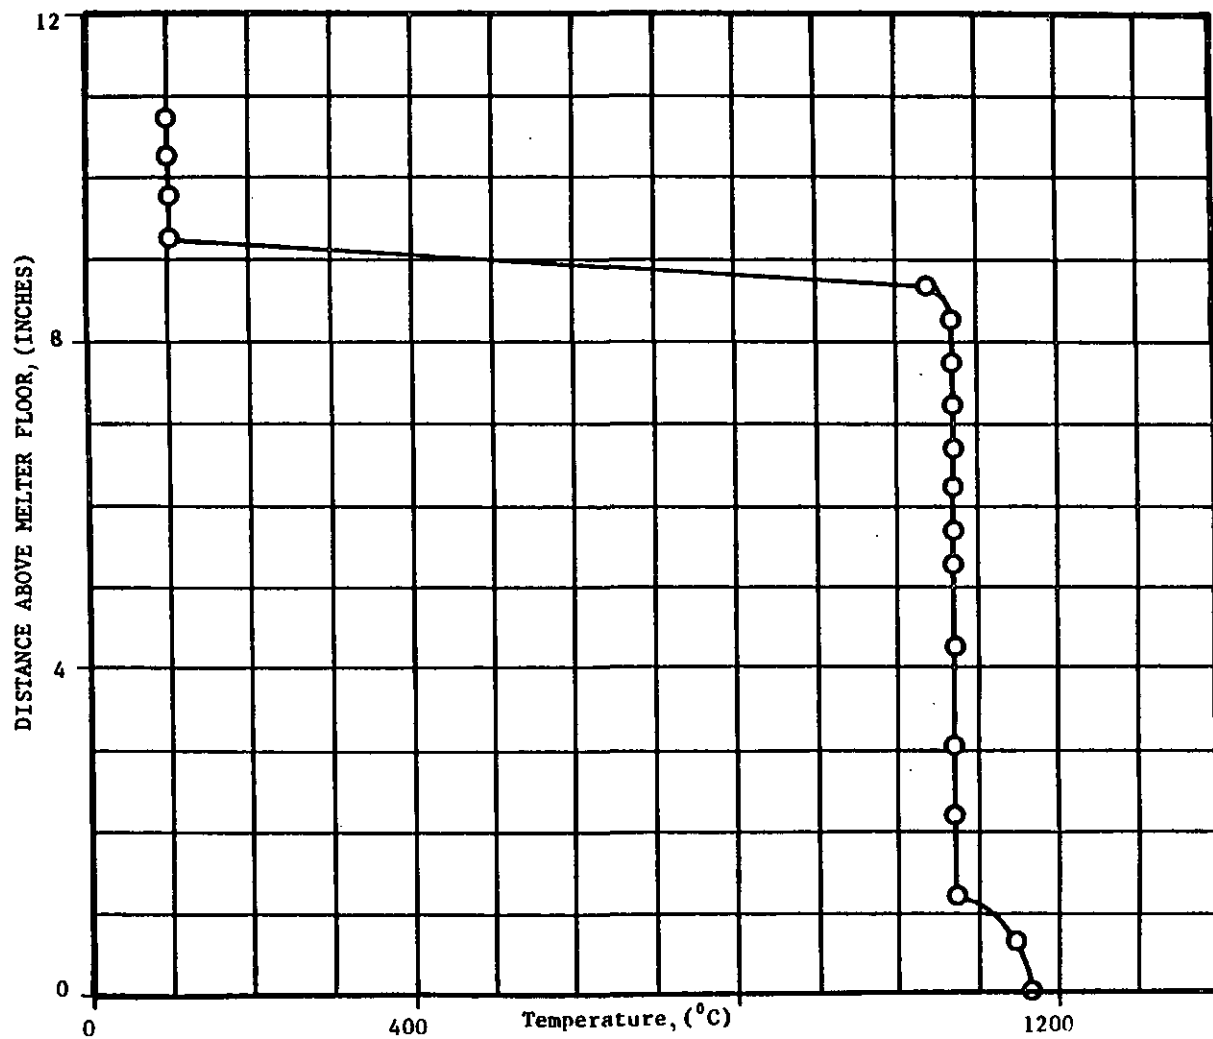
FIGURE 2. Typical Vertical Temperature Profile Taken During a Hot Bottom Incident

Convergence of electrical current at the face of an electrode normally causes a higher local power density there with an accompanying temperature rise of 20 to 60°C compared to the glass bulk. If convection were severely impeded, this temperature rise could be much more pronounced, which indeed apparently occurred and led to the deformation of electrode D (Electrode Wear section).

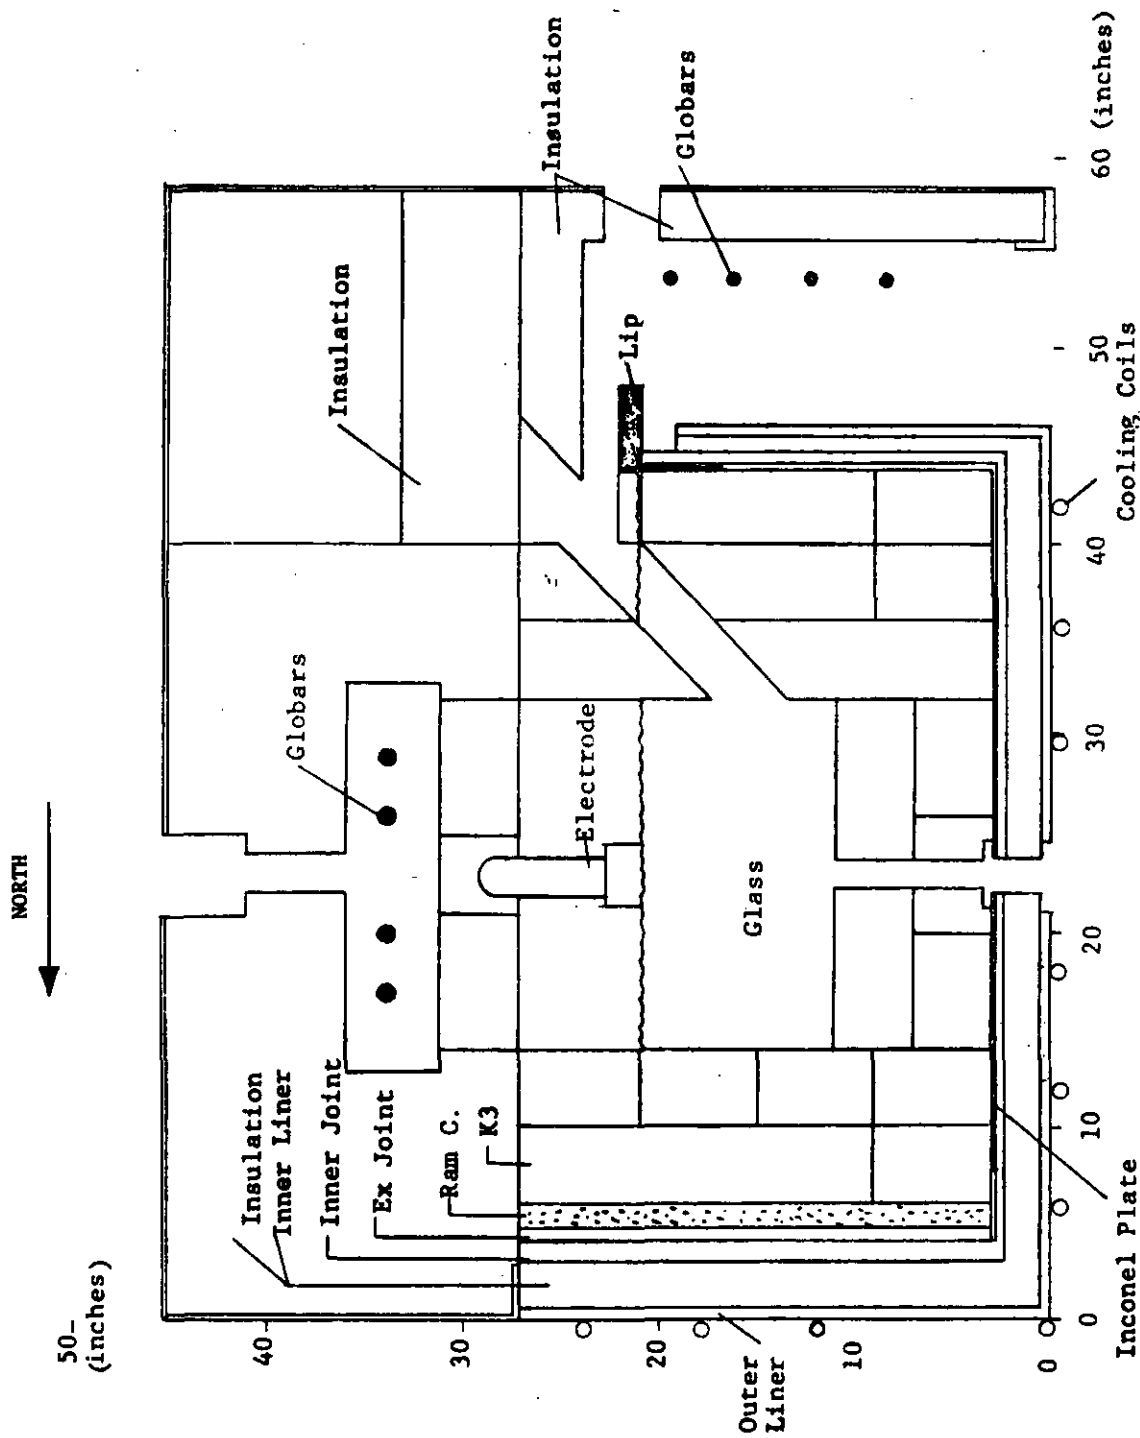
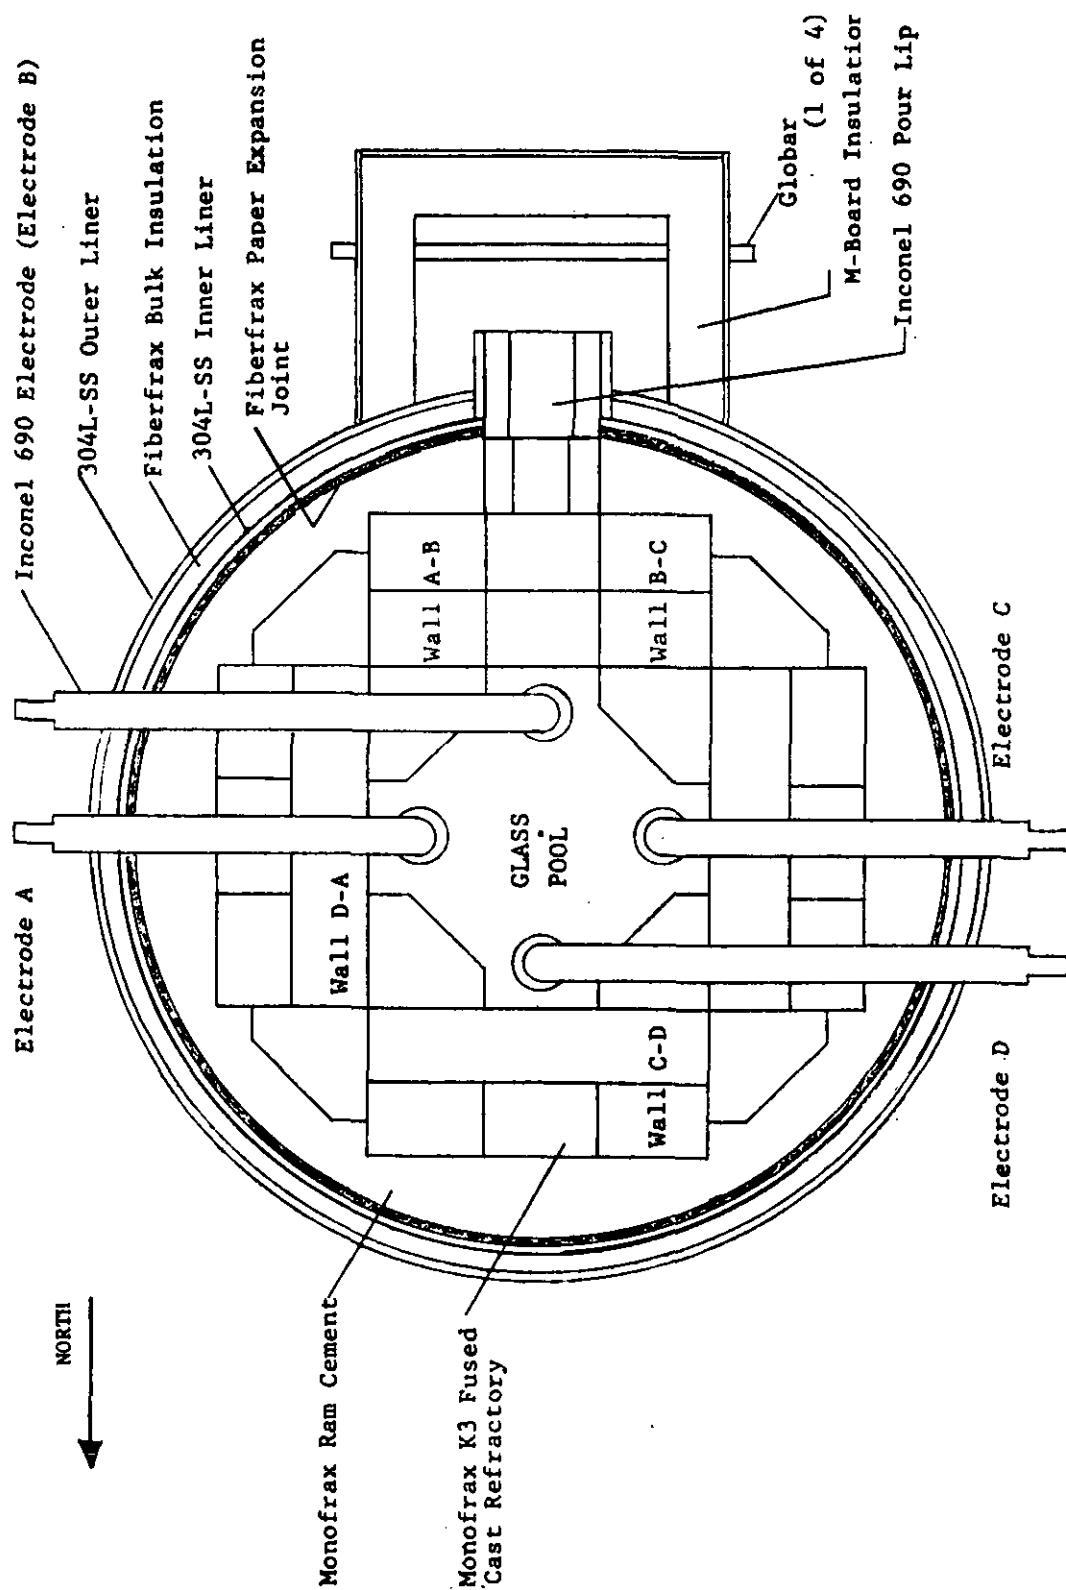
General construction features of the SCM are shown in Figures 3 and 4 for orientation purposes. Figures 5 and 6 show the condition of the melter at the beginning and end of Campaign 1 (October 15, 1979, to March 3, 1980). Figures 7 and 8 show the condition of the melter at the beginning and end of Campaign 2 (April 9, 1980, to August 19, 1980). Figures 9 and 10 show the condition of the melter at the beginning and end of Campaign 3 (September 9, 1980, to February 11, 1981). The throat is located on Figures 5 through 9 for reference purposes.

FIGURE 3. Vertical Section of the SCM

FIGURE 4. Horizontal Section of the SCM at the Top of the Melt Pool

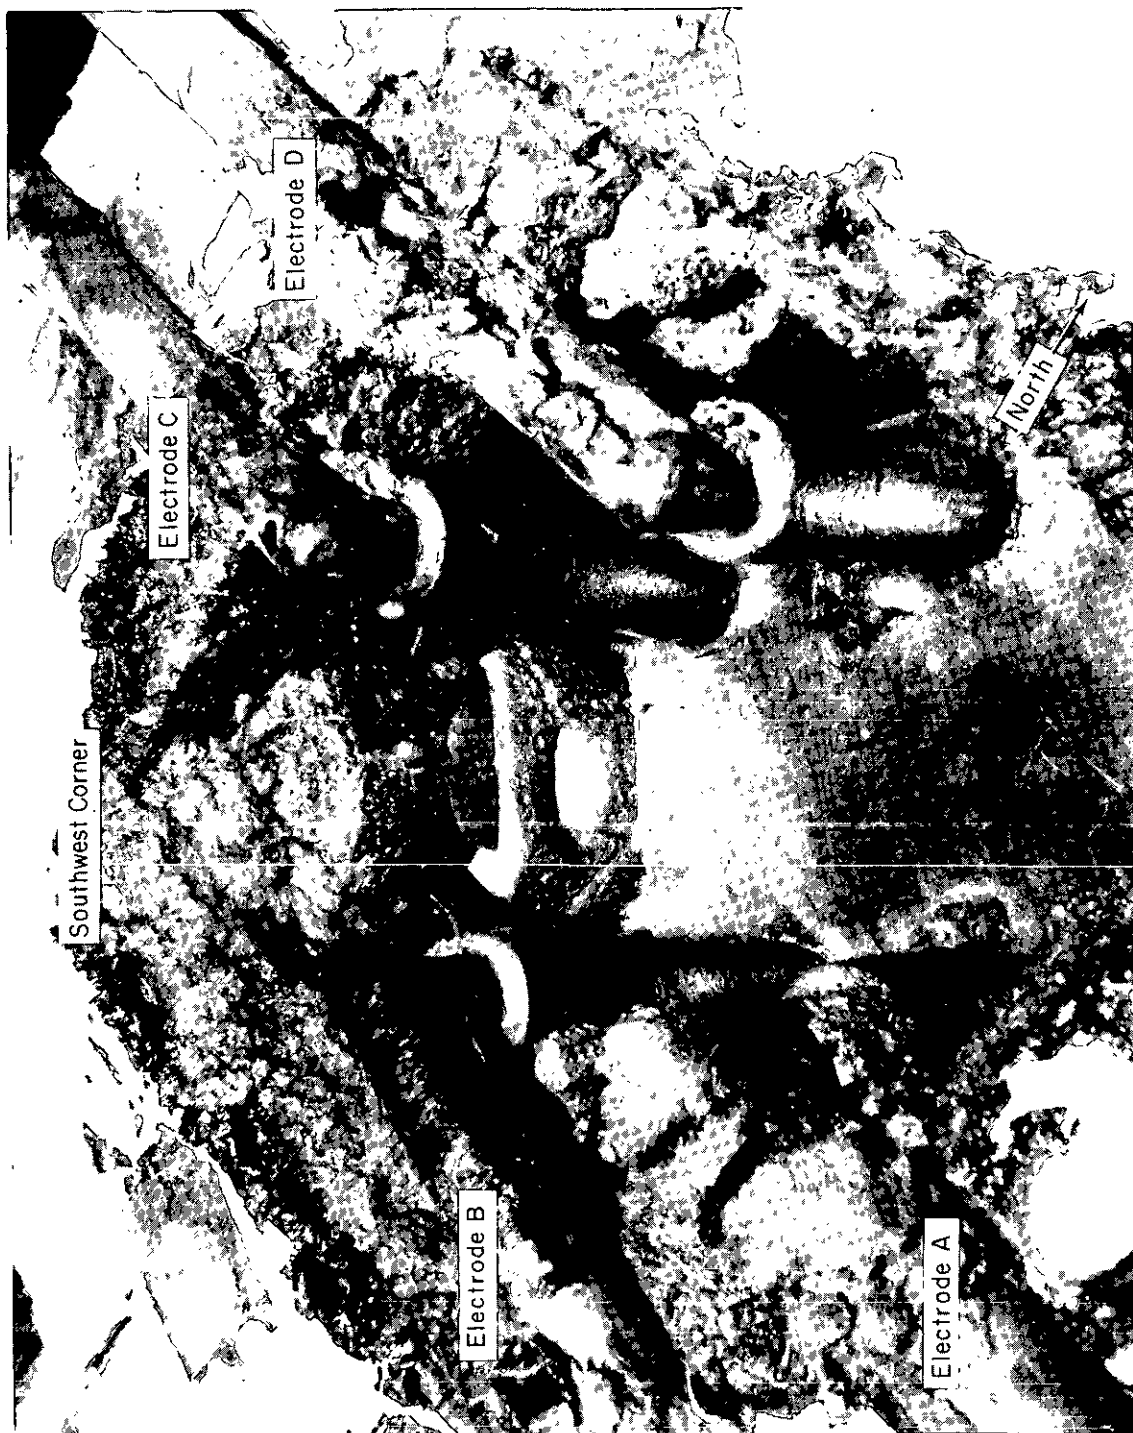
FIGURE 15. Melt Chamber After Shutdown (South View)

Extensive refractory wear is apparent all around the throat and there is vertical cracking at the top. The generally smooth contour of the wear pattern and its symmetry seem to indicate that refractory loss was not due to spalling but instead was simply due to corrosion/erosion mechanisms. In addition, the dimensions of the throat are essentially the same as those measured at the end of Campaign 2 which was terminated due to excessive loss of

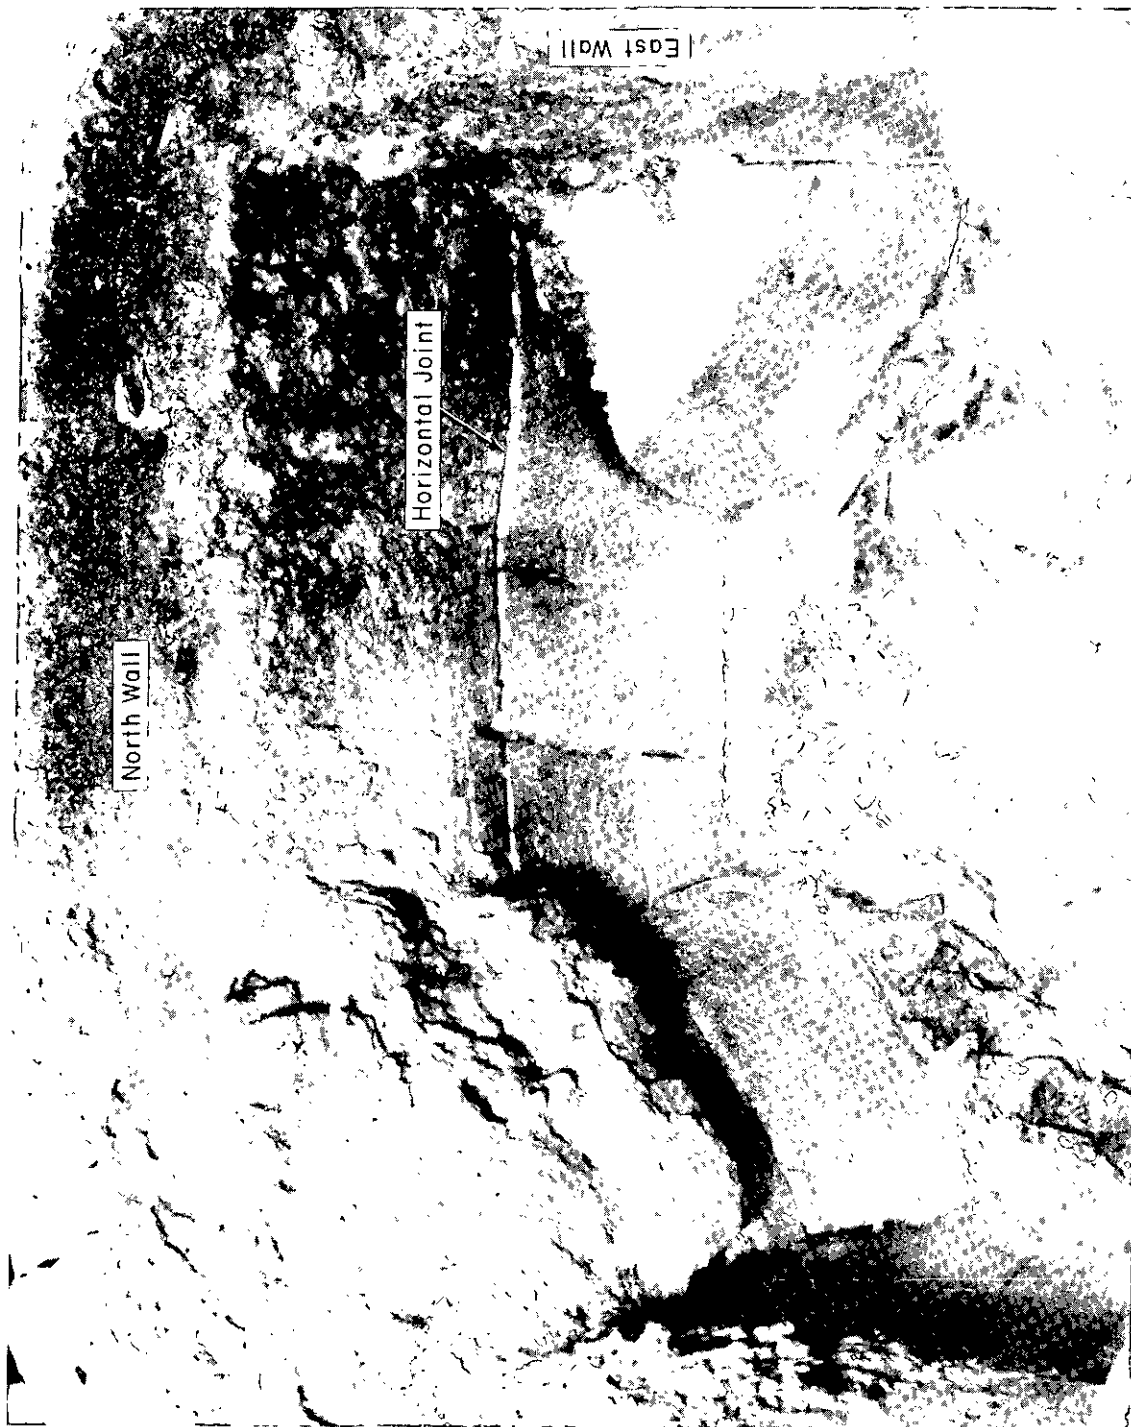
FIGURE 16. Closeup of North Wall

Figure 16 is a closeup of the north wall after removal of the electrodes. Two vertical cracks are apparent beneath the horizontal joint in the brick, but they penetrated less than 1 inch into the wall.

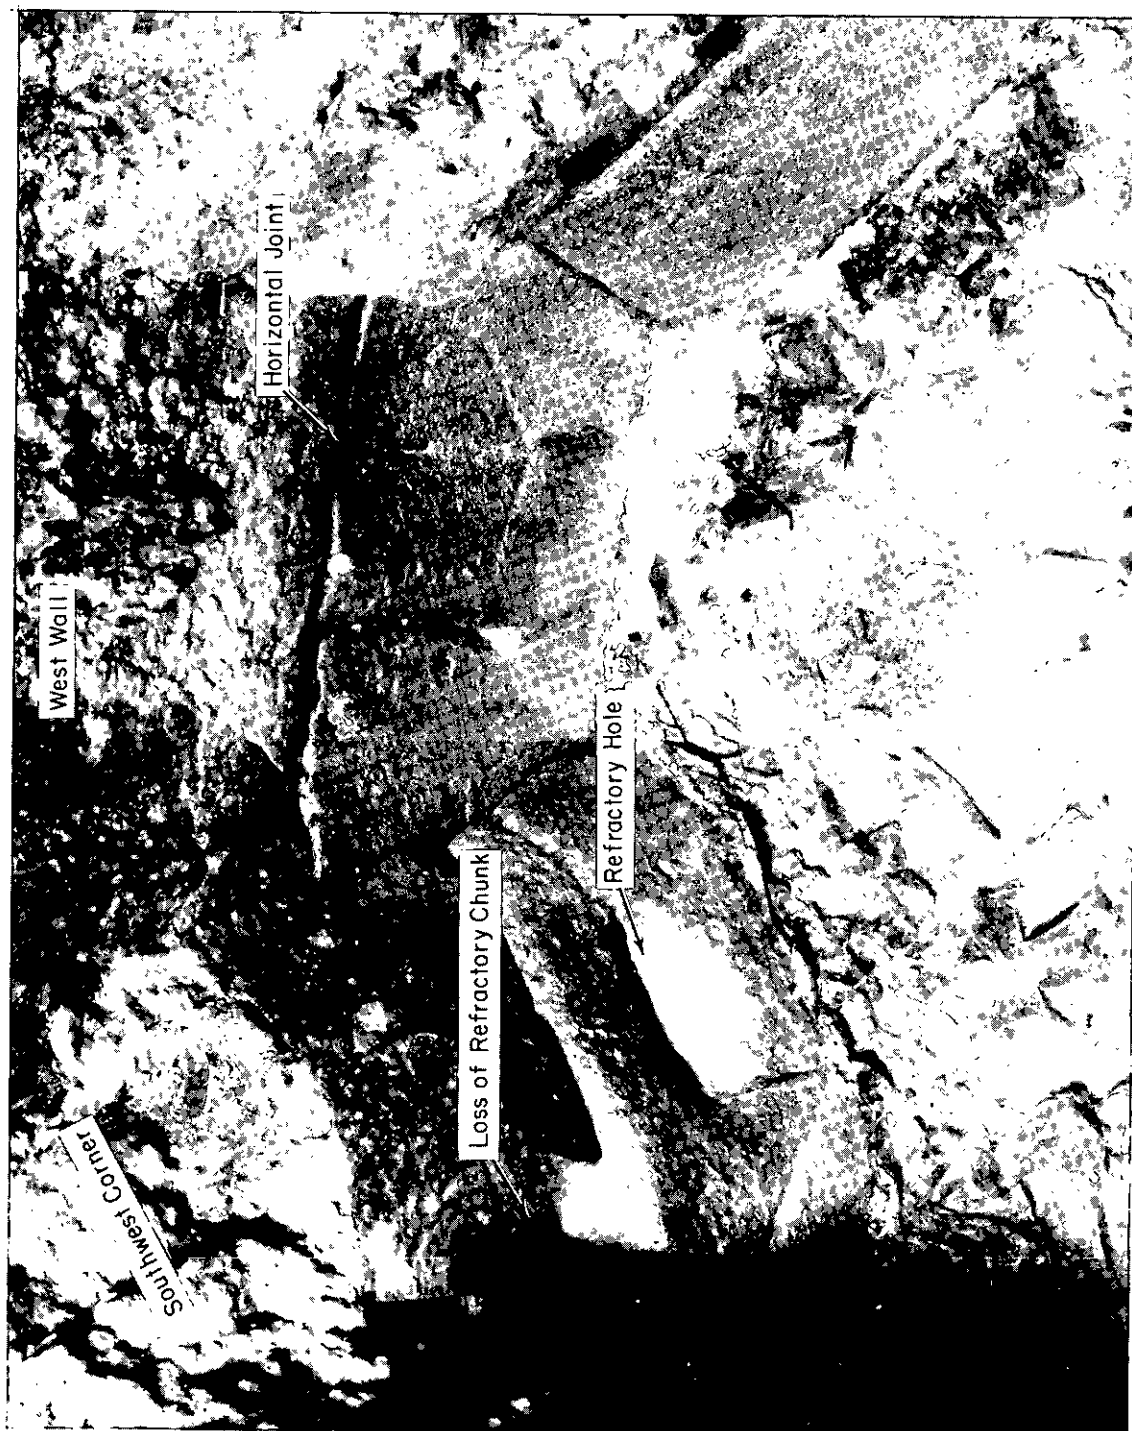
FIGURE 18. Closeup of West Wall

Figure 18 is a closeup of the west wall. Both vertical and horizontal cracks are apparent but again the depth of penetration was only 1 to 2 inches. One small chunk of refractory was lost from a brick in the southwest corner, and the refractory hole previously mentioned is again visible.

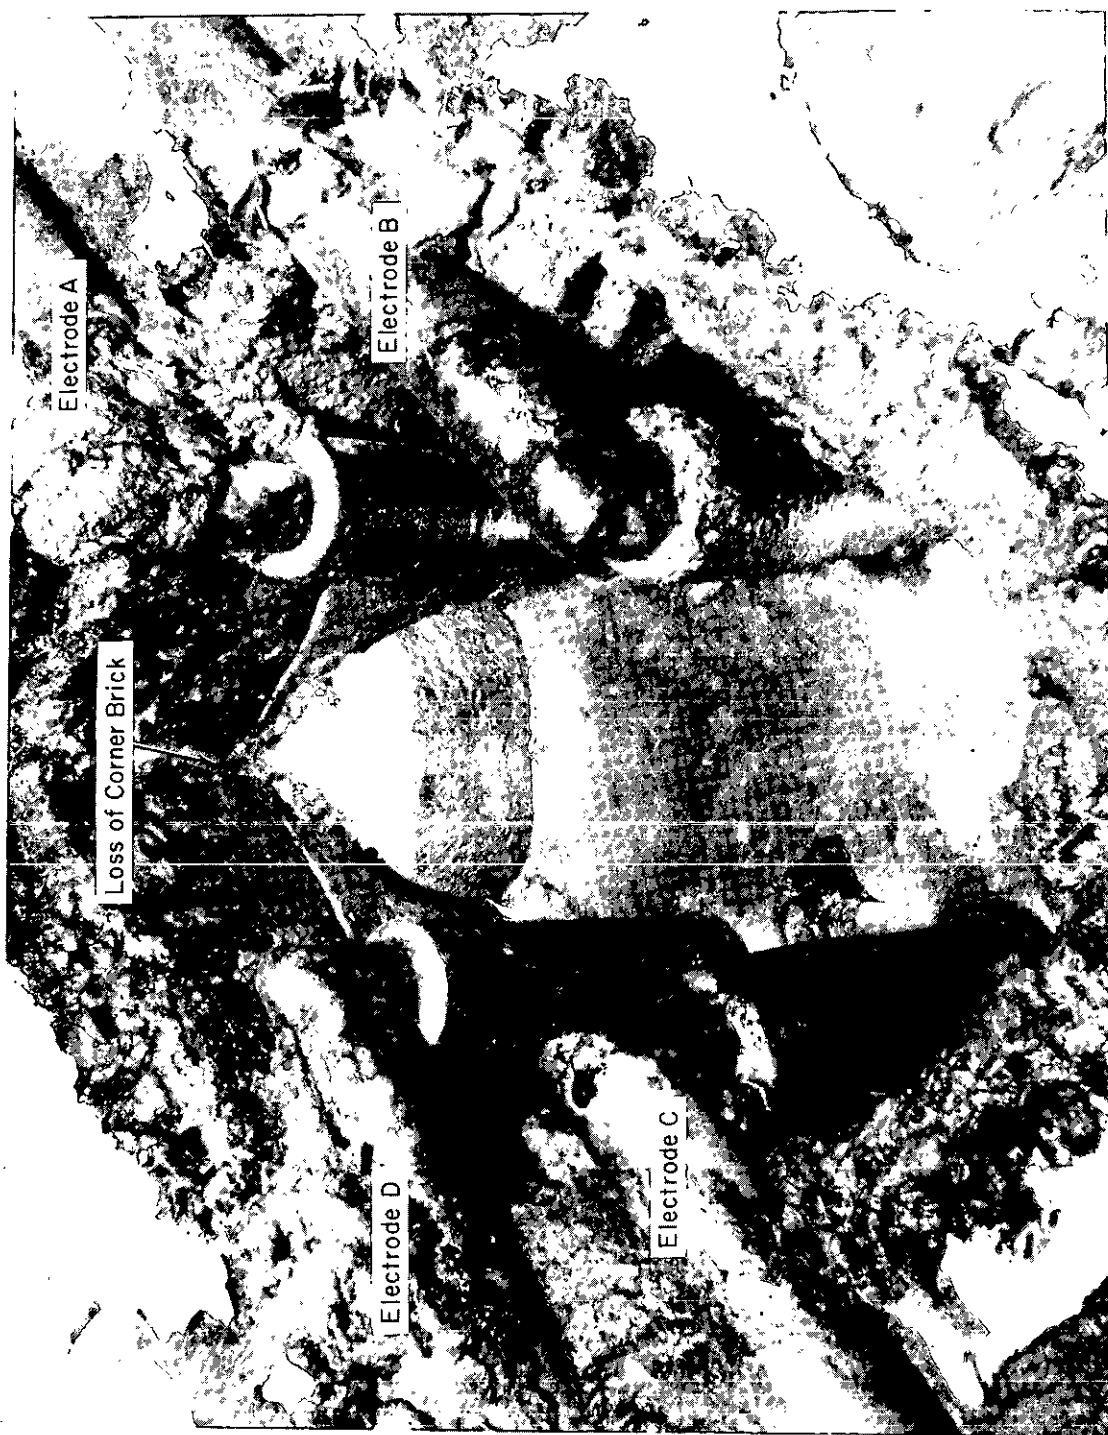
FIGURE 19. Melt Chamber After Shutdown (North View)

Figure 19 is the north view of the melt chamber immediately after shutdown with 1 to 2 inches of glass still on the melter floor. An evacuated canister was used to drain the melter. The suction pipe of the canister was not inserted all the way to the melter bottom to prevent the floor deposits from clogging the pipe. One corner brick on the northeast wall apparently fell into the melt pool at some point during Campaign 3. Portions of the brick were subsequently found embedded in the glass remaining on the melter floor. Note, however, that the corner bricks were simply installed to make an otherwise square tank approximately round to match the geometry of the CFM. These bricks were not interlaid with any larger bricks on the north, south, east, or west sidewalls to reduce shifting. Thus no particular significance is attached to the loss of this corner brick.

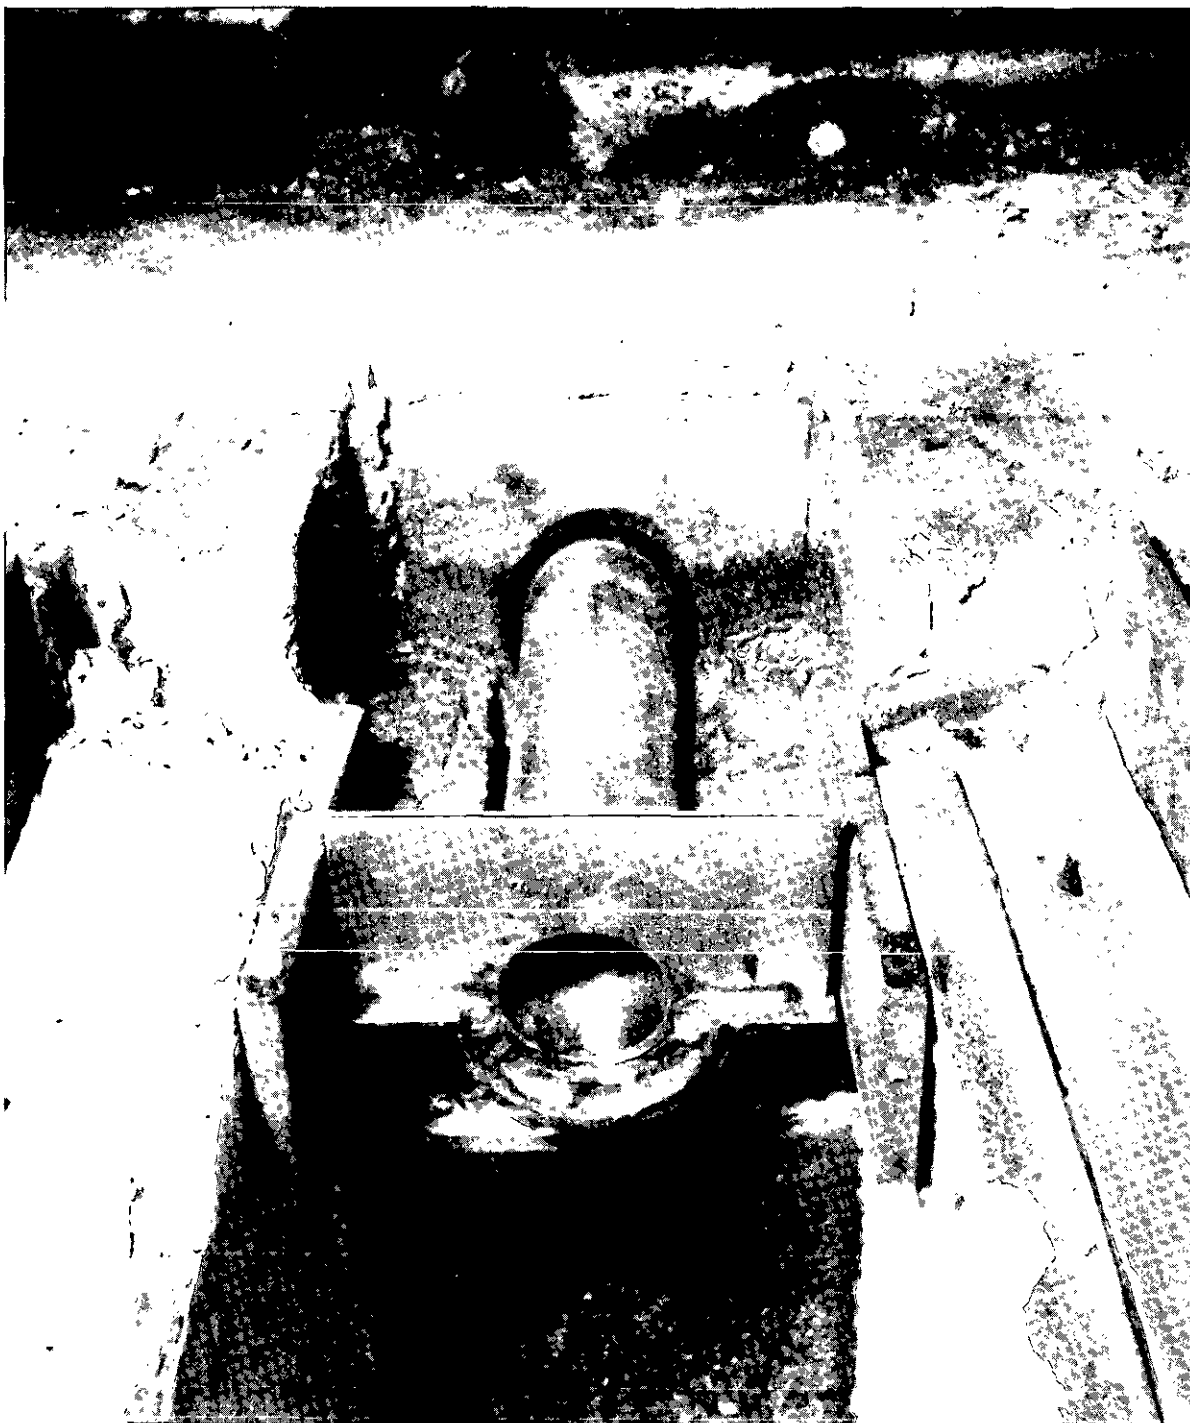
FIGURE 21. Inconel® 690 Replacement Sleeve Attachment in Pour Chamber Before Campaign 3

Campaign 2 was terminated when unmelted material was observed in the glass discharge stream. After the melter was drained and shut down, examination of the throat section revealed that the hot face of the throat had eroded/corroded away up to the meltline, thus allowing unmelted material to enter the pour stream (Figure 8). The throat region was repaired by inserting an Inconel® 690 sleeve made from 2-inch schedule 40 pipe through the throat/riser section. The sleeve was then welded to the stainless steel inner liner to prevent glass from flowing around the sleeve and into the pour stream. Figure 9 shows the throat of the Inconel® 690 pipe in the melt chamber and Figure 21 shows the attachment of the sleeve to the inner shell in the pour chamber.

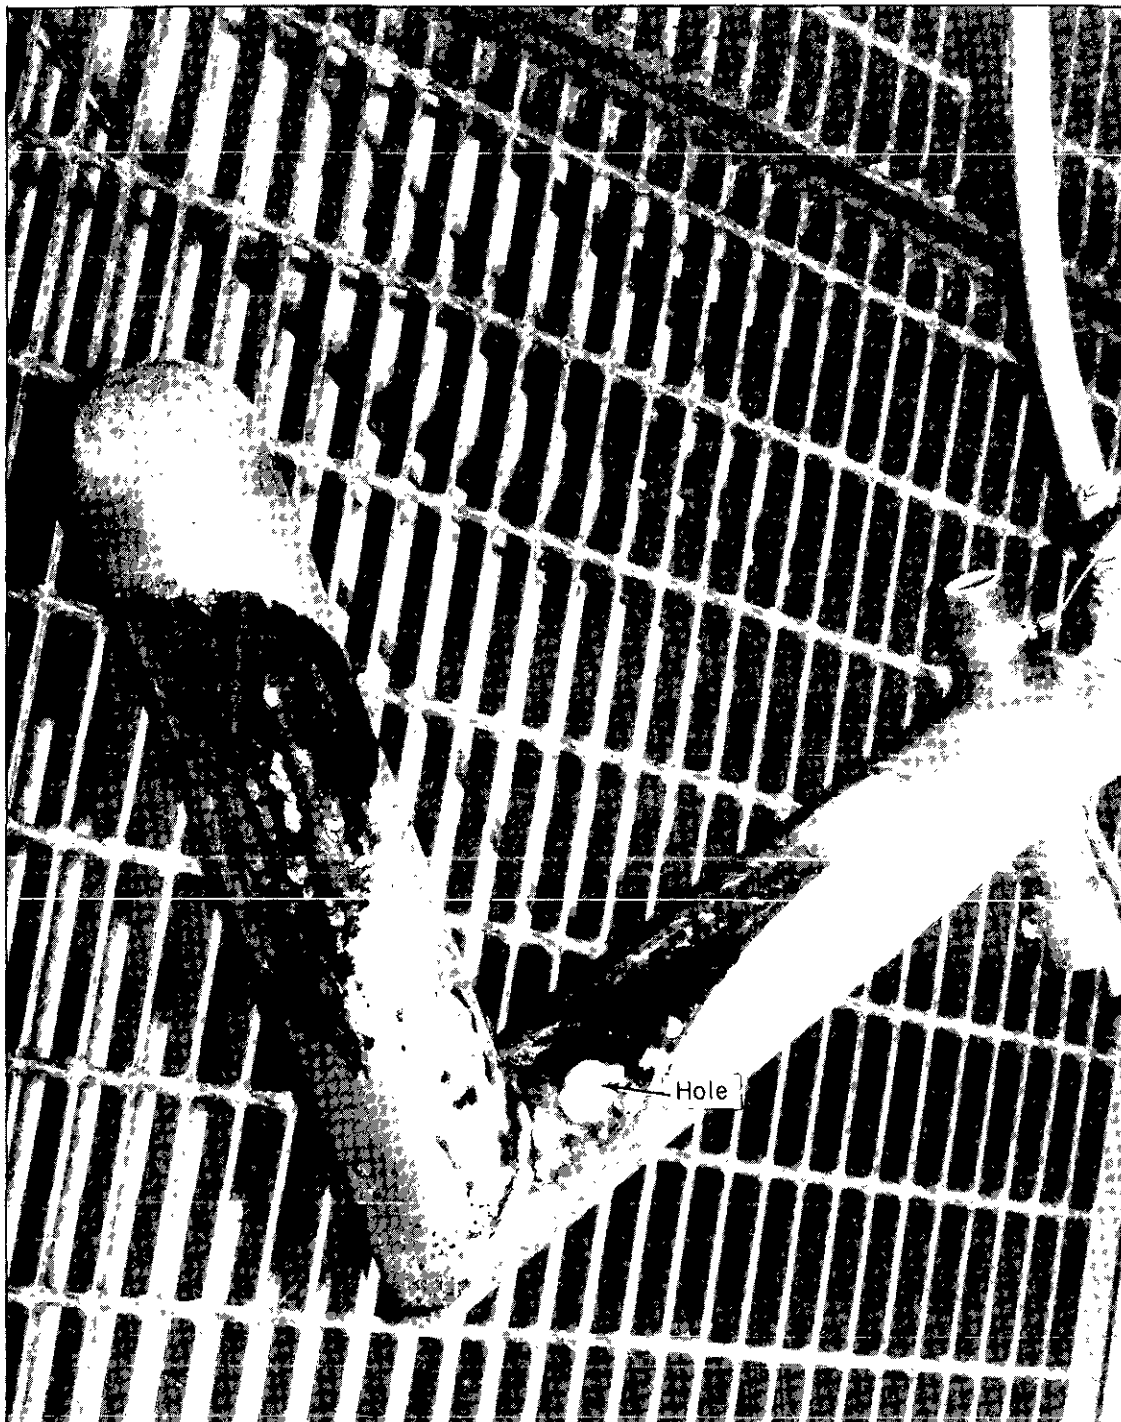
FIGURE 25. Nominal 3-inch OD Electrode (A) after Campaign 1

Campaign 1 ended when a hole developed in electrode A approximately 3 inches below the melt line. As Figures 25 to 28 show, the wear was very different on the nominal 3-inch-OD electrodes compared to that for the nominal 2-inch-OD electrodes. The larger electrode was attacked severely below the melt line, with little attack at the melt line (Figure 25). The extent of penetration depended markedly on position for this electrode, being greatest in the direction of maximum current flow (Figure 26). The small electrodes (higher current flux) showed relatively little wear below the melt line, but extensive localized necking at the melt line (Figure 27). There was little dependence of extent of penetration on position around the electrode (Figure 28).

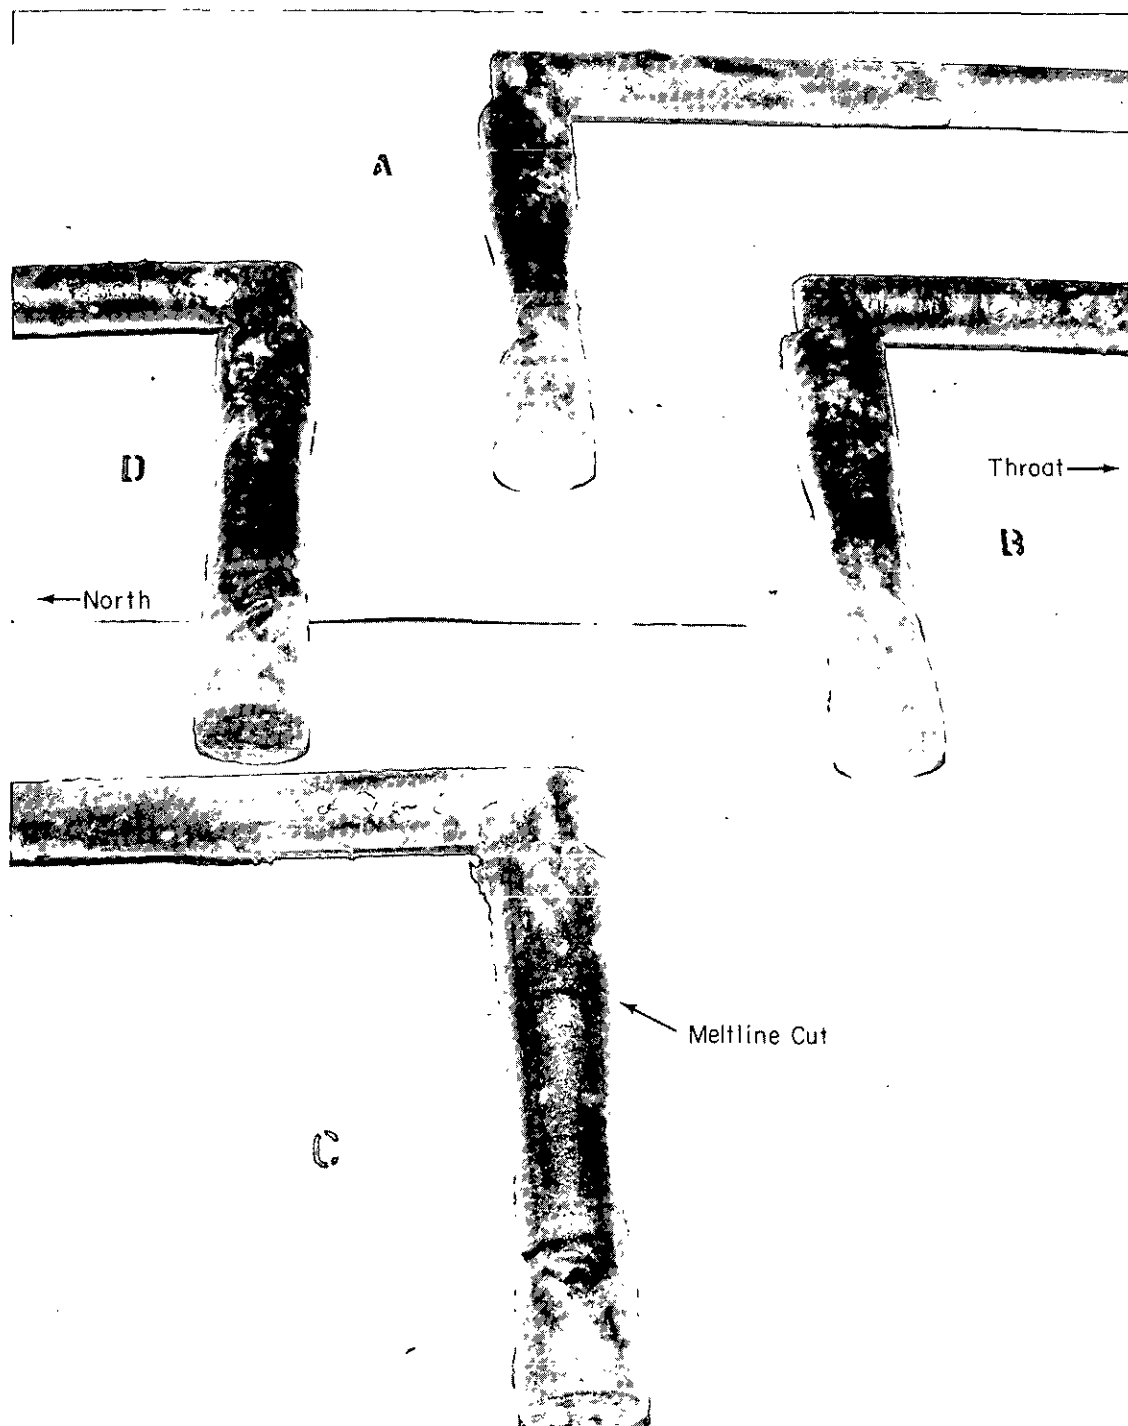
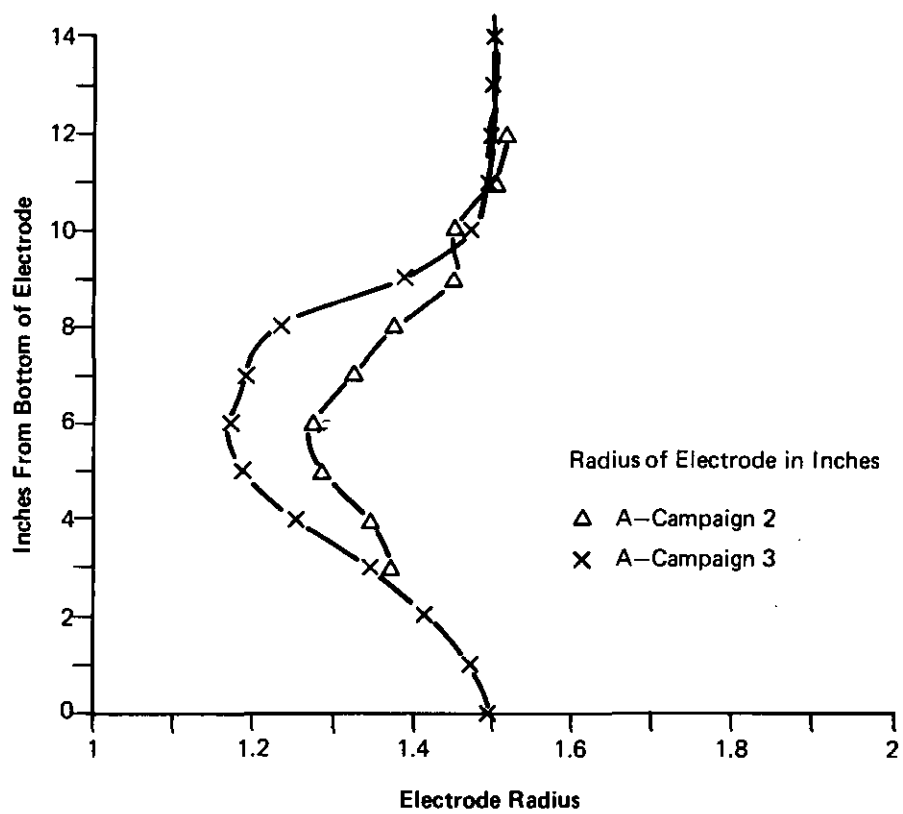
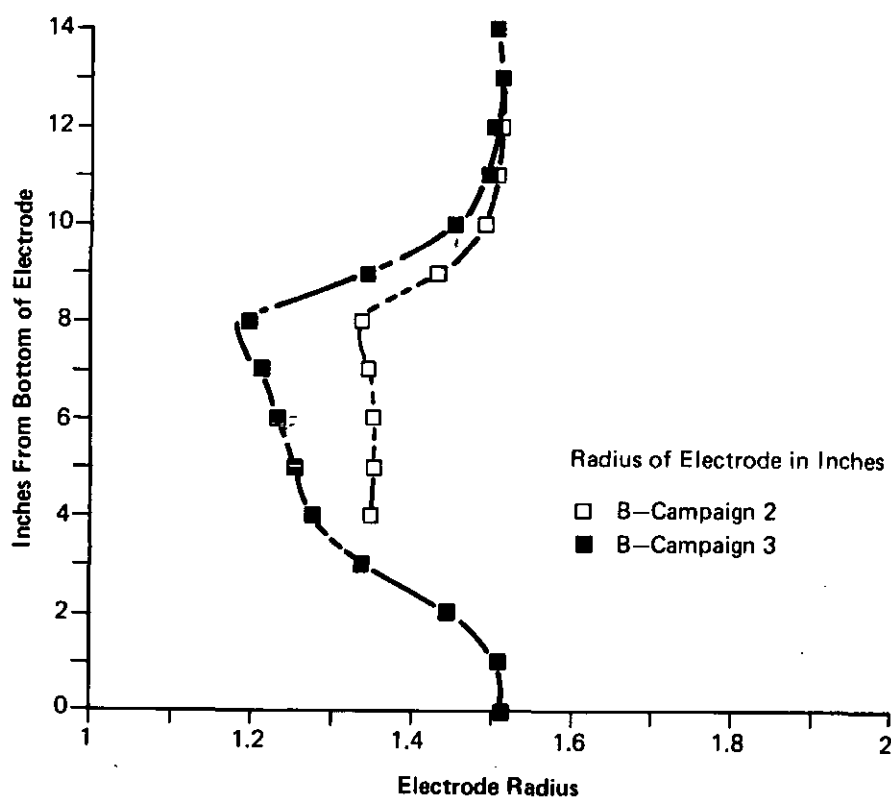
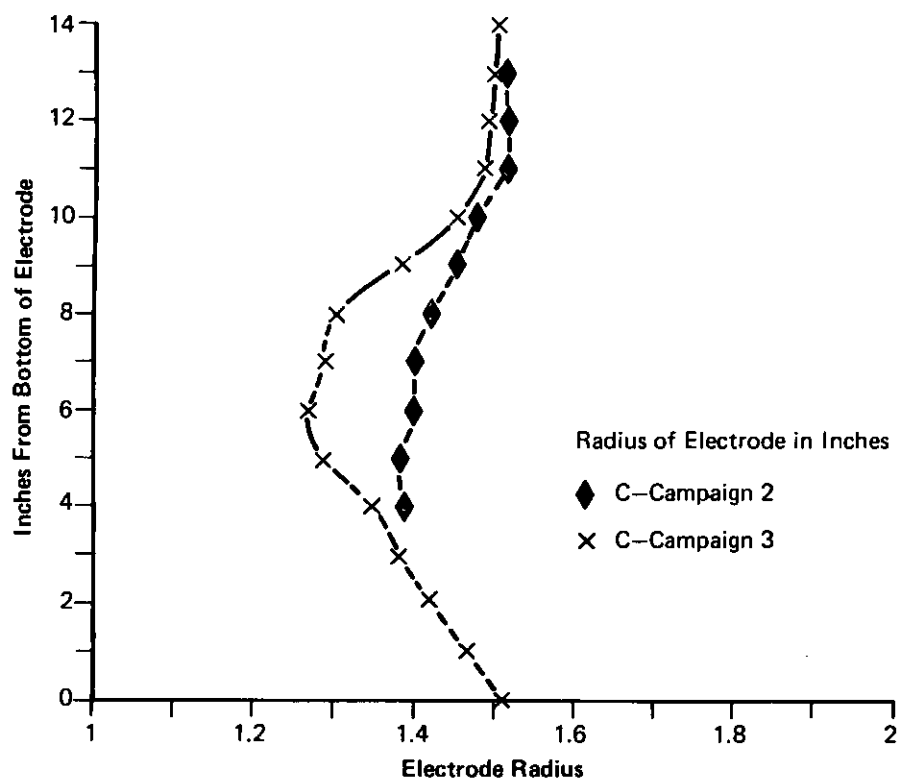
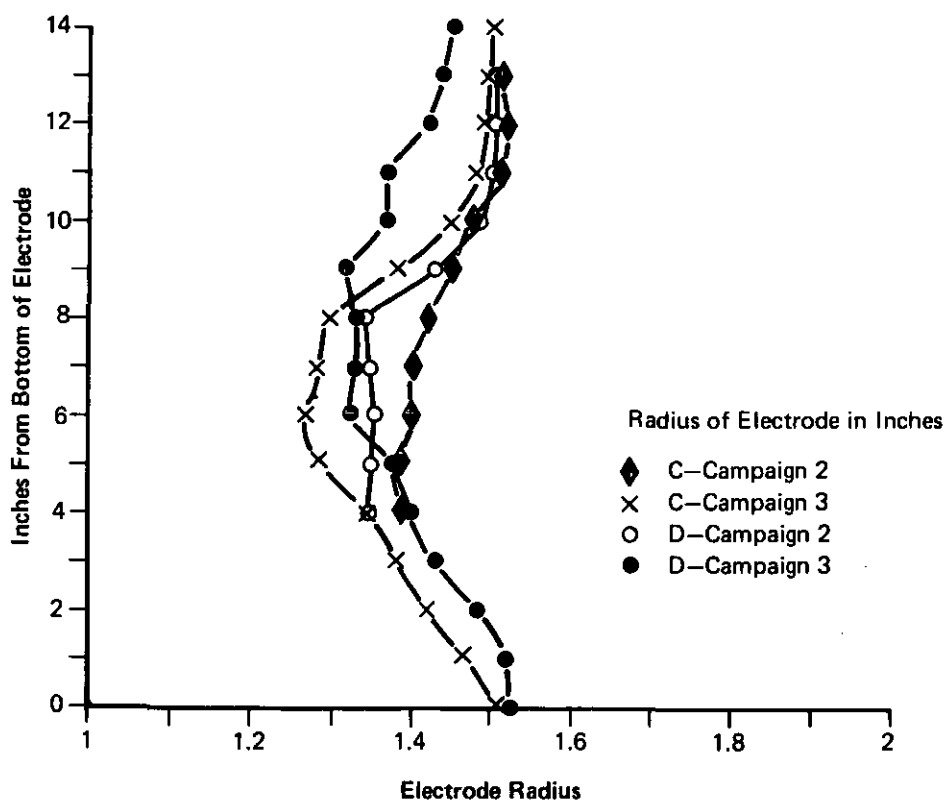
The wear patterns for the bar electrodes at the end of Campaigns 2 and 3 are shown in Figures 29 to 32. The location of the micrometer when each measurement was made is also shown. These measurements assume that the wear about the centerline of the bar was symmetric. Maximum electrode wear occurred 4 to 5 inches below the melt surface for powder feeding of Frit 211 + TDS simulated waste. This corresponded to the location of the hottest temperature when the melter is being fed. Data from a physical model of the SCM indicated that this was the region where fresh feed (relatively

oxygen rich) first contacted the electrodes. The combination of these two effects probably accounted for the axial shape of the electrode wear patterns.
