HISTORY OF THE SMALL CYLINDRICAL MELTER

**T. L. ALLEN
D. C. IVERSON
M. J. PLODINEC**

DP-1676

Publication Date: August 1985

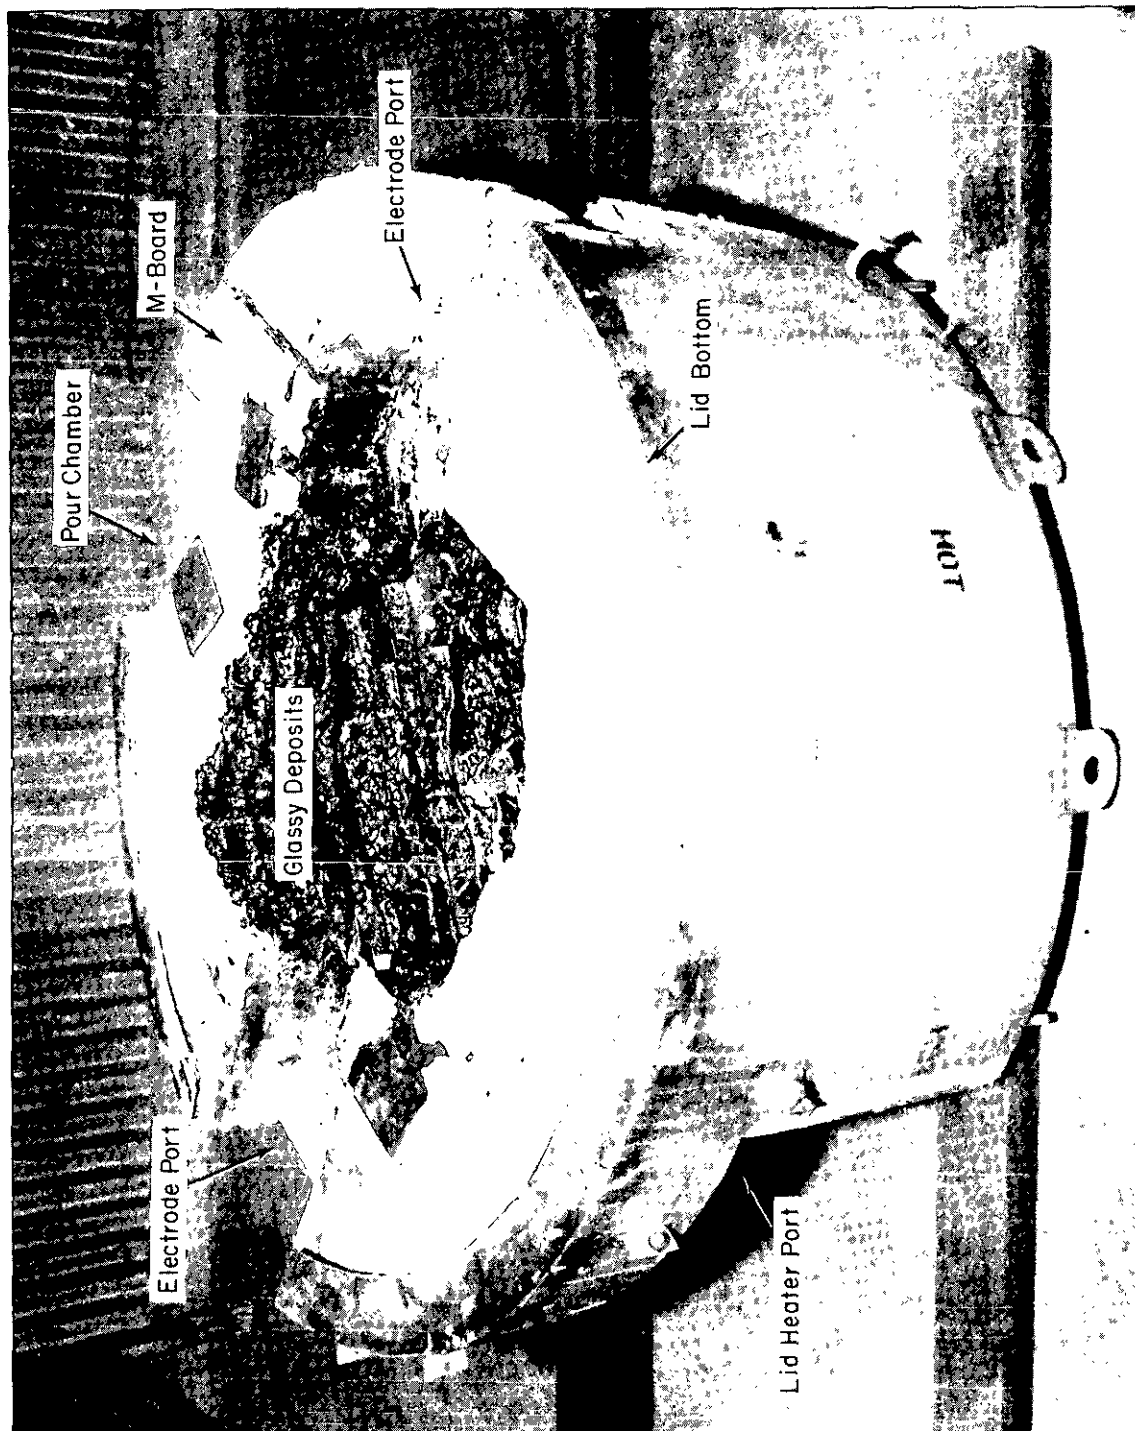
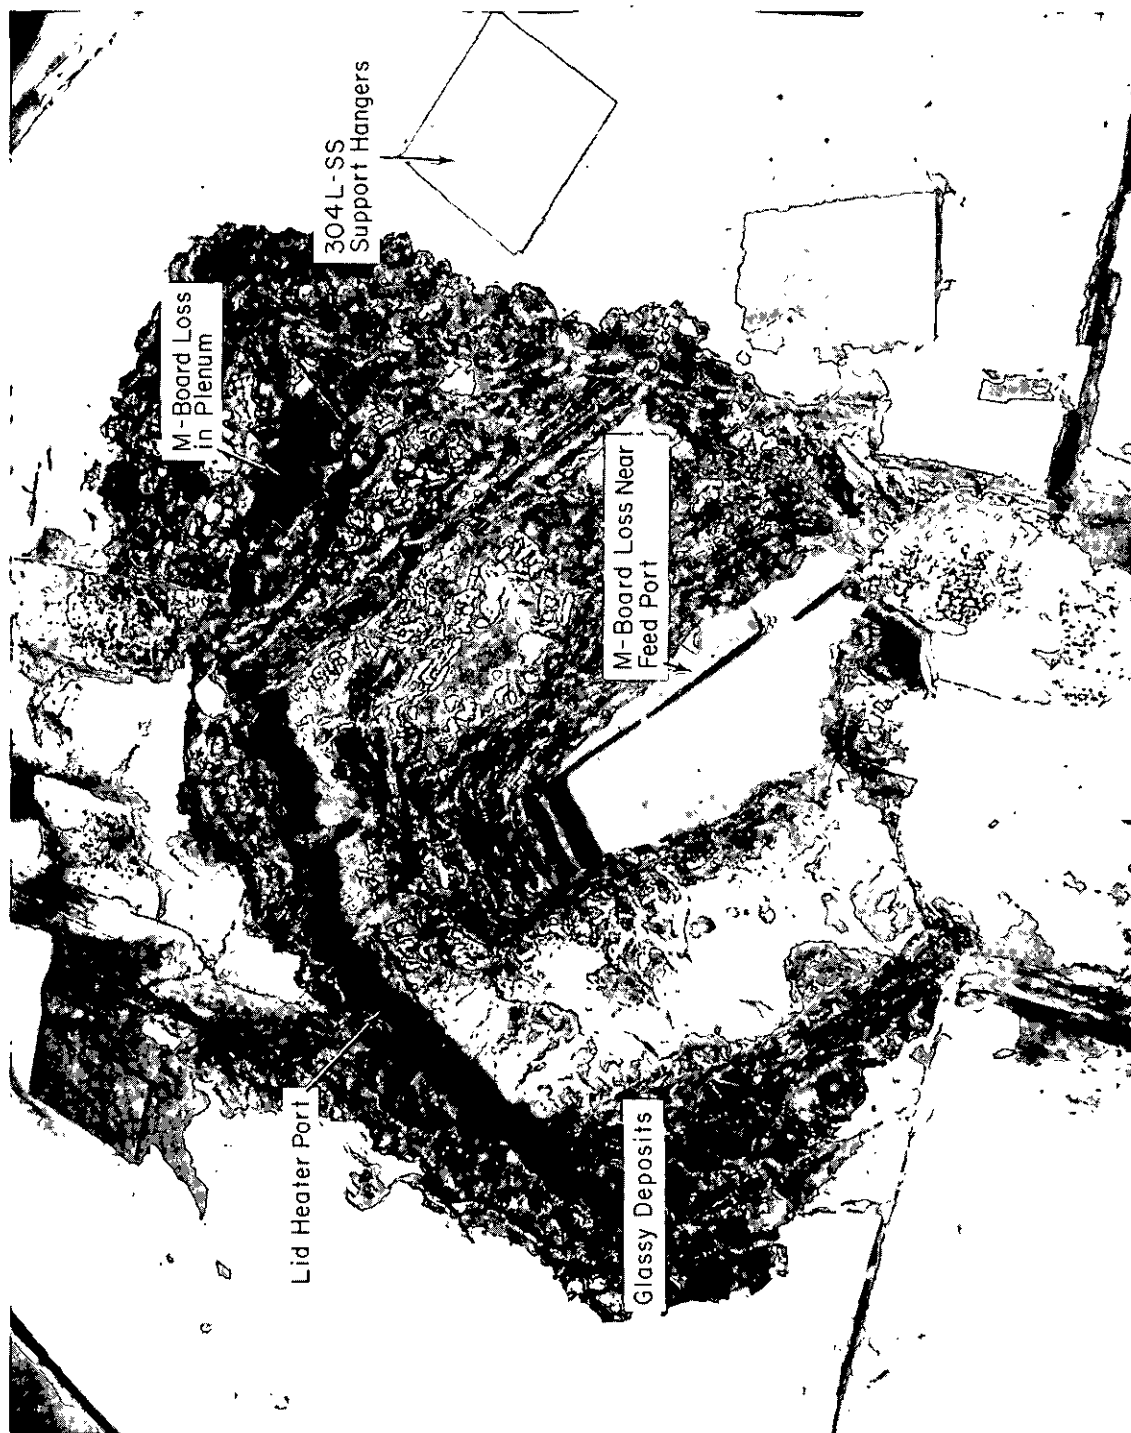
The condition of the melter lid exposed to glass vapors is shown in Figure 40 at the end of Campaign 2 and in Figures 41 and 42 at the end of Campaign 3.

Glassy deposits completely coated the inside of the melter lid in the plenum region (Figure 42) and caused the loss of 1 to 2 inches of M-Board™ in various locations over the course of Campaign 3. Presumably, this lid material went into the melt pool and because of its alumina/silica composition, may have contributed significantly to the deposits on the melter floor. The Type 304L SS hangers were also lost. Based on these results, the use of M-Board™ [and other similar insulating boards, e.g., Fiberfrax™ (Product of Carborundum Co.)] is not recommended in regions of a melter where molten glass vapors and splatter are present unless the intended period of use is only a few months.

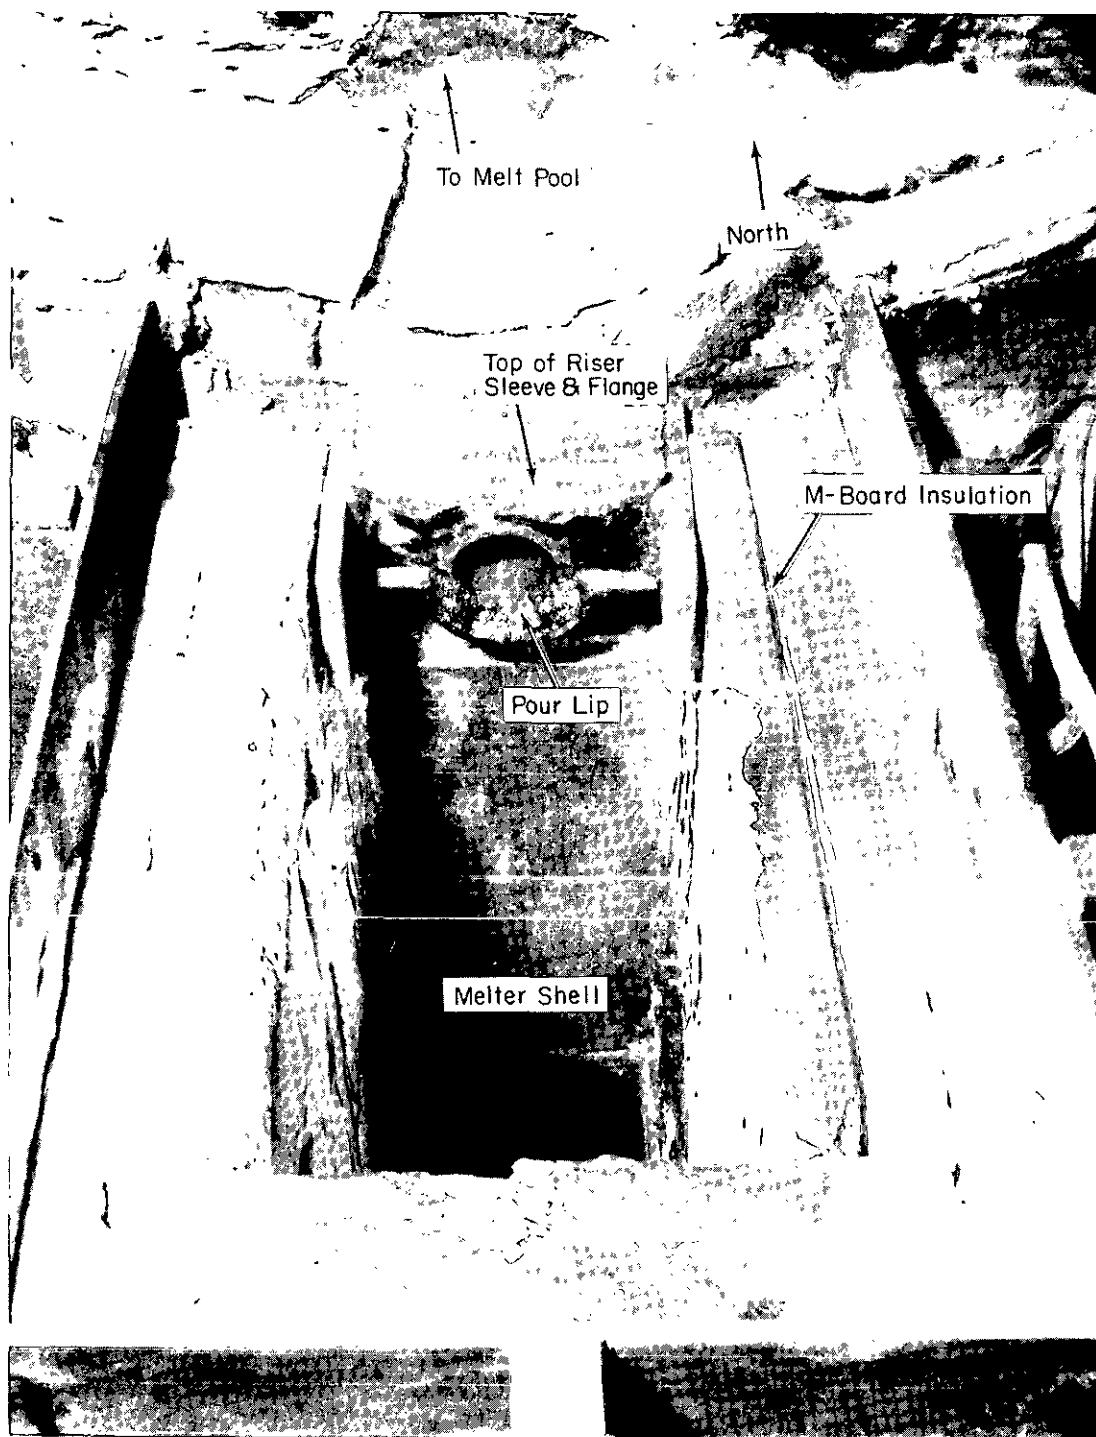
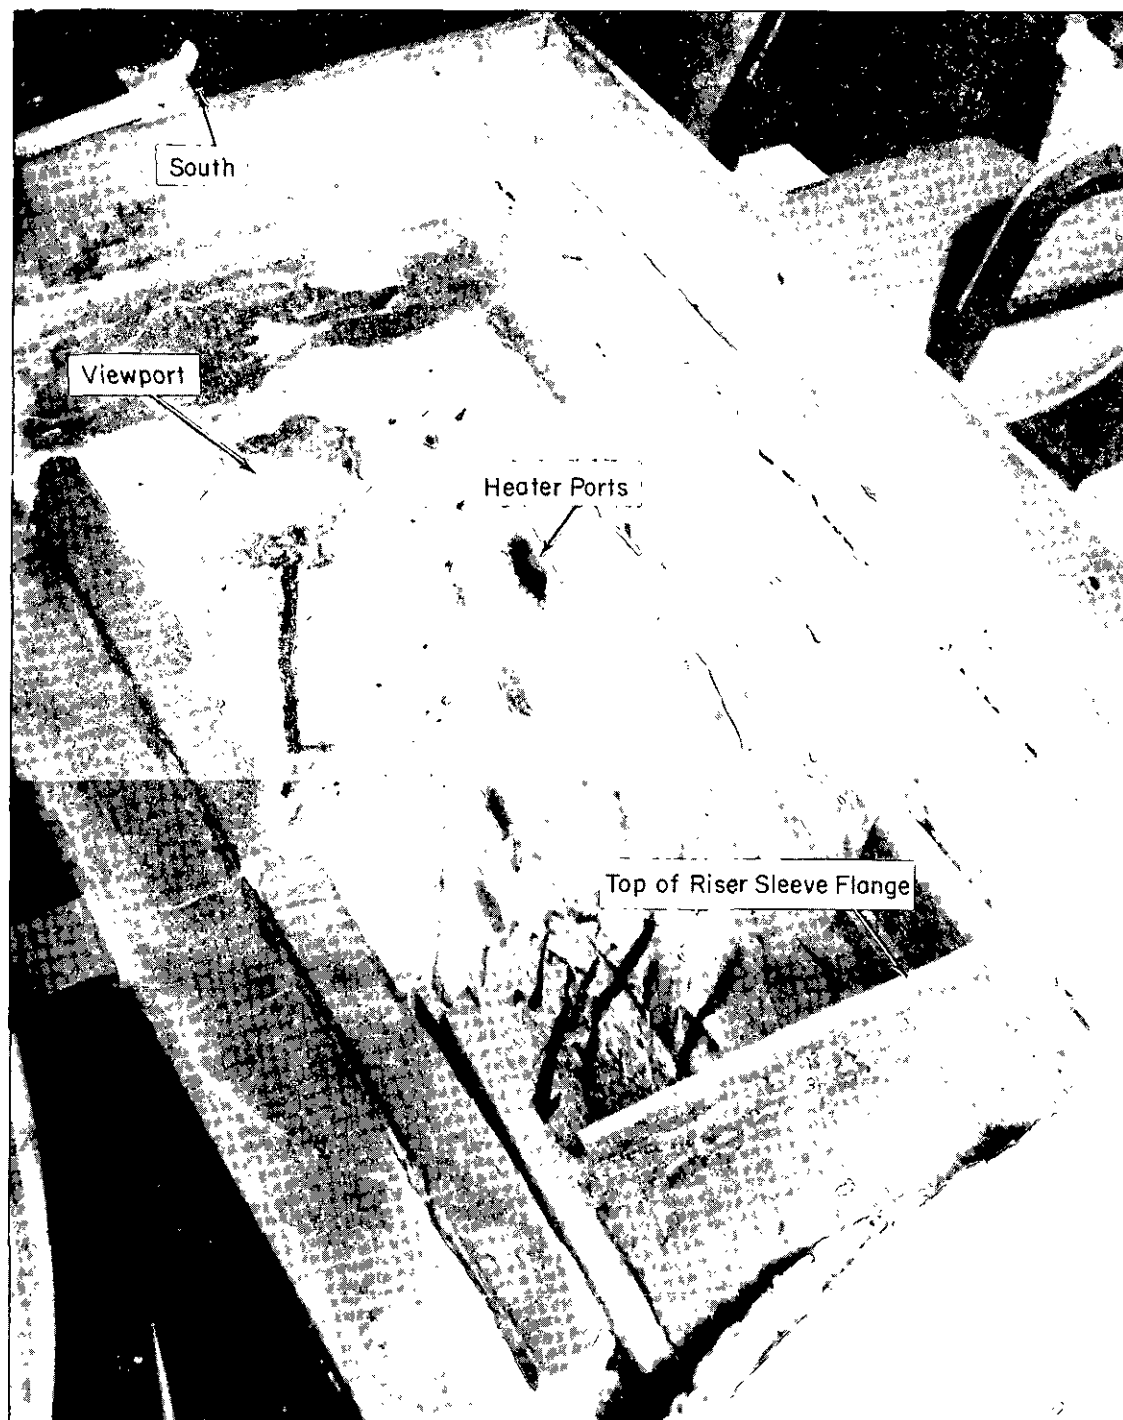
The condition of the pour chamber at the end of Campaigns 1, 2, and 3 is shown in Figures 46 to 49. The M-Board™ insulation in

These photographs is the original material installed before the start of Campaign 1. Some glassy deposits are present on the interior walls but the insulation generally appears to be in good condition. This is in sharp contrast to the appearance of the same material in the melter lid after it was used only during Campaign 3 (Figure 40). The difference, of course, is that there is much less splatter and entrainment in the pour chamber even though glass vapors are present.

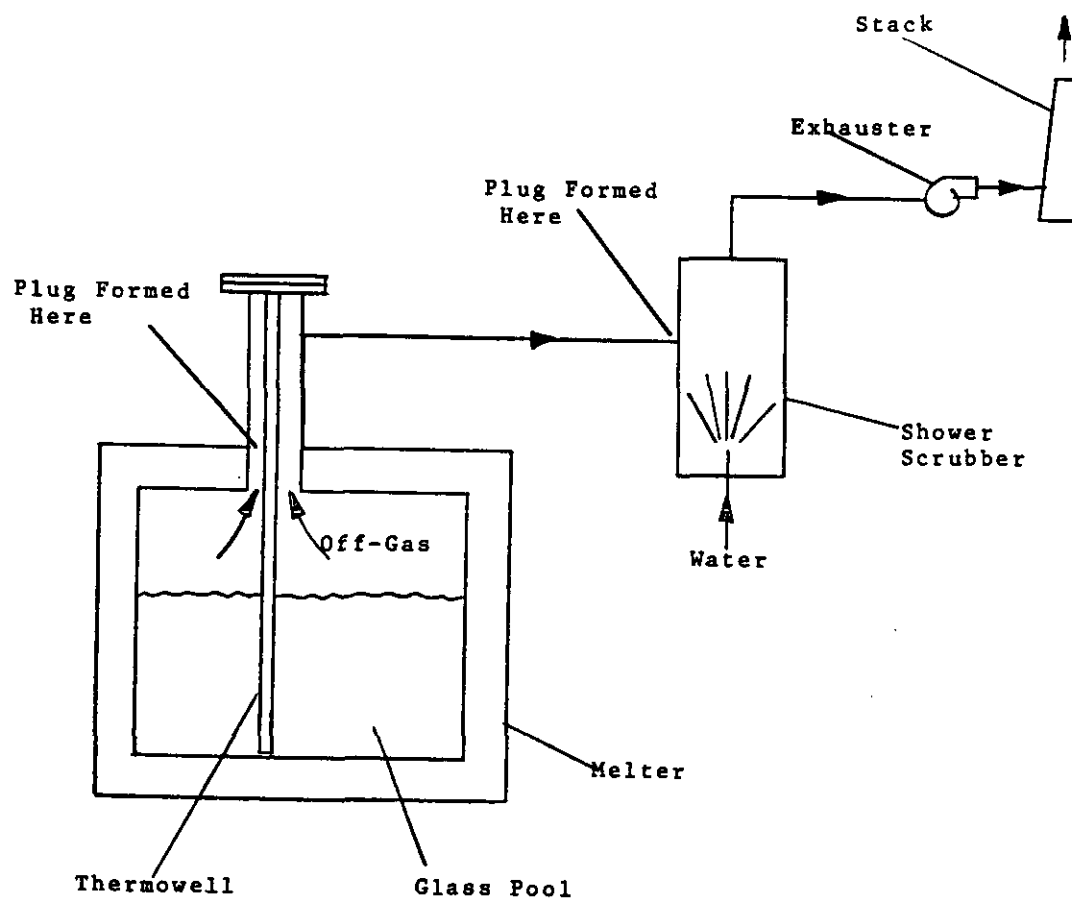
FIGURE 54. Off-Gas System for Slurry Feeding During Campaign 3

No rigorous program for characterization of melter off-gases and equipment performance was in effect during any of the three melter campaigns. The off-gas system for slurry feeding during Campaign 3 consisted of only a shower type scrubber and exhauster (Figure 54). Only two off-gas line plugs occurred during

Campaign 3: one between the thermowell and the inside of the off-gas line, and a second at the entrance to the scrubber. The second plug apparently occurred because water spray from the scrubber entered the off-gas line.

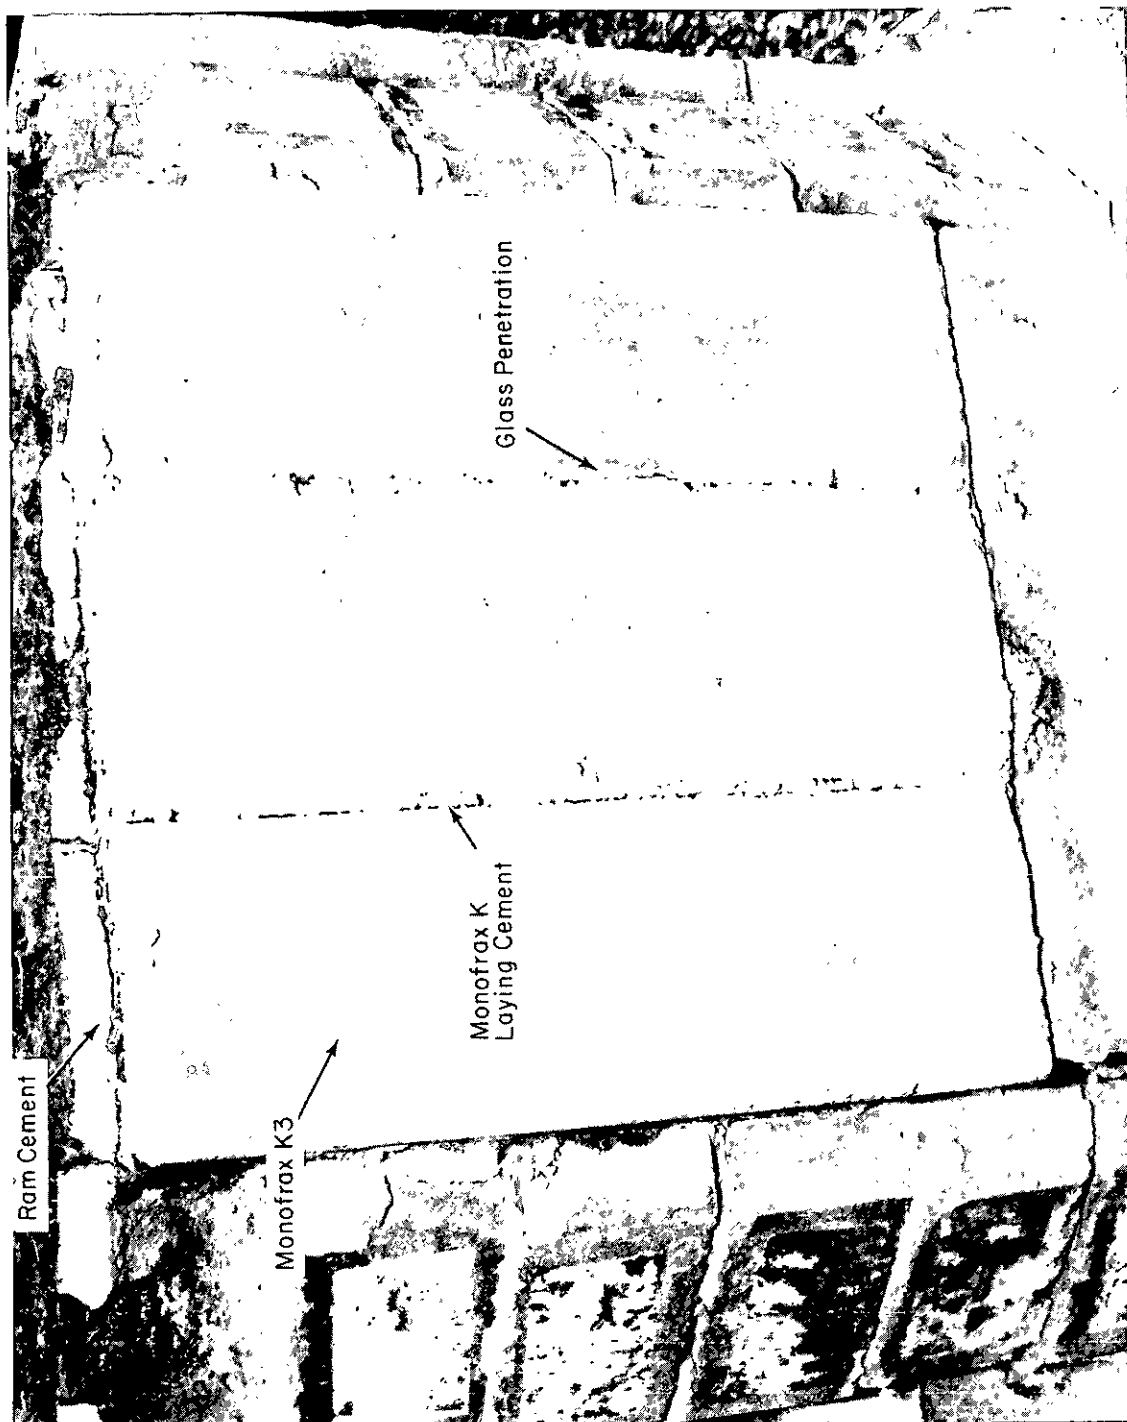
FIGURE 57. Ram Cement™ Removed (North Side)

Figure 57 shows the cold side of the 8-inch-thick Monofrax™ K3* after the Ram Cement™ was removed. The Monofrax™ K3 appears

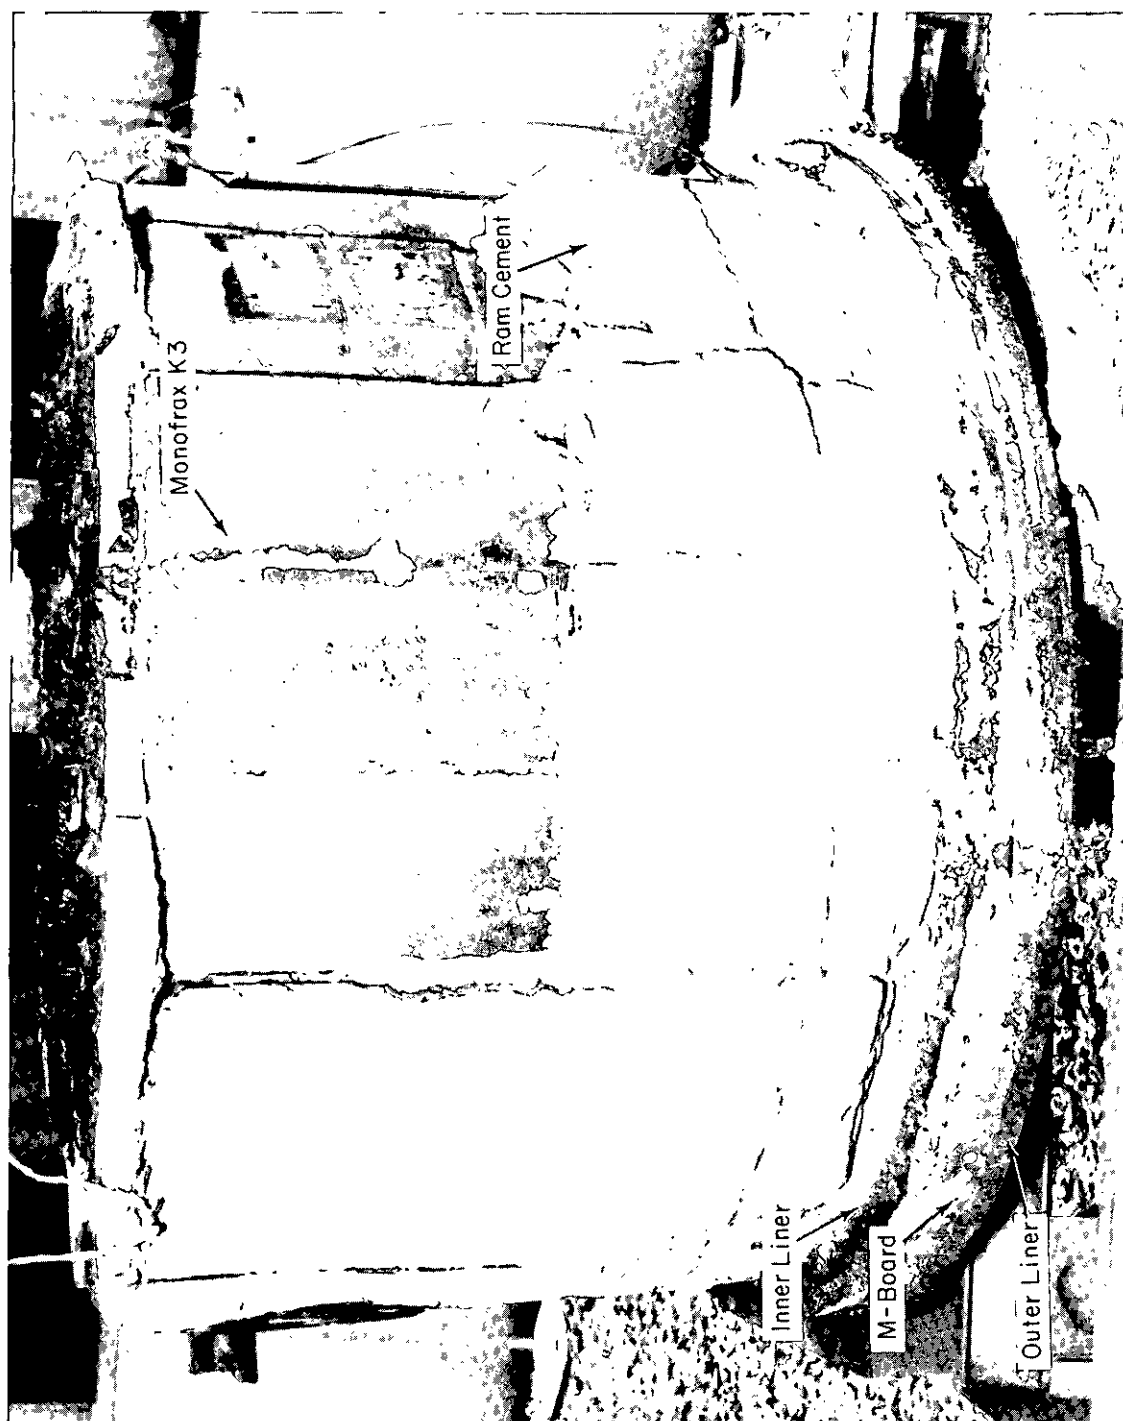
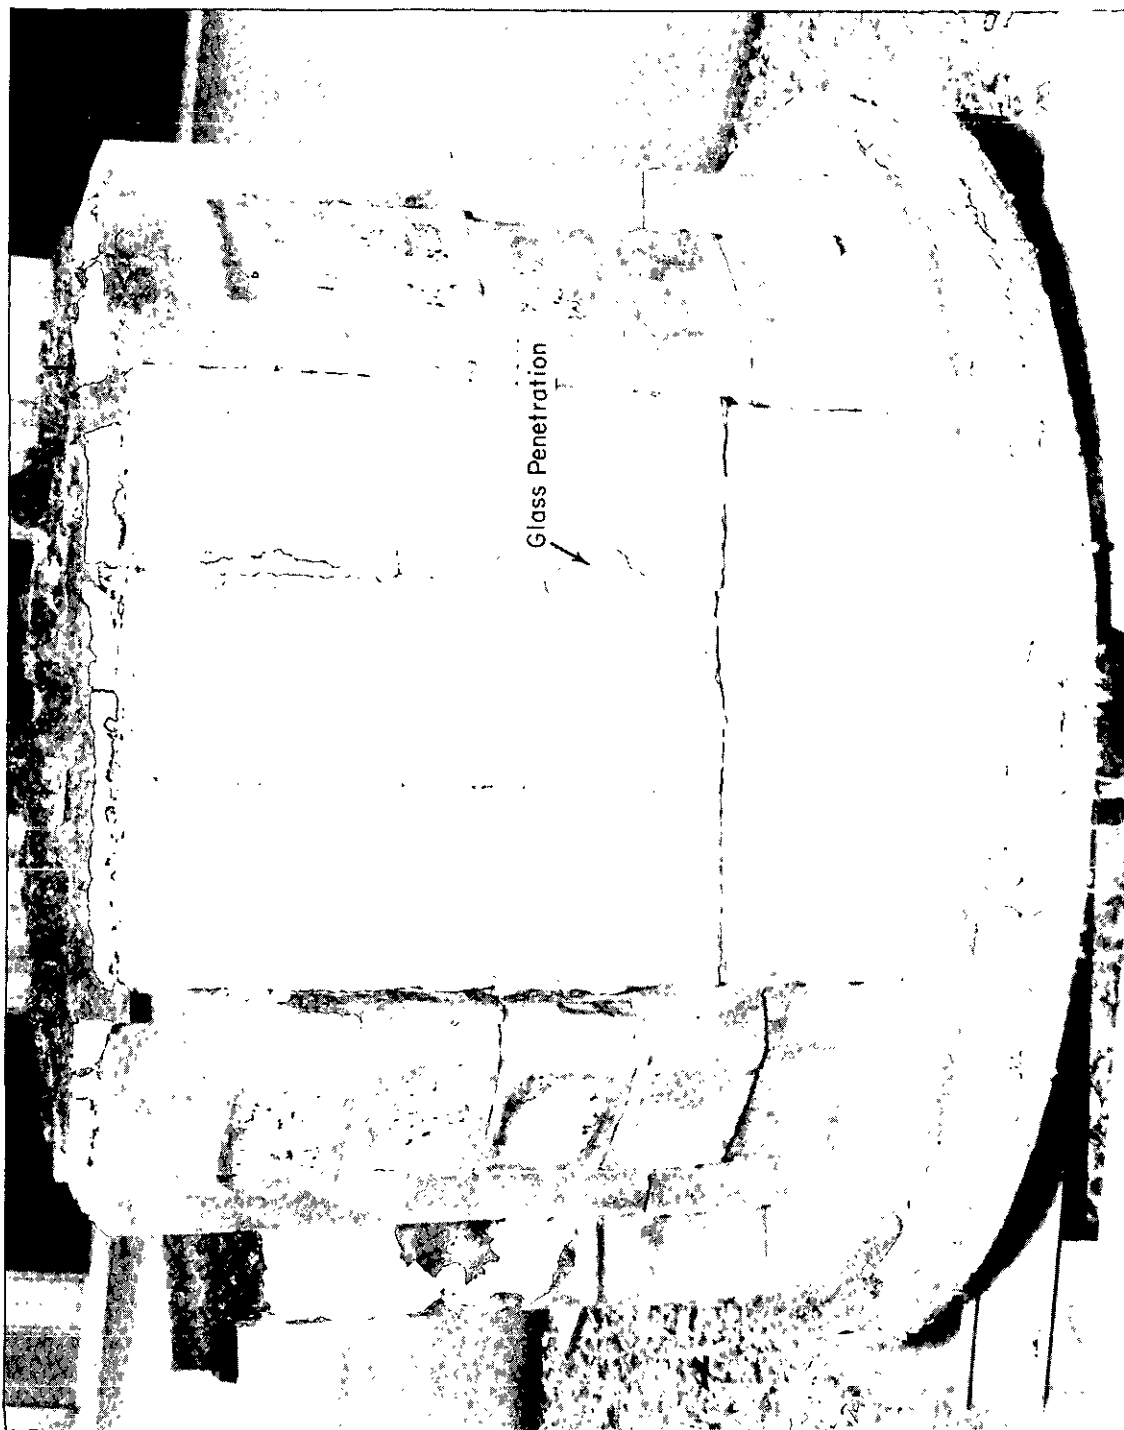
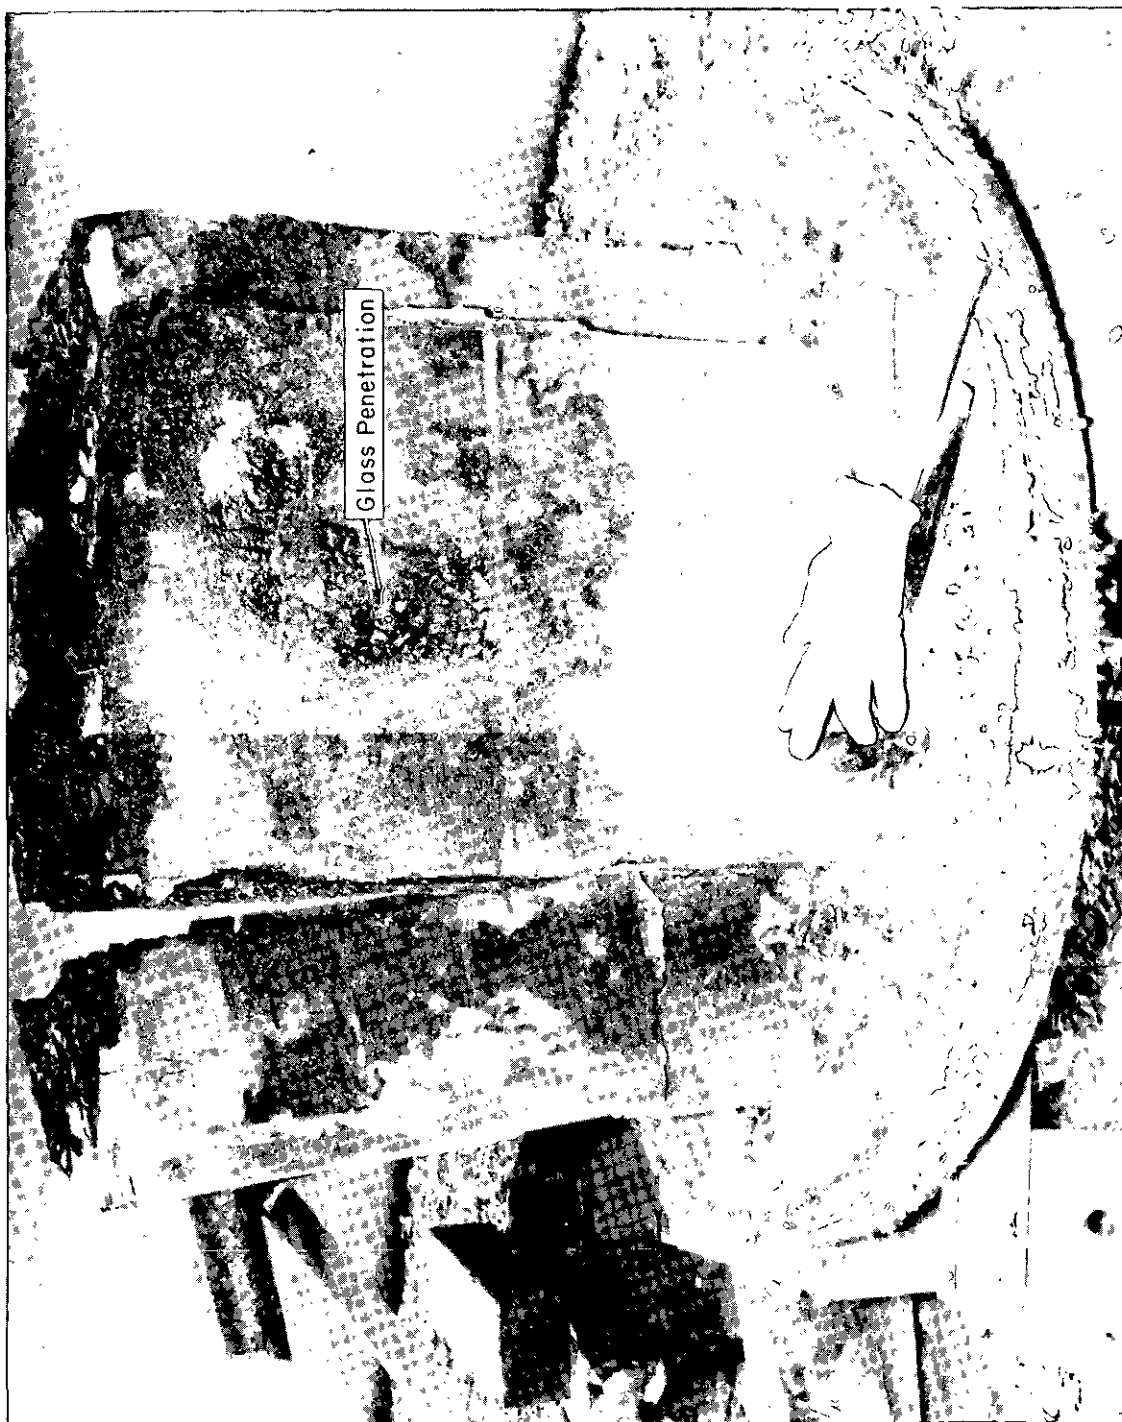
Figures 59 to 61 show the cold side of the Ram Cement™, the cold side of the 8-inch-thick Monofrax™ K3, and the cold side of the Monofrax™ K3 with 4 inches of brick removed, all on the east side of the melter. Cracking but no glass penetration of the Ram Cement™ occurred (Figure 59) which is similar to what was seen on the north side. Some glass penetration at a brick joint is seen in Figure 60. The glass penetration shown in Figure 61 appeared to have oozed through the brick itself rather than migrated along a brick joint. This may have resulted from high brick porosity due to a manufacturing defect.

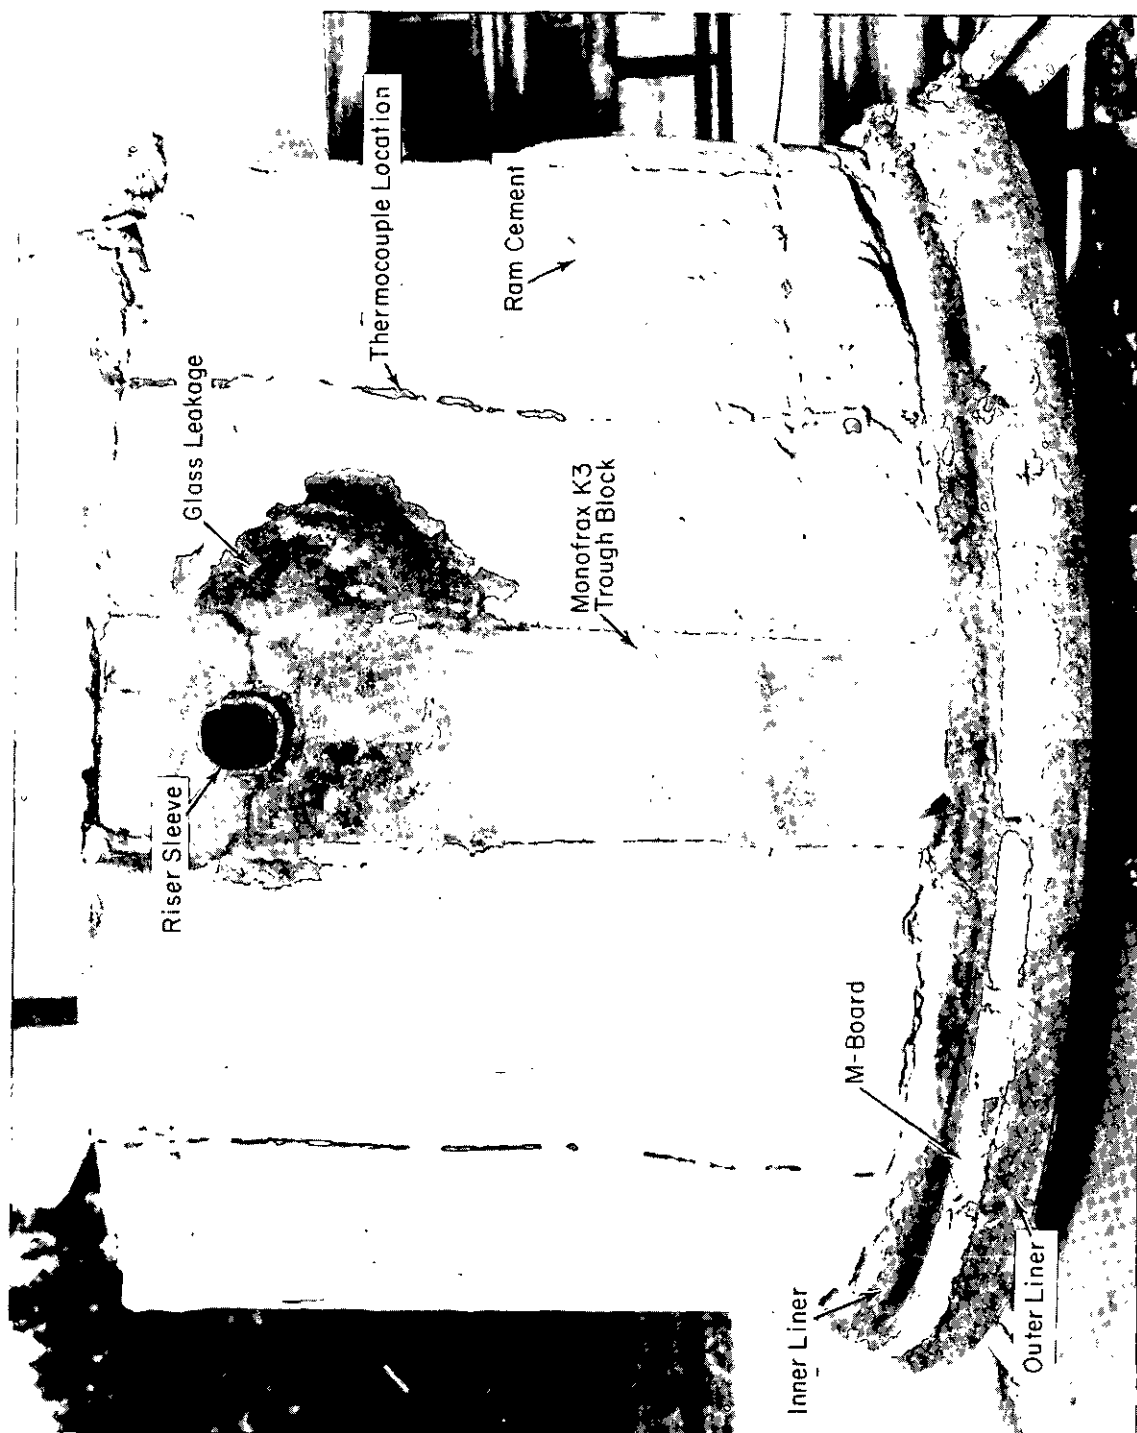
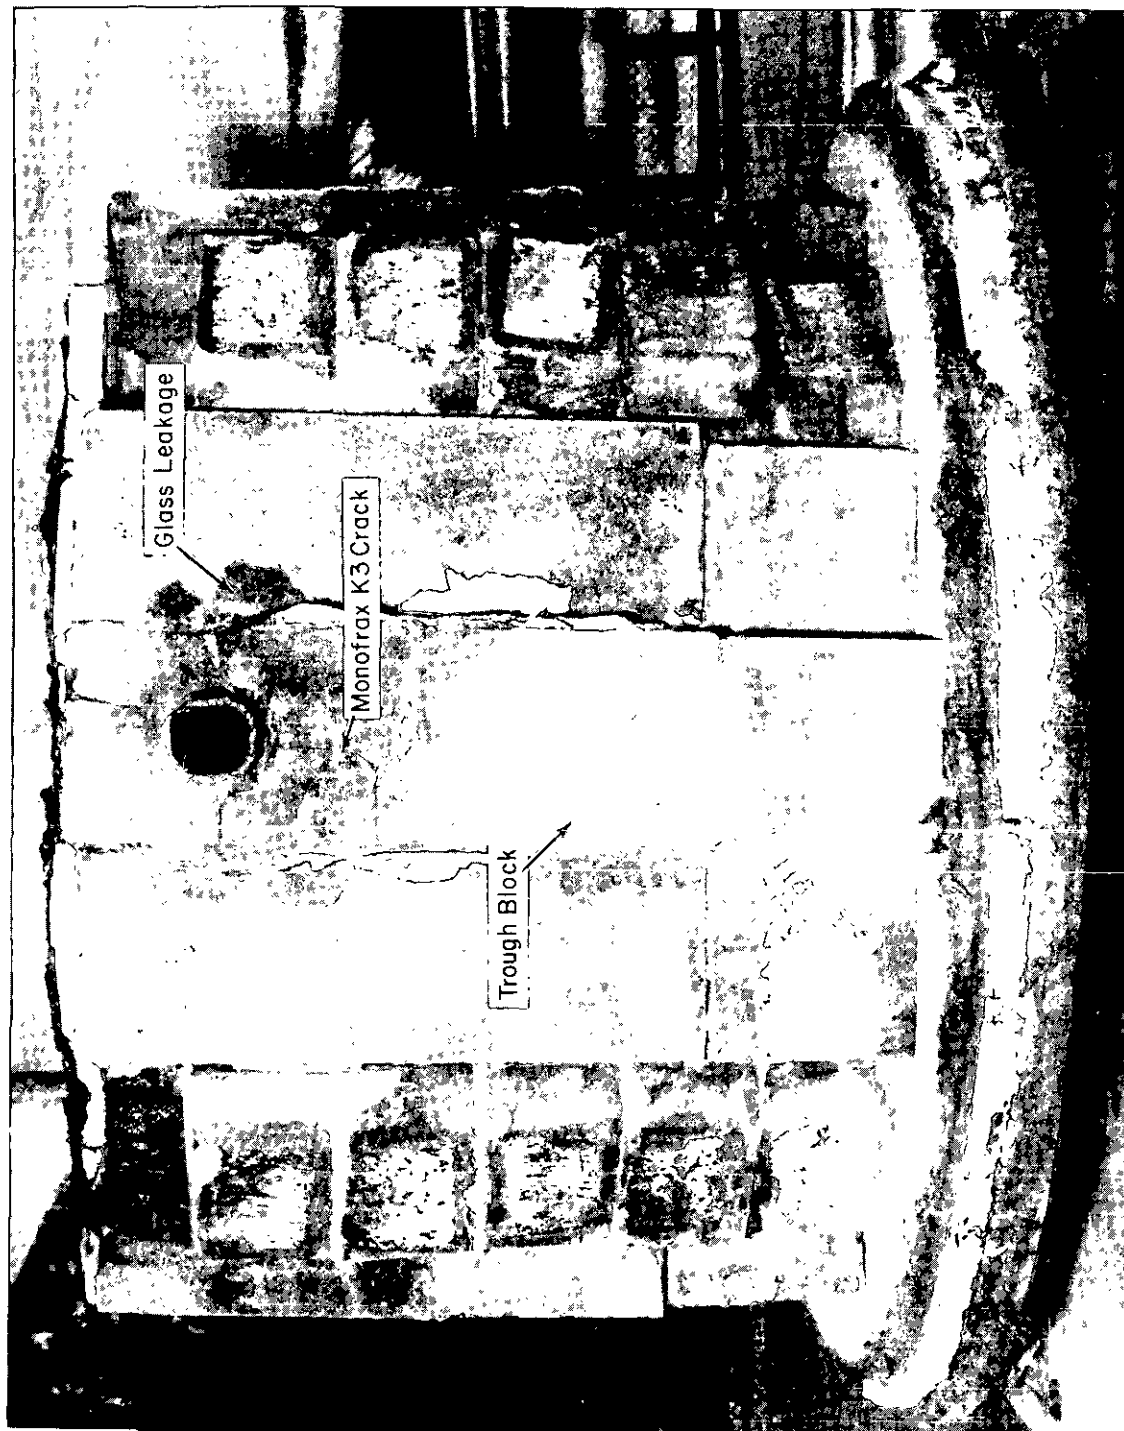
Figures 62 and 63 show the disassembly of the south side of the SCM where the throat, riser, and trough were located. The Ram Cement™ on this side (Figure 62) appeared to have experienced much less cracking than on the north and east sides (Figures 56 and 59). Glass penetrated through the Monofrax™ K3 near the trough (Figure 62) but was stopped by the presence of the Type 304L SS inner liner which was electrically isolated from the outer liner. In fact, glass leakage to the inner liner was expected (by design) at this point since the Inconel® 690 pour lip (Figure 3) was welded to the inner liner at the top of the trough block. Glass leakage in this region was not nearly as extensive as anticipated.
