AEC RESEARCH AND DEVELOPMENT REPORT

# STRESS CORROSION CRACKING OF TYPE 304 STAINLESS STEEL

STATUS REPORT - MARCH 1, 1964

*Savannah River Laboratory*

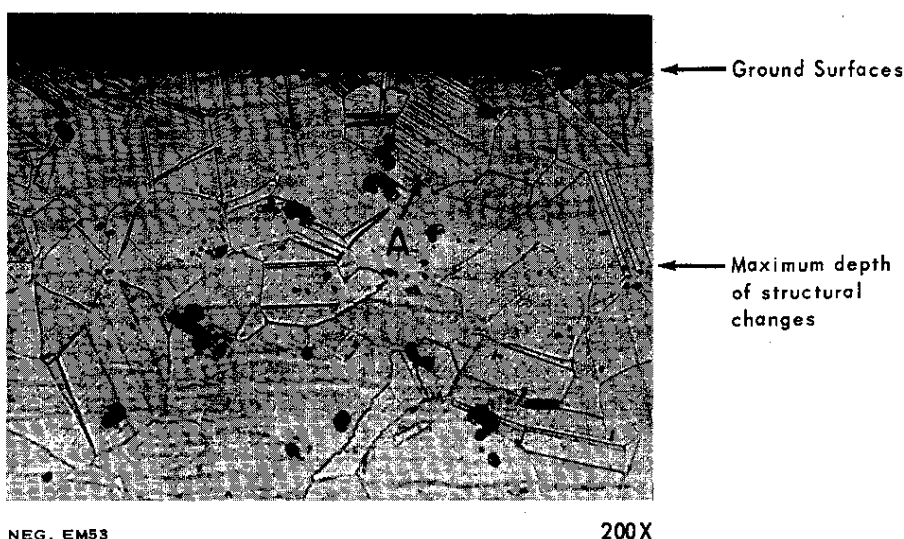
FIG. 1 STRUCTURAL CHANGES ACCOMPANYING DRY GRINDING

Note strain markings, such as shown at A, in the grains near the surface.

Specimens with dry-ground surfaces were used in these studies because previous work had shown that a dry-grinding operation produced a surface that was highly susceptible to stress corrosion cracking in dilute chloride solutions.<sup>(10)</sup> The dry-grinding operation caused structural changes, indicated by strain markings in individual grains of the metal, to a depth of approximately two grains (Figure 1). No such changes were observed in specimens with wet-ground or polished surfaces.

Although the dry-grinding operation was observed to increase the susceptibility to stress corrosion cracking, no direct relationships between the structural changes that occurred upon grinding and stress corrosion cracking were noted. The cracks were observed to follow the strain markings in some regions (Figure 5, region A), but did not follow the markings in others (Figure 5, region B). Electron microscopy of several cracks did not reveal any structural change in the matrix immediately in advance of the crack tip; however, indications of a second phase were observed adjacent to the crack (Figure 6). This structure was not seen in all samples and the possibility exists that it was produced by replication artifacts. However, Douglass, et al.<sup>(5)</sup> recently reported that ferrite ( $\alpha$ -Fe) was present along the crack walls of several stress corrosion cracks examined by transmission electron microscopy.

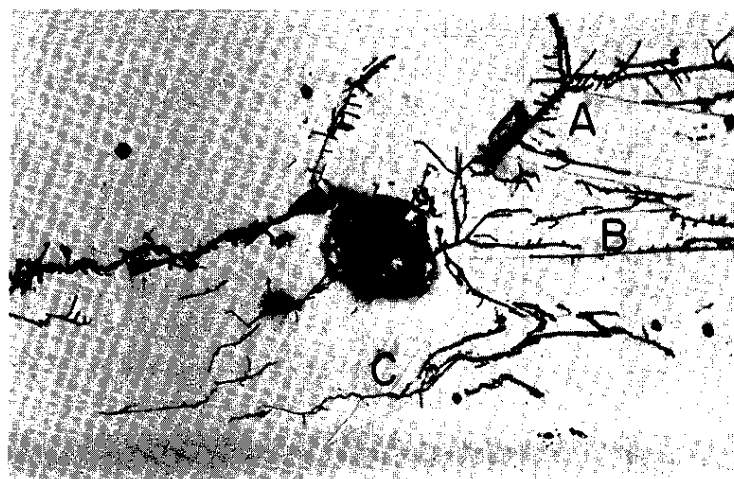
NEG. EM2

FIG. 3 STRESS CORROSION CRACK PROPAGATION ALONG GRAIN AND TWIN BOUNDARIES. Note regions A, B, and C.

The cracks in the dry-ground samples were principally transgranular and formed pronounced Widmanstätten patterns in several cases (Figure 4). Grain boundary and twin boundary cracking were also observed in limited regions (Figure 3).

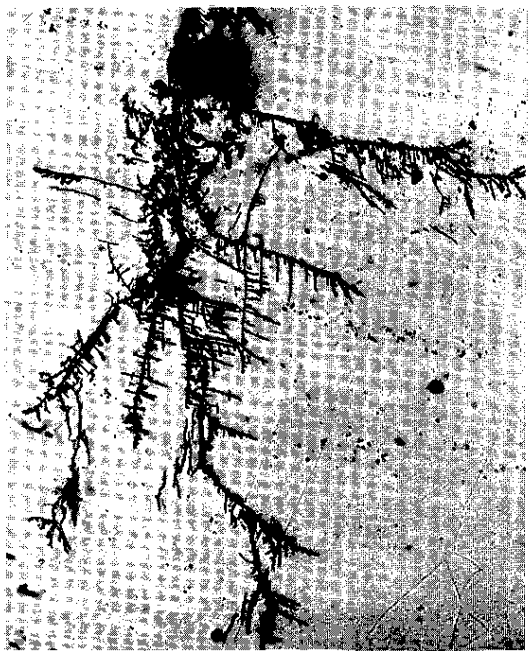
NEG. EM20

- a. Note the Widmanstätten pattern of the crack. (Specimen polished parallel to sample surface.)

FIG. 4 TYPICAL STRESS CORROSION CRACKS IN GROUND SAMPLES

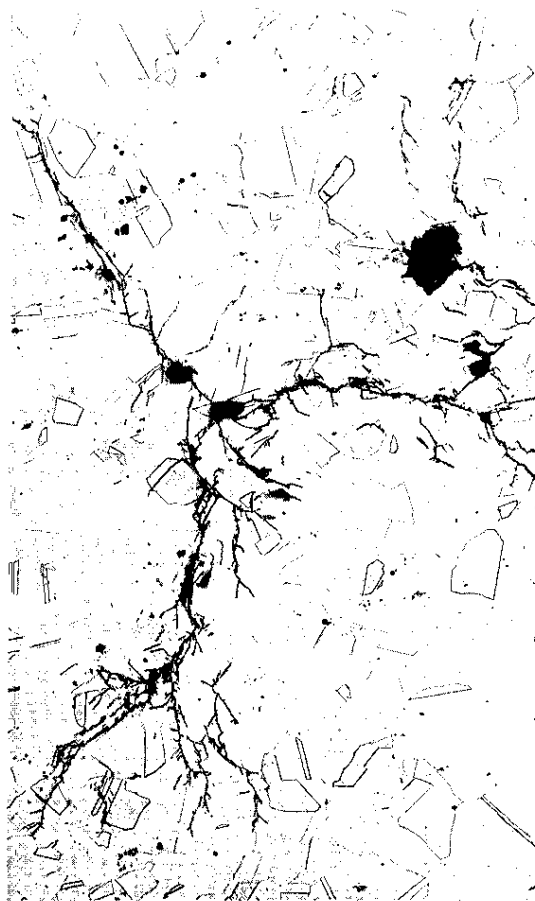
NEG. EM11

- b. Note the pits associated with cracks. (Specimen polished parallel to the sample surface.)

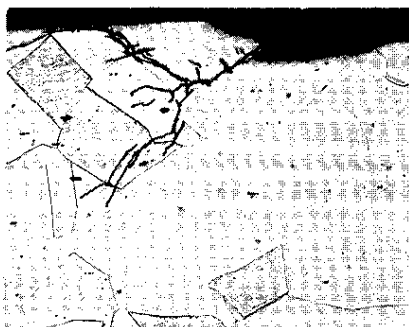
NEG. EM16

- c. Note that the cracks often change directions at grain and twin boundaries. (Specimen polished perpendicular to the sample surface.)

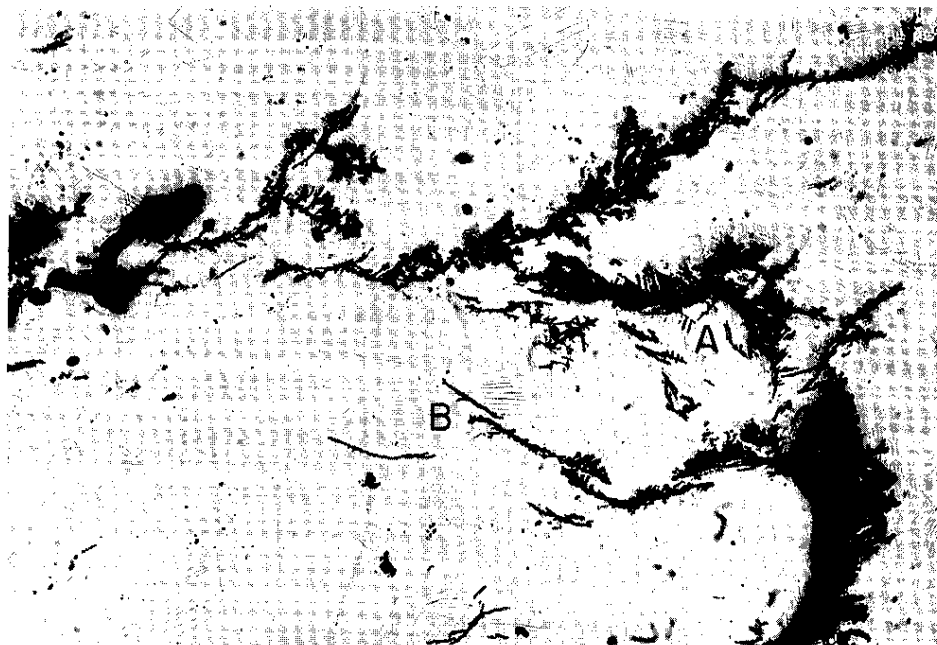
NEG. EM18

FIG. 5 RELATIONSHIP BETWEEN STRAIN MARKINGS RESULTING FROM DRY GRINDING AND THE DIRECTION OF CRACK PROPAGATION

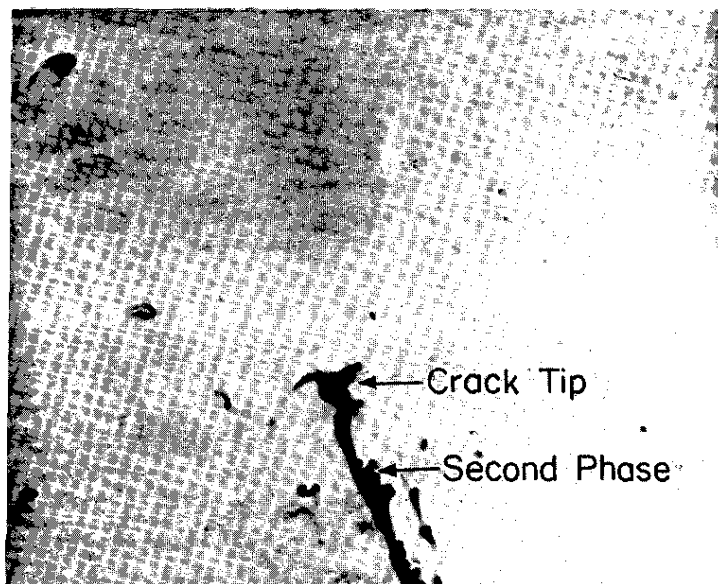
NEG. 1523A

FIG. 6 TIP OF STRESS CORROSION CRACK IN TYPE 304 STAINLESS STEEL. Note the indication of a second phase along the crack wall.

The significance of a phase change preceding the propagation of a stress corrosion crack is apparent if one considers the role of hydrogen in crack propagation. Several investigators<sup>(11-12)</sup> have presented evidence to show that hydrogen pickup and stress corrosion are fundamentally related and suggest that hydrogen embrittlement occurs during the stress corrosion processes. In this event, hydrogen should diffuse into the metal more rapidly than the crack propagates. The diffusion rate of hydrogen in  $\gamma$ -Fe is approximately  $3 \times 10^{-9}$  cm/sec at  $154^\circ\text{C}$ <sup>(13)</sup>, and crack propagation rates approximately three orders of magnitude faster than this have been observed<sup>(14-16)</sup> (Table III). However, the diffusion rate of hydrogen in  $\alpha$ -Fe is approximately  $5.5 \times 10^{-5}$  cm/sec at  $154^\circ\text{C}$ <sup>(13)</sup>,

which is of the same order of magnitude as the observed crack propagation rates. Thus, if a  $\gamma \rightarrow \alpha$ -Fe transformation does precede stress corrosion crack propagation, a fundamental relationship between hydrogen embrittlement and stress corrosion cracking could be rationalized.

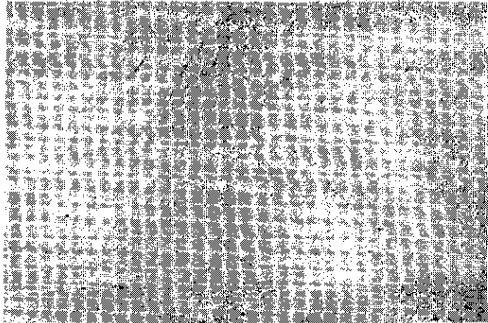
a. Specimen aged 3½ hours  
after charging.

b. Specimen aged 5½ hours  
after charging.

FIG. 7 SECOND-PHASE PRECIPITATION AND CRACKING IN THE SURFACES OF  
CATHODICALLY CHARGED TYPE 304 STAINLESS STEEL SPECIMENS

The as-charged samples exhibited no evidence of a second-phase precipitate or cracking; however, after aging approximately 3-1/2 hours at room temperature, incipient precipitation was observed (Figure 7a), and after 5-1/2 hours second-phase platelets (or needles) were seen (Figure 7b). This precipitate was not identified; however, it was probably the same phase that Vaughan, et al.,<sup>(11)</sup> described as iron hydride. Cracking often occurred in the specimen surface during second-phase precipitation and such surface cracks were observed adjacent to the second phase both within the grains (Figure 7c), and along grain boundaries (Figure 7d). These observations agreed with the previous work, which showed that the formation of transgranular cracks accompanied precipitation of a second phase.

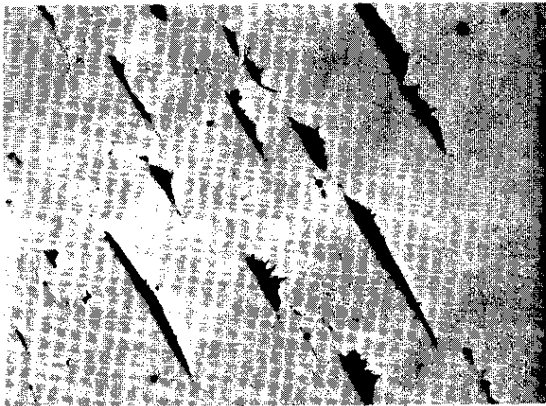
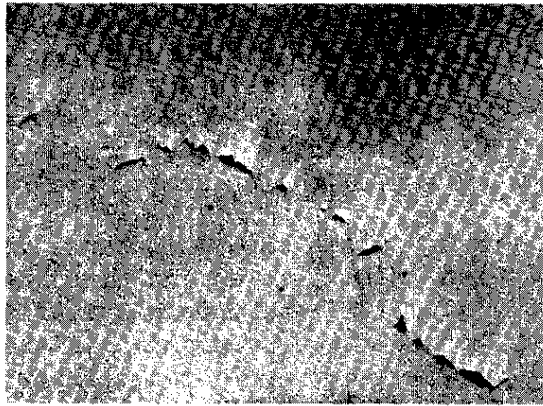
c. Cracking occurring within grains.

d. Cracking occurring at grain boundaries.

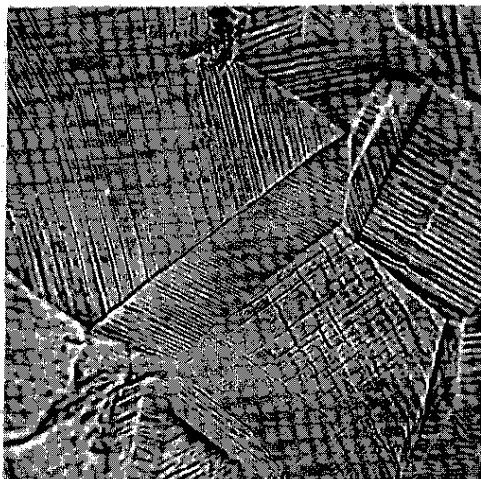
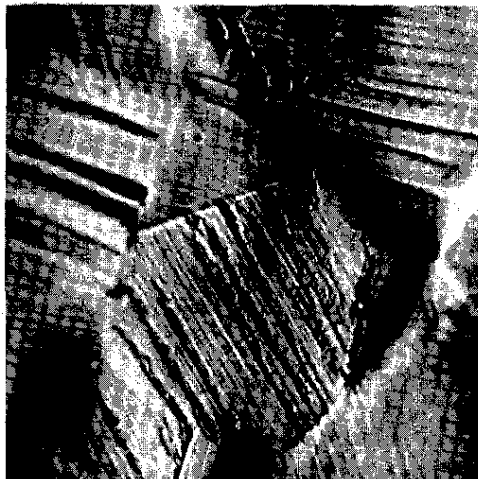
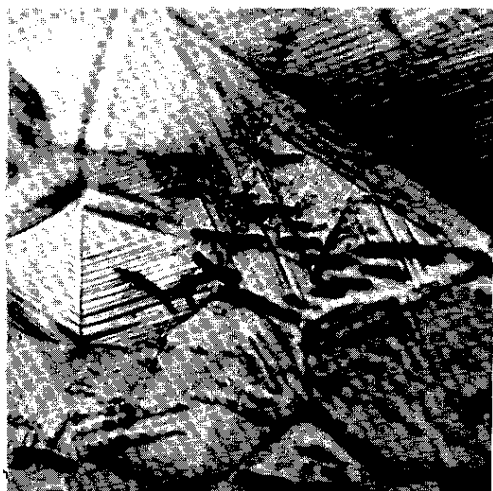
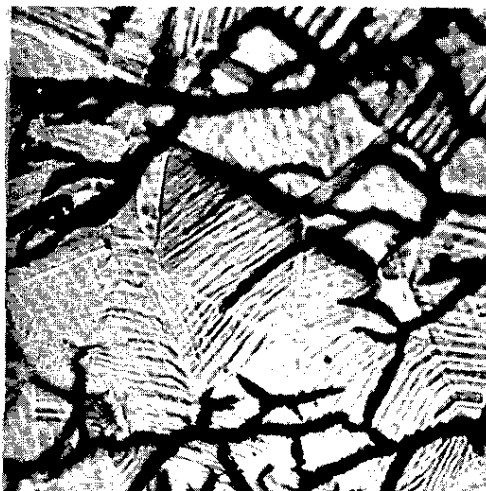
- a. Initial pitting in very localized regions. Exposure 5 minutes.

- b. Extension of pits to form linear traces of corrosion parallel to slip lines. Exposure 15 minutes.

- c. Initiation of cracks (dark centers) within lines of corrosion. Several cracks have joined to form a single branched crack in the center of the field. Exposure 15 minutes.

- d. Pattern of well-developed cracks. Exposure 30 minutes.

FIG. 8 SEQUENCE OF CRACK INITIATION IN TYPE 304 STAINLESS STEEL U-BEND SPECIMEN IN BOILING  $MgCl_2$

- Initially, corrosion pitting occurred in localized areas (Figure 8a).
- The pitting was followed by extension of the corrosion to form linear traces of corrosion product on the sample surfaces; these traces were often parallel to observable slip traces (Figure 8b).
- Additional exposure caused cracking to occur in the corroded regions (Figure 8c).
- At still greater exposures, the small cracks within each grain connected to form the branching, transgranular cracks shown in Figure 8d. By this time the crystallographic nature of the cracks was not readily apparent. However, the branches often changed directions at grain boundaries, and many of the branches were parallel to slip lines.

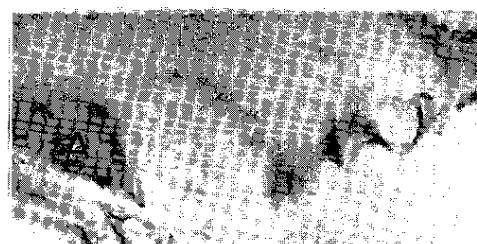
a. Attack at a stacking fault A.

b. Attack along a grain boundary B.

c. Attack along parallel crystallographic planes C.

FIG. 9 TRANSMISSION ELECTRON MICROGRAPHS OF ELECTROPOLISHED TYPE 304 STAINLESS STEEL. Note the preferential attack (light, high-transmission regions) at various structural features. This attack was the result of the electrochemical thinning of the foils.

The electropolishing caused preferential chemical attack to occur at stacking faults, grain boundaries, and along certain crystallographic planes (Figure 9). This preferential attack was not noted in all regions, but occurred to some extent in almost every sample. The stacking faults were generally more reactive than the other sites of preferential attack and in some cases were completely dissolved.

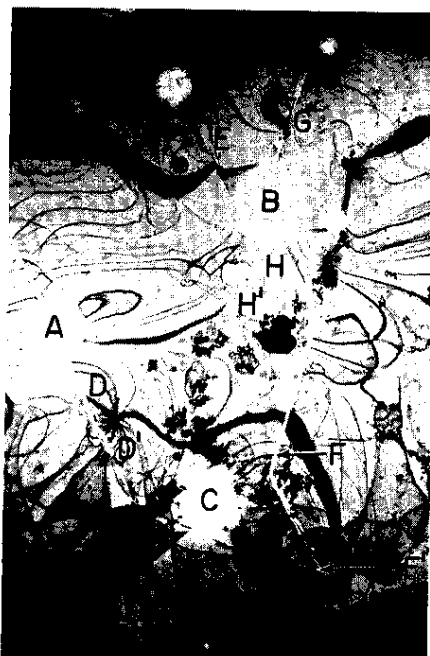
a. After 15-minute exposure.

b. After 25-minute exposure.

FIG. 12 PROPAGATION OF EXISTING CRACKS IN TYPE 304 STAINLESS STEEL FOIL DURING EXPOSURE TO A SOLUTION OF DEIONIZED WATER AND 100 PPM CHLORIDE (as NaCl) AT 100°C. Note that after 15-minute exposure cracks in the foil propagated from holes A, B, and C ended at points D, E, F, G, and H, and that after 25-minute exposure the cracks had propagated to D', E', F', and H'.
