ULTRASONIC SOLDERING OF ALUMINUM

J. Byron Jones and John G. Thomas

AEROPROJECTS INCORPORATED

December 1954

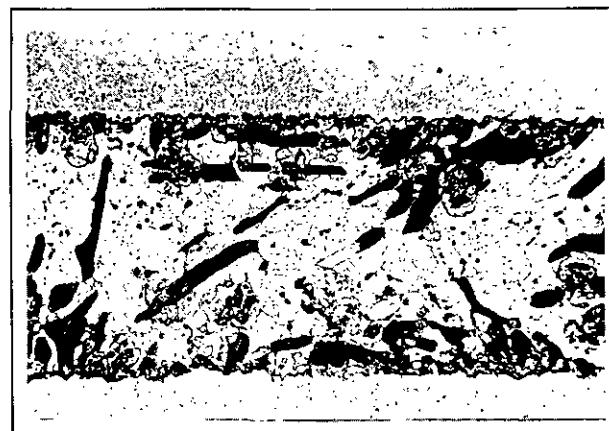
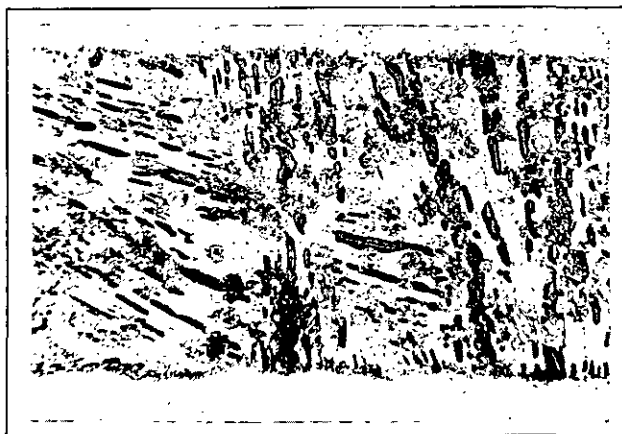
FIGURE 7

CROSS SECTIONS OF LAP JOINTS ULTRASONICALLY SOLDERED
WITH 64% TIN-32% ZINC-4% ALUMINUM (SOLDER ALLOY A-1)
AND EXPOSED TO 95°C, LOW-CONDUCTIVITY, AERATED, DISTILLED WATER

(Nital etch, 400X)

Photomicrographs were made of cross sections of lap specimens with representative solders A-1, A-6, B-1, and C-1: before exposure and after 182, 422, 902, and 3638 hours of corrosion exposure. These micrographs, presented in Figures 7, 8, 9, and 10, show the changes in the metallurgical structure of the joints during the exposure period.

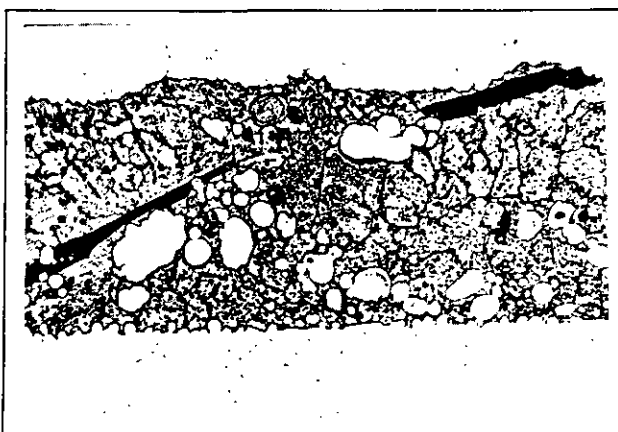
FIGURE 8

CROSS SECTIONS OF LAP JOINTS ULTRASONICALLY SOLDERED
WITH 82% TIN-14% ZINC-4% ALUMINUM (SOLDER ALLOY A-6)
AND EXPOSED TO 95°C, LOW-CONDUCTIVITY, AERATED, DISTILLED WATER

(Nital etch, 400X)

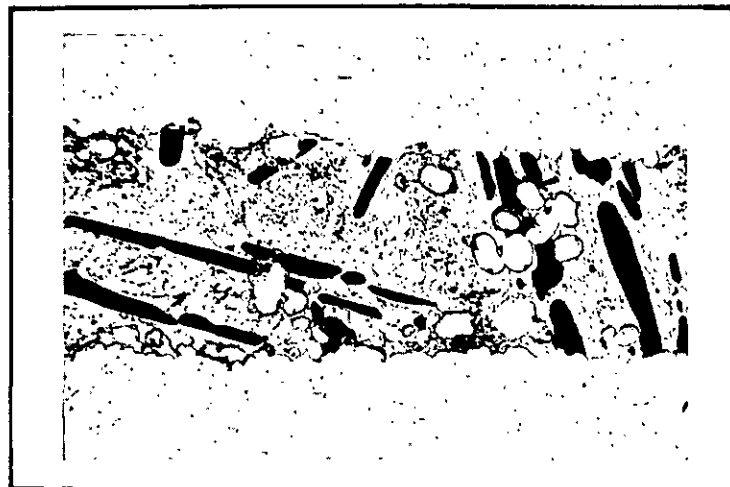
FIGURE 9

CROSS SECTIONS OF LAP JOINTS ULTRASONICALLY SOLDERED
WITH 73% TIN-23% ZINC-4% ALUMINUM (SOLDER ALLOY B-1)
AND EXPOSED TO 95°C, LOW-CONDUCTIVITY, AERATED, DISTILLED WATER

(Nital etch, 400X)

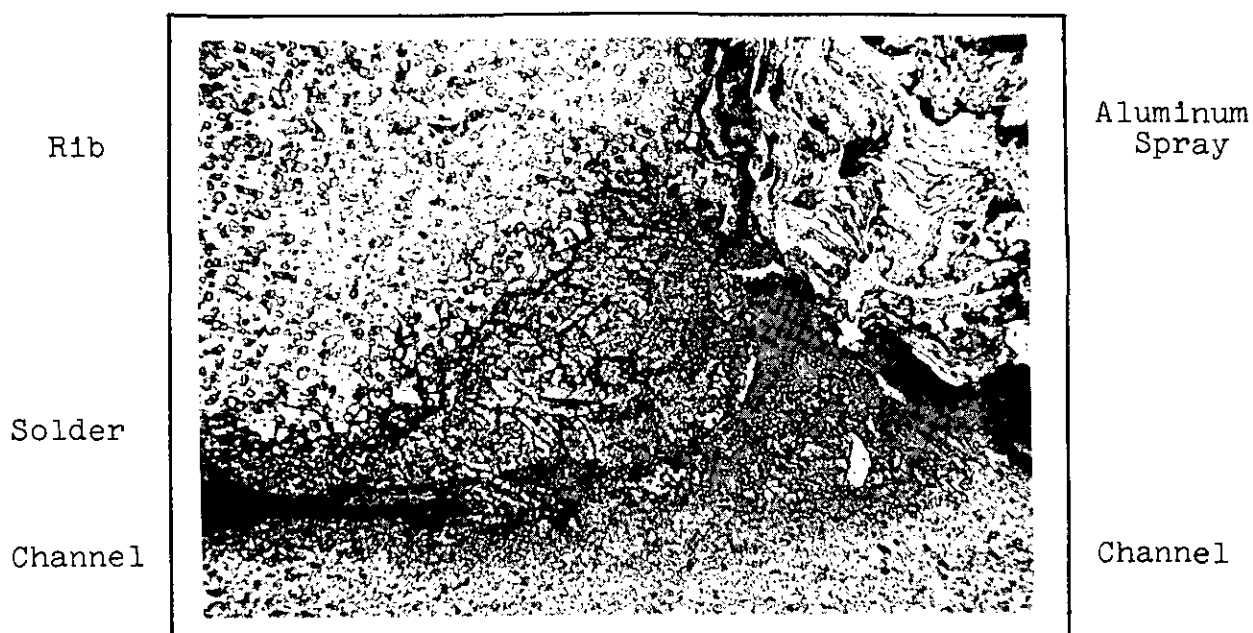
FIGURE 12

CROSS SECTION OF FILLET AREA OF RIB-CHANNEL ASSEMBLY
ULTRASONICALLY SOLDERED WITH 85% TIN-15% ZINC
AND ALUMINUM SPRAYED FOR PROTECTION
AFTER 4000 HOURS EXPOSURE IN 95°C, LOW-CONDUCTIVITY, DISTILLED WATER
AT BATTELLE MEMORIAL INSTITUTE
(0.5% HF etch, 300X)

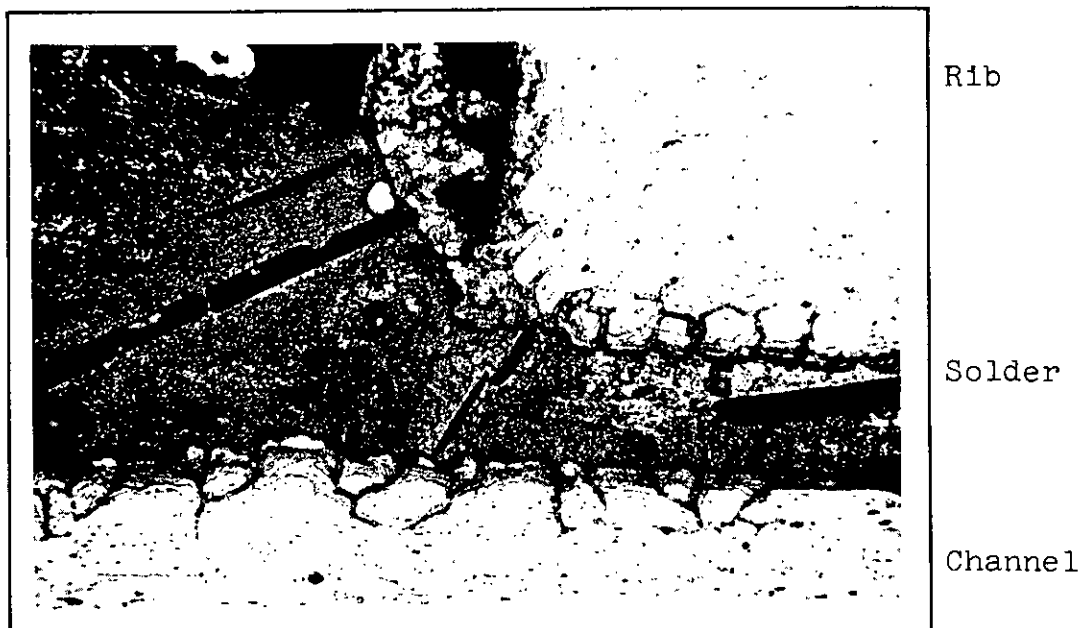
FIGURE 15

CROSS SECTION OF FILLET AREA OF RIB-CHANNEL ASSEMBLY
ULTRASONICALLY SOLDERED WITH 76% TIN-20% ZINC-4% ALUMINUM
AND AGED AT ROOM TEMPERATURE FOR 84 DAYS
(0.5% HF + 2% Nital etch, 250X)
