DP-MS-85-4

ALLCOR® WELDING AND WELDMENT CORROSION RESISTANCE

A paper proposed for presentation at the
ASM Metals Congress, Metallography-Welding
Toronto, Ontario
October 13-18, 1985

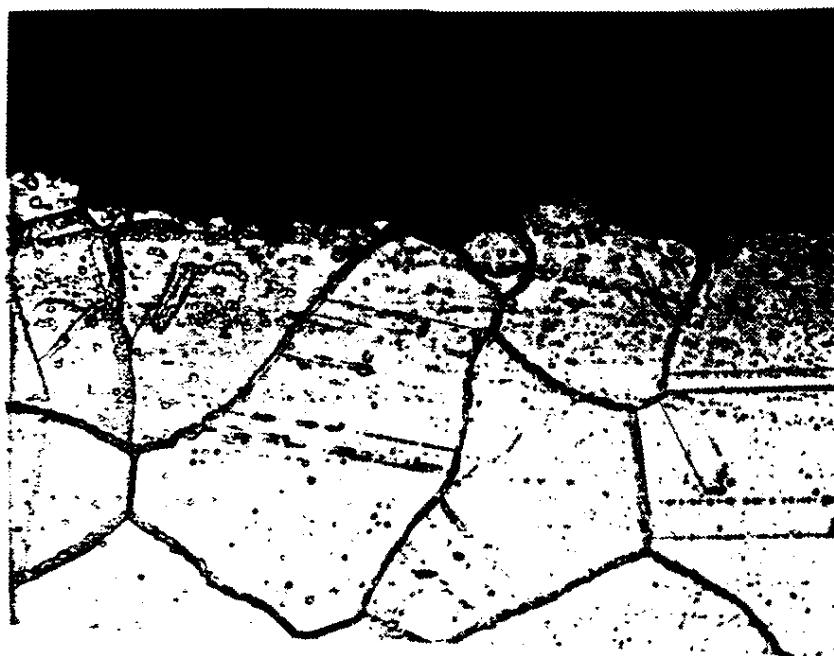
FIGURE 9. SURFACE AND ETCHED CROSS-SECTIONAL VIEWS OF ALLCORR EXPOSED TO FORMIC ACID/HALIDE SOLUTION AFTER HEAT TREATMENT AT 930°C (1700°F). GRAIN BOUNDARY ATTACK IS EVIDENT.

Weldments of Allcorr and Allcorr/Hastelloy C-276 were corrosion tested in as-welded and heat treated states, with heat treatments representative of exaggerated conditions for multipass and repair welding and service upsets. Table 3 illustrates the relative effect of oxidizing vs. reducing acid environments on Allcorr. Corrosion resistance in oxidizing nitric/halide is high, whereas rapid grain boundary attack occurs in reducing formic acid/halide solution, Figure 9.
