MEMORANDUM

May 31, 1972

CORROSION OF 8001 ALUMINUM FUEL CLADDING

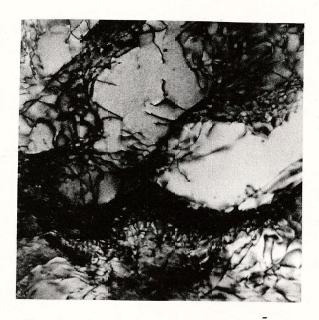
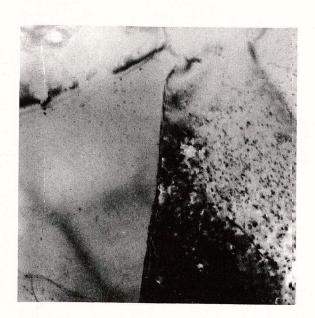
FIG 1. STRUCTURES OF HEAT TREATED 8001 ALUMINUM

As-Fabricated

A. Grains elongated during coextrusion

C. Dislocation tangles and subcells

D. Clean boundaries few dislocations

The microstructure of 8001 was characterized by both light microscopy and electron microscopy. In the as-fabricated condition, grains were elongated in the direction of extrusion, Figure 1A. Heat treatment slightly above Mark 18 operation temperatures caused complete recrystallization over the entire cladding thickness (Figure 1B). Distinct changes in dislocation substructure accompany the recrystallization; the dense dislocation tangles and subcell boundaries characteristic of the as-fabricated cladding (Figure 1C) disappeared during recrystallization leaving grain or subgrain boundaries with few observable dislocations (Figure 1D). Theoretically, the as-fabricated cladding should corrode faster than the annealed cladding because of the stored energy in the metal in the form of dislocation tangles and other lattice defects.

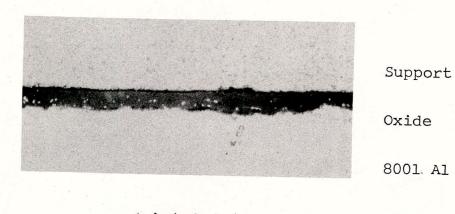
FIG 2. CATHODIC ALUMINIDES IN OXIDE FILM (Note nickel and iron aluminides near metal surface have not been oxidized.)

The corrosion resistance of 8001 is attributed to fine, uniform dispersions of second phase iron and nickel aluminides that are cathodic to the matrix. The function of the second phase is to allow hydrogen ion reduction before the ions reach the metal-oxide interface and thereby prevent the hydrogen gas from disrupting the protective oxide by bubble formation at the metal-oxide interface. Figure 2 shows a few of the larger cathodic particles that are retained in the oxide film of 8001. The film was grown in the loop under conditions similar to those shown in Table I except that the exposure time was 6.8 days. The cathodic particles are apparently oxidized as the specimen continues to corrode.

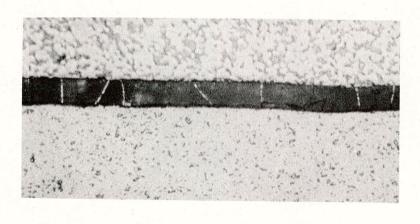
FIG 3. STRUCTURE OF OXIDES ON 8001 ALUMINUM

Support
Oxide (17 ±1 µm)

a. As-Fabricated

Support Oxide (13 \pm 1 μ m) 8001 Al

b. Heat Treated 420 min at 400°C

The oxides formed under the conditions shown in Table I showed distinct differences for the as-fabricated and heat treated specimens. The oxide on the as-fabricated specimens was highly stressed and fragmented, particularly at the outer surface, Figure 3a. The oxide on the heat treated metal was thinner and fragments were blocky in appearance, about as thick as the oxide itself, Figure 3b. In both

cases, the fractures extended through the oxide to the metal surface. These differences may be attributable to differences in residual stresses on the specimen, as it is well known that such stresses are transferred to oxide films as the metal oxidizes. The effect of these differences on turbidity in the moderator is unknown.

Examination of the oxide films by X-ray techniques showed that the oxides were primarily amorphous, with 10% of the oxide crystallized. The crystalline portion was a high temperature form of alumina, boehmite ($\alpha Al_2O_3 \cdot H_2O$); this structure is normally formed at >80°C. Although the bulk cooling water temperature was only 50°C the calculated oxide-water interface temperature was 130-160°C. The calculated oxide-metal interface temperature was 55°C above the oxide-water interface temperature, or 185-215°C, thus accounting for the high temperature oxide. A comparison of the X-ray diffraction peak heights of weighed amounts of boehmite and the peak heights of the sample indicated the boehmite was only 1.5 μ m thick. Because the oxide film thicknesses were measured at 12-18 μ m (Figure 3), apparently only about 10% of the oxide was crystalline.

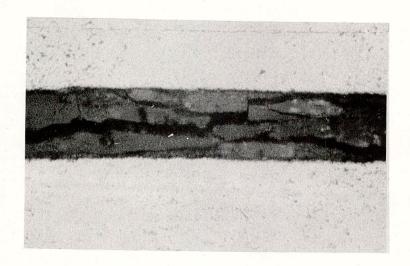
Black Oxide

FIG 4. "BLACK" ALUMINUM OXIDE (A high temperature rapid oxidation product)

If the cooling water temperature was raised to 75° C instead of 50° C, while the loop was operated at a heat flux of 10^{6} pcu/(hr)(ft²) the oxide gradually darkened and was black at the end of three days. Such operating conditions are more severe than normal reactor conditions for the Mark 18, which are: a coolant temperature of $<75^{\circ}$ C at the position of maximum heat flux $\sim 10^{6}$ pcu/(hr)(ft²) or a coolant temperature of 80°C maximum at a lower heat flux.

"Black" oxide has been reported¹ for some areas of cladding on Mark 16 fuel in the C-l cycle. The assumption that the black oxide formed because of "dogboning" of the fuel is supported by its formation in the loop under severe conditions, thus indicating that the black areas operated at a higher temperature and higher heat flux than the rest of the fuel. A cross section of the thick 36 µm (1.4 mil) "black" oxide formed in 75°C cooling water is shown in Figure 4. This oxide, physically stripped from its base metal and examined by X-ray diffraction technique, was found to be nearly identical to the normal oxide (boehmite) formed under less severe conditions. The estimated water-oxide interface temperature was 185°C. The calculated metal-oxide interface temperature was 300°C and no intergranular attack of the 8001 was observed.
