TECHNICAL DIVISION
SAVANNAH RIVER LABORATORY

DPST-82-231

MEMORANDUM

EVALUATION OF CORROSION AND DEPOSITION IN THE 1941 MELTER

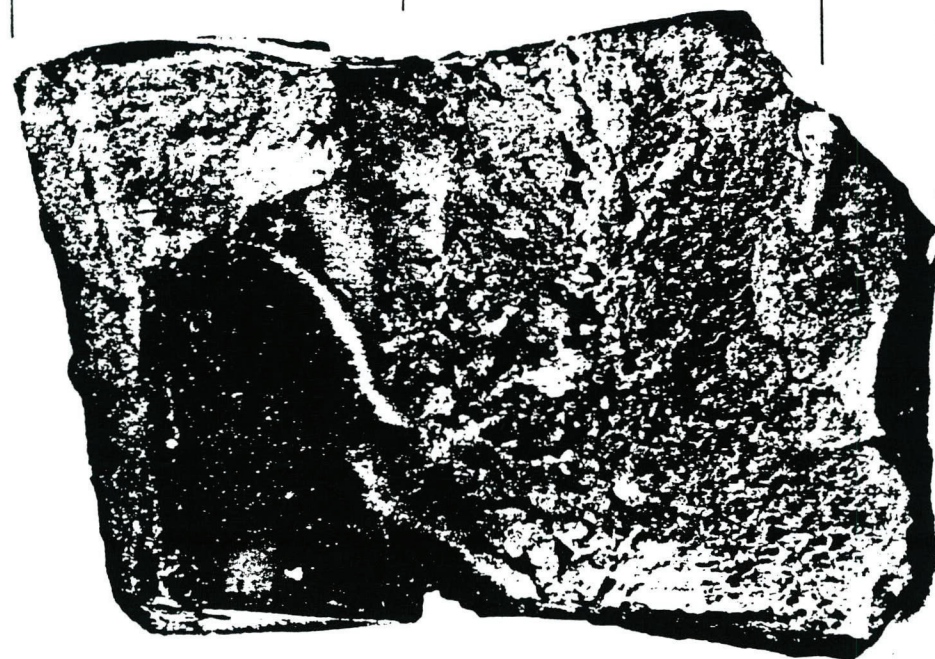
Fig

A large specimen of the entire cross section of the slag layer shows that the slag is composed of three layers (Figure 3). The results of electron microprobe analysis and x-ray diffraction analysis of specimens from each layer are given in Table 1 and discussed in the following paragraphs.

Layer 1 (closest to bottom) is composed of four phases:

- 1) FeNiMn spinel
- 2) FeNiMnCr spinel
- 3) A phase which was not identified (containing O and Si)
- 4) A glass matrix enriched in aluminum

Layer 2 (above Strata 1) is composed of 4 phases:

- 1) FeNiMn spinel (structure similar to the structure of the mineral trevorite)
- 2) Sodium calcium iron silicate (structure similar to the structure of the mineral acmite)
- 3) Glass matrix
- 4) Entrapped waste glass of normal waste glass composition

Layer 3 (top of the slag) is composed of 3 phases:

- 1) FeNiMn spinel (structure similar to the structure of the mineral trevorite)
- 2) Sodium calcium iron silicate (structure similar to the structure of the mineral acmite)
- 3) Glass matrix

CROSS SECTION OF SLAG

Layer 1 of the slag was probably formed during this period of melter operation. It contains spinels which contain higher levels of Cr than were found in any other layer of the slag. The glass matrix of layer 1 contains higher levels of Al than found in any other layer in the slag. None of the material found on the wall of the melter formed during this period.

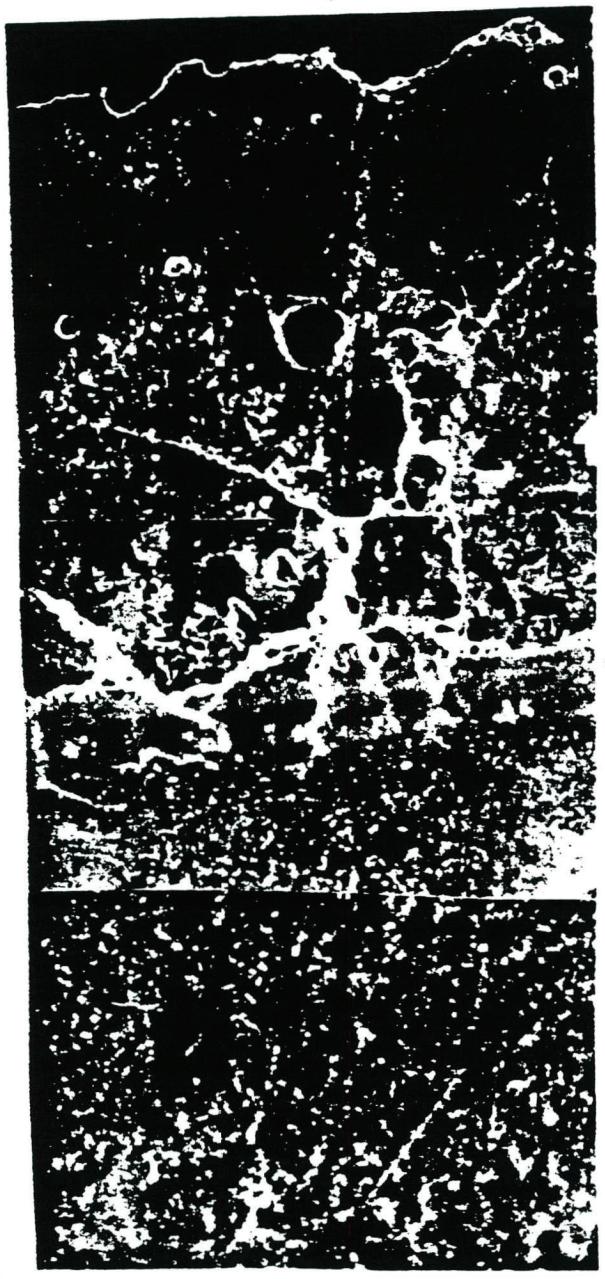
Figure 4
CROSS SECTION OF MATERIAL FROM WALL

A specimen from a core drilled from the wall of the melter below the melt line is shown in Figure 4. This specimen contains three different zones which are discussed below:

Material from the glass that remained on the melter wall was composed of a glass matrix of the normal waste glass composition with >30 volume % FeNiMn spinel particles. This material adhered to the melter wall when the melter was drained because it was more viscous than the waste glass in the melter. Increasing the content of second phase particles in glass increases its viscosity.³

The composition of this material shows that it came from the glass and not from the Monofrax K-3. The FeNiMn spinel and the glass in this layer are composed primarily of elements found in waste glass (Fe, Ni, Mn, Si). This layer contains very little Cr (approximately 0.8 wt %). Chromium is one of the main constituents of Monofrax K-3. The CrFeNi spinels in the Monofrax K-3/glass reaction zone contain approximately 20 wt % Cr.

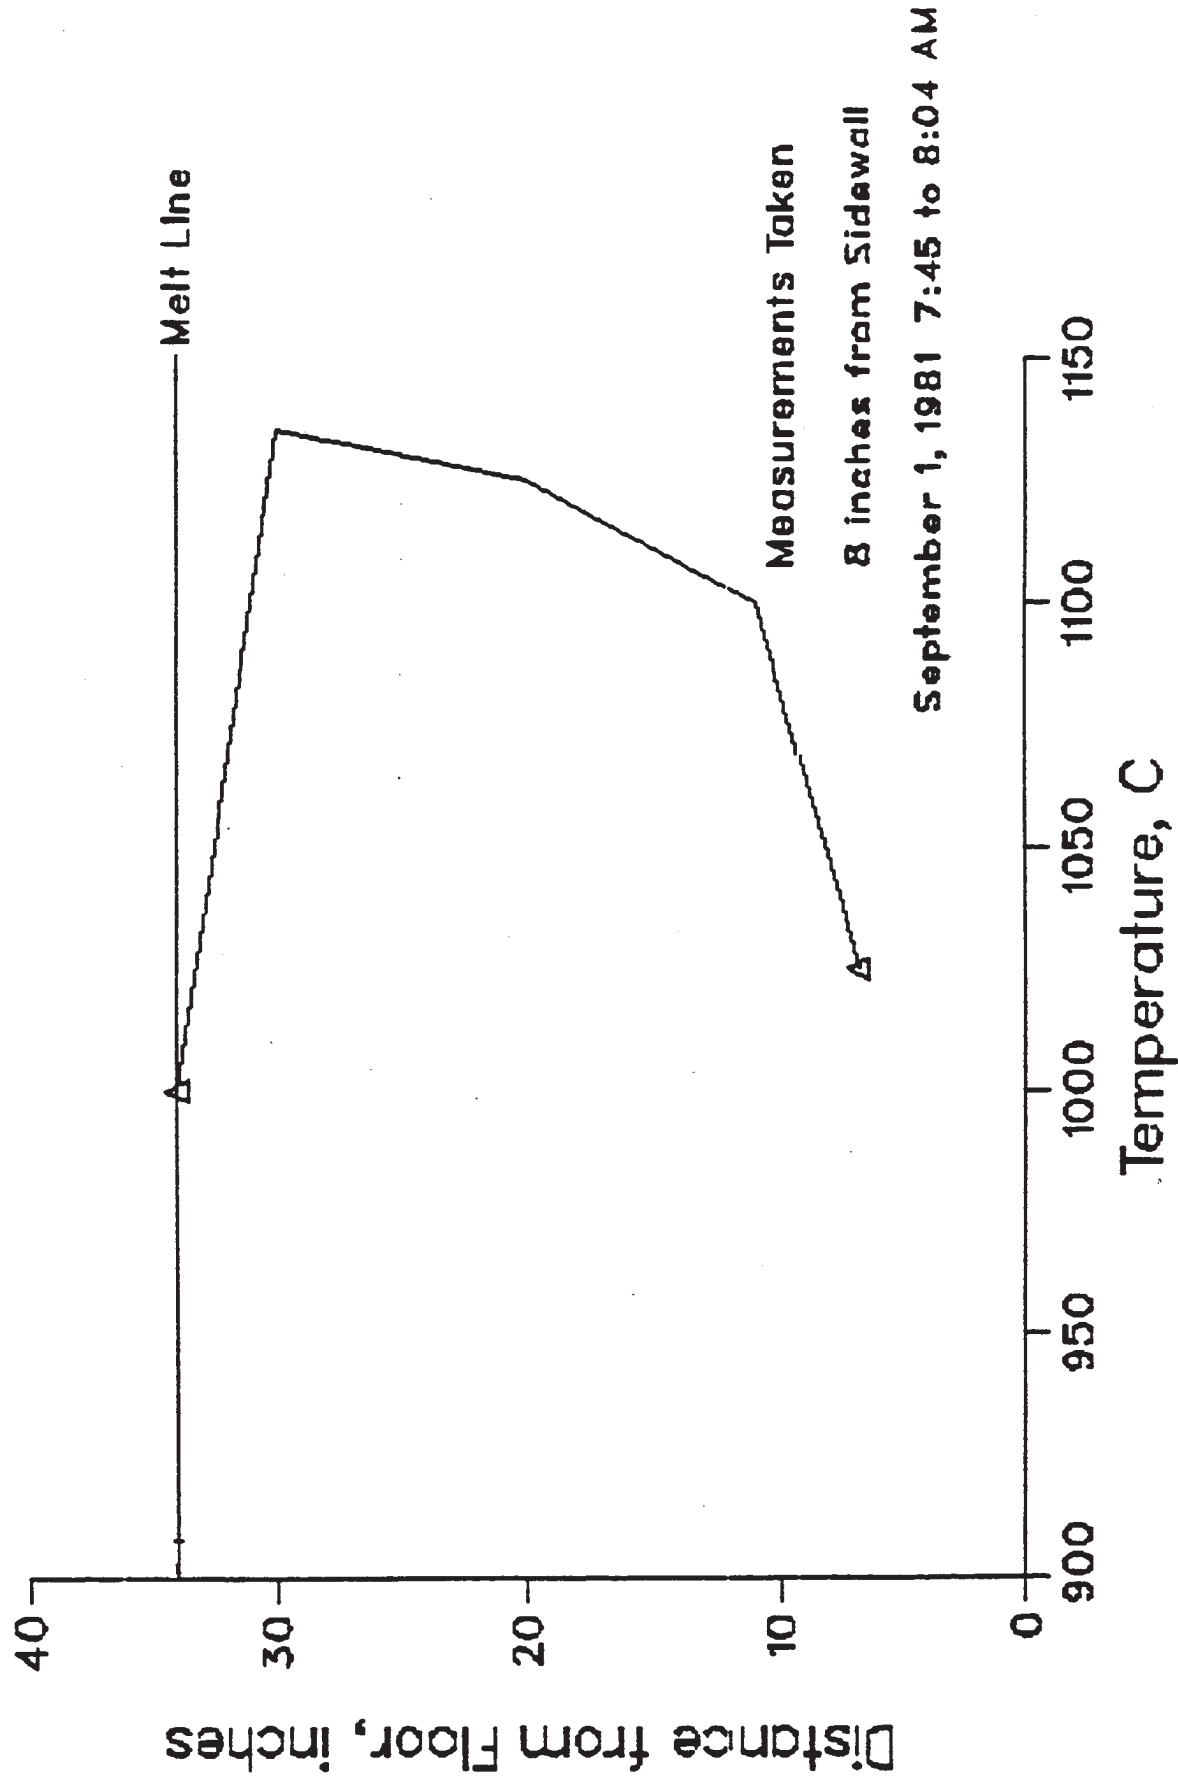
Figure 7
APPROXIMATE 1941 MELTIER TEMPERATURE PROFILE

Temperature probes of the 1941 melter made during operation at a bulk glass temperature of 1150°C show that the temperature at the bottom of the melter was about 950°C.⁵ This temperature would cause second phase particle formation in this part of the glass. Slag would result from accumulation of these particles at the bottom of the melter.

- During normal waste glass production the temperature should be controlled so that excessive corrosion does not occur. Corrosion not only wears out the melter but contributes to slag accumulation.
- The temperature of the glass should be maintained above its liquidus temperature. Waste glass melters should be designed so that the entire melt chamber can be controlled above the glass liquidus temperature. If low temperatures are desired during idling for extended periods, the composition of the glass could be changed to prevent slag accumulations. All of the waste glass could be flushed out with a glass. A composition such as pure frit + 20 wt % Al_2O_3 which has a much lower liquidus temperature. This will result in the production of extra canisters of glass, but will prevent the problem of slag accumulations.
