9978 and 9975 Type B Packaging Internal Data Collection Feasibility Testing

April 2012

Savannah River National Laboratory Savannah River Nuclear Solutions, LLC Aiken, SC 29808

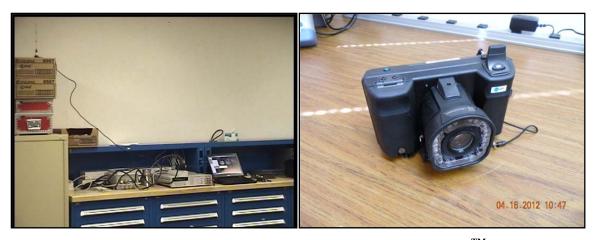
The Librestream OnsightTM Wi-Fi camera, shown in Figure 5-1, was tested first. The OnsightTM camera was placed on top of 9978 packaging for the baseline test which lasted 15 minutes. The camera was then placed inside the packaging and the lid was secured with bolts that were torqued to 30 foot-pounds per assembly instructions. The red star shown in Figure 5-2 shows the location of the camera. The signal strength value displayed in the Fortress ES820 connections web interface was observed at the 25 foot location for 15 minutes. The packaging was then loaded on a dolly and slowly repositioned further away from the base station until the signal was lost.

Figure 5-1. Fortress ES820 Access Point (Left) and Librestream OnsightTM Wi-Fi Camera (Right).

- IEEE 802.11 b/g
- Orthogonal Frequency Division Multiplexing Modulation
- Onsight[™] Camera Transmit Power of 14 dBm and Receive Sensitivity of -82 dBm
- Fortress[™] ES820 AP Transmit Power of 23 dBm and Receive Sensitivity of -97 dBm
- 7 dBi vertically polarized omnidirectional antenna on the Fortress ES820-Radio 1 (Pacific Wireless Model MA24-7N)

The Wi-Fi baseline test resulted in a signal strength reading of -54 dBm at a distance of 25 feet between the camera and the base station. Once the camera was sealed within the 9978, the signal strength fell to -81 dBm. A viable radio link was maintained from within the 9978 using standard Wi-Fi protocol to a distance of 50 feet before the communication link was lost. Unfortunately, due to the physical size of the Wi-Fi enabled camera, similar testing could not be performed with 9975 packaging.

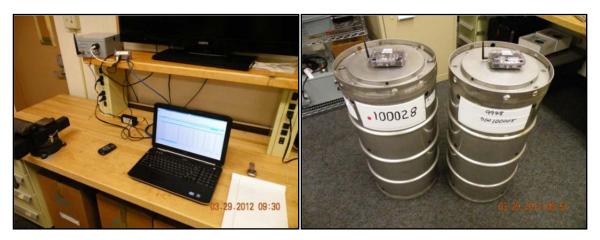
The On-Ramp Wireless prototype system and two Model 9978 packaging are shown in Figure 6-1. Two On-Ramp Wireless GPS radio nodes were used in a series of tests in which their signal strength data was collected. No temperature data was transmitted in the proof-of-concept testing. The radios and ungrounded packagings were tested at distances of 25, 75, and 175 feet. The 75 and 175 foot locations were not line-of-sight with the base station. The On-Ramp Wireless software was configured to communicate signal strength data every 15 seconds.

Figure 6-1. On-Ramp Wireless ULP system with AP base station and Model 9978 Type B packagings with 2 GPS radio nodes.

A baseline test was performed at distances of 25, 75, and 175 feet with one of the GPS radio nodes placed on top of a 9978 packaging as shown in Figure 6-1. The radio nodes were then placed inside the drums as shown in Figure 6-2. Signal strength data was collected for 15 minutes after the lid was placed on the drum body, but not secured with bolts.

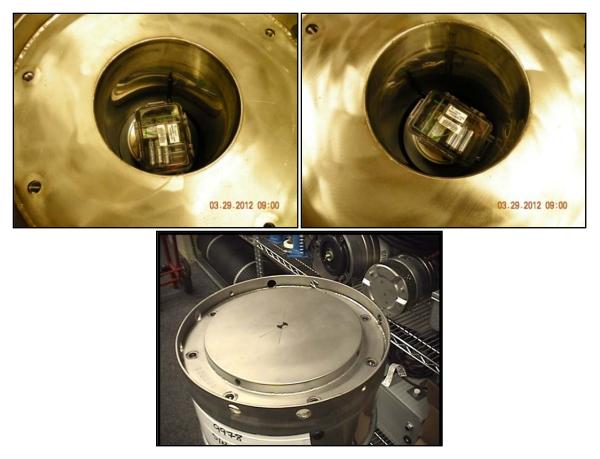
Figure 6-2. The locations of the transmitters inside the 9978 packaging.

The radio signal strength data for both radios placed within the 9978 packaging are shown in Table 6-3, Table 6-4, and Table 6-5. In Table 6-3 and Table 6-4, it is evident that the signal strength parameters dlRssi and ulRssi decreased as the distance from the package and base station increased. This result was expected. However, neither radio node fell outside their signal strength limits. A viable communication link was achieved to 175 feet for both radios. Because radio node 106b5 was found to have 10 dBm less signal strength than radio node 10402 in the baseline test, the radio nodes were swapped between packagings. Table 6-5 shows the data collected at this distance. Both radio nodes produced a viable communication link. This test was only performed at the 25 foot location.

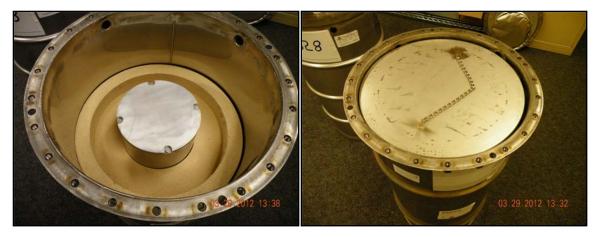
Figure 6-5. Model 9975 with radio node inside lead enclosure with bolts torqued to 13 ft-lbs (Left) and with the insulation top subassembly installed (Right).

The next phase of testing was performed with the 9975 packaging shown in Figure 6-4. The collection of baseline data did not have to be repeated since this was accomplished in previous testing with the 9978. One of the On-Ramp Wireless GPS node radios was placed inside of the lead-shield assembly body. Data was collected for 15 minutes. Then the lead-shield assembly lid was installed and the lid bolts were torqued to 13 foot-pounds as prescribed in the assembly instructions. Signal strength data was collected for 15 minutes in this configuration. The insulation top subassembly was installed and more measurements were taken as shown in Figure 6-5. Finally, the drum lid was installed and the lid bolts were torqued to 30 foot-pounds as shown in Figure 6-6. Data was collected in this configuration for 15 minutes. The packaging was loaded onto a dolly and transported to the 75 foot location and signal strength data was collected for 15 minutes.

Another series of tests were performed without the aluminum lid installed on the lead-shield assembly. Data was taken in the following two configurations:

- 1. Insulation top subassembly installed and without the drum lid.
- 2. Insulation top subassembly and the drum lid installed and bolts torqued to their appropriate value.

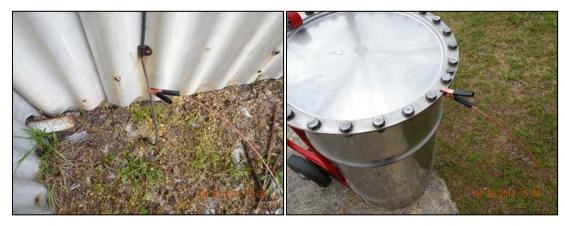
A series of tests were performed to determine if grounding the packagings had any effect on their communication links. An On-Ramp Wireless radio node was placed inside each packaging. The packagings were then re-assembled and positioned 17 feet away from the base station at a location just outside the building where the closest available earth ground was located. Figure 6-7 shows the 9975 and its connection to earth ground. Data for both packagings was collected at this location for 15 minutes. The 9975 was only tested at this location because of its limited range of less than 50 feet.

Figure 6-7. Grounding wire connection (Left) and connection to Model 9975 package (Right).

The 9978 was re-located to the 75 and 175 foot locations inside the building and connected to earth ground at those locations. Data from the packaging was collected for 15 minutes at each location as shown in Table 6-7. The results from the 9975 are shown in Table 6-8. As is evident from the tables, grounding the 9975 and 9978 had no effect on the communication link at any location.
