# SR19036 Improve TRP Cutter Head Performance

SRNL-STI-L4520-2020-00010, Revision 0

**Keywords:** Tritium Extraction Facility,  
Target Rod Preparation

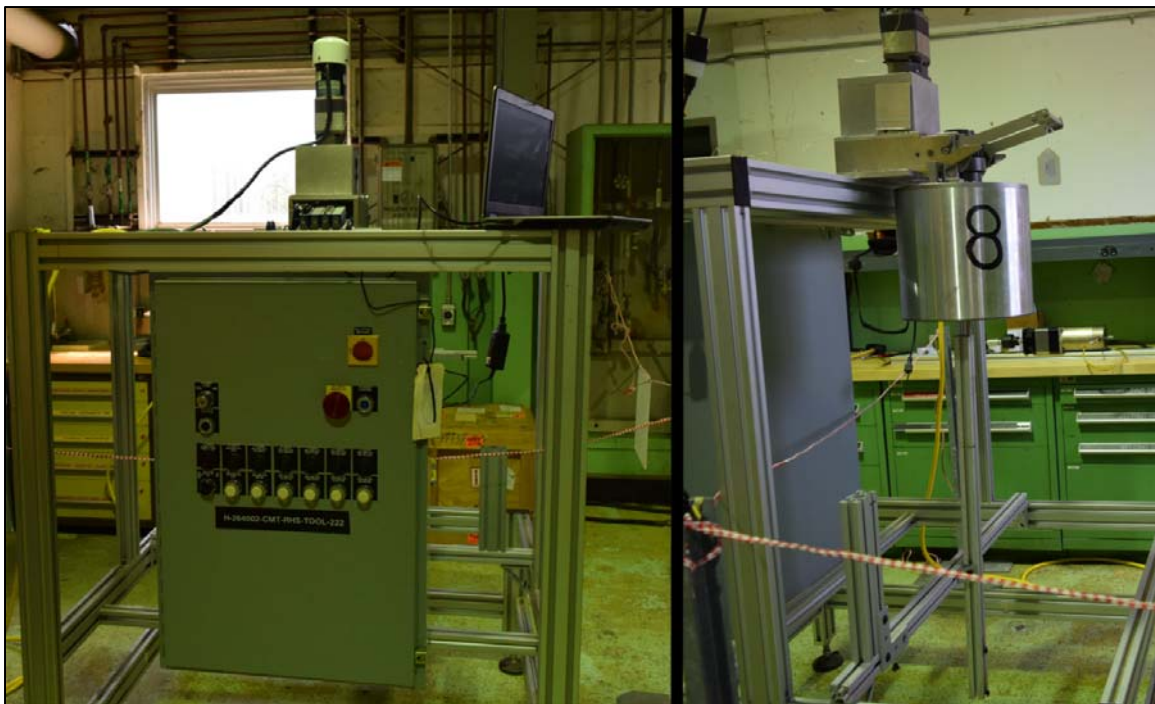
Figure 1-1. Test Stand General Setup

All testing was planned and accomplished on a test stand that simulates the breaching of a TPBAR in a clean area in building 723-A (Fig 1-1). There are several variations between the testing environment in 723-A and the TRP hot cell environment.

The test stand gives a rough representation of the TPBAR breaching process but is certainly not an exact replica of the TRP hot cell. As an example, the motor installed on the test stand is a generic industrial model motor whereas the motor installed in the TEF is a radiation hardened motor, both of which are manufactured by Empire Magnetics. The radiation hardened motor has specialty electrical components that may not reject heat as well as an industrial motor. Additionally, all breaching tests in 723-A were in open, ambient air (natural convection), whereas the TRP cell has a slight, constant, negative pressure. This negative pressure would supply a small amount of forced convection over the motor. Additionally, the TRP cell is an inert cell filled with Nitrogen, rather than typical ambient air. Ambient air is mostly made of Nitrogen so the difference in heat transfer coefficients between Nitrogen and ambient air are insignificant. Simulated debris on the outside of the mock TPBARs could not be accurately replicated during the breaching cycles in 723-A. This debris is present in the TRP hot cell and its presence could have a negative impact on the operation of the motor. There was no additional heat load added to the motor during testing. The TRP cell contains auxiliary equipment that adds heat to the cell, this equipment includes lights, cameras, vacuums, or other motors running in proximity of the cutter head drive motor.
