# **Estimating Effects of Various Factors on Corrosion of Pipeline Grade Carbon Steel Under Disbonded Coating — Progress Report**

SRNL-L5430-2019-00008, Revision 0

# Estimating Effects of Various Factors on Corrosion of Pipeline Grade Carbon Steel Under Disbonded Coating — Status Update

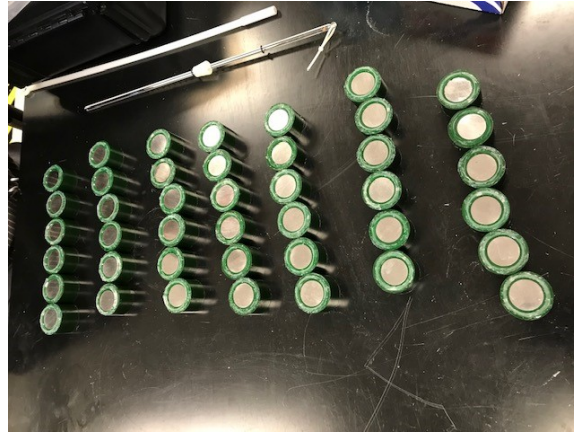
**(a) Coupon with cavity to place soil-water solution**

**Corrosion of API 5LX52 Carbon Steel Coupons:** Corrosivity of the soil samples towards the carbon steel coupons under coating disbondment was measured by exposing several coupons to the samples. The coupons were made by potting 1 inch diameter disks in a two-part epoxy solution. A holding cup was made for each coupon, with bottom of the cup consisting of the potted coupon. Some coupons' metal surface was covered with the coating samples to simulate coating disbondment; these coupons are referred as coating disbondment coupons hereafter. Soil plus water mixture was injected under the coating in the coating disbondment coupons. Soil samples were placed in each cup, with several coupons at each temperature points. Coupons' details of the are provided in Table A-1. The coupons were placed in several chambers where relative humidities was close to 100%. Images of the coupons and chambers are presented in Figures 1 and 2, respectively.

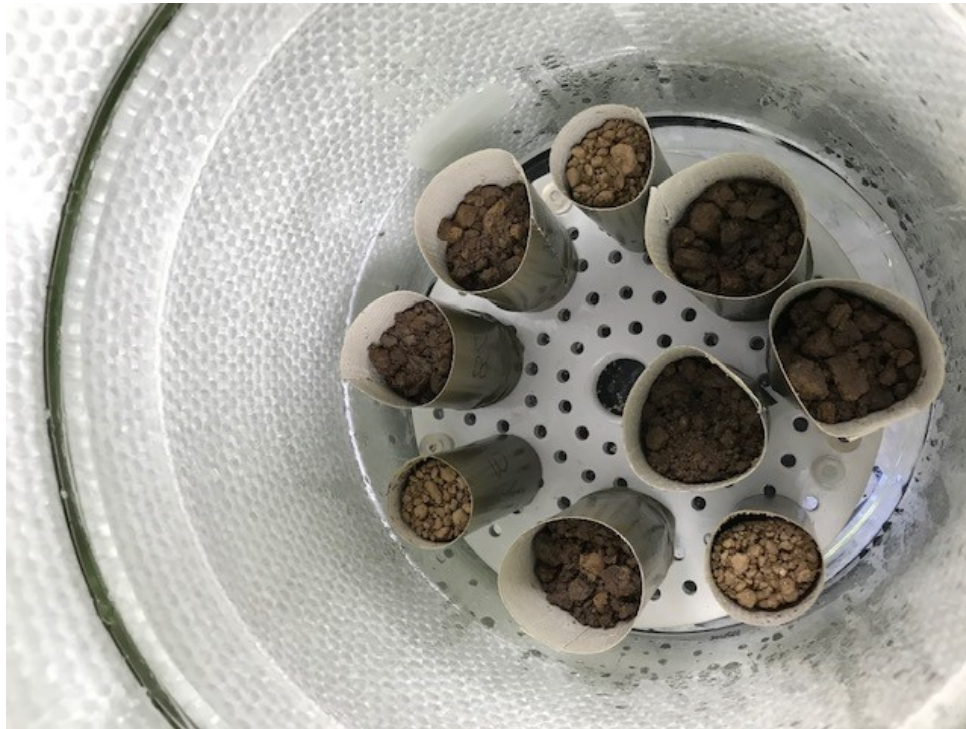
**(b) Images of the coupons**

**(c) Polyken tape coat applied to the coupons to simulate a disbonded**
