## **Testing of the Dual Rotary Filter System**

D. T. Herman  
M. D. Fowley  
D. B. Stefanko

August 2011

Savannah River National Laboratory  
Savannah River Nuclear Solutions, LLC  
Aiken, SC 29808

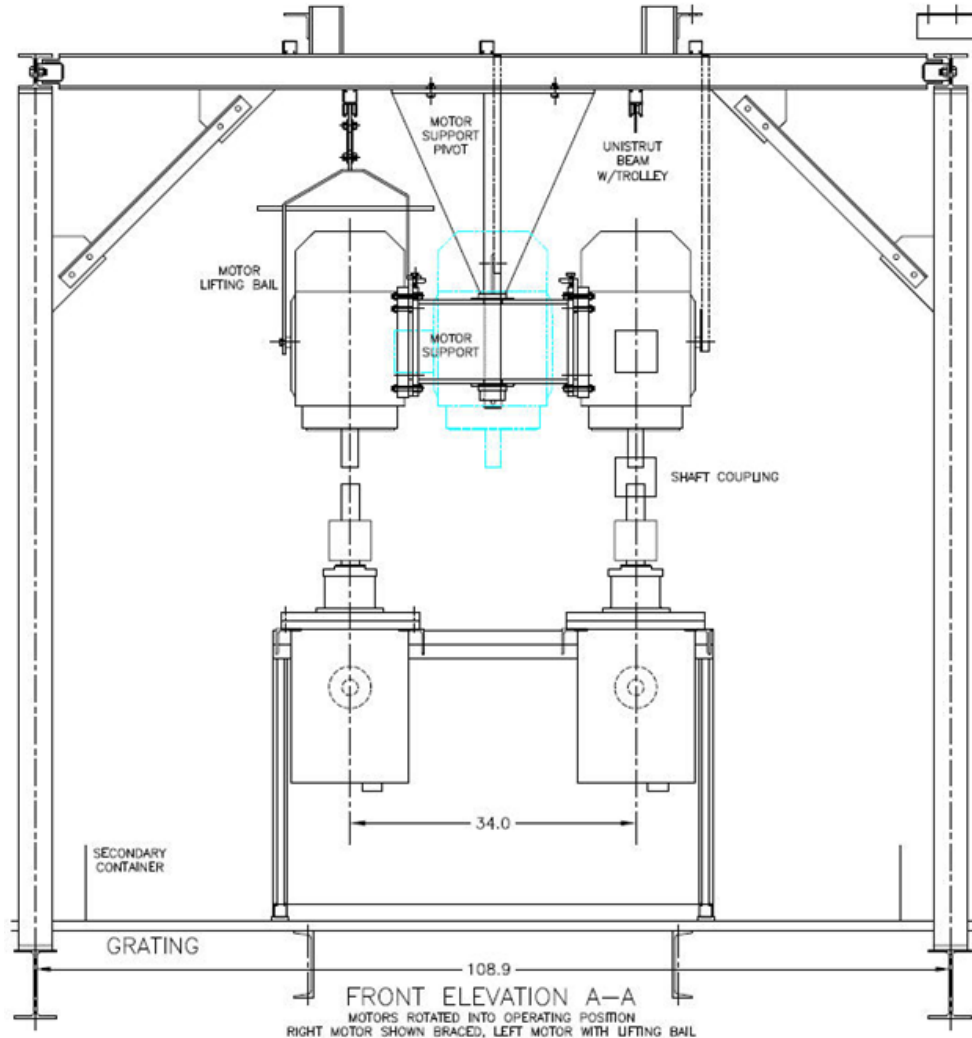
**Figure 1. Dual Filter/Motor Support Design**

An original intent of the installation was to verify the proposed tank-top support configuration of the filters and filter motors. The bank of filters and their respective motors were to be independently supported since they were isolated by the required shielding between them. To this intent, the SRNL main support structure for the filters was fabricated using unistrut and was set in a secondary container on the mezzanine. The filter motors were hung above the filters from an existing I-beam frame that was part of the mezzanine. This configuration is shown in Figure 1.

This original mounting configuration proved to be insufficient due to excessive vibration. Additional support structures were required to stiffen the structure for continued operation at tolerable vibration levels. A photo of the final reinforced filter setup is shown in Figure 2.

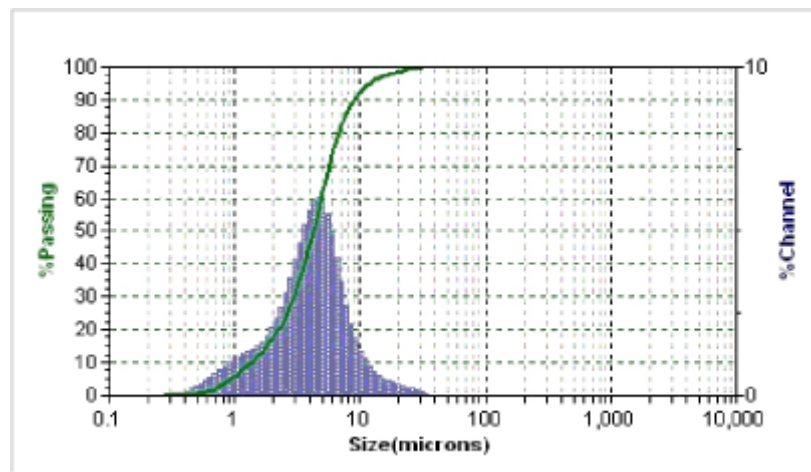
**Figure 6. Particle Size Distribution of Initial Feed**

The particle size distribution of the sludge and MST is shown as Figure 6. The graph is an average of 3 different measurements. Particle size was also measured between tests and after testing was complete. There was very little change in the particle size distribution between all three measurements.

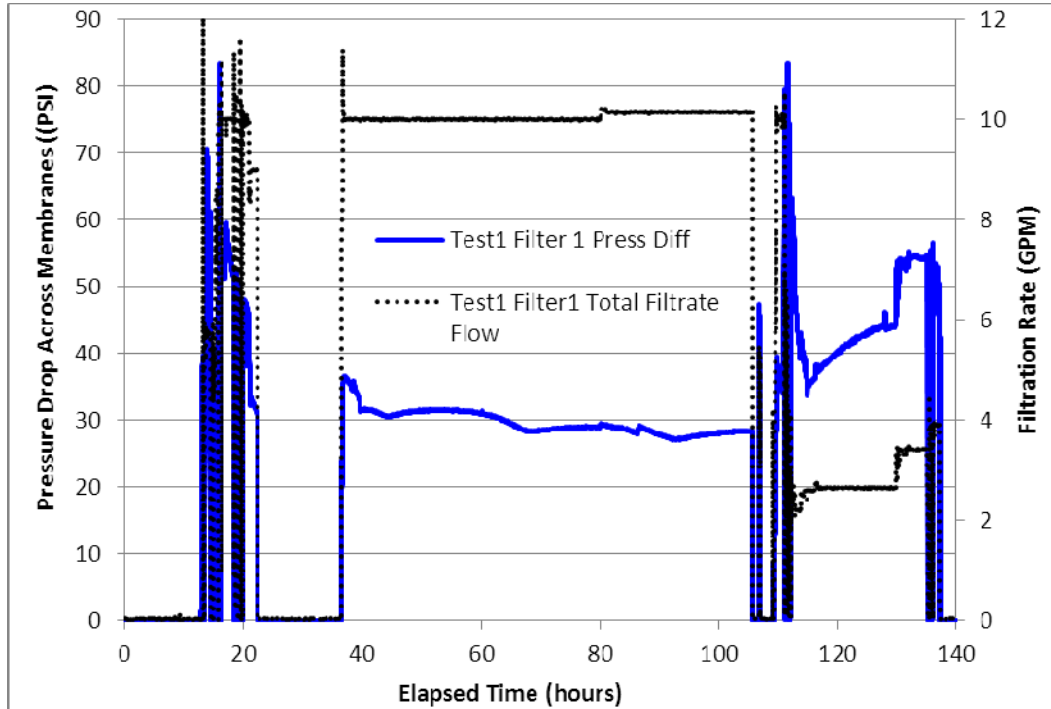
**Figure 7. Pressure Drop and Filtration Rate during Test 1**

the pressure drop and filtration rates for Test 1 and Test 2 are shown in Figure 7 and Figure 8. Note that during Test 1, the simulated salt solution without sludge simulant was the feed until approximately 111 hours of the elapsed test time. The sudden change in filtration rate and pressure drop after that time is due to the introduction of the 0.6 g/L sludge simulant solids and 0.4 g/L MST.

The pressure drop required to achieve the filtration rate set point for both tests was greater than expected. During Test 1 Filter #1 showed evidence of blocked filter media. This was evident due to the reduced production (Filter #2 was almost four times that of Filter #1) as compared to the historic water flux performance as well as a large discrepancy between filtration rates of Filter #1 and Filter #2.

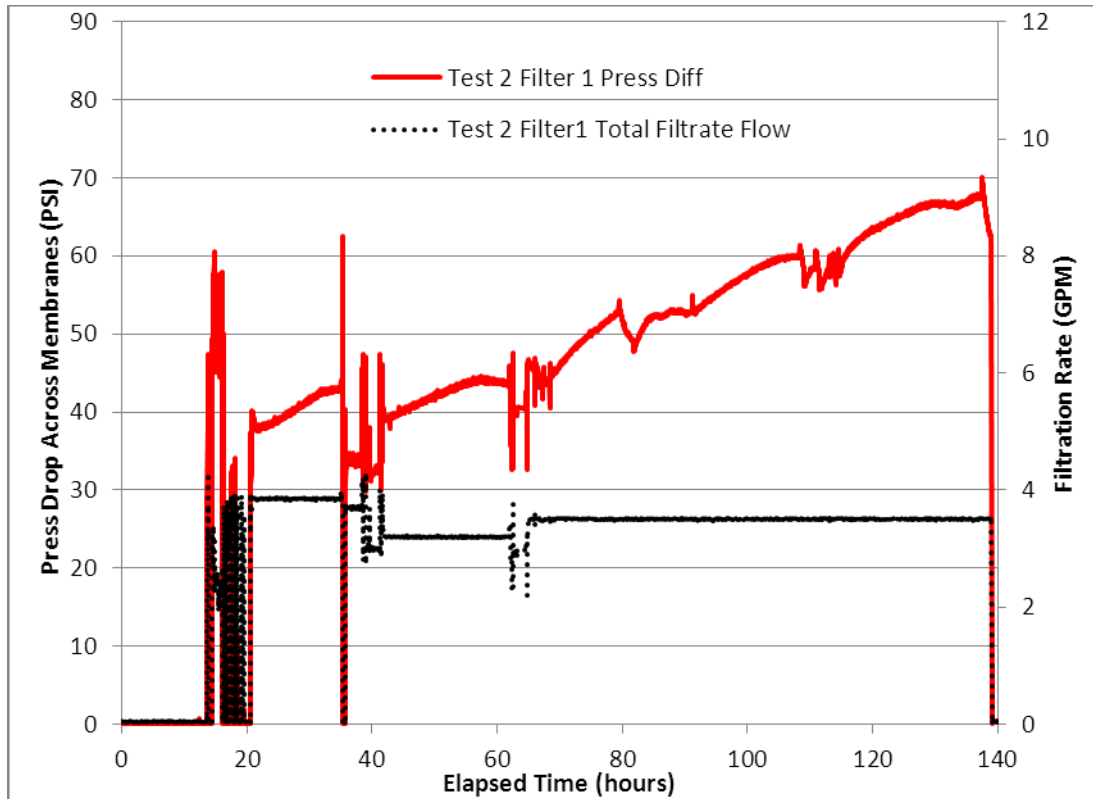
**Figure 8. Pressure Drop and Filtrate Flow during Test 2**

Test 2 (Figure 8) utilized the same feed as the end of Test 1, specifically, the simulated salt solution with 0.6 g/L SB6 simulant and 0.4 g/L MST. At the end of the test, the amount of sludge was increased to 1.29 g/L.

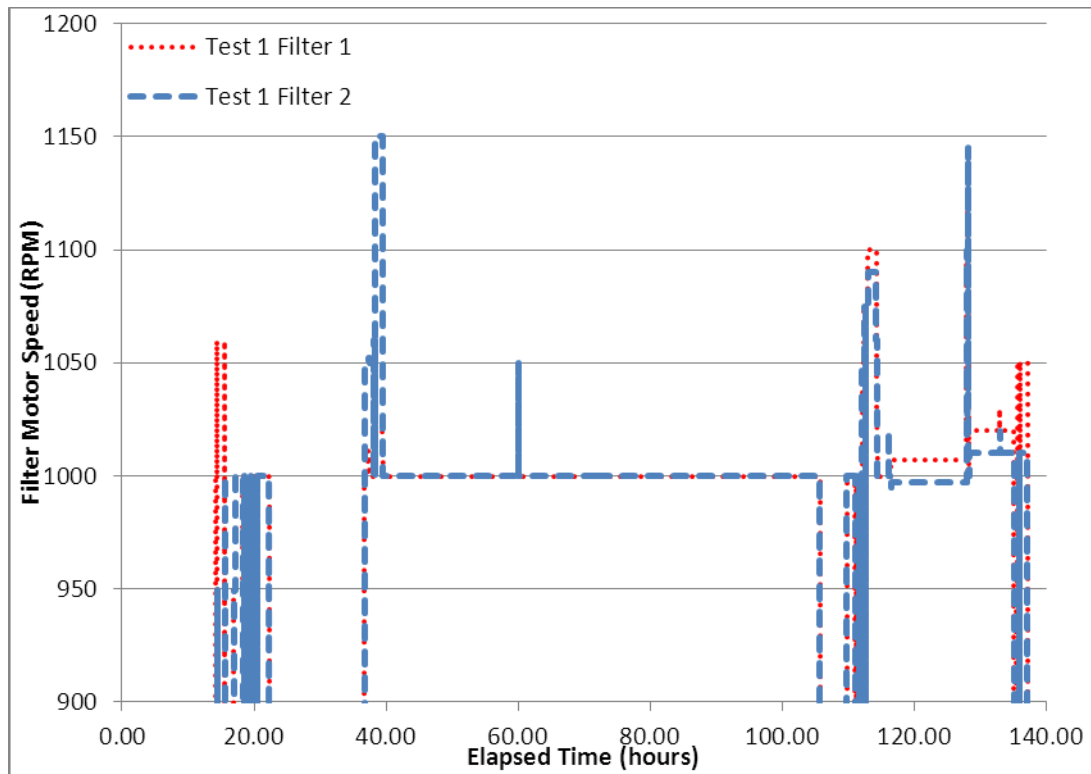
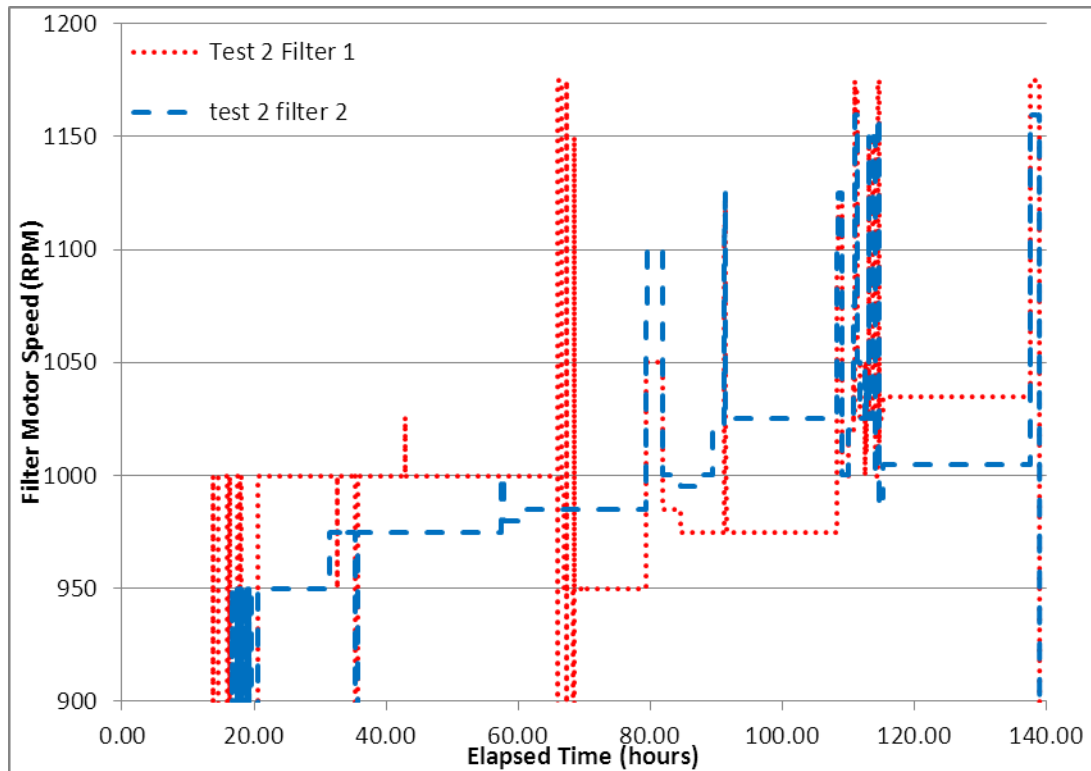
During both tests, the filters were primarily run at a reduced rotational speed. Graphs of the filter operational speed for Test 1 and Test 2 are Figure 9 and Figure 10 respectively. Historically, the filters have been operated at approximately 1200 rpm. Two issues required the reduction of the filter speed during the two tests. During Test 1, the vibration amplitude was very significant at full speed, due to approaching a resonant frequency in the support structure. Operating at reduced speed for the filters while the test stand was being stiffened and motor to filter alignment improved kept the vibration to a manageable level. Secondly, operating the filters at full speed added to the heat load of the system and exceeded the system cooling capacity of the facility. The filters had to be run at reduced speed to maintain the temperature of the process fluid.

**Figure 9. Rotational Speed of Filters during Test 1**

**Figure 10. Rotational Speed of Filters during Test 2**

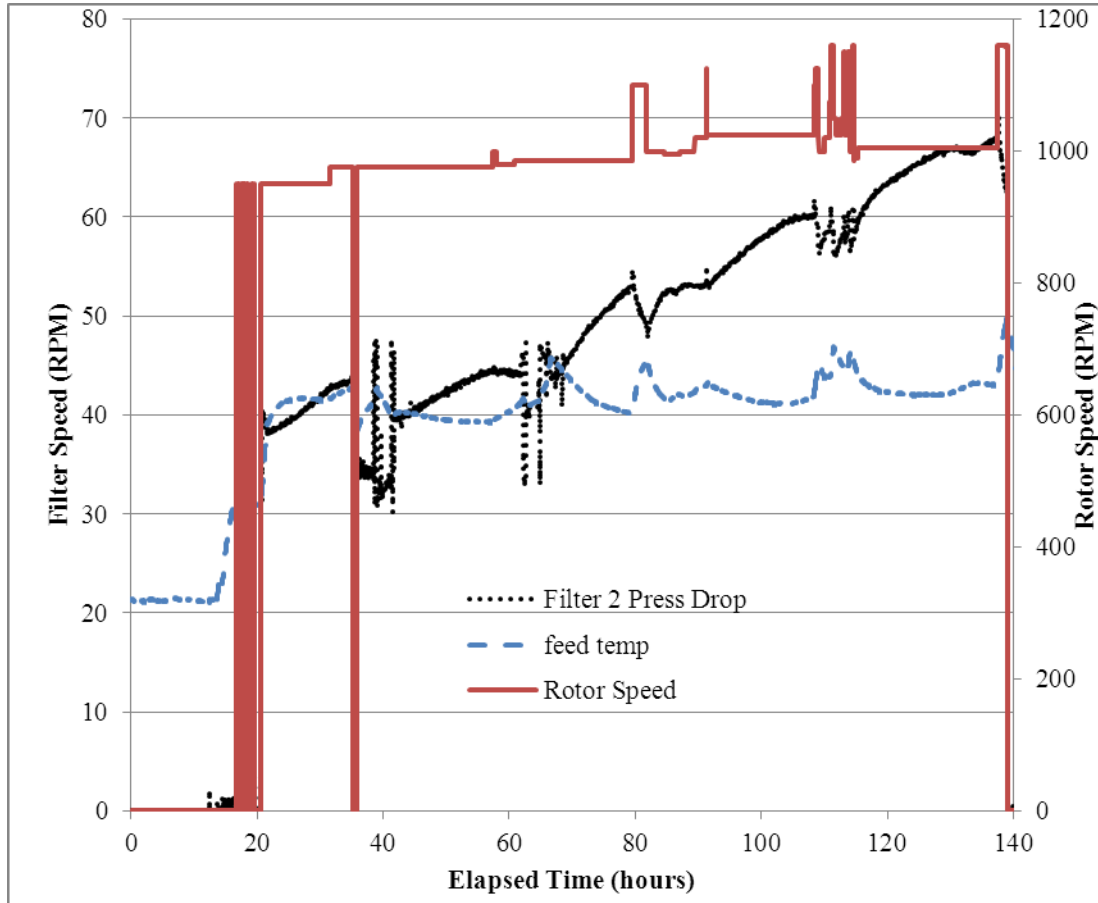
**Figure 11. Test 2 Filter 2 – Effect of Increasing Rotor Speed**

Increasing the speed of the rotors resulted in a significant reduction in the pressure drop across the filters. It also resulted in a marked increase in feed temperature. As can be observed in Figure 11, the decrease in pressure drop directly corresponded to the increase in temperature resulting from the increase in rotor speed. The change in viscosity due to the change in temperature was the dominant effect on pressure drop.

It is anticipated that an increase in rotor speed would aid in the prevention of filter cake buildup and; therefore, maintain a higher filtration rate. The impact of temperature dominated any effect of rotor speed change to filtration rate in this set of tests.

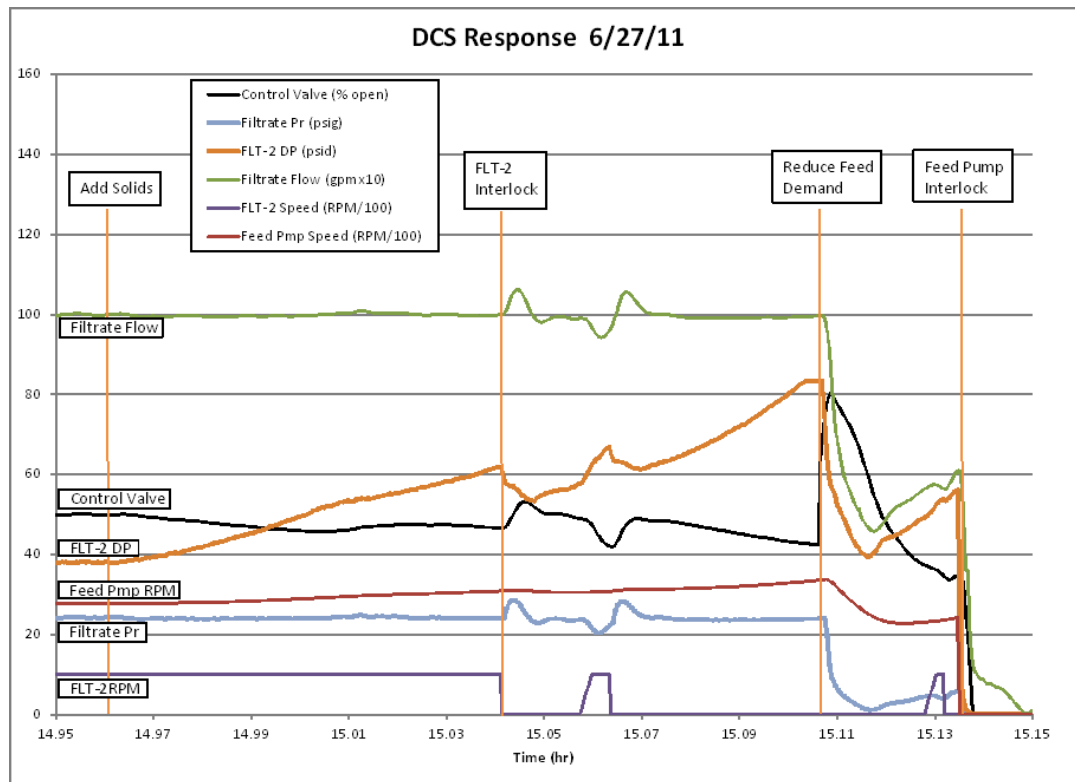
**Figure 13. DCS Response to Parameter Change Prior to Tuning**

While the control logic was able to respond to gradual system changes, step changes initially caused problems. If a large change was made to a set point, the control logic altered the system variables to respond. The system would drive parameters such as pump speed or valve position until the set point condition was met or the parameter was maximized/minimized. For example, if an increase in filtrate demand was entered, the control logic would respond by altering the concentrate valve position. The valve position would continue to close until the new set point for filtrate demand was reached. If the system response was not fast enough, the valve would close entirely resulting in a loss of flow and consequential trip of the system due to lack of concentrate flow. Figure 13 illustrates set point changes resulting in the shutdown of the system.

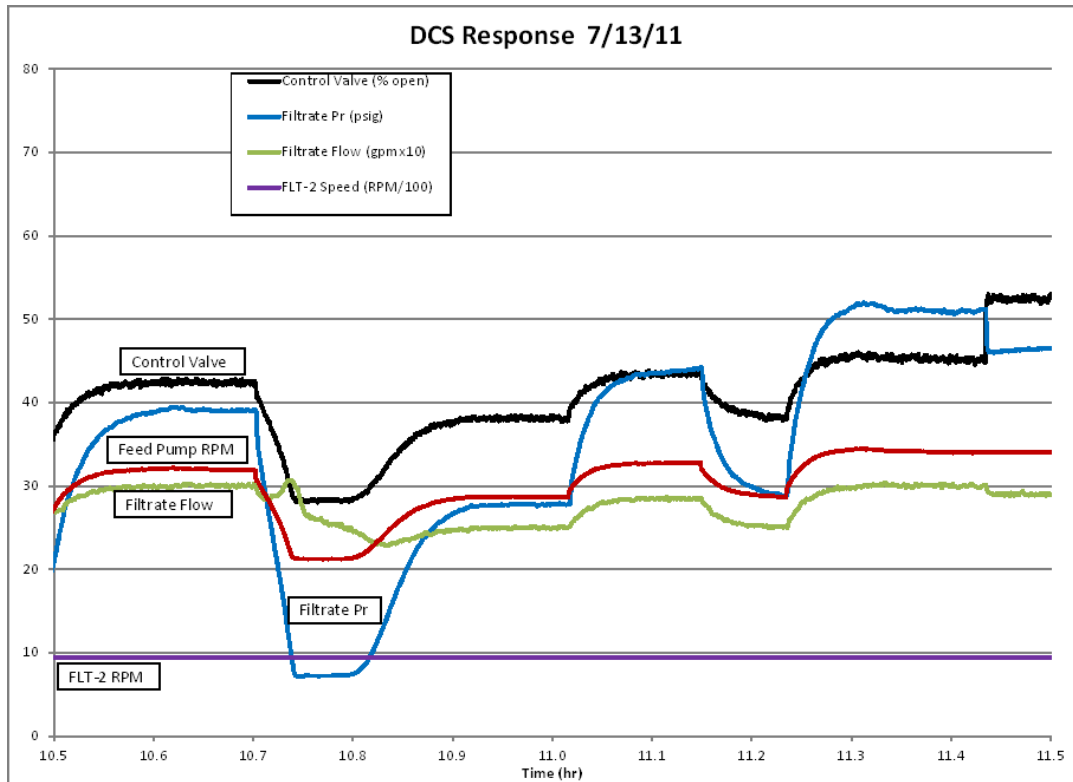
**Figure 14. DCS Response to Parameter Change after Tuning**

The control logic was tuned to respond to dramatic changes by altering several parameters without causing the system to shut down. This was accomplished by setting limits to the amount of adjustments that could be made to the response parameters. For example, the control valve position was limited to 20% open to prevent a complete closure of the valve and resulting system shutdown. Other parameters were then altered, such as pump speed, to allow the system to achieve the new set point. An example of the tuned system response is illustrated in Figure 14.

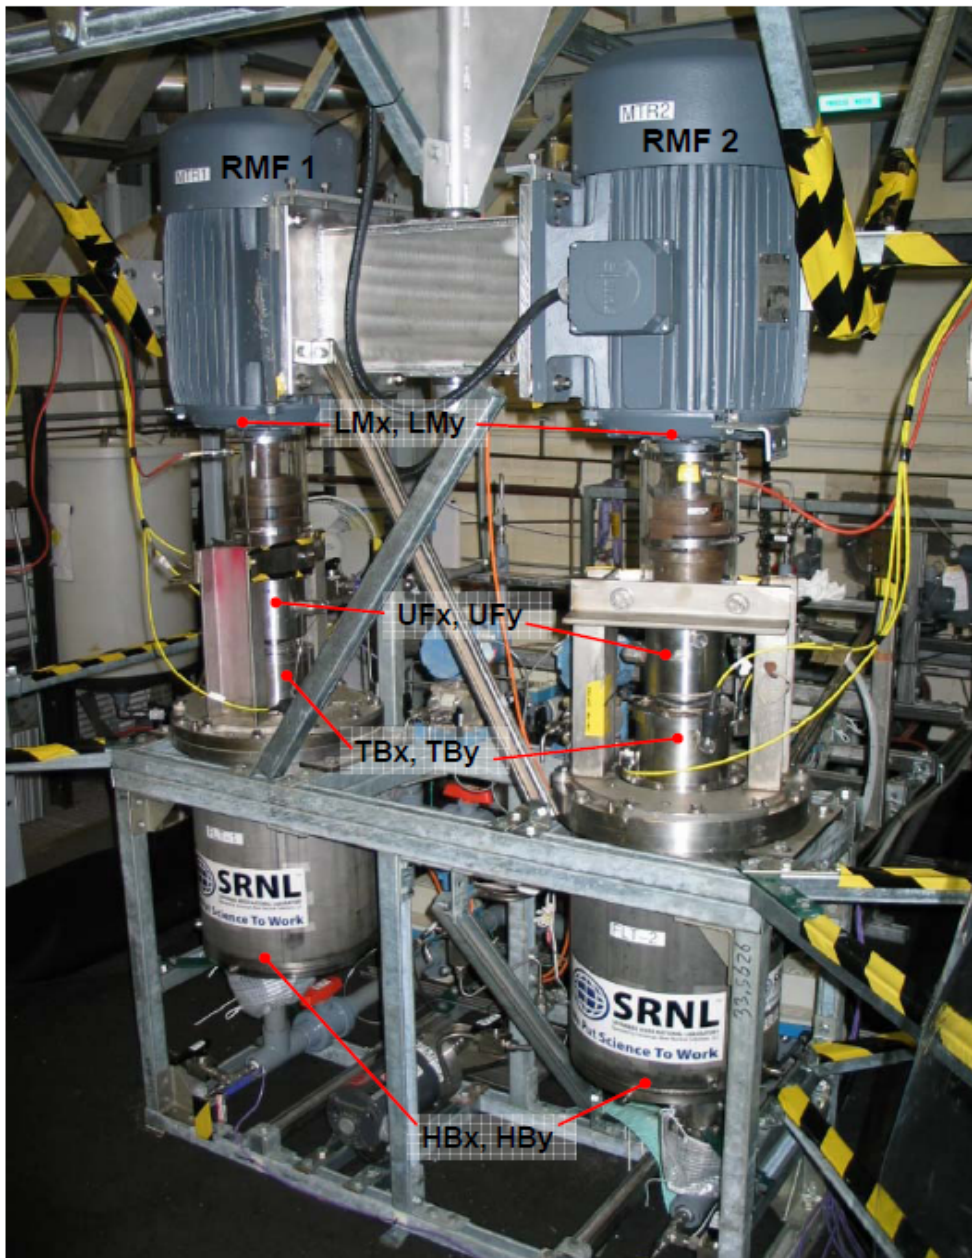
**Figure 15. Vibration Monitoring Point for Dual Rotary Microfilter System**

Casing vibrations were collected off the rotary microfilter units during dual rotary filter system testing. Figure 15 shows the measurement points. Sensors were arranged orthogonal at each elevation for recording information in two radial directions. A portable machinery analyzer (CSI model 2120-2) and general purpose accelerometers (Wilcoxon Research 742) were the primary tools used during monitoring. A speed series was conducted at the end of filter tests with a Data Signal Processing Instrument (ADRE 408 DSPi) and Velometers® (Bently Nevada 330500) to collect additional waveforms and generate spectra at different speeds.

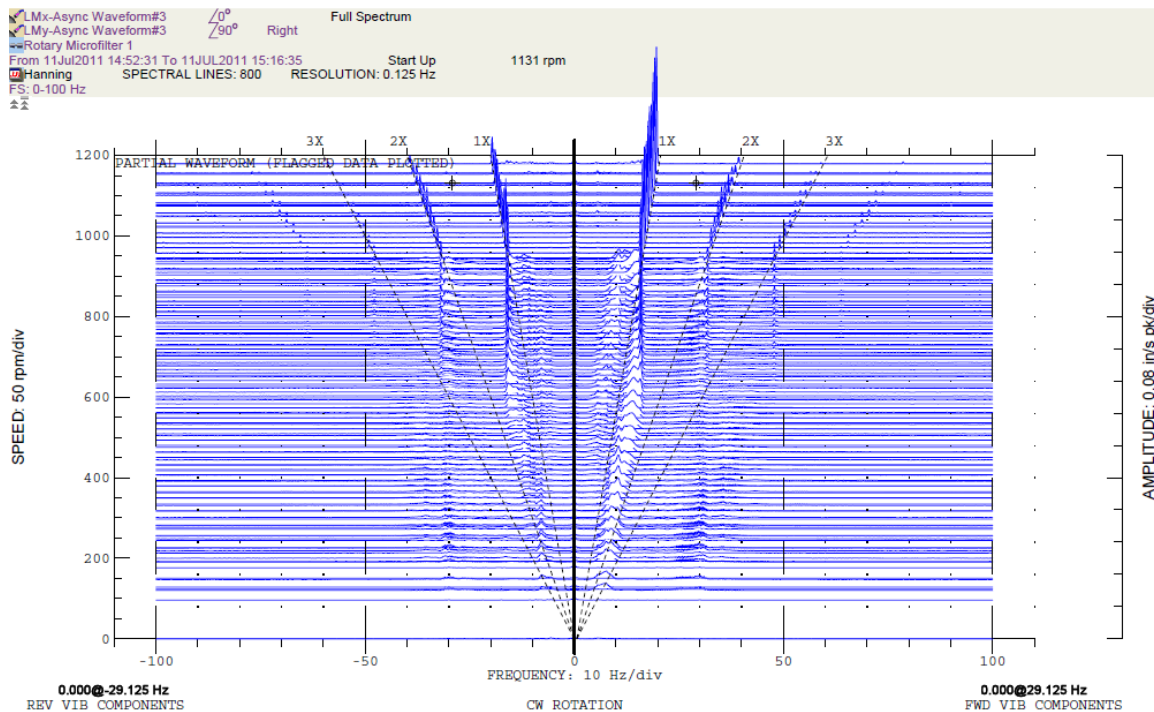
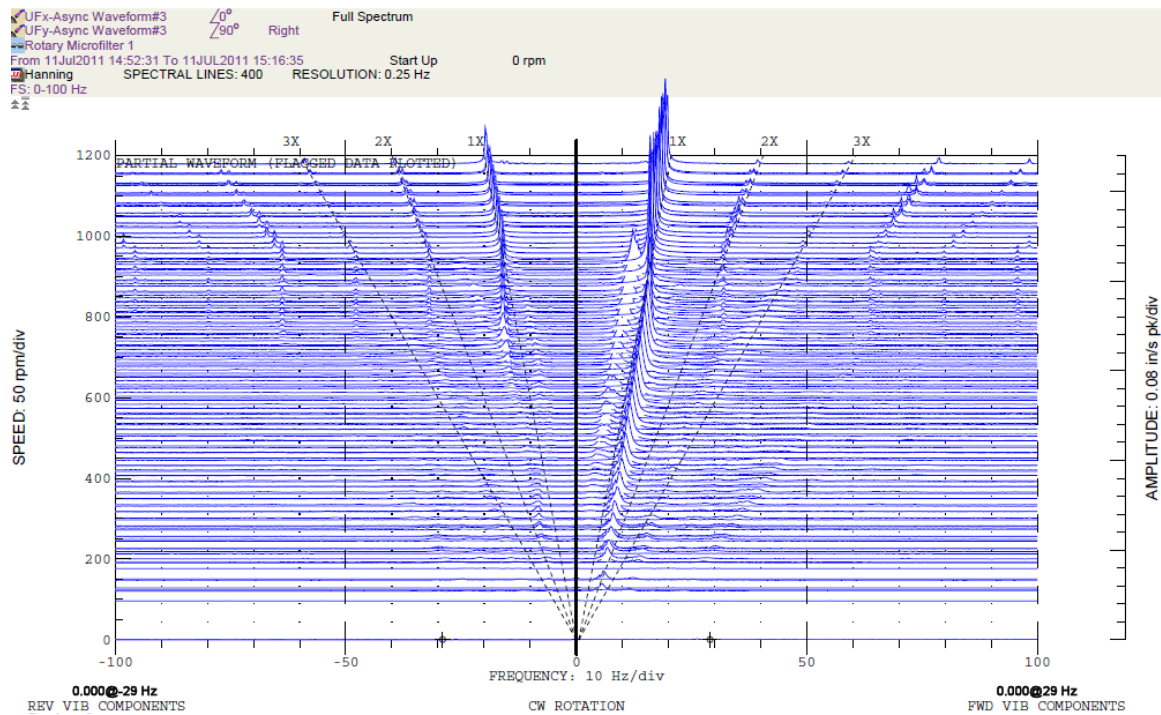
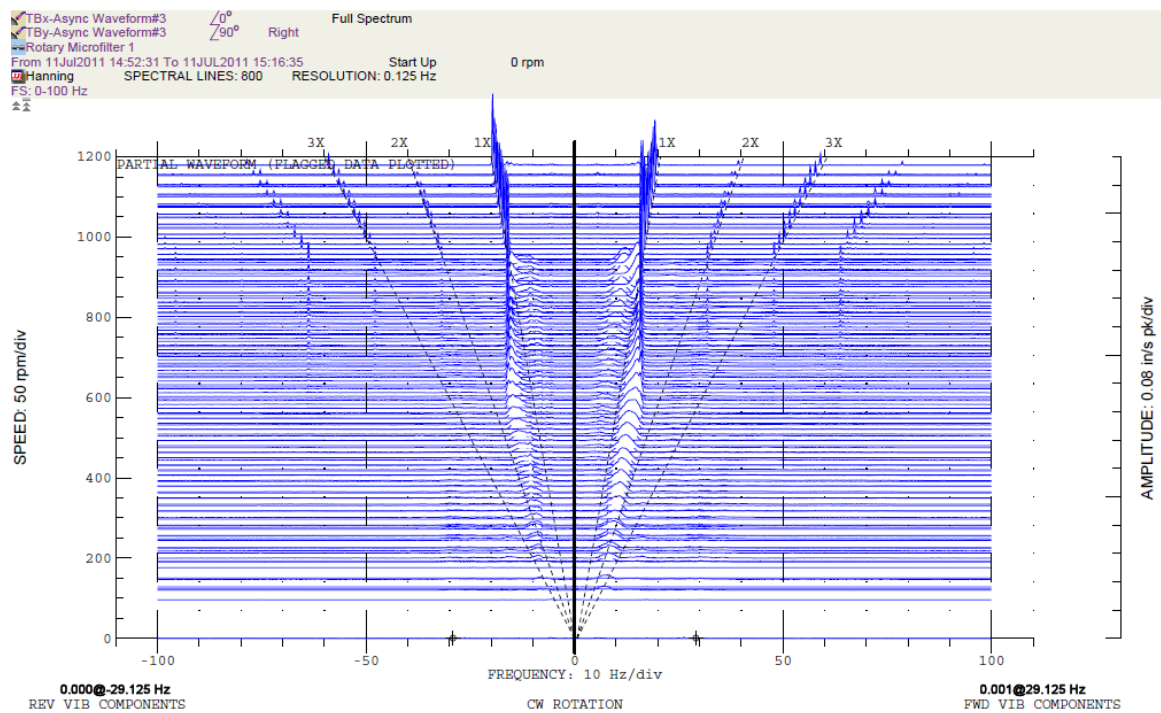
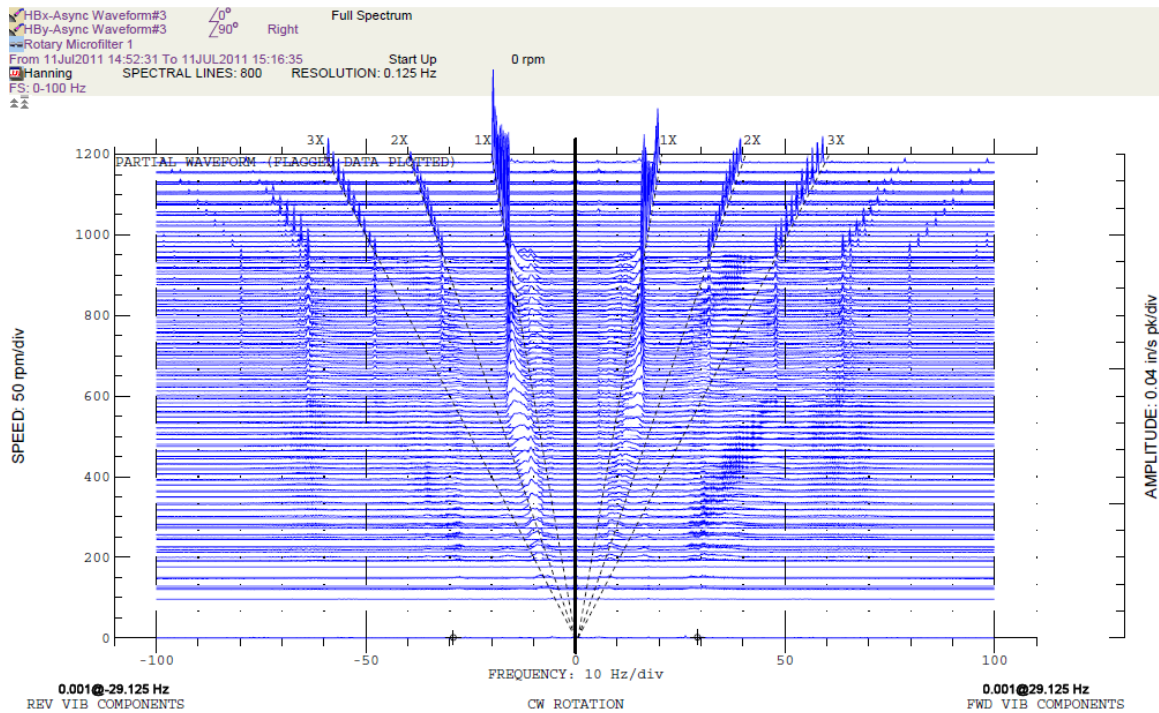
Spectrum cascade plots, or more simply, cascade plots for Filter #1 are shown in Figure 16 through Figure 19 during startup and shutdown of the equipment. The full spectrum cascade plots show a series of vertical peaks on different spectra. The fundamental, or first harmonic, appears around 16.125 Hz (967.5 rpm). The frequency becomes visible in the plot around 600 rpm and the peak amplitude is fairly constant as the machine speed increases to 960 rpm. When the 1X forcing frequency, typically caused by a combination of runout, shaft bow and unbalance, reaches this frequency, the vibration amplitudes grow significantly and harmonics which track

Sidebands are also evident in the cascades. These sum and difference frequencies are produced when one signal modulates another and can occur by nonlinearities and asymmetries in rotor systems or during rapid changes in machine accelerations or decelerations.

**Figure 16. Cascade Plot of Motor Vibration for Filter #1**

Figure 17. Cascade Plot of Rotary Union Vibrations for Filter #1

Figure 18. Cascade Plot of Gas Seal Housing Vibrations for Filter #1

**Figure 19. Cascade Plot of Rotor Housing Vibrations for Filter #1**

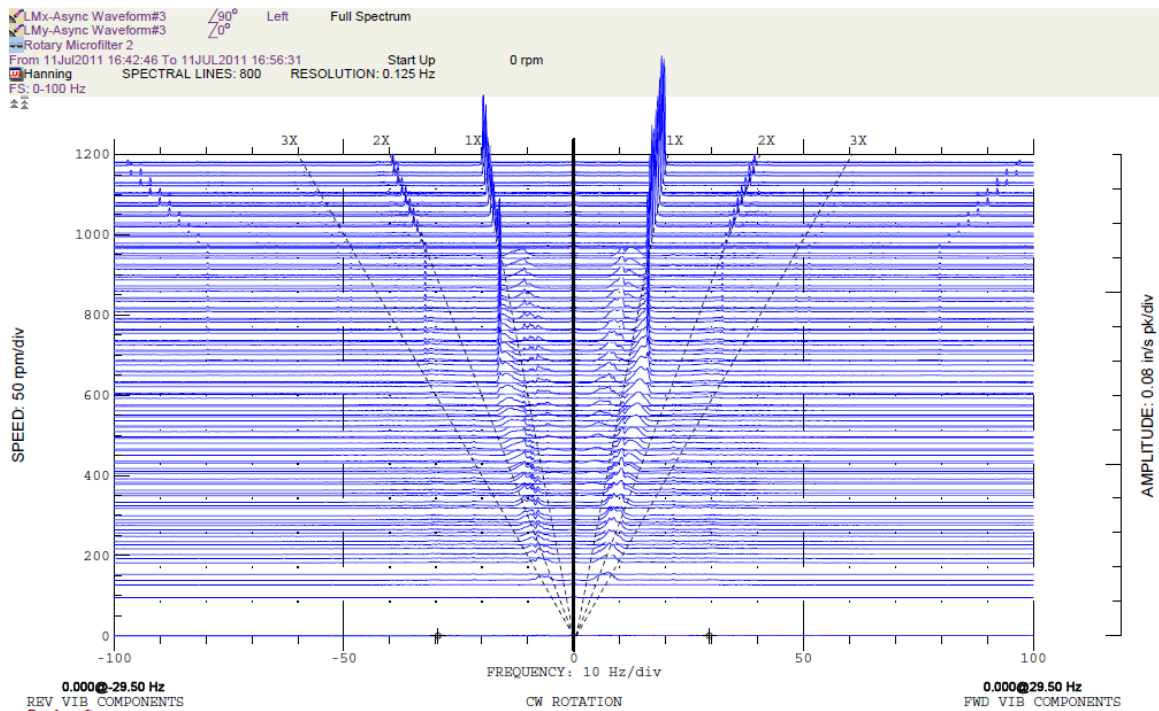
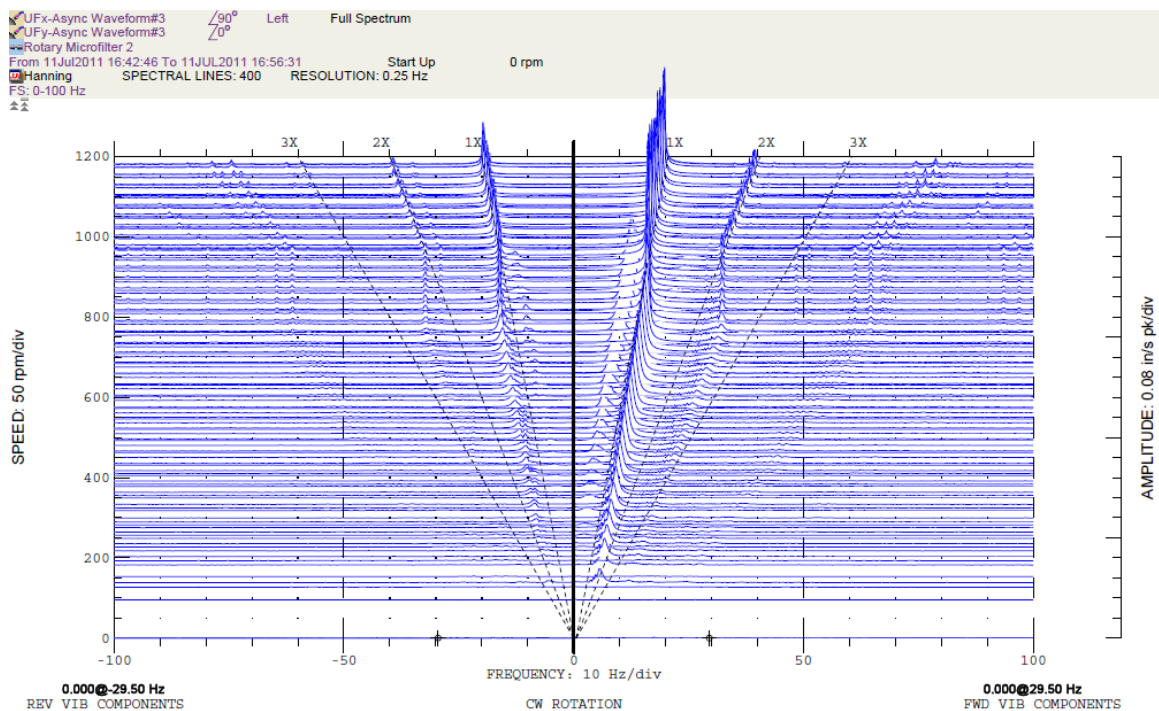
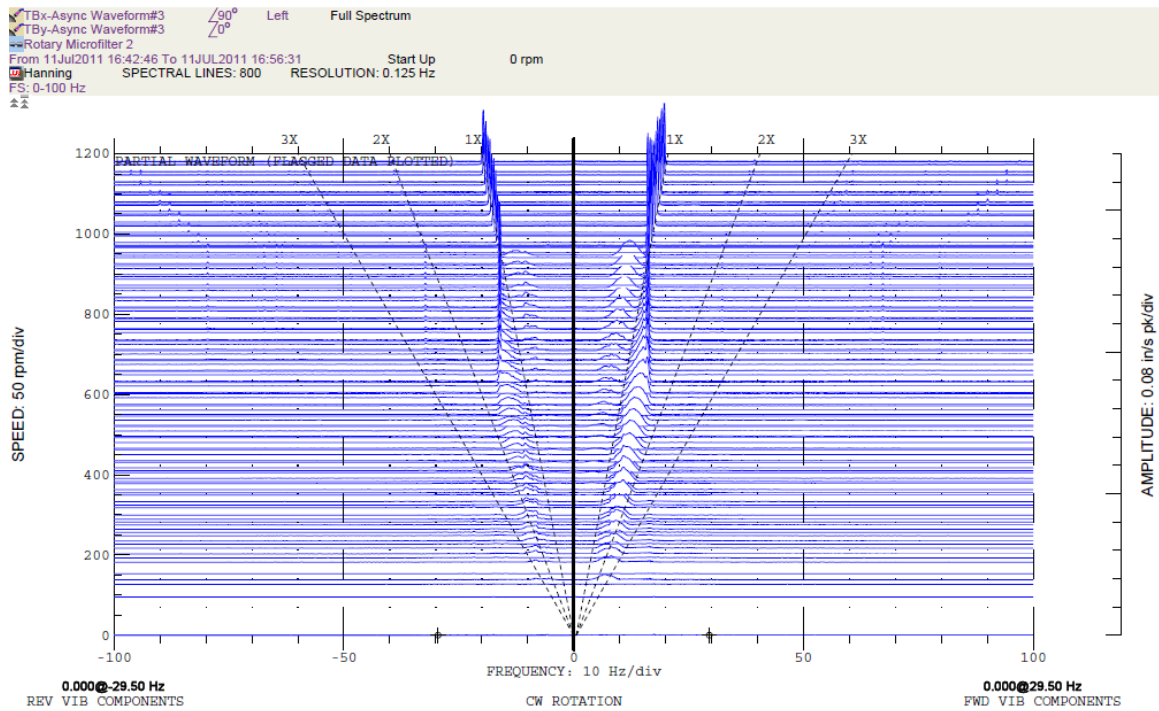
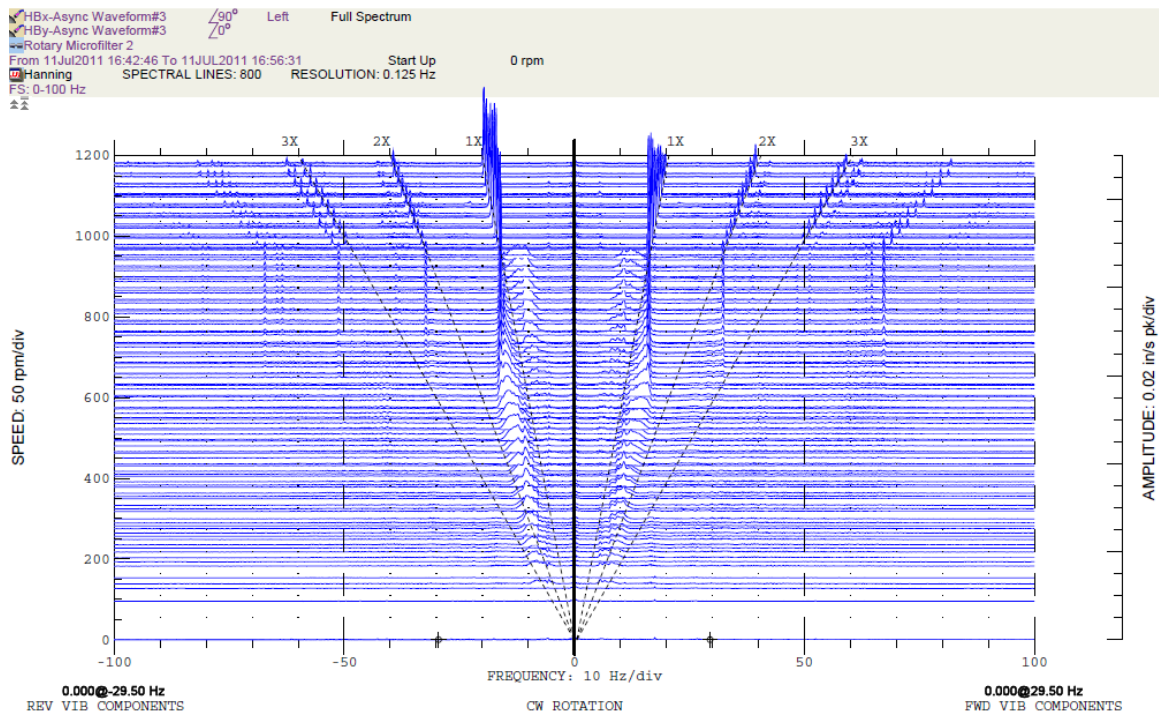
Cascade plots for Filter #2 are presented in Figure 20 through Figure 23. A vibration pattern similar to Filter #1 is observed in these data plots. This suggests the cause of the vibration is common in the design of the filter, or being caused by the equipment set up. The reverse precession seen in Figure 23 for rotary microfilter housing 2 is worth mentioning and could be due to misalignment at the motor coupling.

Figure 20. Cascade Plot of Motor Vibrations for Filter #2

Figure 21. Cascade Plot of Rotary Union Vibrations for Filter #2

**Figure 22. Cascade Plot of Gas Seal Housing Vibrations for Filter #2**

**Figure 23. Cascade Plot of Rotor Housing Vibrations for Filter #2**
