## **Testing of the Dual Rotary Filter System**

D. T. Herman  
M. D. Fowley  
D. B. Stefanko

August 2011

Savannah River National Laboratory  
Savannah River Nuclear Solutions, LLC  
Aiken, SC 29808

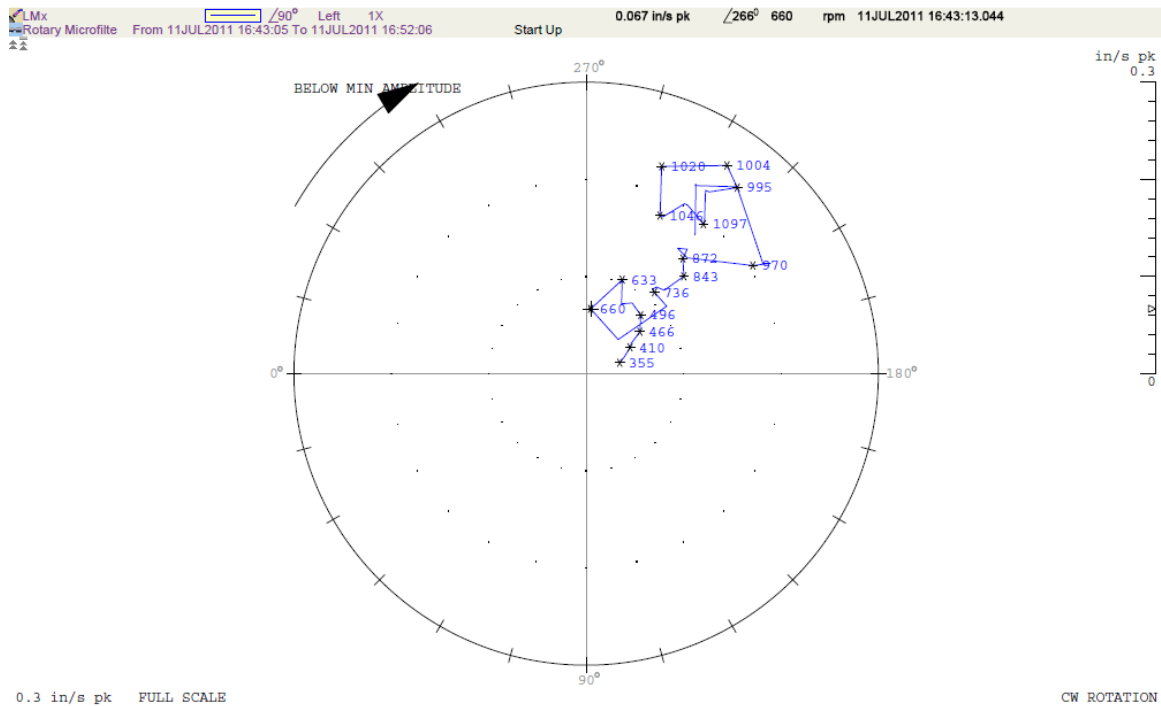
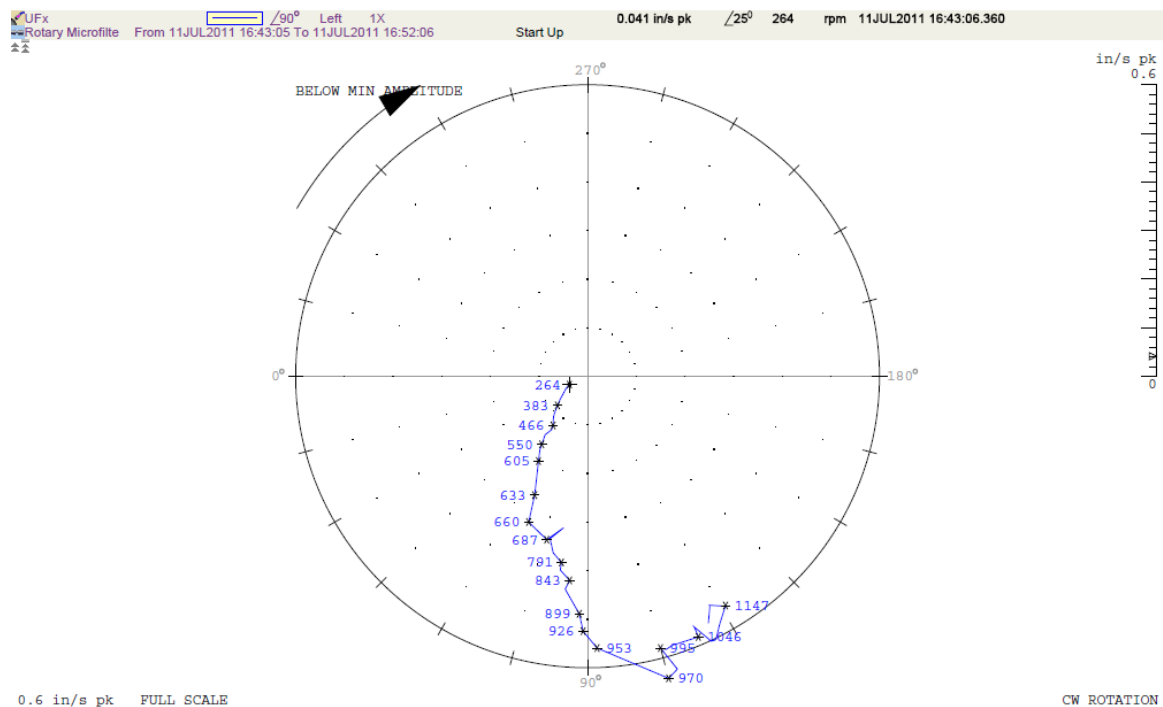
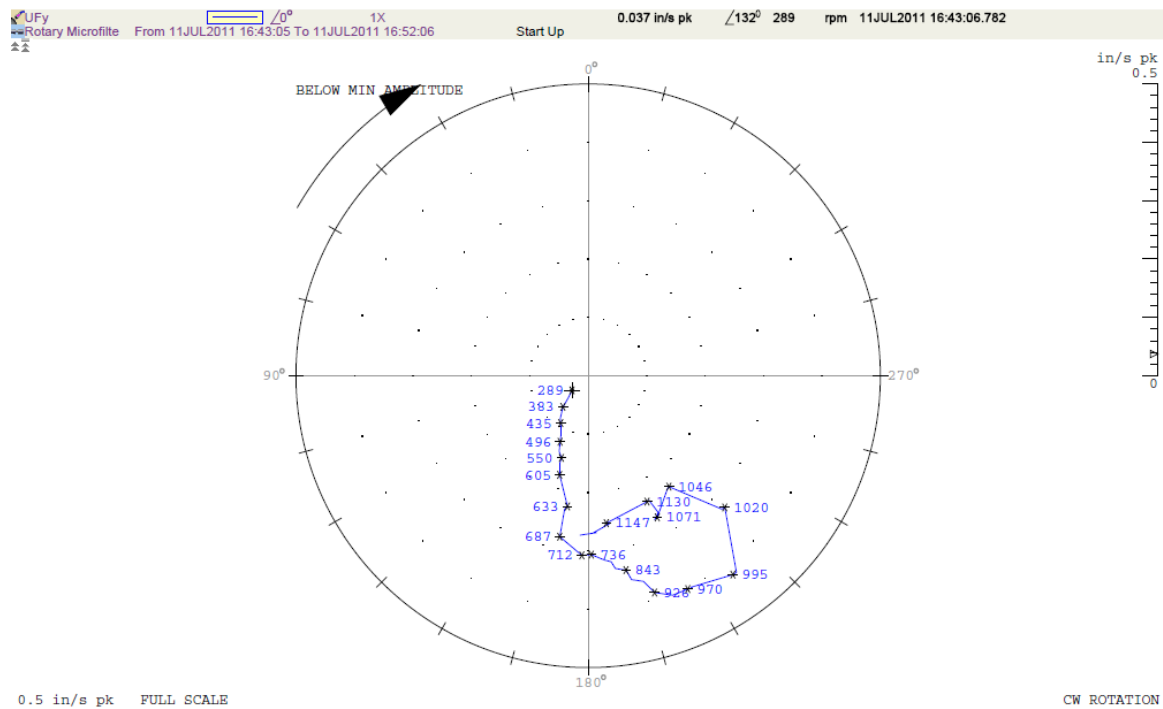
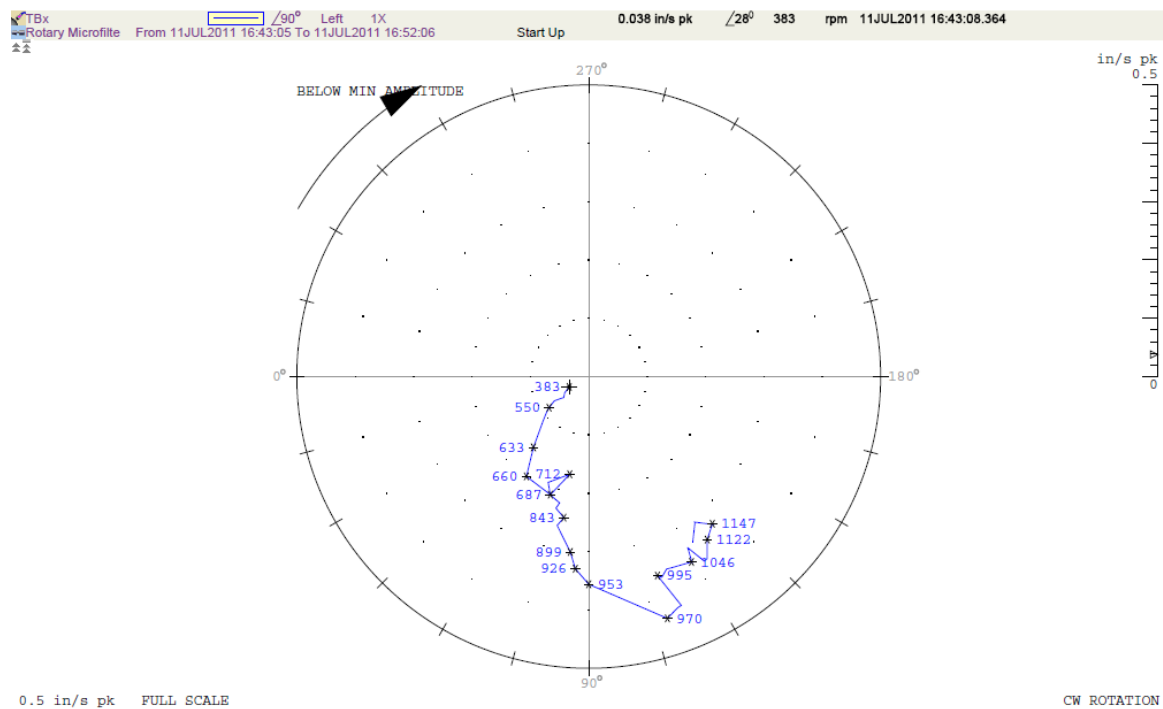
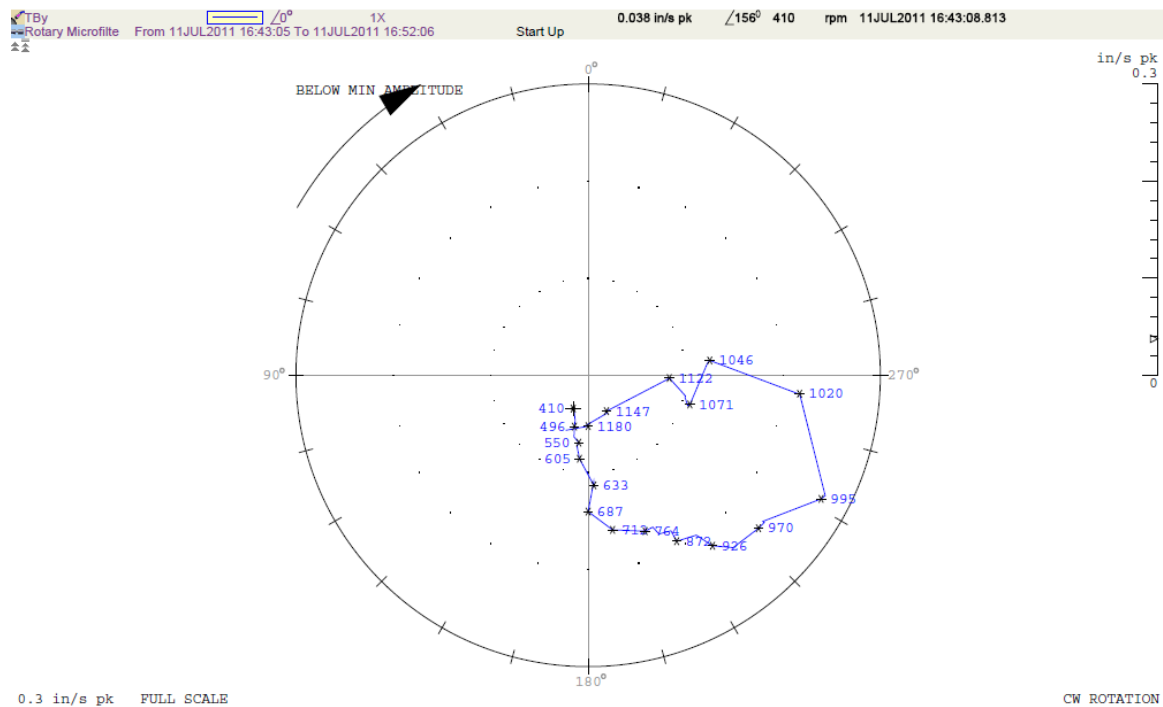
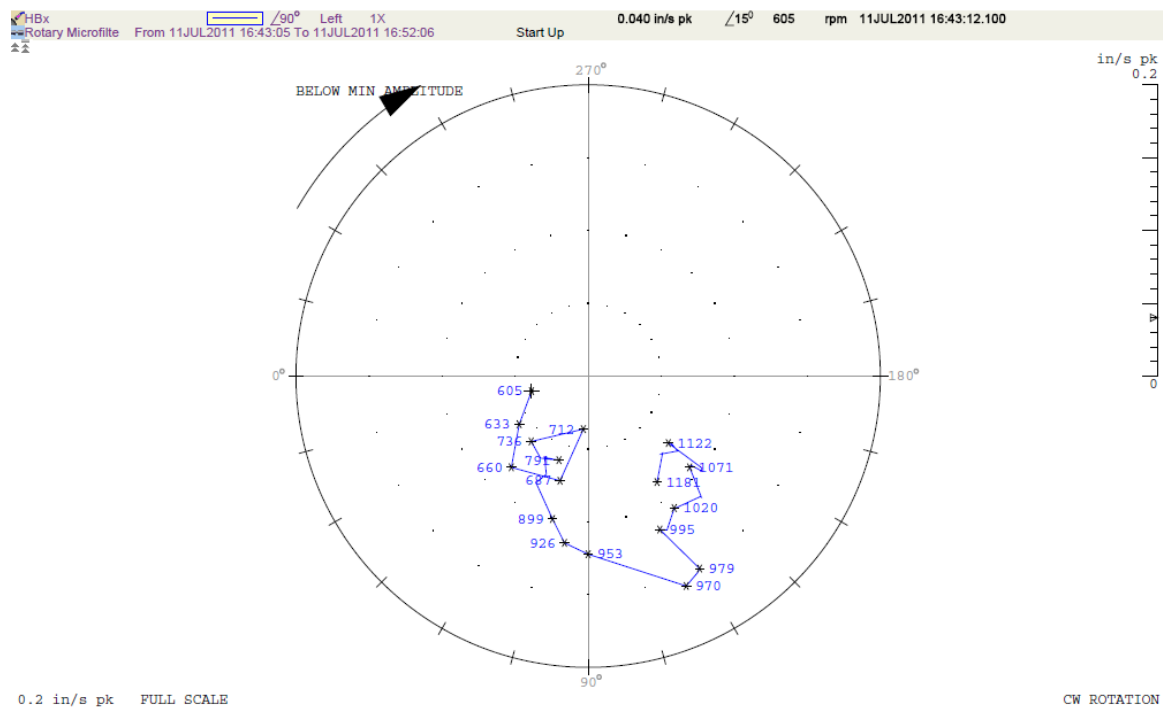
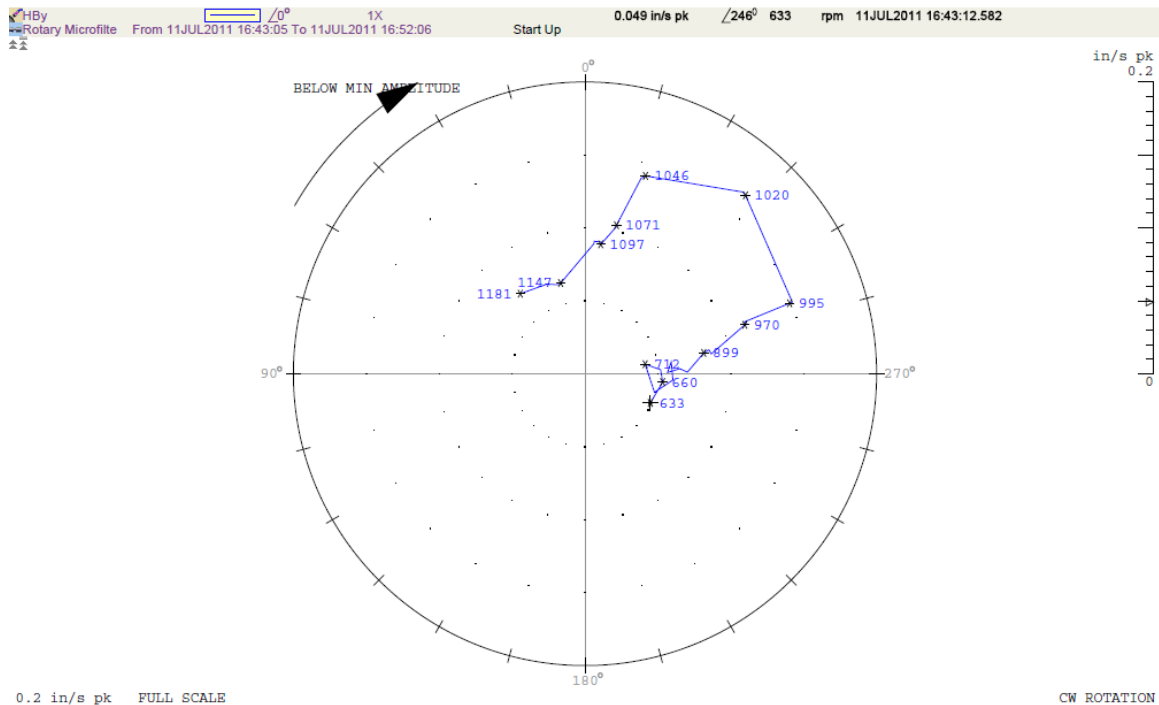
Several polar plots are presented in Figure 24 through Figure 31. Polar plots are most commonly used to locate the direction of the heavy spot for balancing purposes and with eddy current/proximity probes that measure displacement. Use of this plot format can also help in

identifying system natural frequencies with casing vibration measurements. Plots from the rotary microfilter speed series display loops around 630 rpm, 970 rpm and 1020 rpm. These loops identify phase changes which is indicative of resonance in a system. Whether the resonance is associated with a rotor critical or structural is hard to distinguish with casing measurements. A relative motion measurement would have helped in the evaluation but there was not enough free space on the shaft to install the probes in the test system.

The following can be deduced from the vibration data:

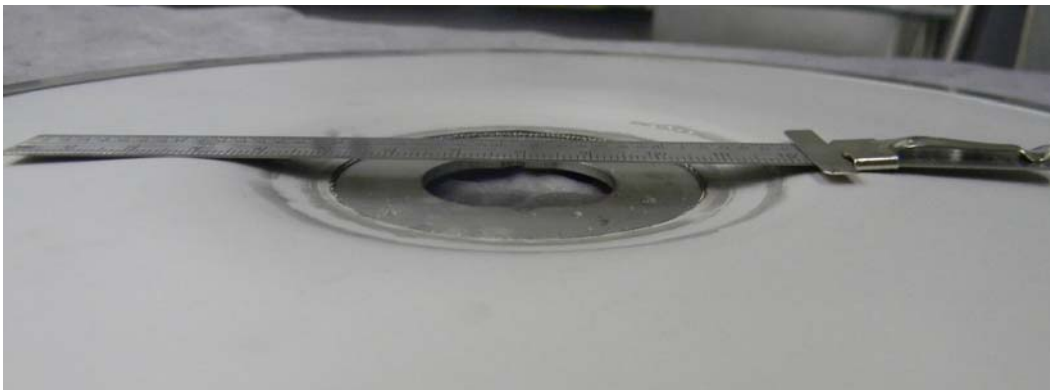
**Figure 32. Filter Disk from Reverse Pressure Testing<sup>x</sup>**

During an interruption of the testing, Filter #1 was removed and inspected. It was observed that the filter disks had undergone a reverse pressurization at some point during the testing. The membranes were no longer sitting flat on the disks and appeared very similar to the disks from the reverse pressurization testing.<sup>x</sup> A photo of a disk from the reverse pressure testing is shown as Figure 32.

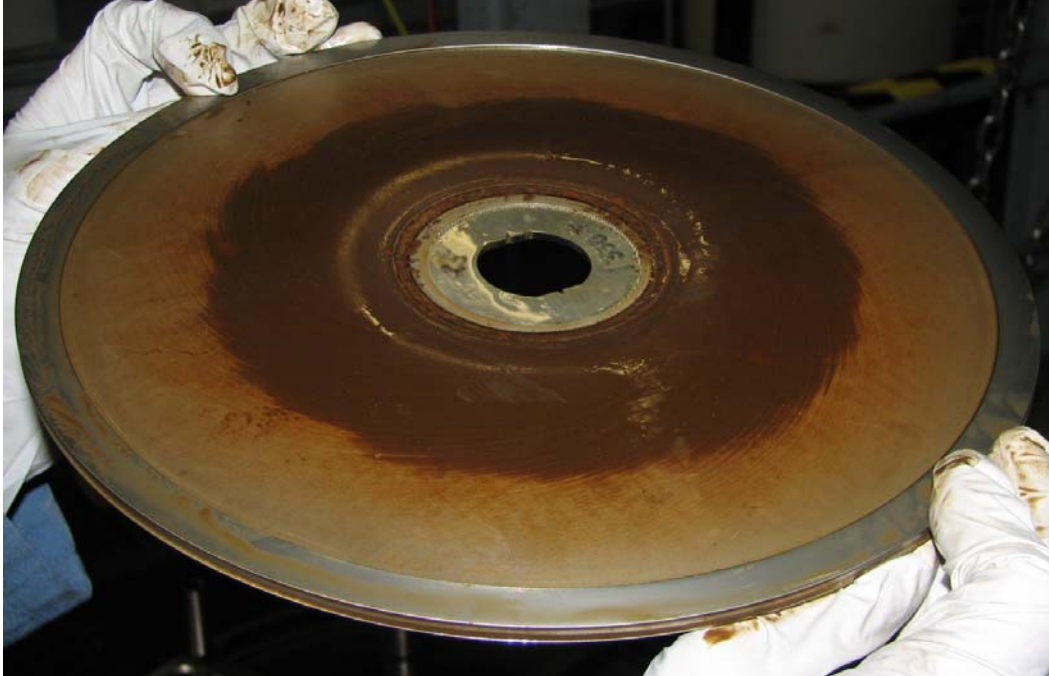
**Figure 33. Disk from Filter 2 (old filter) with Evidence of Reverse Flow**

A photo of a disk from Filter #1 after the first 100 hours of testing is shown as Figure 33. The membrane was no longer sitting flat on the disk support structure and showed a deformation similar to that seen in Figure 32 though not to the same extent.

Two probable causes exist for the deformations. The first potential cause of a reverse flow through the disks severe enough to deform the membranes would be a vacuum pulled on the filter chamber as the filter housing gravity drained into the feed tank. The filter housing may have been vented through the filtrate line resulting in the reverse flow through the disks. This is the more likely cause and is consistent with the movement of the stationary seal face in the rotary union of Filter #2 discussed in 3.2.4.

The second potential cause would be operation (spinning) of the disks with no feed pressure. On one occasion during testing of the control system, the feed pump tripped off by an interlock but the filters continued to operate. The filters continued to spin for approximately two minutes before being turned off. This situation would have resulted in a reverse flow through the disks as the centrifugal force expelled filtrate from the disks back to the housing. This is considered less likely based on the authors' experience operating filters in the past and observations made during the reverse pressurization testing.

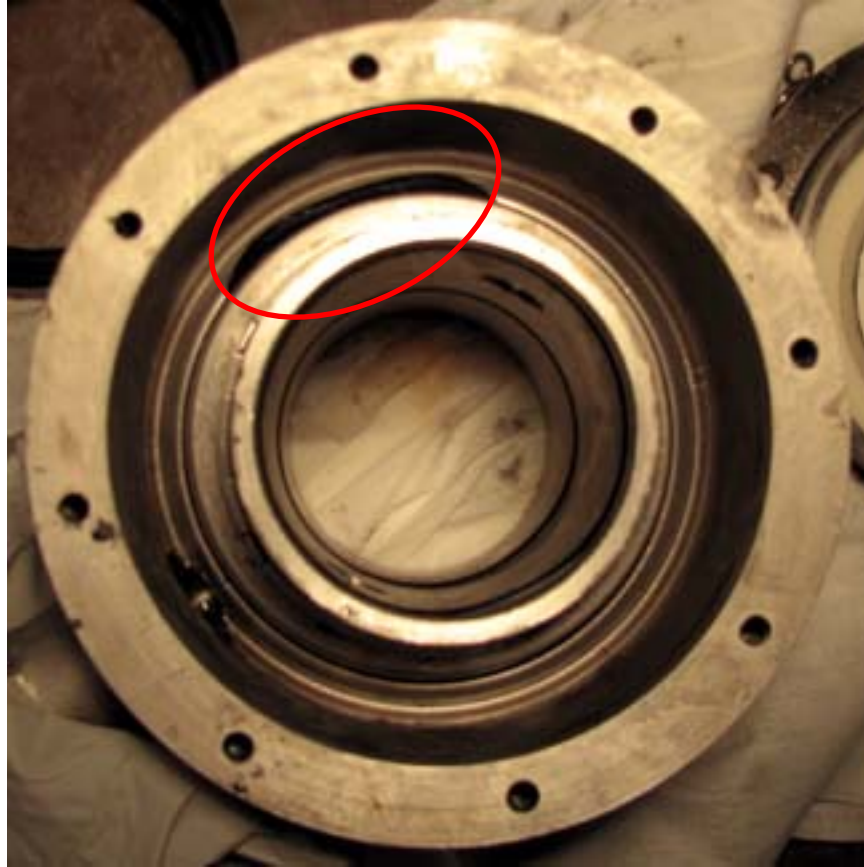
**Figure 34. Leak Path from Rotary Union**

During a restart of the filter, filtrate leaked from the rotary union of Filter #2. The system was shut down and the rotary union was removed and disassembled. A picture of the cause of the leak (Figure 34) shows the concentric O-ring that seals the stationary face of the mechanical seal in the rotary union housing extruded.

Up to this point, the system had been running without incident. Prior to the start of Test 2, the system was shut down without isolating the filtrate lines as previously discussed. The hypothesis is the gravity drain of the feed from the filter housing, pulled a vacuum on the filtrate line and resulted in the stationary seal face being drawn inward. This resulted in the condition shown in Figure 34.

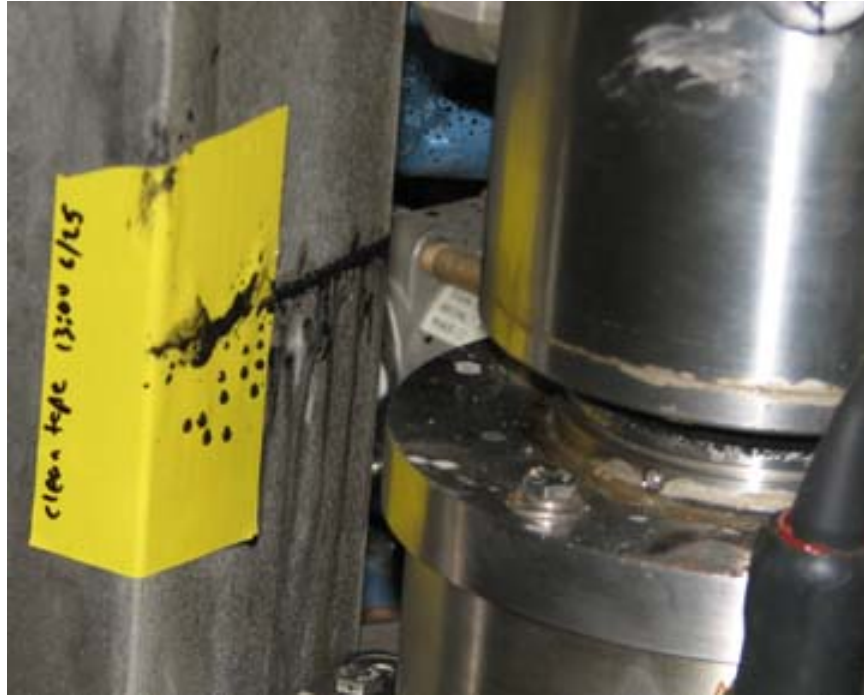
**Figure 35. Rotary Joint of Filter # 2 with Evidence of Salt and Carbon Discharge**

The system was originally plumbed with a hard pipe connected to the rotary union based on SRR input on the deployment design. This configuration was run for the first 100-hour test. Historical setups of the RMF had always used a flexible line to connect the rotary union to hard piping to dampen vibration. Approximately 60 hours into testing, evidence of wear on the carbon seal face and the passage of minute quantities of filtrate were observed on the rotary union of Filter #2. A line of material, carbon and salt solution residue, was observed on the bearing support structure (Figure 35). The line was formed over time as the material passed the seal face and was eventually slung from the rotating parts of the rotary union to form a visible black line on a nearby support structure.

The rotary union on Filter #2 was rebuilt with new seals between Test 1 and Test 2. With the flexible lines installed for the second test, the line of salt and carbon was not observed. The rotary union from Filter #1 also did not have any additional dried salt traces, indicating that the material weep across the seal faces had been minimized. No changes occurred to the Filter #1 rotary union between tests. The passage of filtrate across the seal faces ceased after the flexible line was installed. No active leak was observed on either rotary union for the remainder of testing.

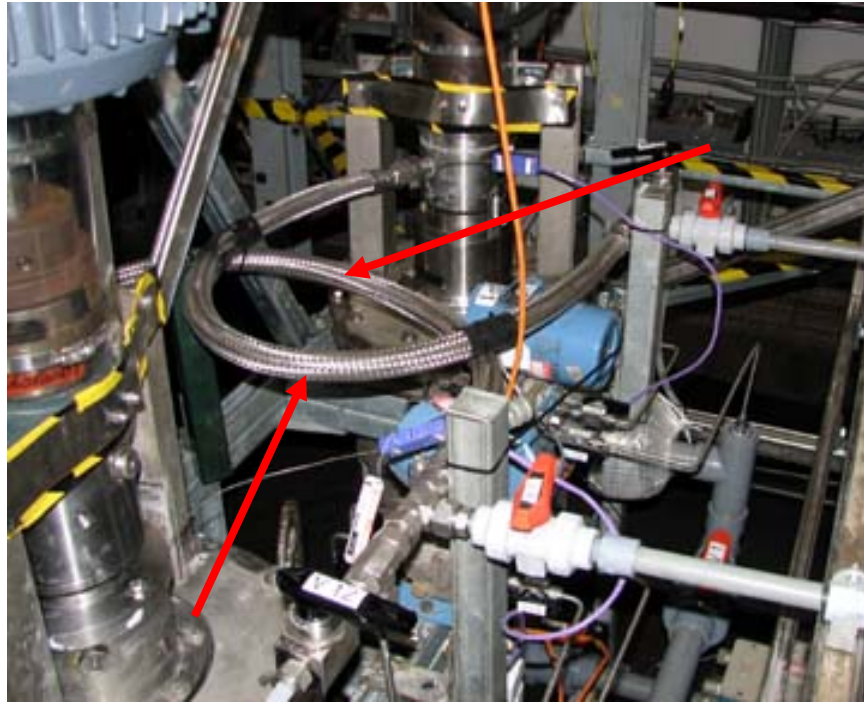
**Figure 36. Flexible Lines between Rotary Unions and Filtrate Piping**

Prior to the second 100-hour test, the hard pipe to the rotary unions were replaced with stainless steel flexible lines (Figure 36). The flexible lines were used to dampen and isolate vibration to the rotary union. The lines in the test are approximately three feet long. This line length was used simply due to availability. Previous tests used flexible lines of approximately one foot.

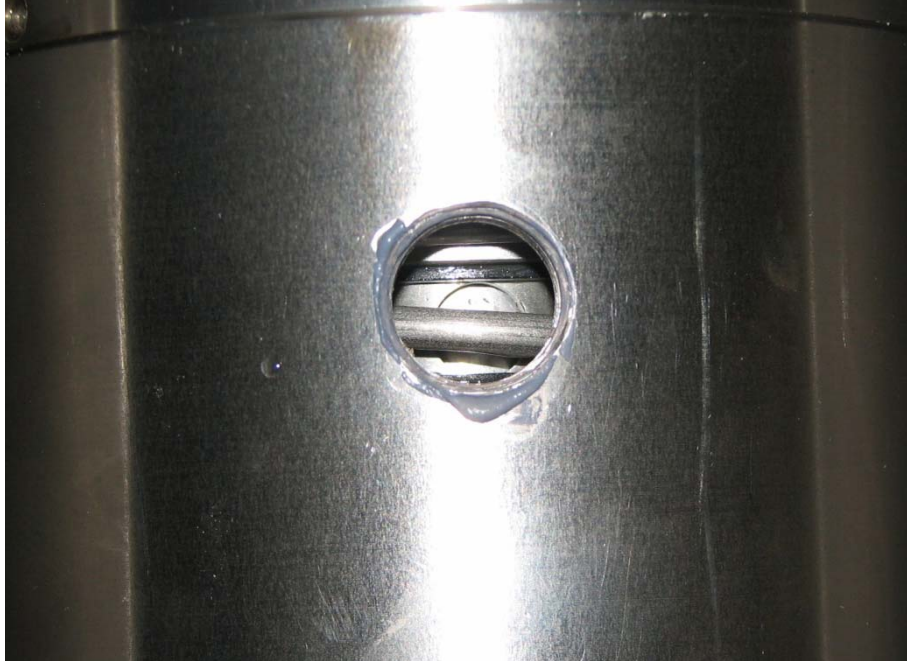
**Figure 37. Rotary Union Connection Showing Blocked Shaft Discharge**

Twice during initial testing, flow dropped significantly for one of the filters. The reason was due to the misalignment of the discharge port in the shaft with the inner hole of the rotary union. The misalignment occurred because the set screws holding the position of the rotary union on the shaft had become loose. The inner sleeve rotated and blocked flow out of the shaft. Figure 37 shows the discharge of the rotary union to the shaft. The inner hole in the rotary union sleeve behind the spring in the center of the photo should show the shaft discharge port. The rotary union has rotated and; therefore, only the side of the shaft is shown in through the inner sleeve hole.

In one instance, a misalignment occurred by the tightening of a pipe connection leading to the rotary union. The connection was tightened due to a minor leak. The rotary union was hard piped to the pipe connection and the torque applied to the connection forced the rotary union to move on the shaft. This and the other instances of misalignment were reported to the vendor and they have since changed the location and size of the set screws. The previous design of two set screws, internal and centered on the rotary union sleeve, replaced the small set screws on the top of the rotary union. An access port, added for installation and removal, was coupled with a flat added to the shaft for set screw anchorage.

SRNL recommended to the vendor the inclusion of a position indicator to aid in proper alignment of the rotary union inner sleeve and the shaft discharge port. Locating those holes is currently challenging and is accomplished by looking through the access ports on the rotary union. This will be very challenging in a remote facility if the union requires replacement.

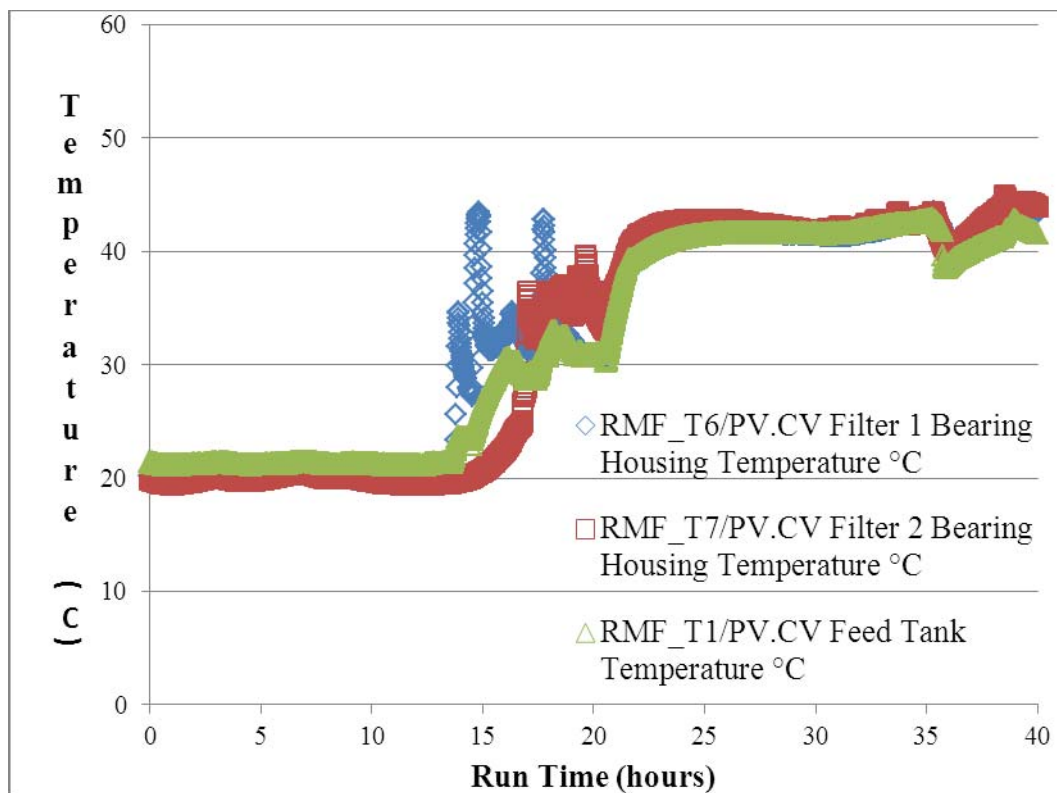
**Figure 38. Filter Main Bearing Temperatures for the First 40 Hours of Test 2**

During the testing, a sharp increase in bearing temperature for Filter #1 was observed on several occasions. The temperature would spike rapidly and would then return to a temperature consistent with the system and Filter #2 bearing temperature. This was only observed during startup of the system. Figure 38 shows three separate occurrences during Test 2.

Monitoring the temperature of the individual bearings may provide insight into the condition of an individual filter. The precursor to bearing failure is expected to be elevated temperature. Plugging of one filter would reduce filtrate flow in that filter. Reduced filtrate flow would result in low cooling and lubrication to the rotary union seals resulting in elevated temperatures.

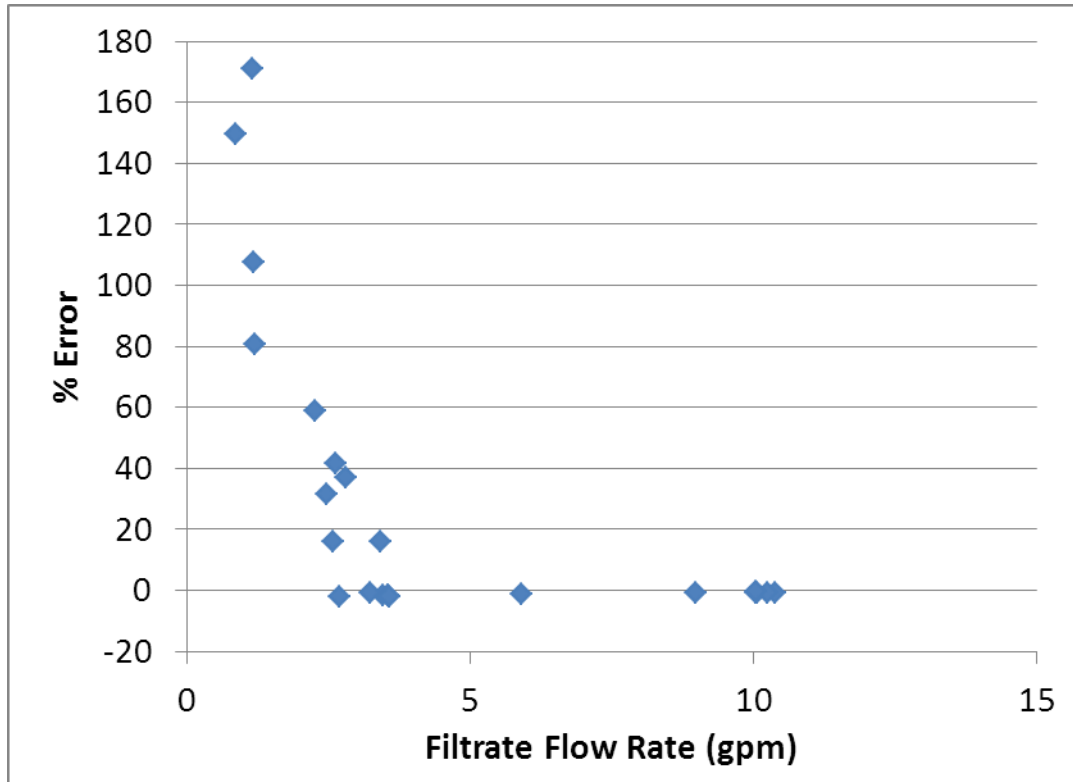
**Figure 39. Filtrate Flow Rate Discrepancy of 1-1/2" Meter**

combined output of the two ½" ABB magnetic flow meters in the separate filtrate lines to quantify the discrepancy. The discrepancy occurred at flow rates less than four gpm. The 1-1/2" Krohne had a maximum range of 240 gpm and the ½" ABB meters had a maximum range of approximately 30 gpm; therefore, the ABB flow meters were more accurate at low flow rates. Figure 39 shows the discrepancy of the Krohne as a percent of reading throughout the range of measured filtrate flow. Below 3.5 gpm, the reading becomes very inaccurate.

In anticipation of this problem, a 1" Krohne flow element was installed in the combined filtrate line. However, the element was never used since the flow rate discrepancy was noticed only towards the end of testing when filtrate set points were intentionally low. In addition, only one Krohne transmitter was available, which would require the elements to be re-wired. The accuracy of the 1" element (0-95 gpm range) is expected to be better than the 1-1/2" element. On the tank top, the filtrate flow rate from four filters is expected to be relatively high (~10 gpm) where this discrepancy should not be seen. However, flow rate alarms or interlocks at low flow set points may be affected by this discrepancy, in which case the 1" Krohne flow element should be considered instead of the 1-1/2" flow element.
